**Whitcher Wildlife Ltd.
Ecological Consultants.**

LYNN ROAD GATEHOUSE, ELY.

PRELIMINARY ROOST ASSESSMENT.

Ref No: 230573.

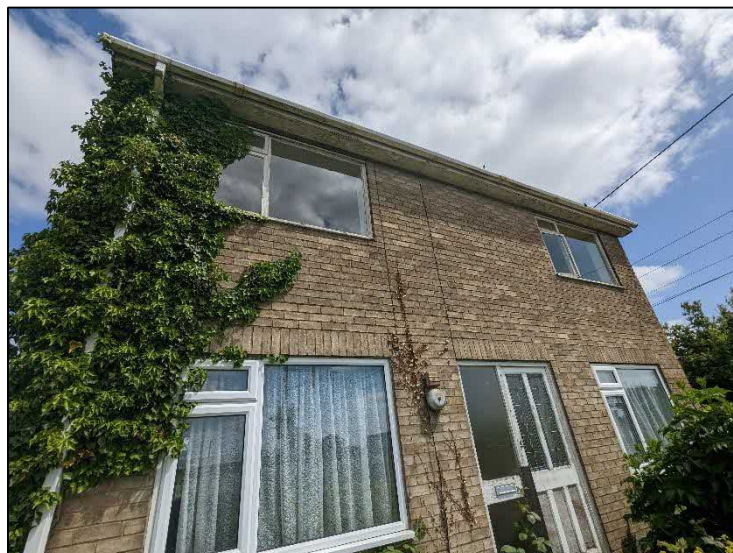
3.3.1. Externally, the walls of the building are in excellent condition with no sections of missing mortar or other defects. They are well pointed with no gaps to allow access for bats within. Ivy was present on all sides of the building, but this was not mature enough or did not have thick enough stems to create potential roosting opportunities for bats. The ivy was also firmly attached to the building, leaving no voids.

3.3.10. The ivy on the external walls has the potential to be used by nesting birds during the nesting bird season, as does the vegetation in the surrounding garden.

4.4. The ivy-covered walls provide suitable nesting habitats for birds within the breeding season (March to September each year). Therefore, the demolition of the building could have a high impact on breeding birds if carried out within the bird breeding season. Furthermore, the demolition is likely to destroy or disturb the surrounding vegetation within the garden, which could also have a high impact on nesting birds if carried out within the bird breeding season.

5.3. It is recommended that the works are undertaken outside of the nesting bird season, which extends from March to September each year. If this work is required during the nesting bird season, this must be immediately preceded by a thorough nesting bird survey. Any active nests found must be left undisturbed until young have fledged.

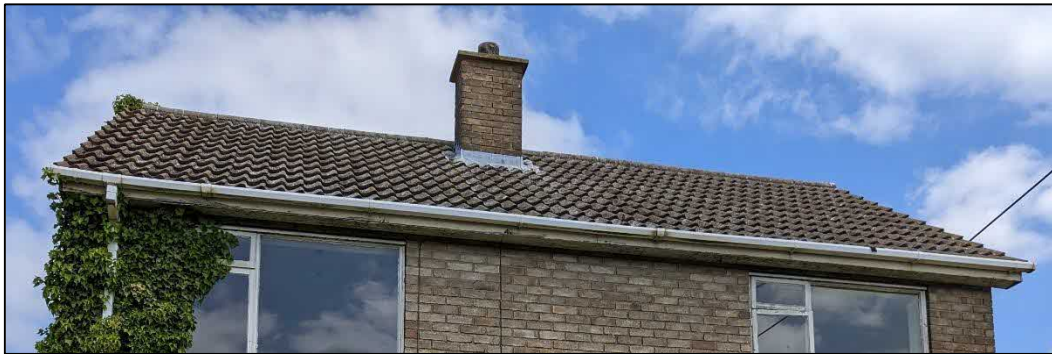
3.3.2. The roof of the building is also in a very good condition with no defects. All roof tiles and ridge tiles are firmly in place and none appear to offer suitable opportunities for bats to access beneath.

3.3.3 The flashing around the chimneys is also flush to the roof offering no access for bats. Both the roof tiles and chimneys can be seen in the photograph below.

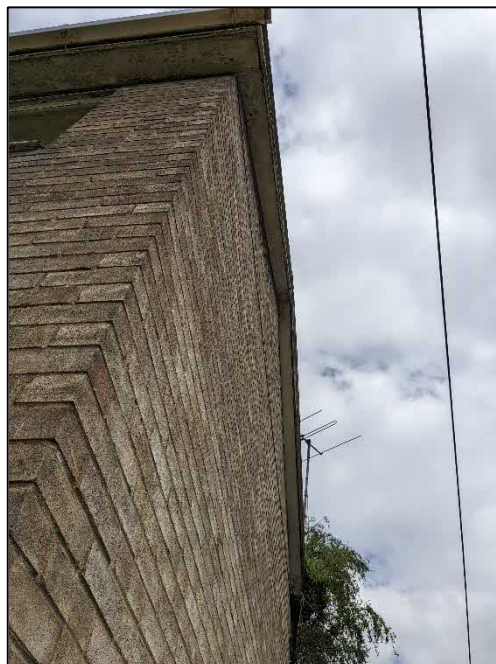
3.3.4. The mortar along the gables is in excellent condition, with none missing to allow bats access into the building or below the tiles.

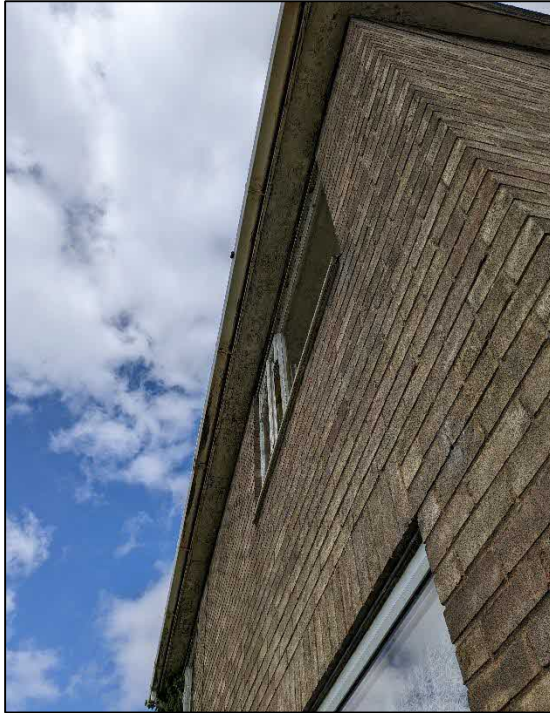
3.3.5. Soffits are present on all sides of the building and they are in good condition, and are fitted flush to the walls with no gaps behind, offering no access opportunities for bats.

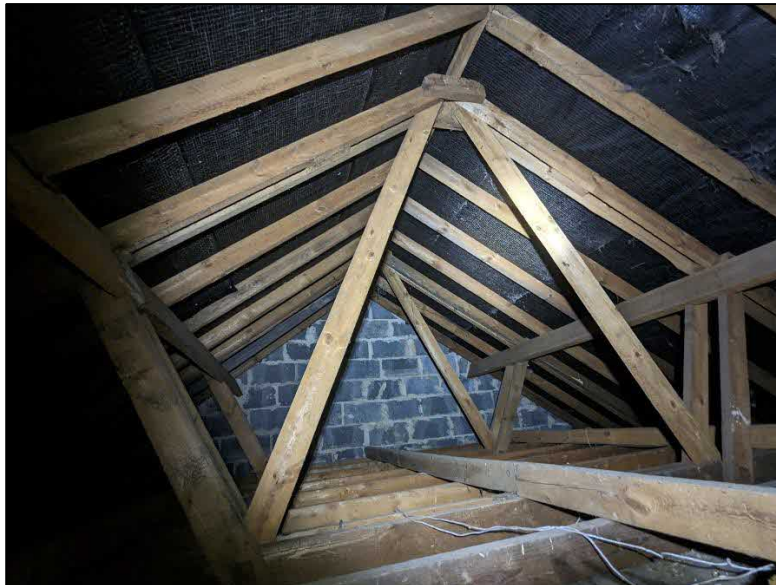
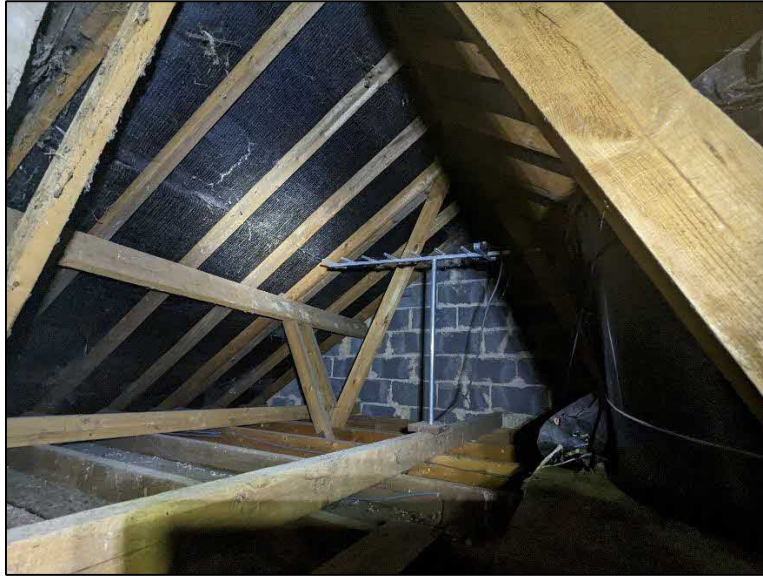
3.3.6. Internally, the property has a loft space which comprises timber rafters and ridge boards. The roof is lined with the lining in excellent condition and no external light could be seen. The photograph below shows the loft space.

3.3.7. The loft space was thoroughly inspected for bats or their field signs, such as droppings and insect remains. Neither bats, nor their field signs were found.
