The windows at Walnut Tree House are of 3 types!

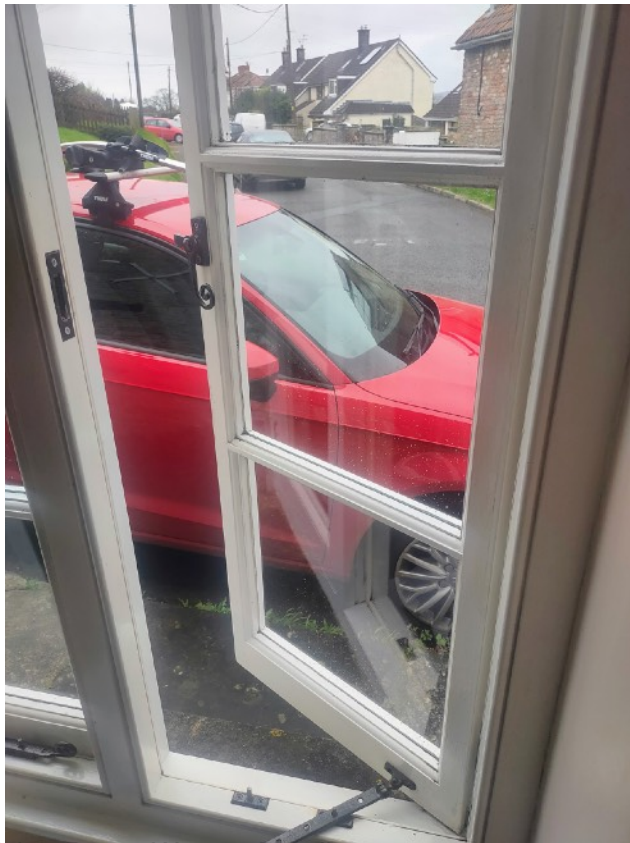
Living Room West 1, Detail
Caption

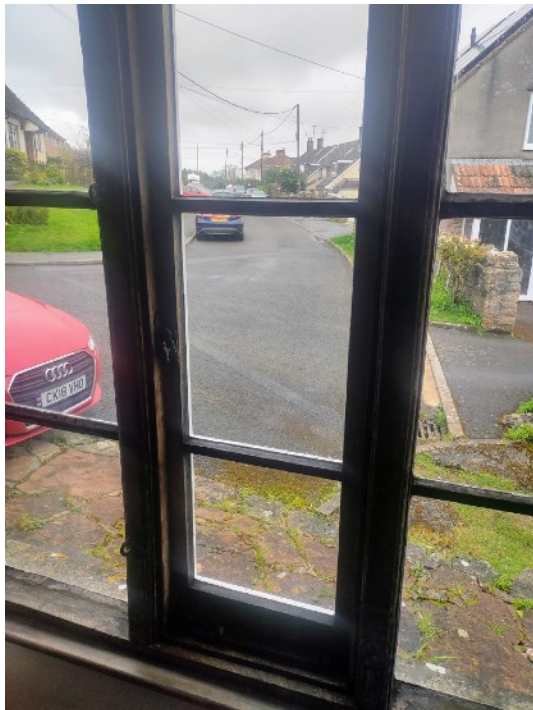
Living Room West 2
Original window

The original window is of hardwood of unknown date.
It is not painted and incorporates an opening casement.

The window we have designed is closely based on the original, with vacuum glass to provide the benefit of double-glazing in a narrow format.

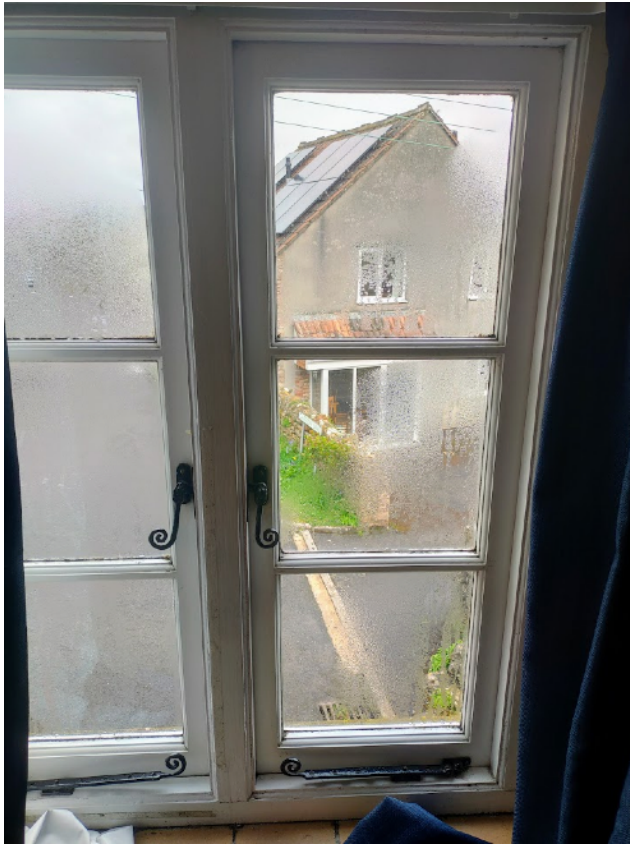
Bed 3
Note condensation

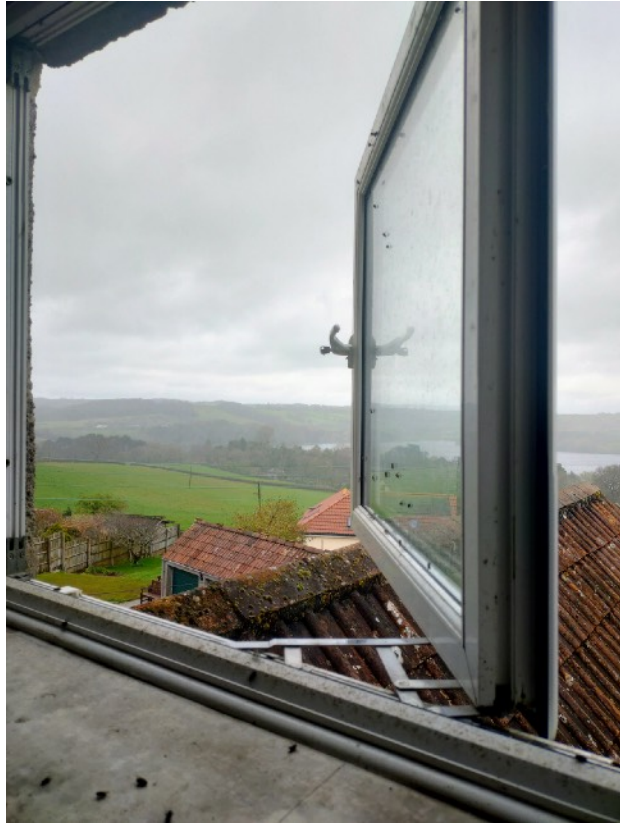
Second Floor
UPVC Window

There are two double-glazed UPVC windows, both facing North, perhaps fitted when the replacement windows failed to keep out wind coming off the lake or the North.
