Preliminary Ecological Appraisal
Outbuilding at the Old Bakehouse
Main Street
Flintham
Nottinghamshire
NGR SK74134 46036

Report prepared by: C J Barker CEnv	Date Issued 28 September 2023
Reviewed by: KB	CBE Consulting, Highbank, 5 Grantham Road, Navenby, LN5 0JJ Tel: 01522 810086 Email: chris@cbeconsulting.co.uk
Report ref: P2804 / 0923 / 01

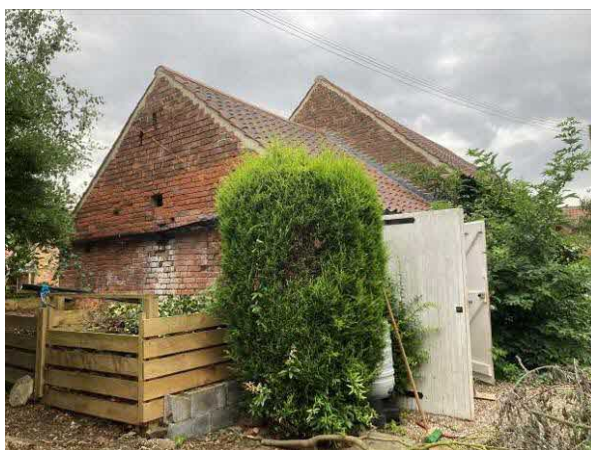
North gable end of building

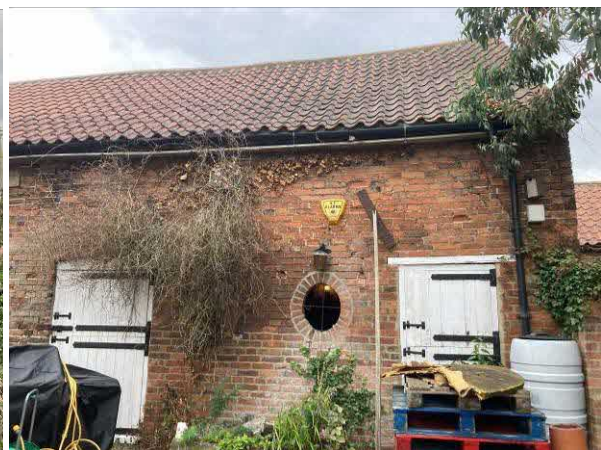
Overall, the roof is in excellent condition but there are some gaps around the roof edges and along the south gable end. The open window on the west side and the open ventilation slots in the brickwork on the eastern side will allow direct access into the interior of the central and southern sections of the building. The northern section appears effectively sealed.

South end of building

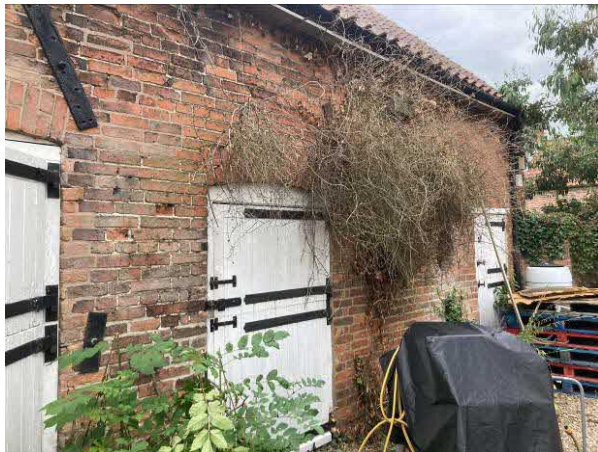
View of doors along west side

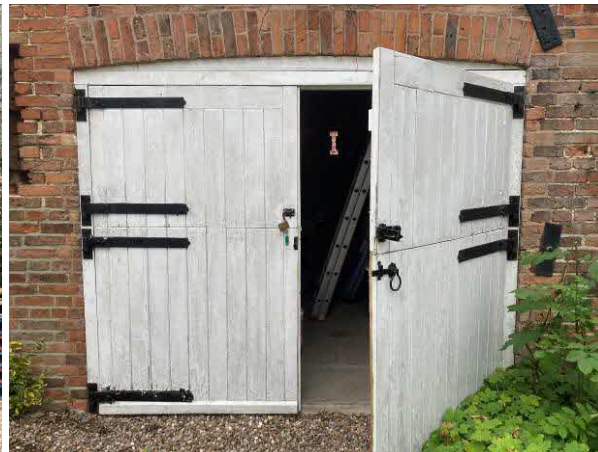
View of main central double doors

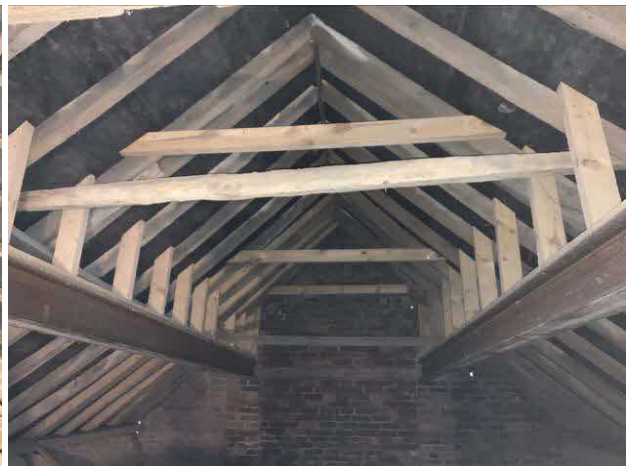
Roof over south end of building

There is an enclosed loft area directly above the ground floor room at the southern end of the building. This has an open doorway into the main barn and was obviously designed to be accessed for storage purposes. There are no windows or vent spaces in the brickwork for this loft room and it is dark with no artificial lighting. This area has a boarded timber floor and there are a large number of scattered droppings on this of mixed age. There was very little evidence of any feeding debris mixed in. The underside of the tiled roof is lined with bituminous felt but there are some open folds and overlaps in this which would allow access through the lining by bats.

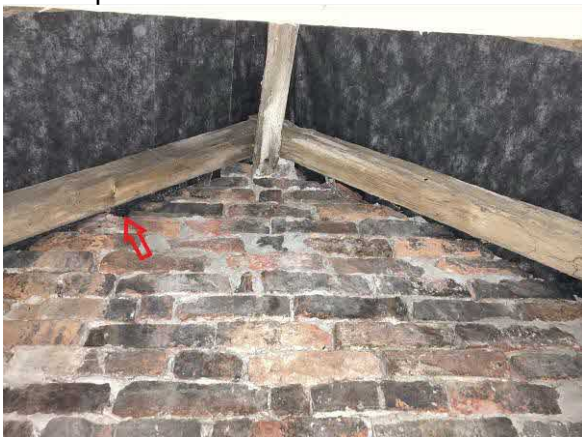
No bats flew within any part of the building interior during the survey period. The two Brown Long—eared bats entering the south gable end roof edge did not emerge into the loft interior and therefore must have roosted on the top of the wall under the tile. This south facing gable end position is quite popular with many species of bat. It is clear that this is access from this into the interior of the building.

Roost location access / egress

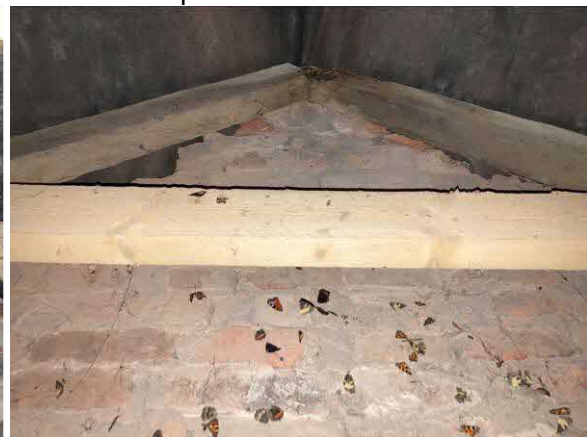
During this survey feeding debris o the form of moth wings was noted on the interior dividing wall close to the loft room entrance for the first time. It is possible this is activity by arachnids as the were no bat droppings mixed in and the wings were caught in webs. The use of this wall by roosting bats cannot be ruled out in the future as there are significant gaps along the top of the brickwork under the roof tiles.

Feeding debris 13 September
