LAND AT FOOT'S FARM THORPE ROAD, CLACTON-ON-SEA

PHASE 1 GEO-ENVIRONMENTAL DESK STUDY AND PRELIMINARY RISK ASSESSMENT

December 2023 Report No. P0400/R01 Issue 1

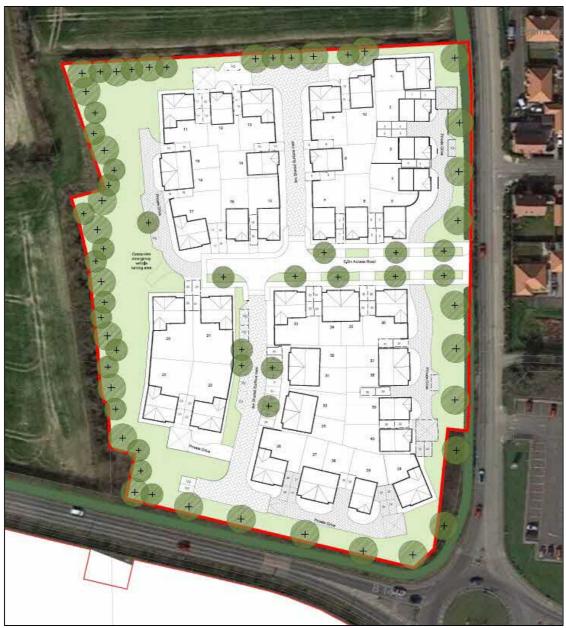
Figure 1Indicative Site Layout Plan (not to scale)

1.4.1 It is proposed to redevelop the site to a residential use, consisting of 40 bungalows, together with private gardens and car parking. A proposed site layout plan is shown as Figure 1.

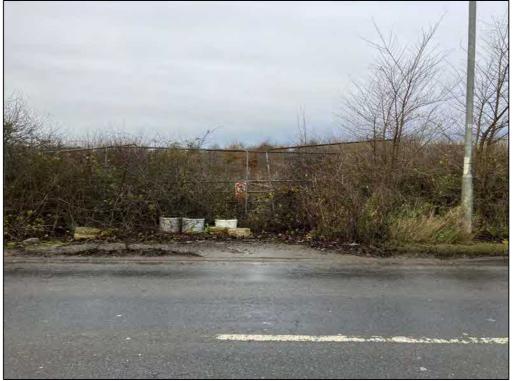
Photograph 1: Site Entrance from Thorpe Road to the east.

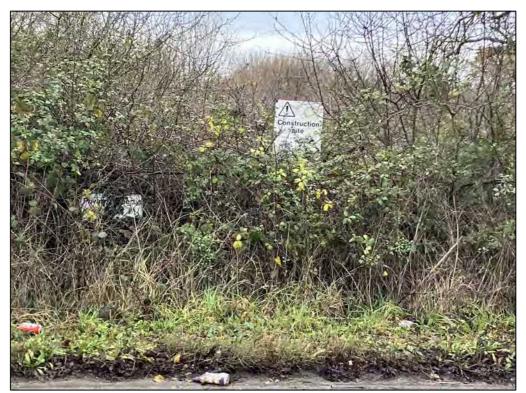
Photograph 2: Signs on the eastern site boundary.

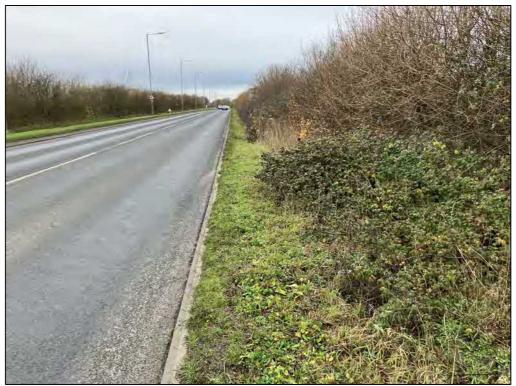
Photograph 3: The site's southern boundary and Centenary Way.

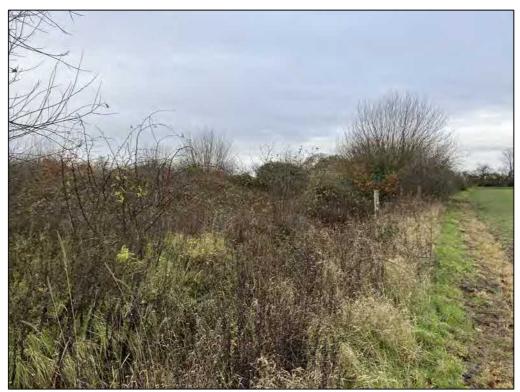
Photograph 4: The northern site boundary.

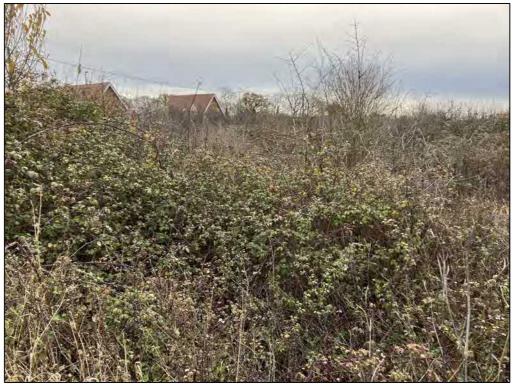
Photograph 5: The site from the northern site boundary.

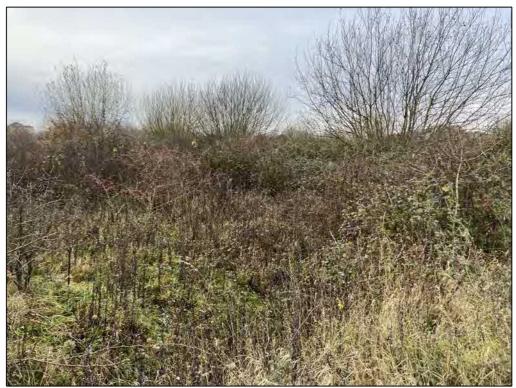
Photograph 6: The site from the northern site boundary.

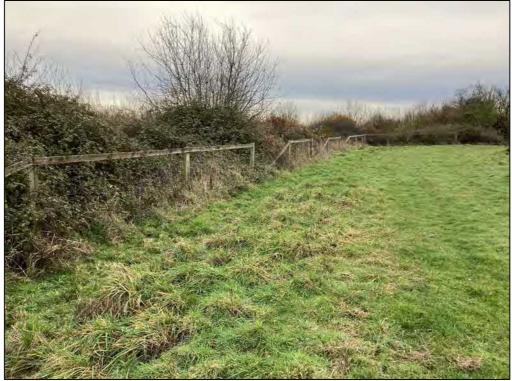
Photograph 7: The site's western boundary.

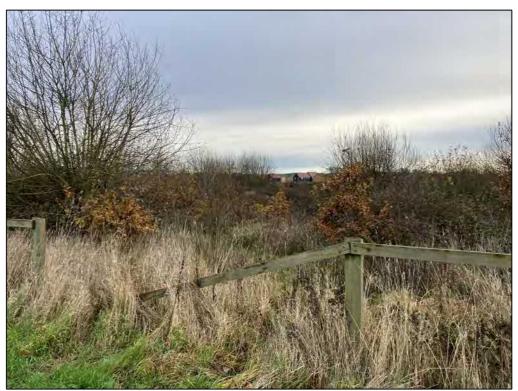
Photograph 8: The site from the western boundary.
