Land Contamination Report

PHASE I – LAND CONTAMINATION DESK STUDY

Site: Land adjacent to Minefield Cottages (Plot 3), Menheniot, Liskeard, Cornwall, PL14 3RY

Date: 26th April 2024

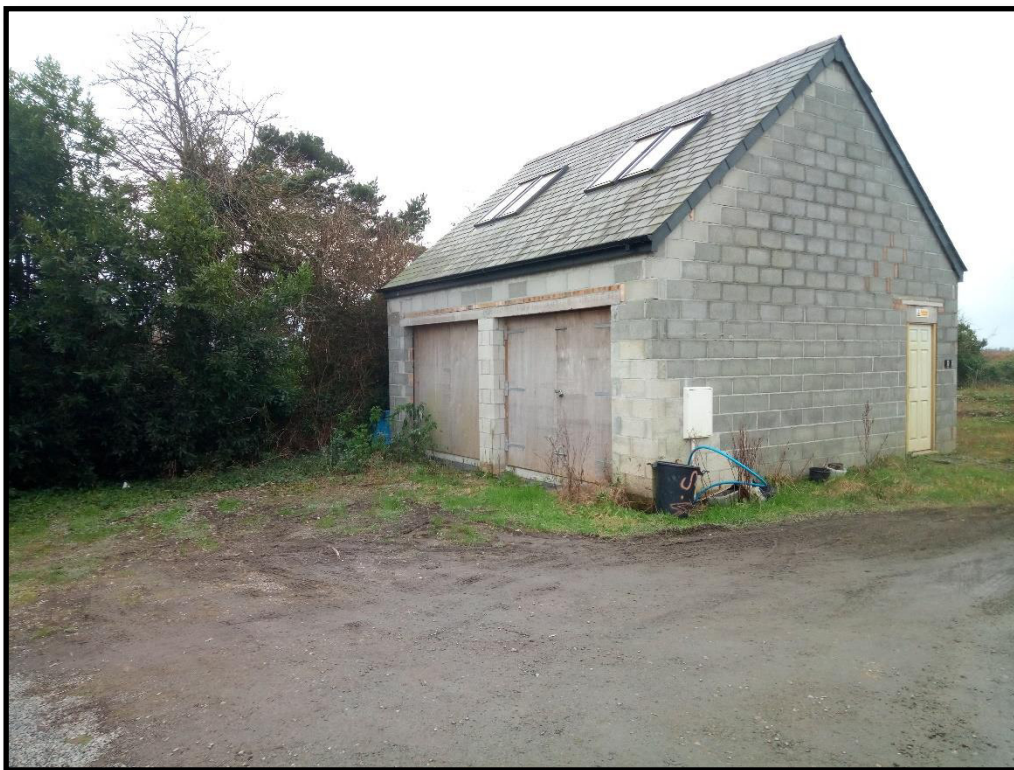
Photograph 4 - View from inside the site, looking south/southwest towards the existing garage.

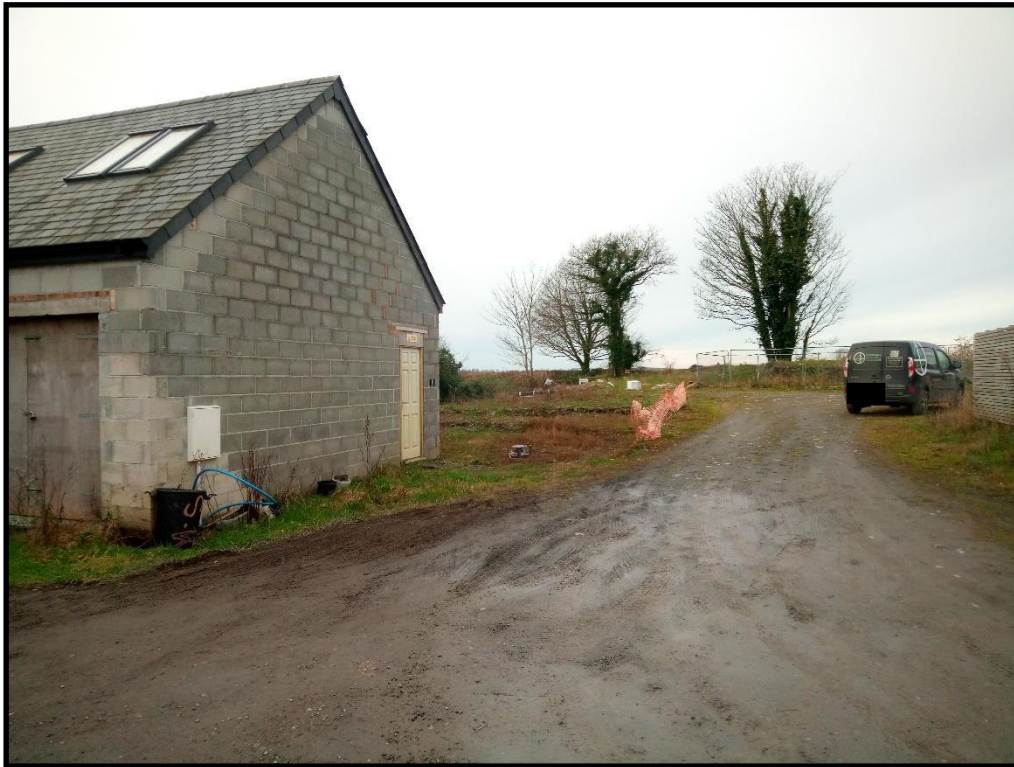
Photograph 5 - View from the middle of the site looking west across the adjoining land.

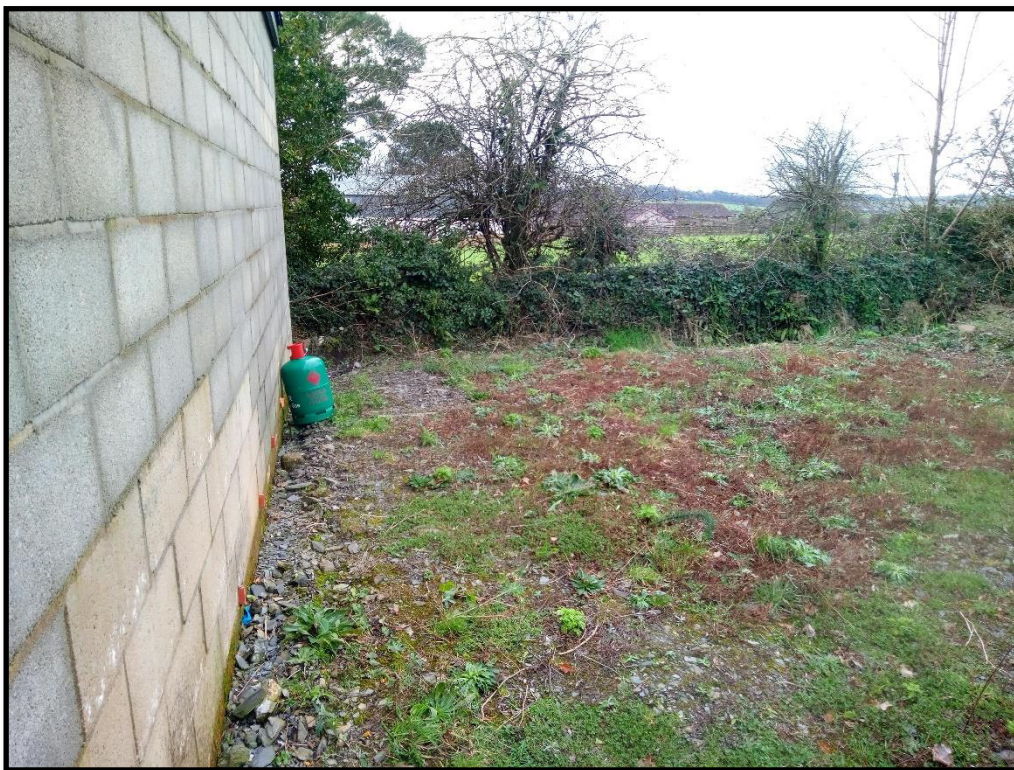
Photograph 8 – Photo of the rear of the garage in the southwest corner of the site. Empty and sealed disused gas bottle located.

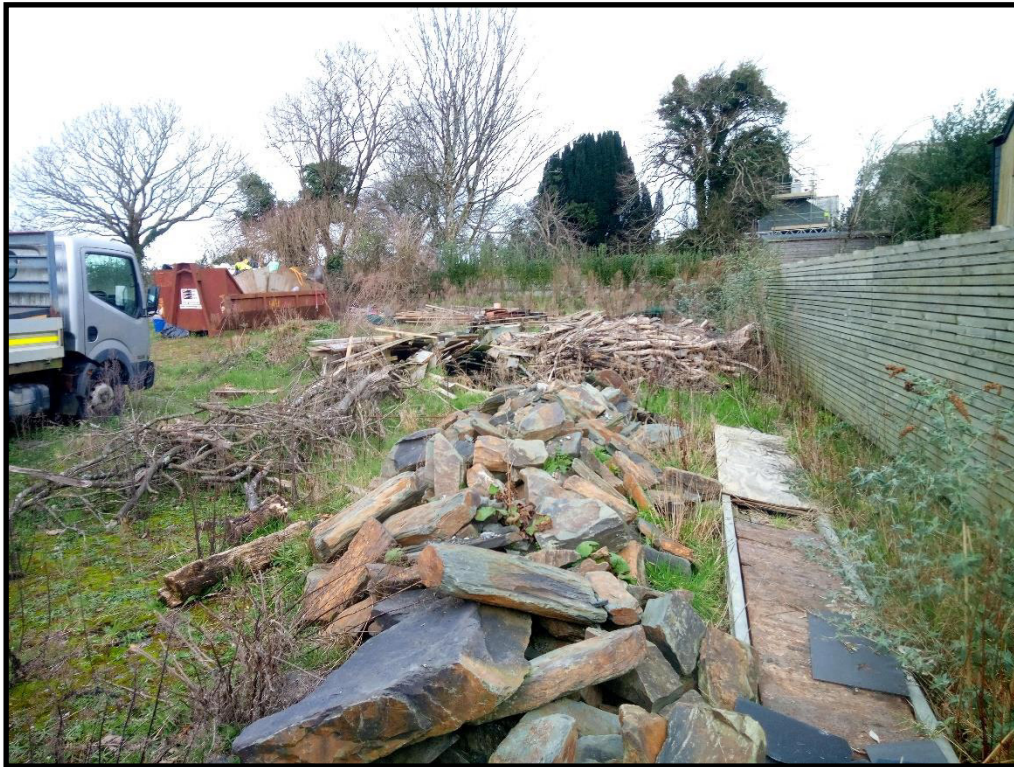
Photograph 11 - View from the northwestern extents of the site looking north (outside of site boundary).

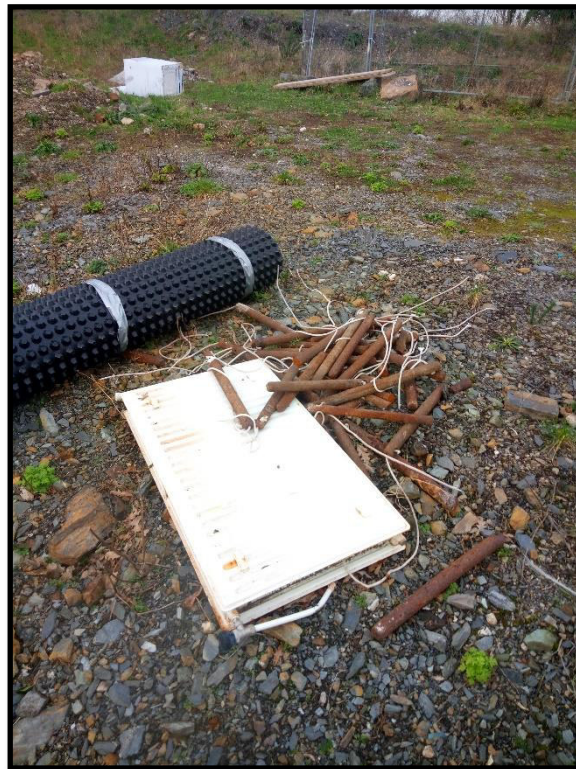
Photograph 19 - View of an empty radiator, metal rods attached by string, and plastic matting in the southern extents of the adjoining land/close to the boundary of the western boundary of the site.

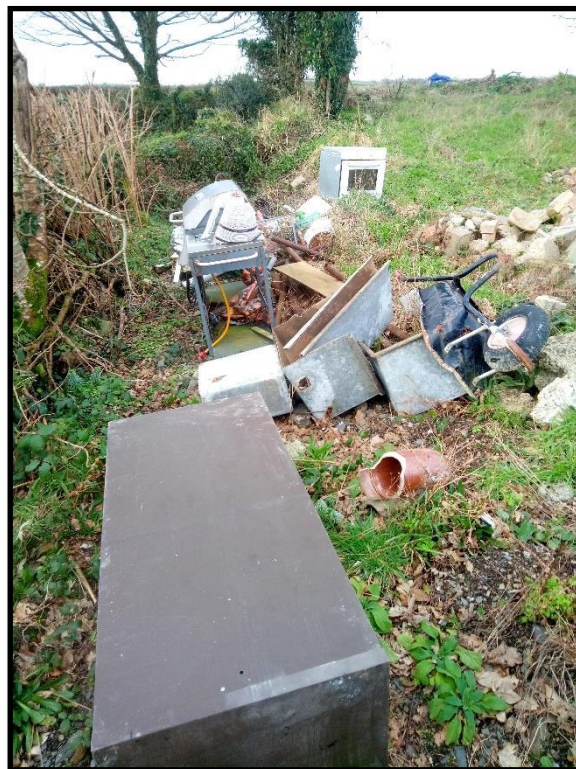
Photograph 20 – View of waste material including a shelving unit, barbecue, old clay pipe, an oven, and other materials in the adjoining land close to the western boundary of the site.

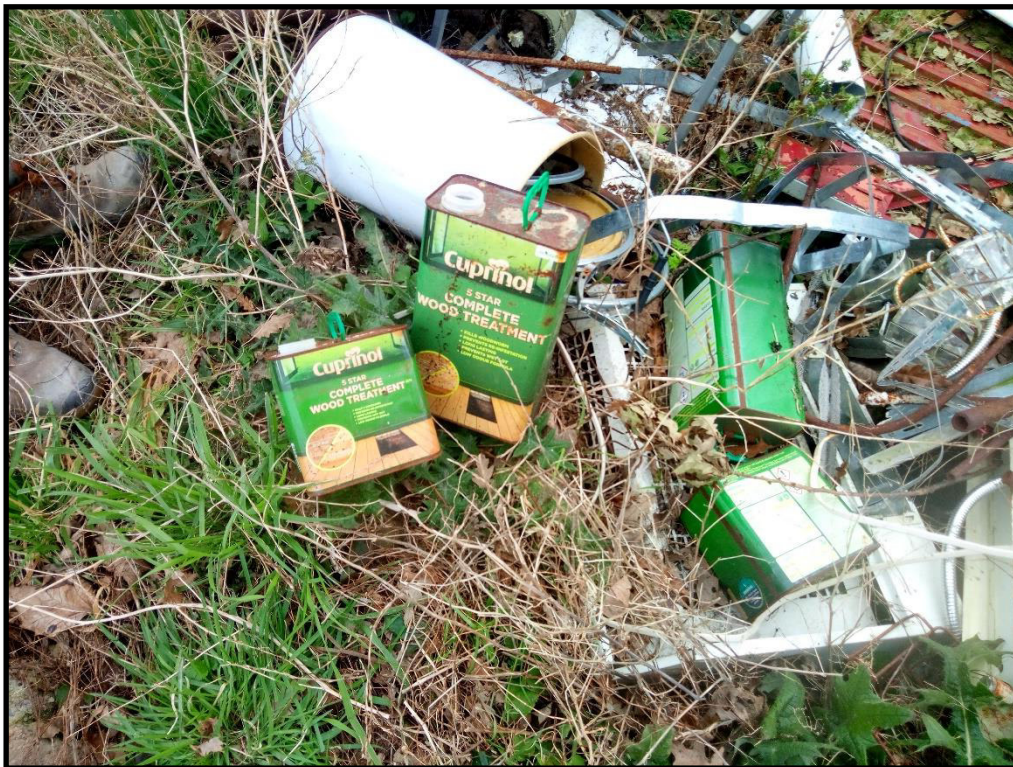
Photograph 22 - View of empty and unsealed wood treatment canisters alongside other waste material in the southern extents of the adjoining land close to the western boundary of the site.

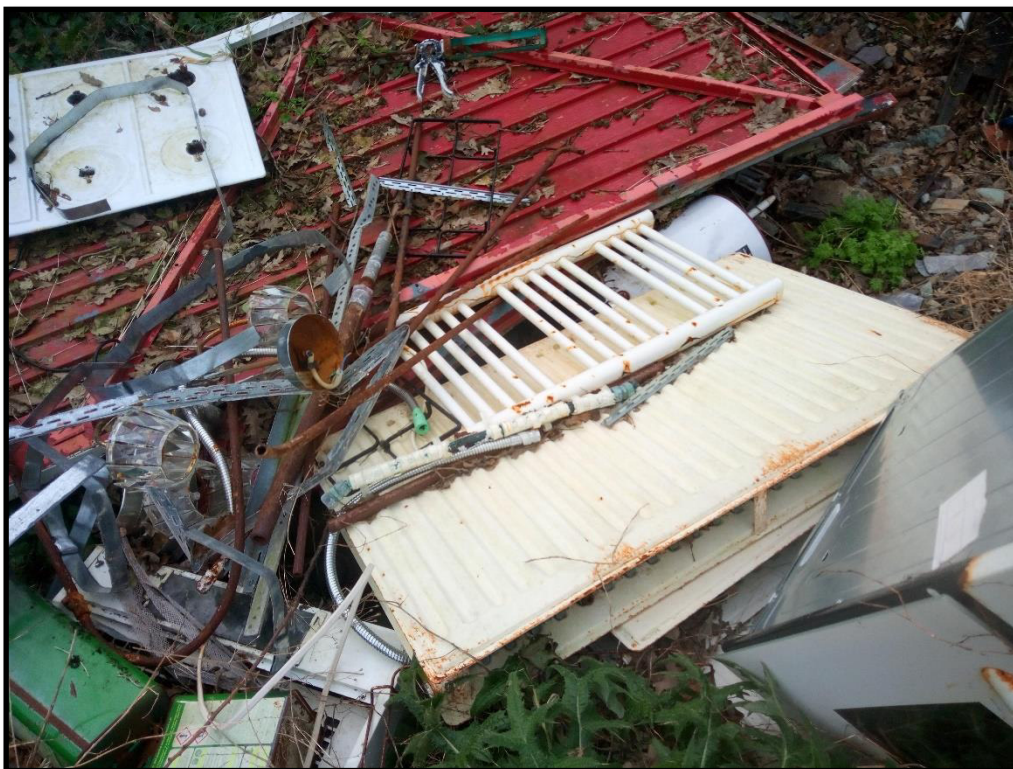
Photograph 23 - View of an empty radiator, an oven, and other waste material in the southern extents of the adjoining land and close to the western boundary of the site.

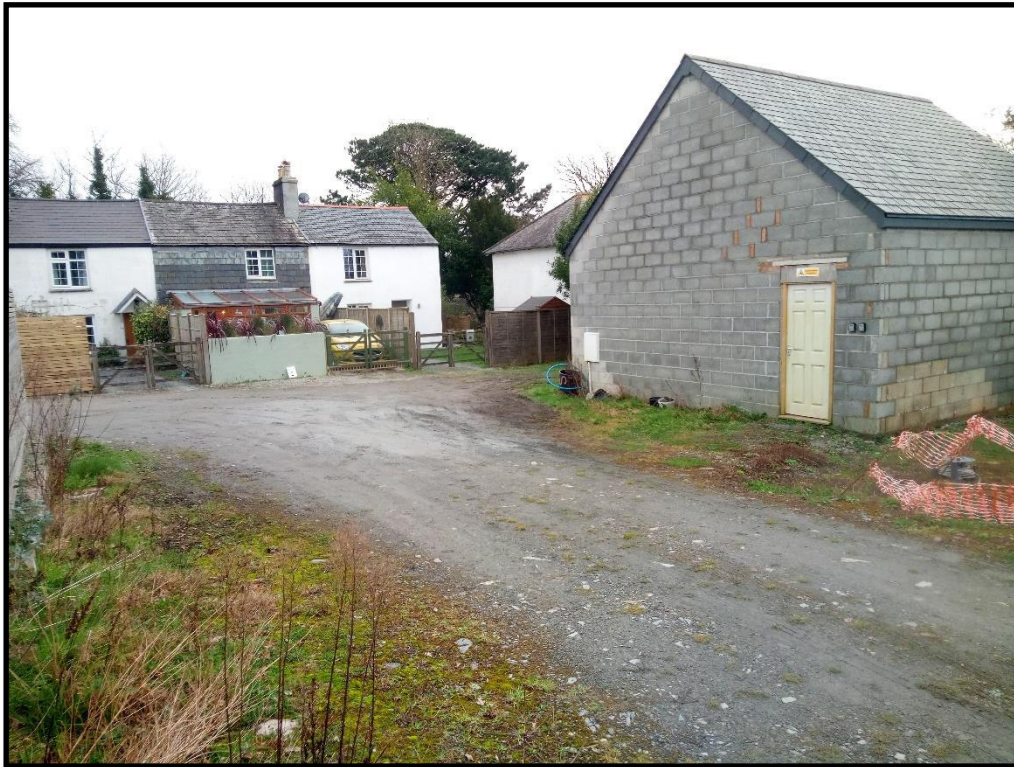
Photograph 24 - View of the western boundary of the site looking east/southeast towards the existing garage.
