Little stone barn ground floor plan

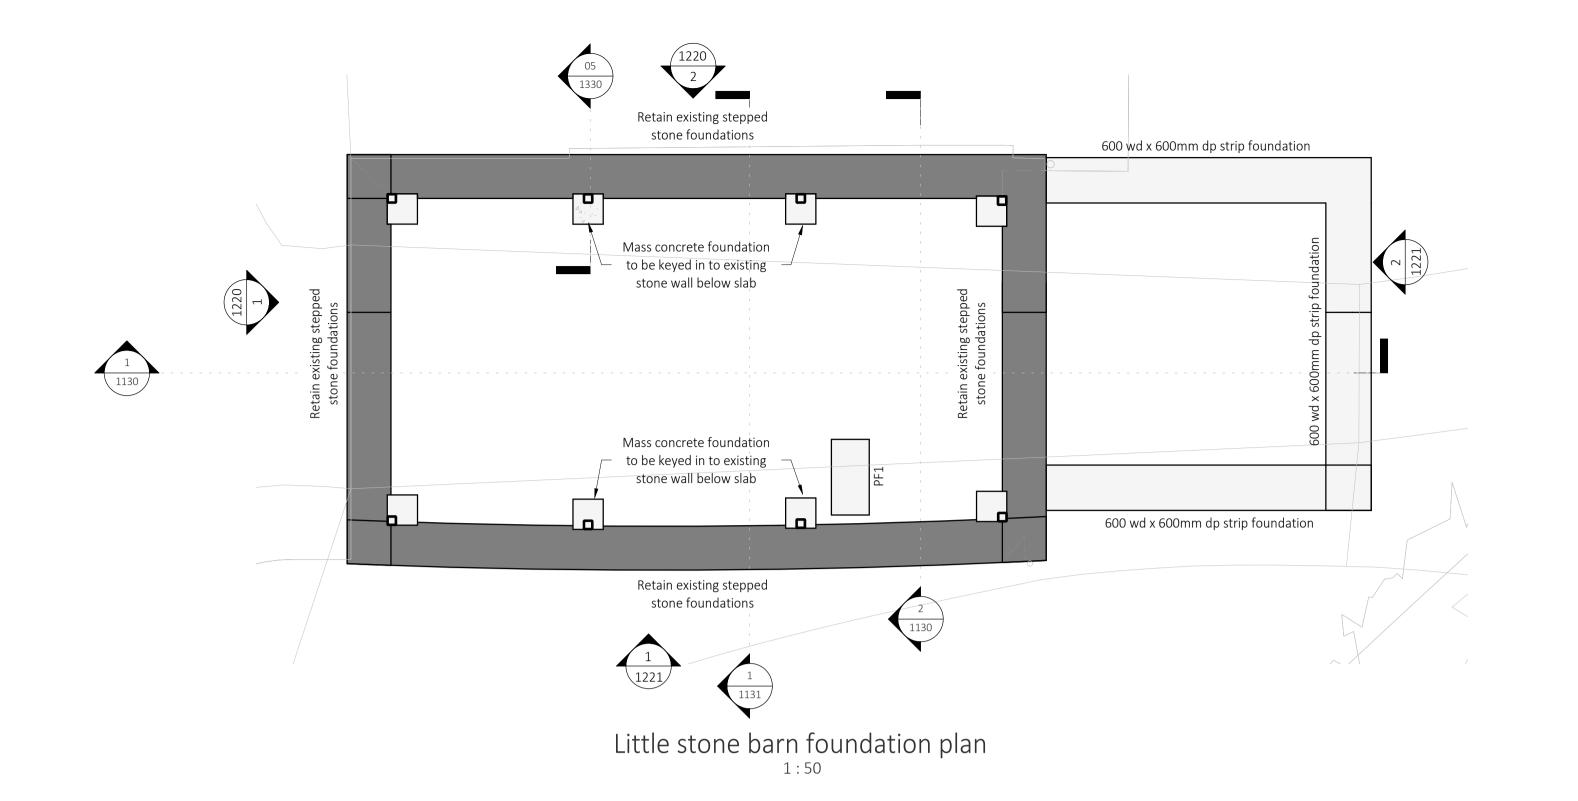
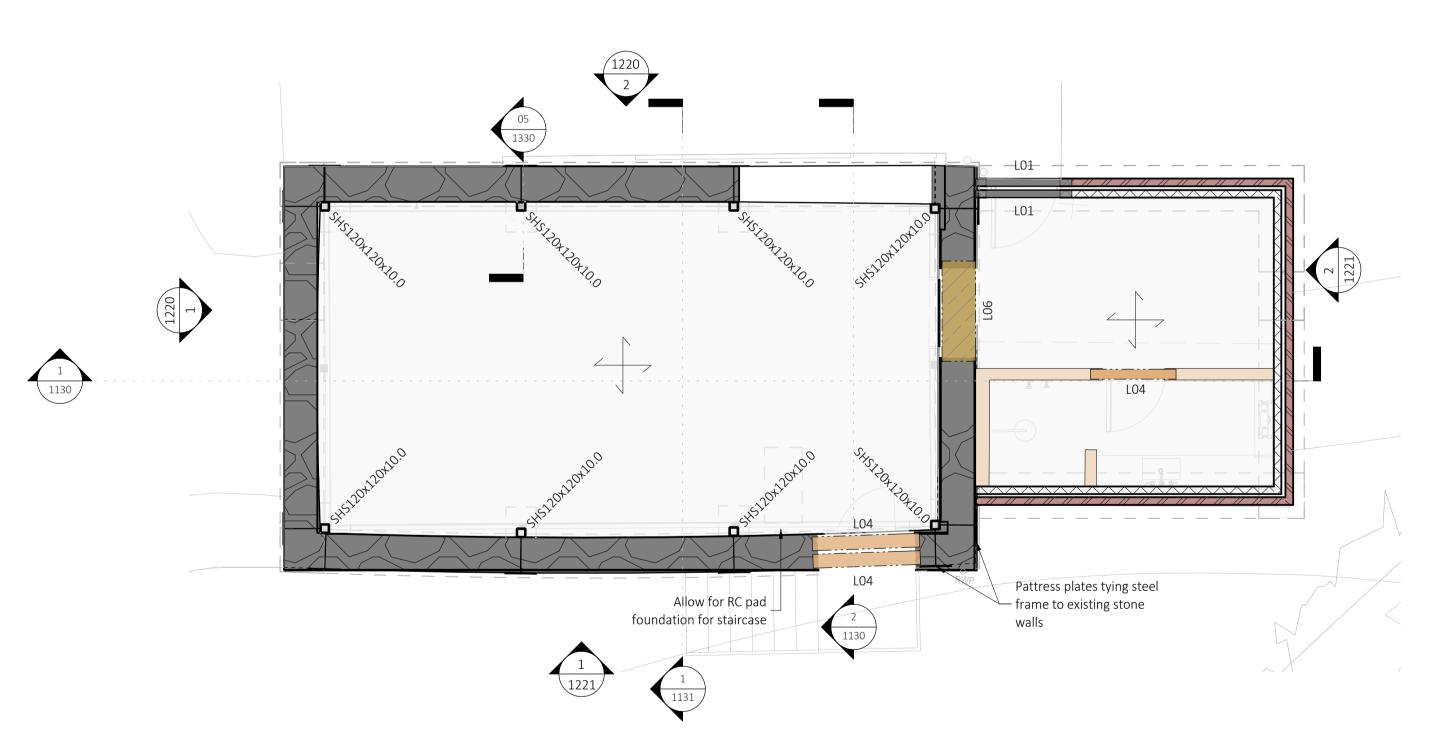
New 200mm concrete ground bearing RC slab

Existing 200 dp x 65mm wd C24 joists @ 450mm c/c approx.

Existing 200mm thick RC slab
