# WEST BRADLEY HOUSE.

Heritage Appraisal.

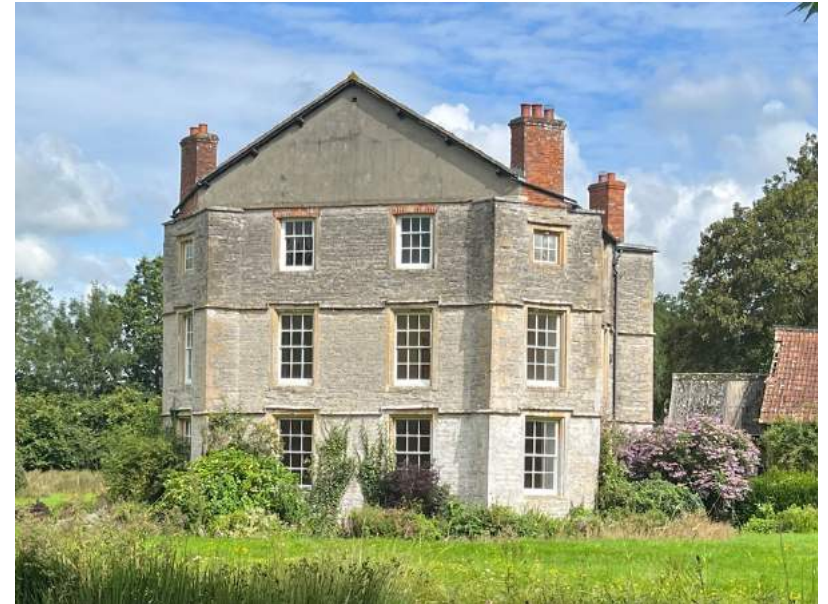
**Figure 7** *South elevation.*

- 5.7 The original elevations survive legibly intact at ground & first floors. The second floor partially survives, but there is insufficient evidence to allow a complete, definitive reconstruction. No fabric or evidence of the original form of the buildings survives above the second floor.
- 5.8 The south elevation is probably the least altered, with two windows on all three storeys. The ground & first-floor windows here, whilst altered, retain clear evidence of their original form.

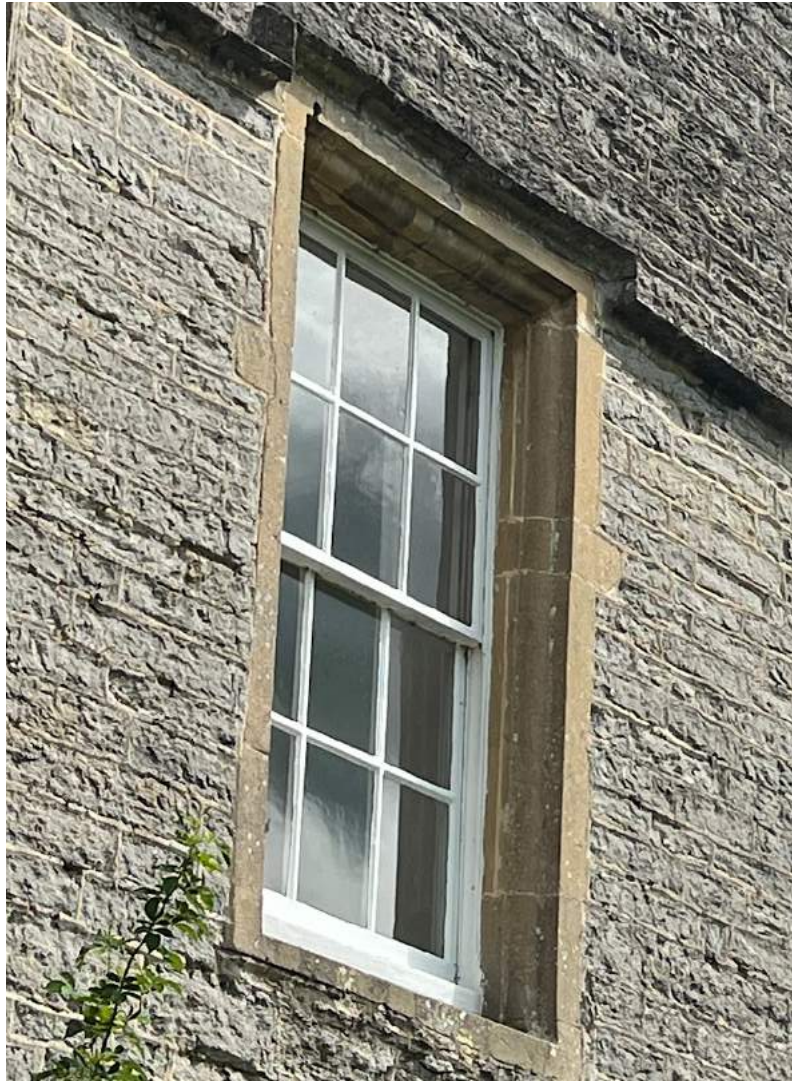
Figure 8 South front, first-floor window.

- 5.9 The windows were originally stone cross-casements, the ends of the transoms are pronounced. The windows have all also been lengthened, as is shown by the surviving glazing rebate.

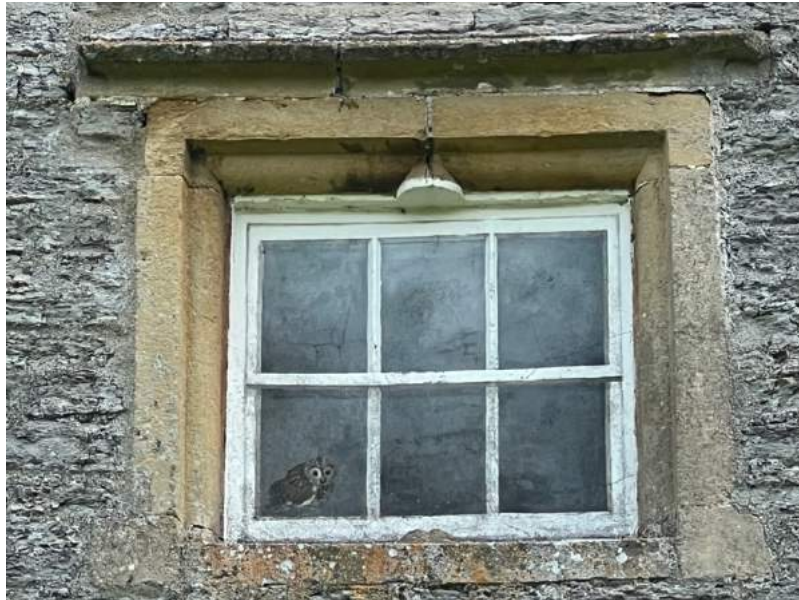
Figure 9 South-west, second floor window.

- 5.11 The second-floor windows of the ordinal fronts are blind, & appear to have historically been so. These windows retain both their original heads & sills; they also retain stubs of the central mullion. These indicate a mullion profile not dissimilar to a traditional ovolo, although there is no trace of the usual raised front fillet, which suggests an unusual, semi-circular profile. This appears to be corroborated by the two basement windows on the west front appear to also have unusual, semi-circular profiled mullions.

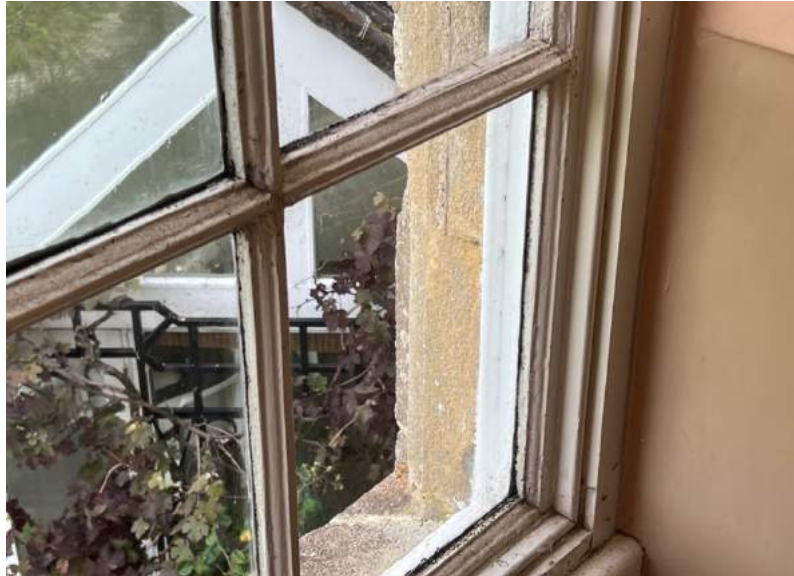
Figure 12 Detail of north-west, first-floor window.

5.12 The change to the windows appears to have occurred in the first half of the 18<sup>th</sup> century, as several early-18<sup>th</sup> century sash

windows survive in the northern half of the building at ground & first floors.

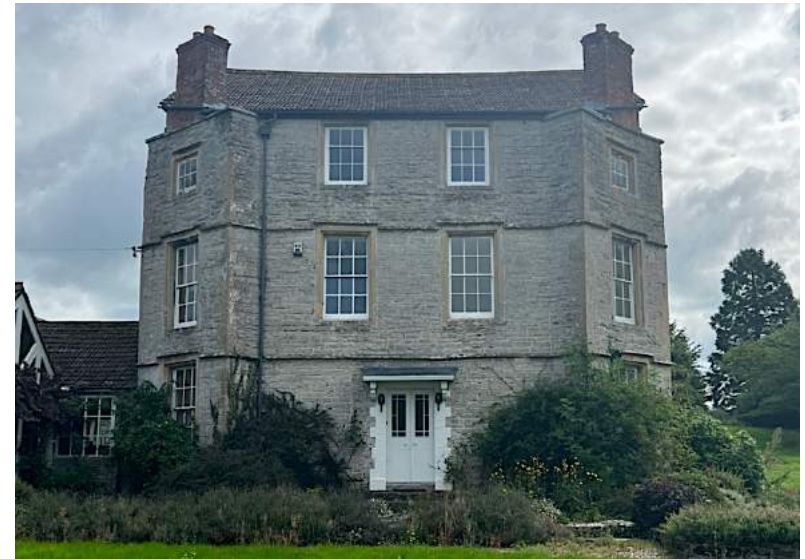
Figure 13 West front.

- 5.13 The south & west elevations are likely to have the principal frontages, as they are balanced; the north & east fronts are imbalanced by the larger & unfenestrated north-east ordinal projection.
- 5.14 The west front mirrors the south front at first & second floor, but at ground floor is unfenestrated, with a central door. The current door is a 19<sup>th</sup> century alteration; however, given the

intactness of the south front, & the secondary nature of the north & east fronts, it seems likely that this was always the approximate position of the principal entrance.

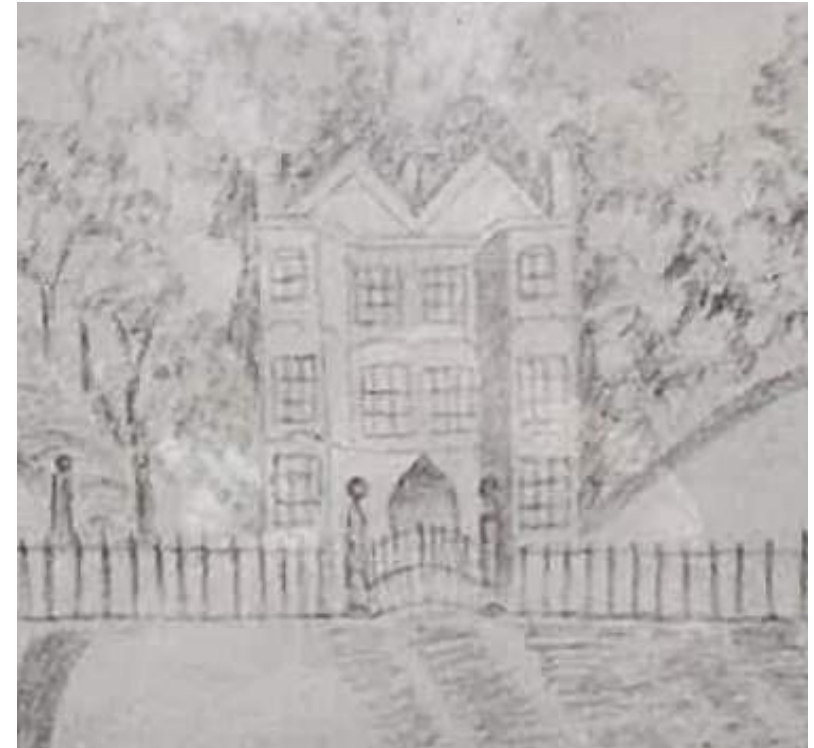
Figure 15 Sketch of the west front dated 1810.

- 5.15 This would appear to be supported both by a considerable area of disruption to the surrounding masonry, & by a sketch dated 1810 (formerly within the house). This sketch is somewhat diagrammatic, but shows an arched doorway in the middle of the west front; the steep pitch of the arch would be uncharacteristic of a house of this date, & may be artistic license in the representation of a depressed arch..

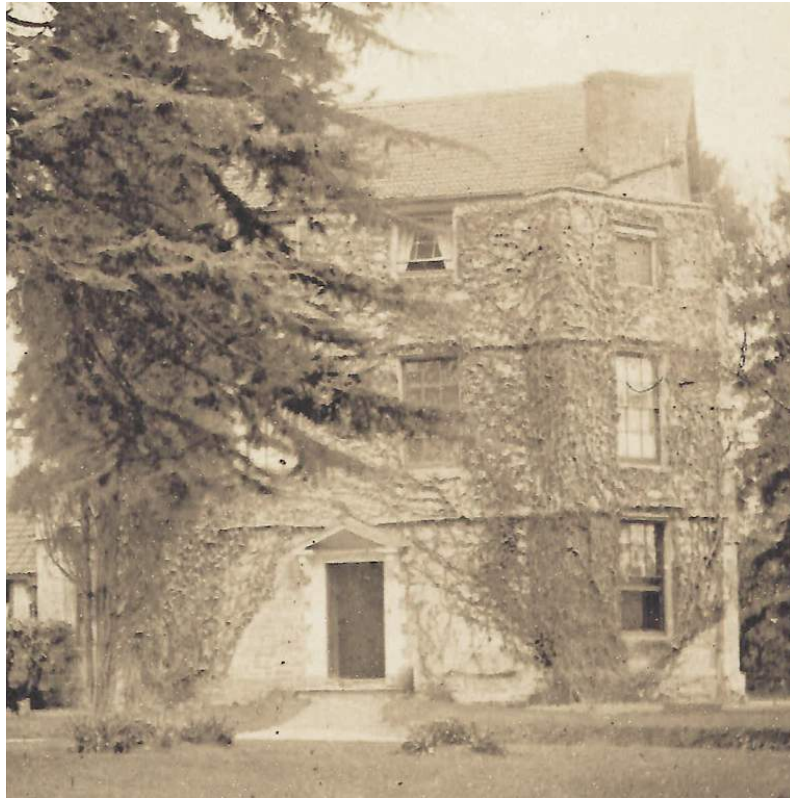
Figure 16 Undated, probably late-19th century photograph of the west front.

- 5.16 An undated, but probably late-19<sup>th</sup> century photograph of the west front shows the present doorway, with its brick reveals & cantilevered consoles, but here supporting an open pediment, rather than the current flat canopy. There is also no trace of the tromp-l'oeil painting in the second-floor window of the south-west ordinal projection.

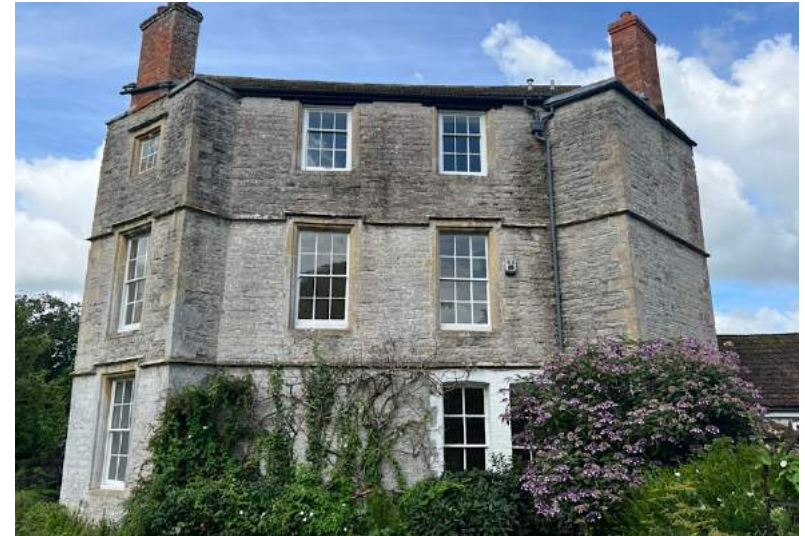
Figure 17 East elevation.

- 5.17 The east elevation has similar fenestration to the south & west at first floor, but is markedly different & less composed at ground floor, compounding the lower status of this elevation. The left side of the ground floor is unfenestrated. There are no visible scars in the masonry, & a fireplace (albeit with a modern surround) exists behind. The right side has a pair of late-19<sup>th</sup> century sashes, with a brick detail comparable to that around the front door. It seems probable that this arrangement replaced a window aligning to that at first floor.
- 5.18 The north-east ordinal projection is distinct from the other three both in that it is larger, & also entirely unfenestrated. This

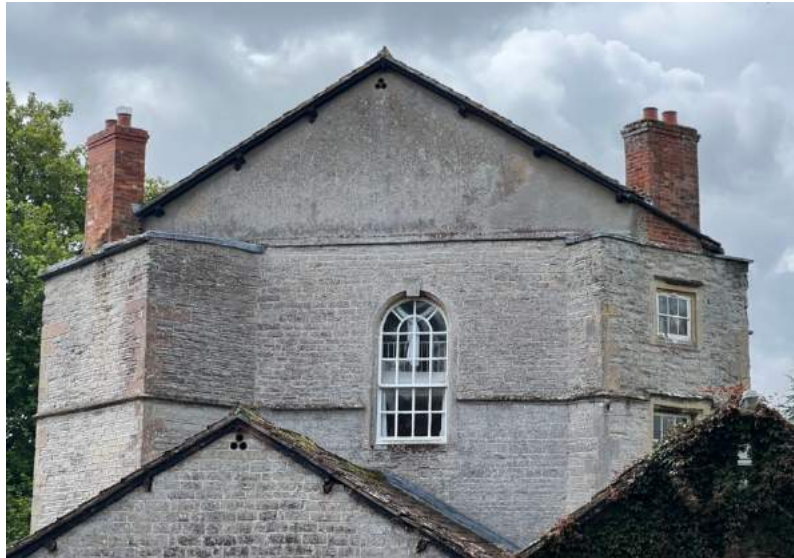
Figure 18 North elevation.

- 5.19 The north elevation is entirely unfenestrated, except for a single large stair window between first & second floors.
- 5.20 This window, which contains a very fine, although somewhat altered, semi-circular headed, early-18<sup>th</sup> century sash no longer aligns to the position of the present stair, although it clearly demarks the 18<sup>th</sup>-century stair position.

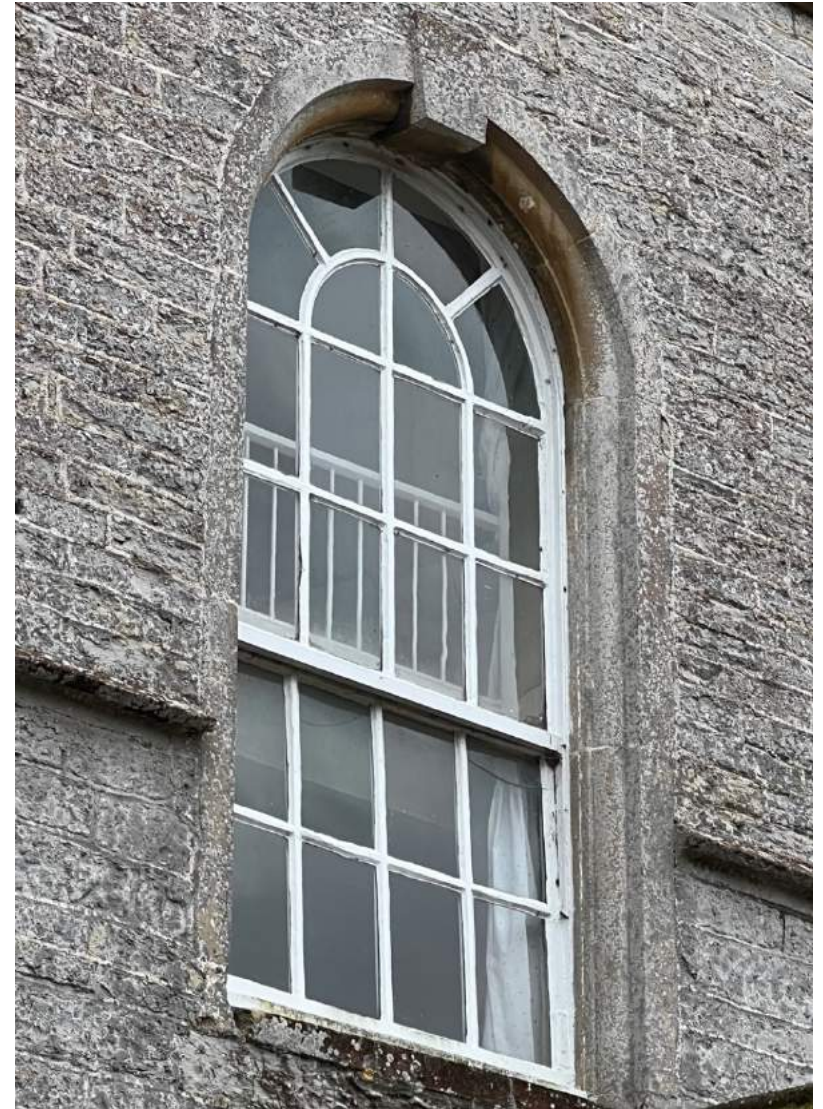
Figure 19 North front, stair window, showing glazing slot on the reveal.

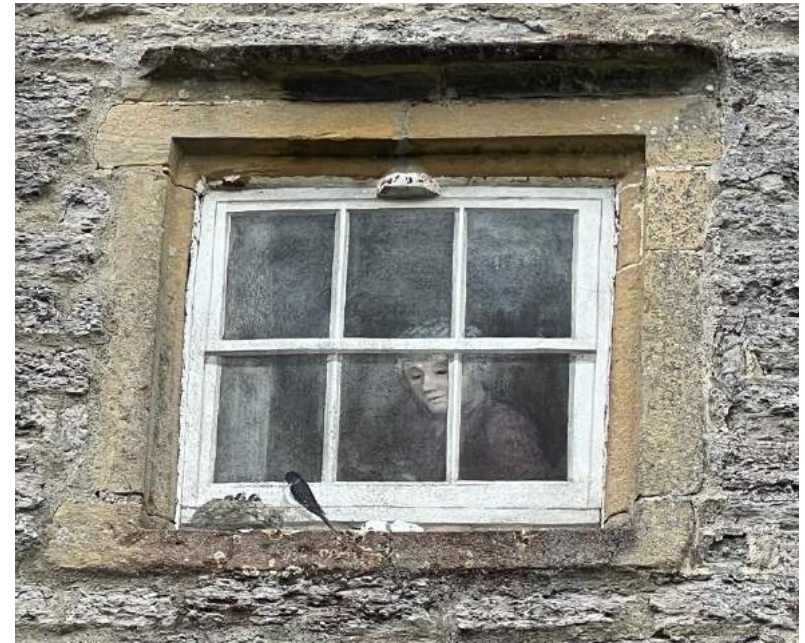
Figure 20 Second floor, north-west blind window.

- 5.25 These windows contain well-executed tromp-l'oeil; the date of these is unclear, but the whimsical style seems not dissimilar to similar painted sashes that was added to Biddesdon House in Wiltshire for members of the Bloomsbury group in the 1920s.
- 5.26 However, apart from the removal of the central mullions, these windows appear to survive fundamentally intact.

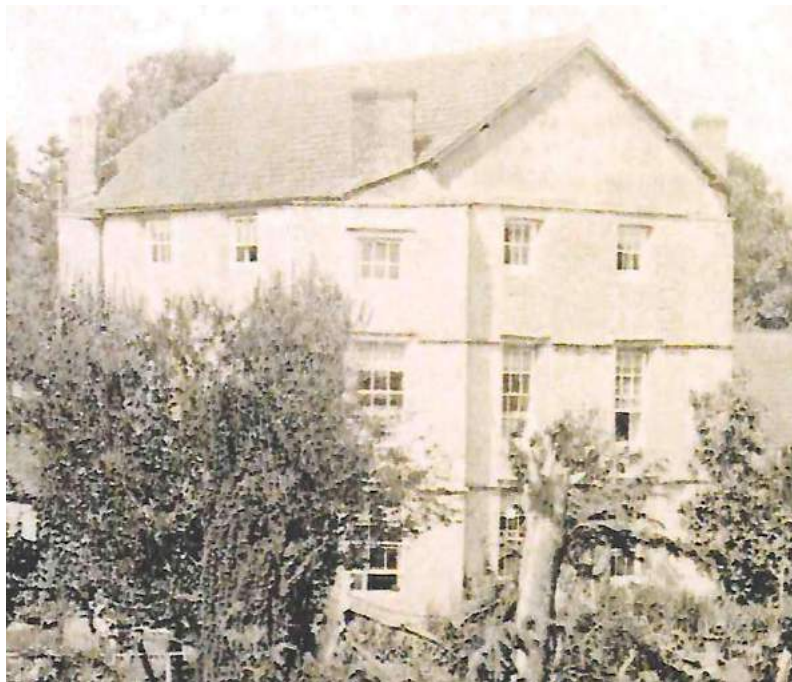
- 5.33 Permission was granted to lengthen the windows in 1987 (106601/000); this is visible as between each of these reveal stones & the sill is a stone of noticeably different in colour. This change is noticeable from early-20<sup>th</sup> century photographs, which show higher sills, & 3/3 sashes rather than the current 3/6.

Figure 25 Undated, possibly early-20<sup>th</sup> century photograph (the ordinal blind window has now been painted), showing higher sills on the second-floor windows on the west & south elevations.

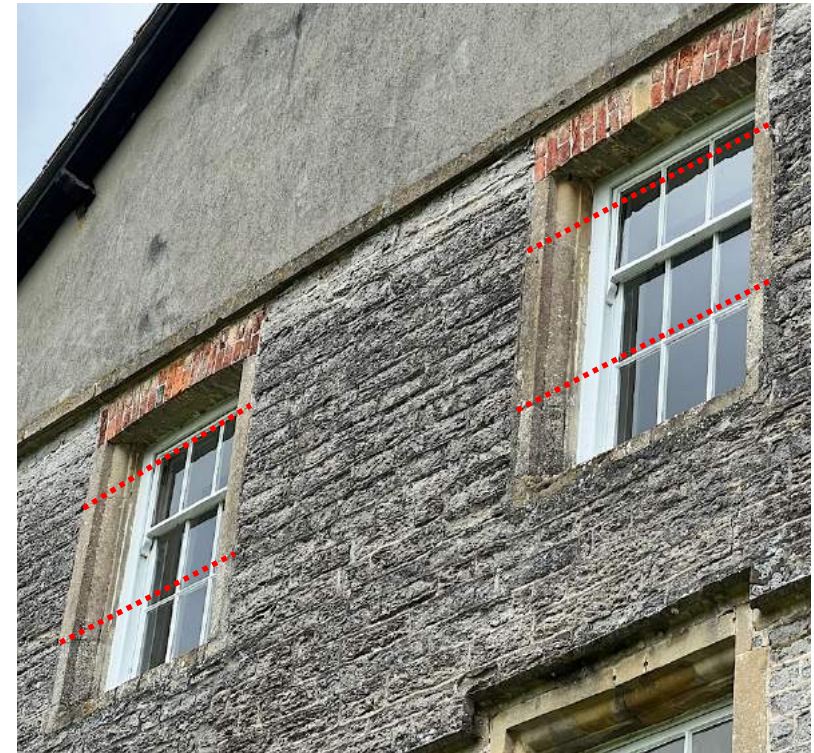
Figure 26 South elevation, second-floor windows; consistent lower & upper breaks marked.

- 5.34 In addition to the alterations to the sills, the heads of the windows also appear altered. There is a further piece of stone above the main reveal stone. These are a consistent colour match, & many, but not all of them have glazing reveals. The level of the joint between the main reveal stone & the upper stone is also consistent on every window.

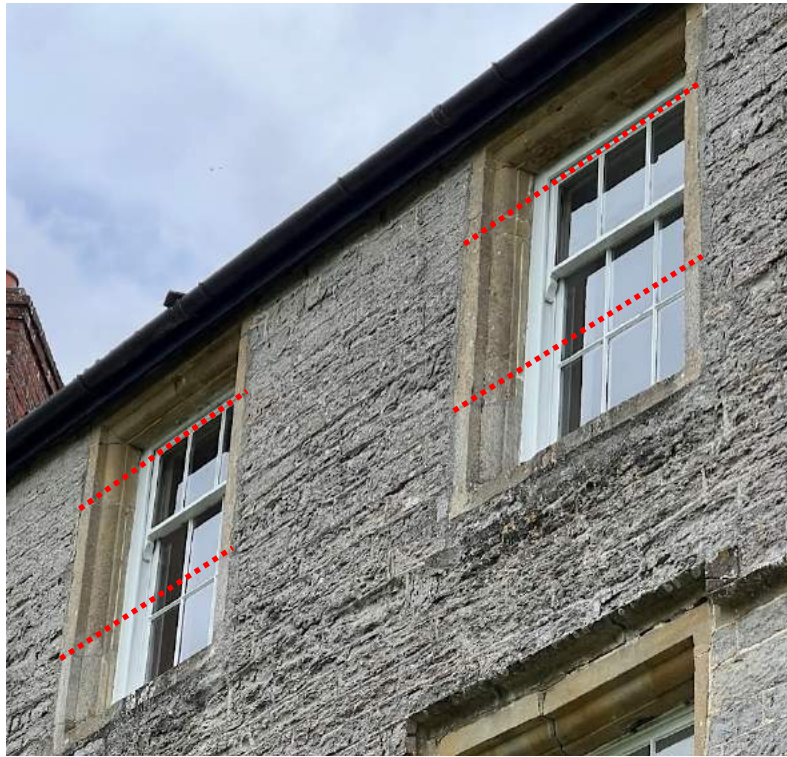
5.35 Consequently, the evidence strongly suggests that the windows may have originally been only the height of the principal reveal stone, which would be very similar in size to the ordinal windows. The raising of the head, which has been carefully executed using a mixture of new & salvaged stone, would appear consistent with the 18<sup>th</sup>-century alterations.

Figure 27 West elevation, second-floor windows; consistent lower & upper breaks marked.

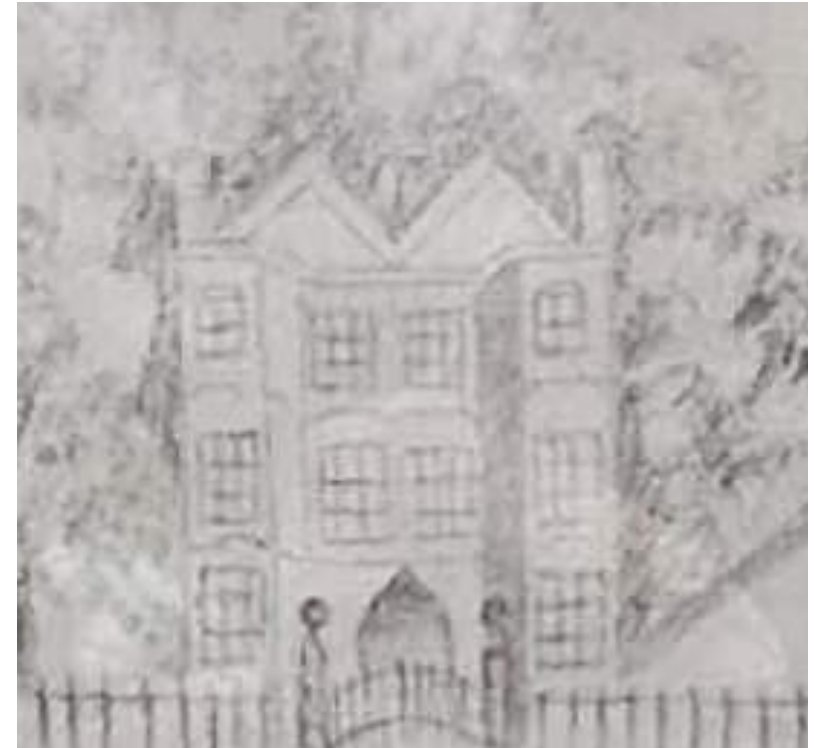
Figure 30 Sketch of the west front dated 1810.

- 5.39 This drawing shows what appears to be a pair of unfenestrated gables, or possibly hips, above the west front, indicating a pair of saddle-back roofs running east-west. There is no attempt to depict a cross-ridge or gables on the north or south fronts.
- 5.40 This rather functional, double-pile roof with a central valley, which appears to relate as awkwardly to the ordinal projections

5.41 It is conceivable that this sketch attempts to depict a building with gables on all elevations, which would be characteristic of the latter 16<sup>th</sup> & early-17<sup>th</sup> century. However, gables at this time were characteristically carefully aligned to window bays; a pair of gables here would sit rather uncomfortably in relation to both the window alignment & the ordinal projections.

5-44 It seems plausible that the roof depicted in 1810 may well have been part of the 18<sup>th</sup>-century updating of the building (treating the south as the principal frontage); it was not uncommon for 17<sup>th</sup>-century houses to be shorn of their gables & mullioned windows in the 18<sup>th</sup> century to give a more fashionable, classical appearance, as at Misarden Park in Gloucestershire.

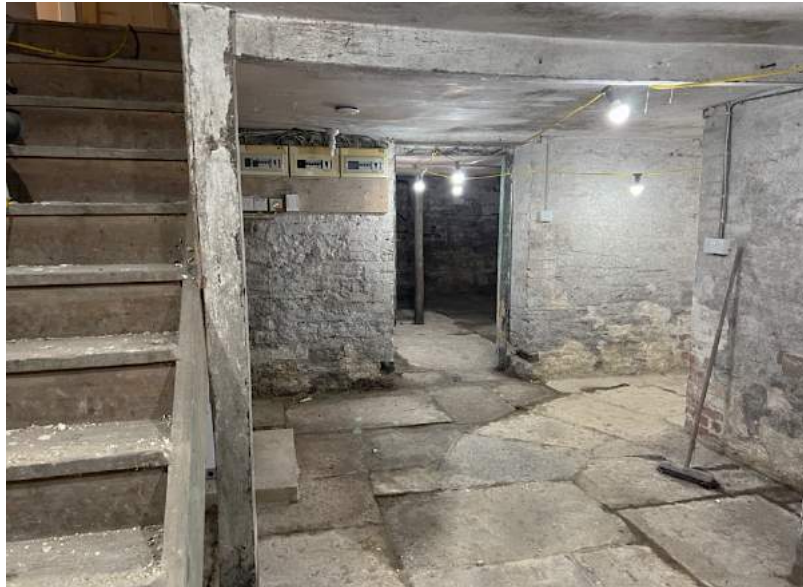
Figure 46 Cellar, north-west room, facing east.

- 5.55 Several of the walls are at slightly irregular angles; this may have been the result of pre-existing constraints, including the potential reuse of earlier fabric, although given the compact form of the building, the reuse of individual internal walls seems unlikely, but there is insufficient evidence currently visible to definitively clarify this.
- 5.56 A culverted watercourse runs beneath the building, its course being marked by the curve of flagstones in the north-west room; this may also have impacted upon the position of internal walls.

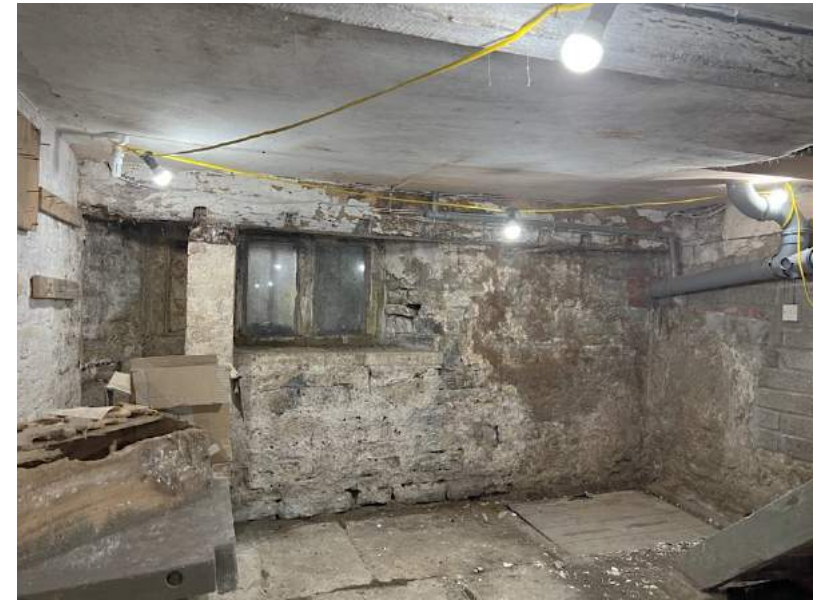
Figure 47 North-west room, west wall with reused beam.

- 5.57 Within the north-west room, parallel to, & almost adjacent to the west wall, is a substantial reused beam, which has been placed upside down, with a row of square mortises for joists.
- 5.58 Several other substantial beams are visible, but these generally rest on areas of brick alteration, & are set within the floor structure, rather than beneath it; the floor structure itself (visible from above) appears to be entirely 19<sup>th</sup>-century, with pit-sawn 2" x 10" joists.

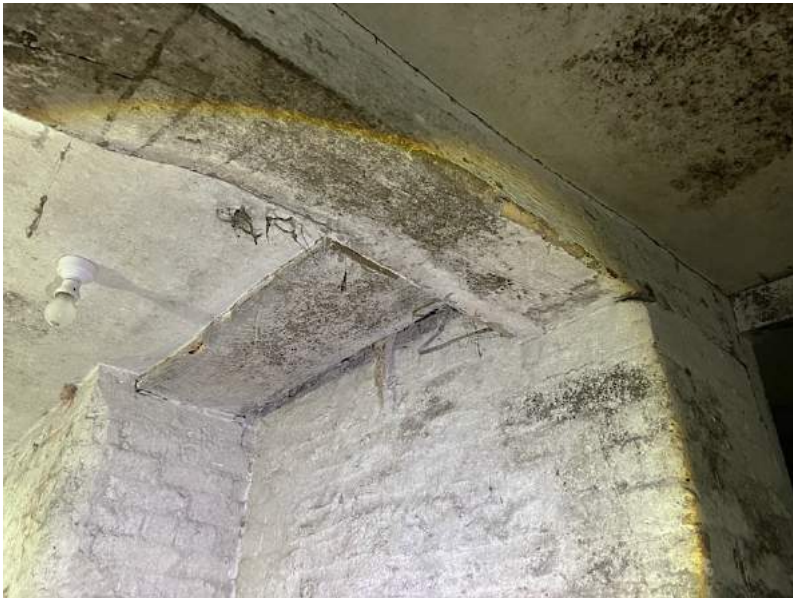
Figure 49 Beams at dog-leg of central passage.

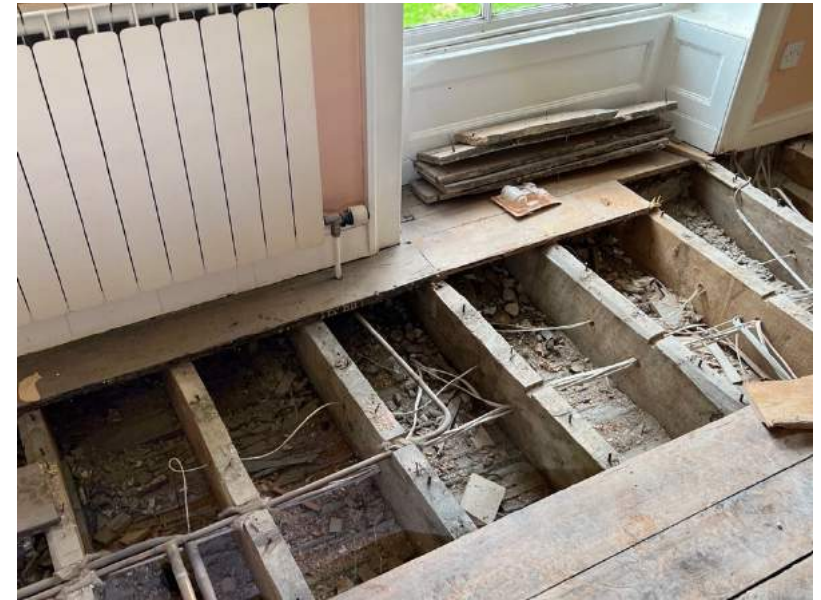
Figure 50 Floor structure above south-east room, from drawing room.

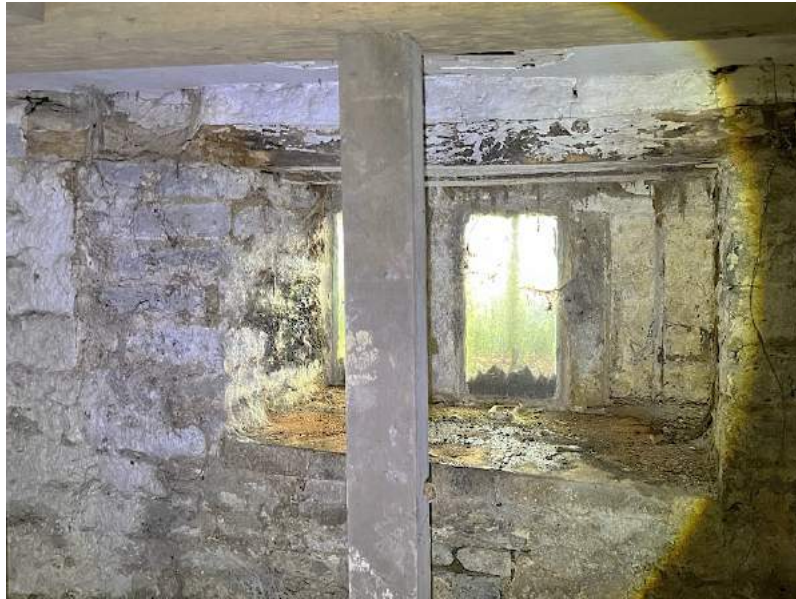
Figure 51 South-west window, with northern light blocked, & splay infilled.

- 5.59 The cellar is lit by three mullioned windows, two on the west & one on the east; nonetheless there appear to be no fireplaces or evidence of former fireplaces at this level of the building, suggesting that it was never intended to be habitable accommodation.
- 5.60 Both the windows on the west side of the building were three-light, but have had one light blocked. In both cases, the light blocked is that closest to the west door, potentially suggesting that the blocking may have been to give greater space to the door & its approach. The south-west window has also had its splays infilled with stonework, presumably to lessen the span of the lintel.

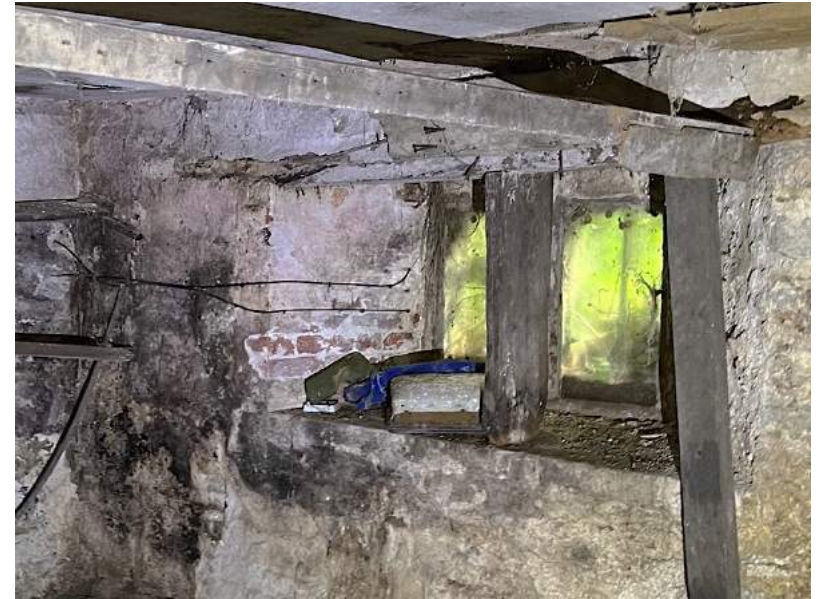
5.61 The single window on the east front is currently two-light, but there is a substantial area of red brickwork to the north of the window. It is unclear whether this brickwork merely infills the splay, or whether there was a third light to the window.

Figure 52 East window, with red brick infill to north (left).

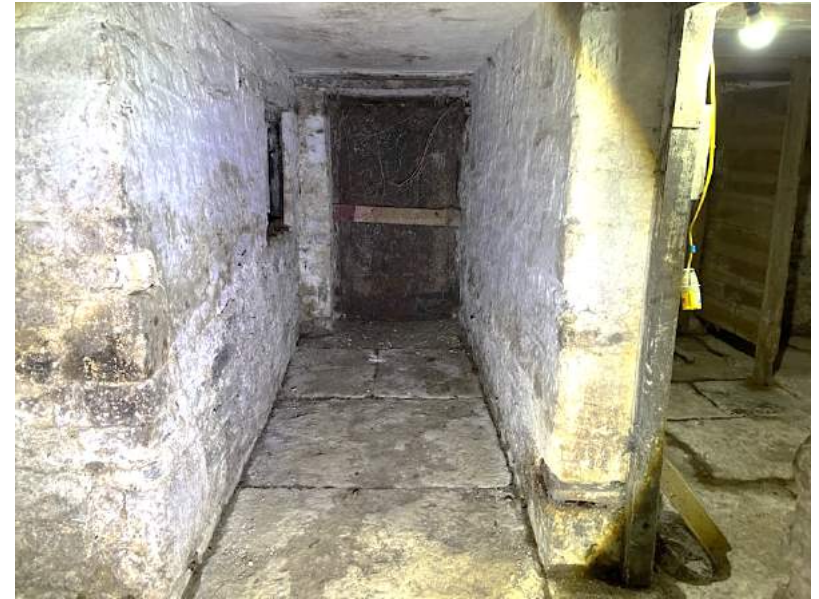
Figure 54 passage facing south to external cellar door.

5.62 The cellar is accessed either by way of utilitarian, 19<sup>th</sup>-century stair beneath the present main stair, or by way of an external door in the middle of the south elevation. The age of this opening is unclear; from the outside it is lined in red brick, suggesting a 19<sup>th</sup>-century date, but from within the reveals are entirely stone, with openings for a sliding timber bar to secure the door (the timber bar itself is a replacement). Such a detail would be rather more characteristic of the 16<sup>th</sup> or 17<sup>th</sup> century than of the 19<sup>th</sup> century. A possible hypothesis would be that the opening is original, but that the external masonry needed repair by the 19<sup>th</sup> century; the presence of the older, stone walls flanking the approach to the door would appear to support this.

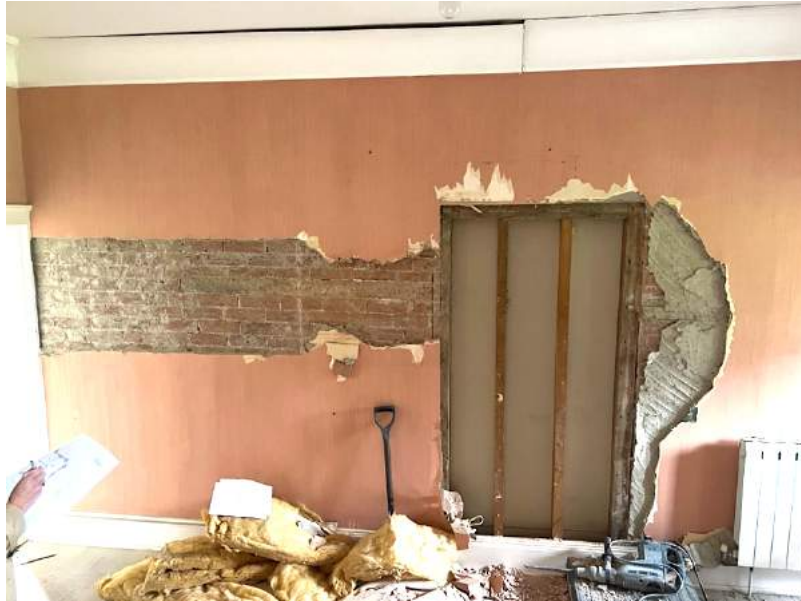
**Figure 57** Hall, south wall, showing brick construction & blocked door to south-west room.

**5.66** The joinery all appears consistent with this date, although the panelled doors have all been stripped, & a door in the southern wall, leading to the south-west room has been removed & blocked. The 19<sup>th</sup>-century joinery here, & elsewhere, appears reasonable quality, but is simple, functional, & unexceptional. The heavy coving that has been added to the room is modern, as is the glazed inner door behind the front door.

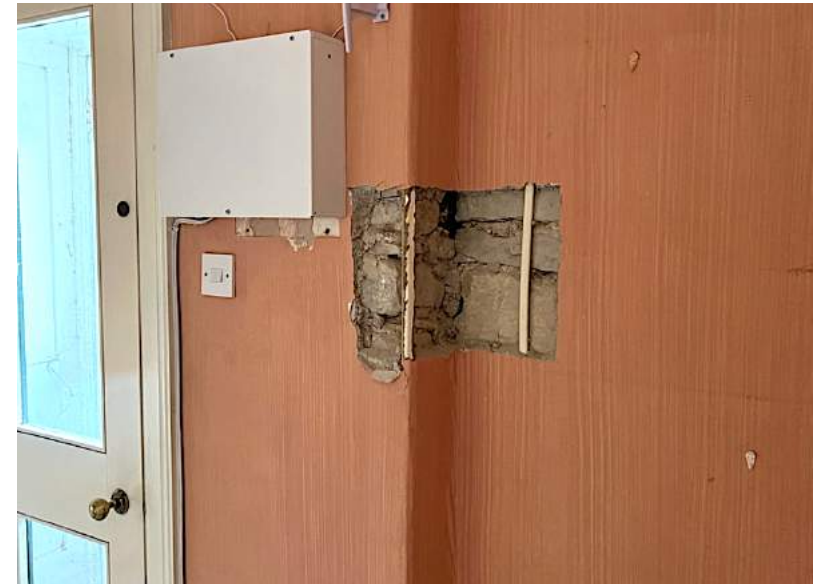
**Figure 58** Hall, detail of step in external wall thickness to north of west door.

**5.67** The west wall of the hall alters in thickness just to the north of the west door. Investigation shows that this appears to be integral to the construction of the stone external wall, rather than the result of a later alteration, although the reason for this remains unclear, & the step does not continue to first floor.

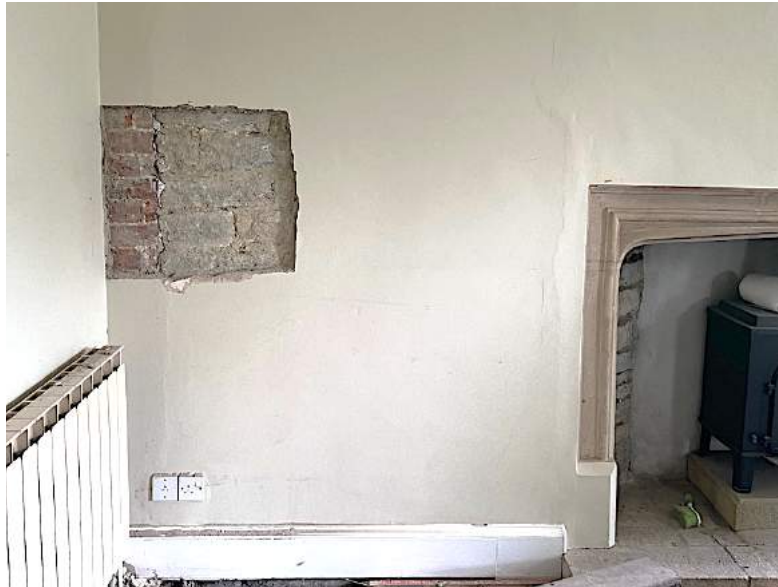
Figure 59 Drawing room, detail of step in wall thickness of eastern elevation (infilled with 19<sup>th</sup>-century brickwork).

- 5.69 The red-brick partition walls also align with, & rest upon substantial, apparently earlier cellar walls. Consequently, whilst the detail of the earlier plan-form of the building remains far from clear, some echo of it appears to survive in the 19<sup>th</sup>-century layout.
- 5.70 The total loss of the pre-19<sup>th</sup> century internal walls above the cellar, but their retention within the cellar determining much of the later plan-form, is curious; one possible hypothesis is that the internal walls above cellar level may have been timber

construction, & thus more vulnerable to irreparable decay from the failing roof valley than masonry walls would have been. It is thus possible that the steps in the wall thickness, above cellar walls, indicate the positions of internal walls.

**5.68** There appears to be a similar step in the thickness of the east wall, just to the south of the present brick partition; this similarly does not continue to first floor. Whilst these two steps do not precisely align with each other, both do align with substantial cellar walls.

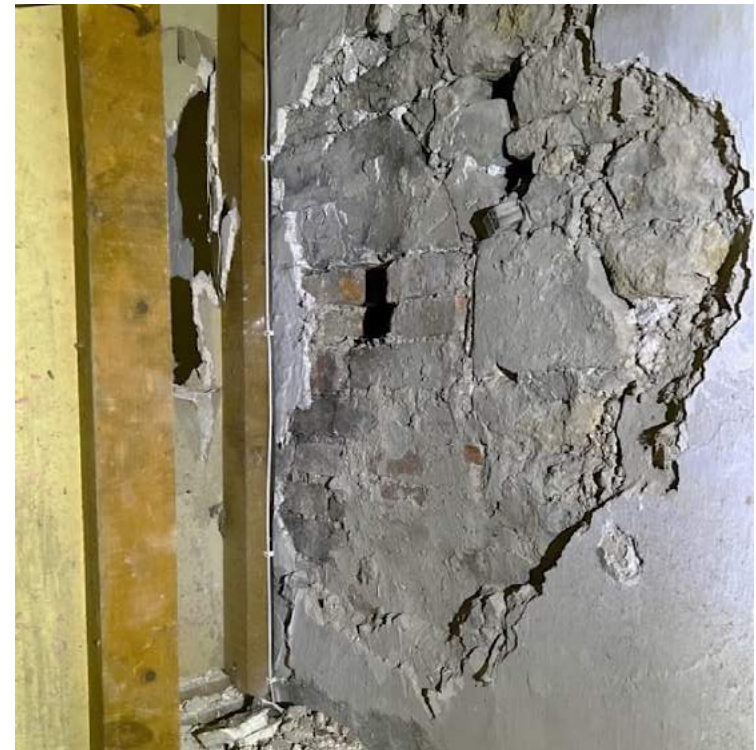
Figure 61 Remains of fireplace behind 19<sup>th</sup>-century stair.

more likely to have been to the south of the passage, in the present south-west room, which would also give the hall & passage a consistent thickness to the inner face of the west wall. The small room in the north-west corner would be the classic position for a buttery/pantry, a room that would not normally have a fireplace, which possibly explains the different form & possibly later date of the revealed remains.

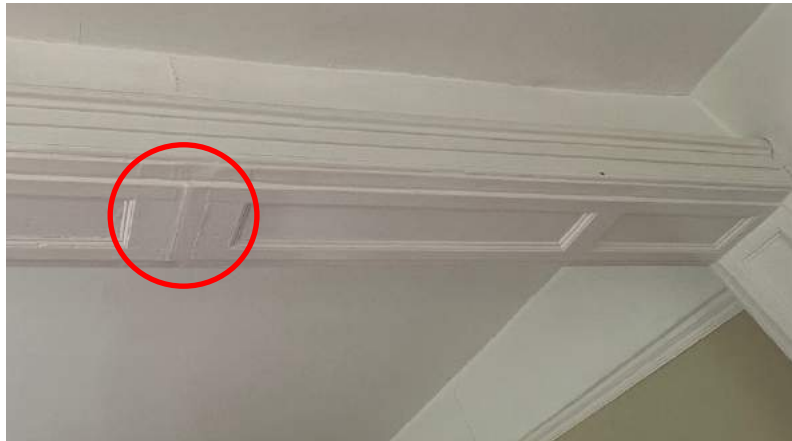
Figure 64 Soffit of drawing room archway, showing scar of alteration.

5.76 The two, rooms on the southern side of the house are now opened to form a single large space. The panelled lining of the opening appears consistent with the 19<sup>th</sup>-century joinery, but displays clear scars of alteration. Opening of the southern jamb revealed a steel I-beam, suggesting that the opening itself is 20<sup>th</sup> century, & the lining formed from salvaged 19<sup>th</sup>-century elements.

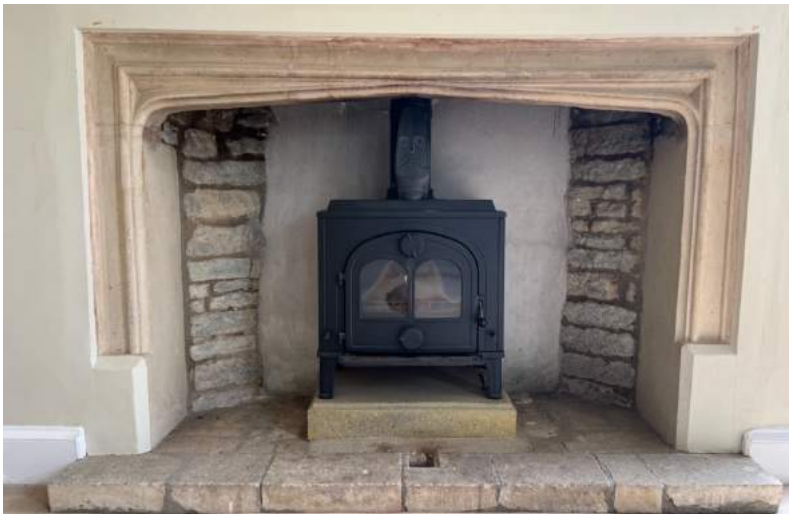
Figure 67 Fireplace, probably 20<sup>th</sup>-century replica.

5.77 The remaining joinery of this room appears fundamentally latter-19<sup>th</sup> century. The fireplaces at either end have stone surrounds with depressed arched heads, prismatically-recessed spandrels. These fireplaces match two clearly historic fireplaces that survive at first & second floors; however, the drawing fireplaces appear to be 20<sup>th</sup>-century replicas.

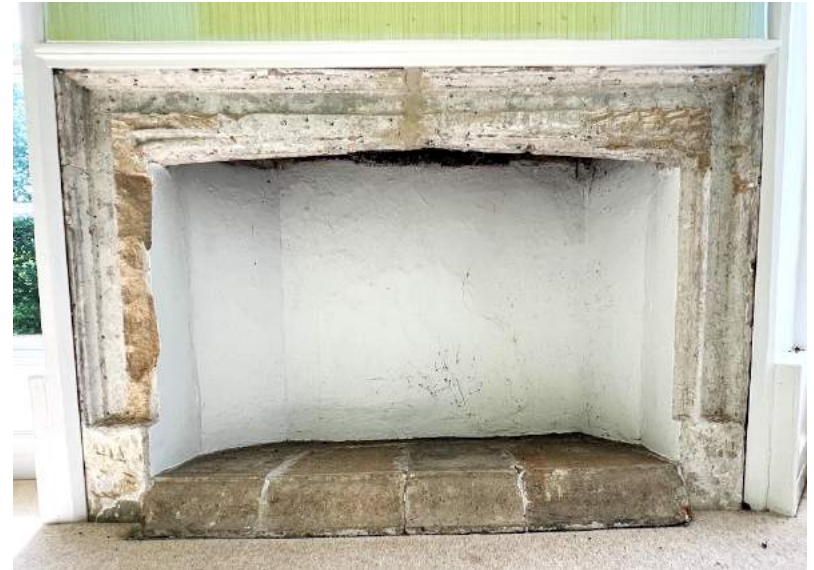
Figure 68 Late-16<sup>th</sup>/early-17<sup>th</sup> century fireplace in the south-west room at first floor.

5.78 The two historic fireplaces, one in the south-west room at first floor, the other (smaller but better preserved) in the north-west ordinal projection at second floor, are similar in design to the drawing room fireplaces, but have a far more convincing patina which suggests that they are original.

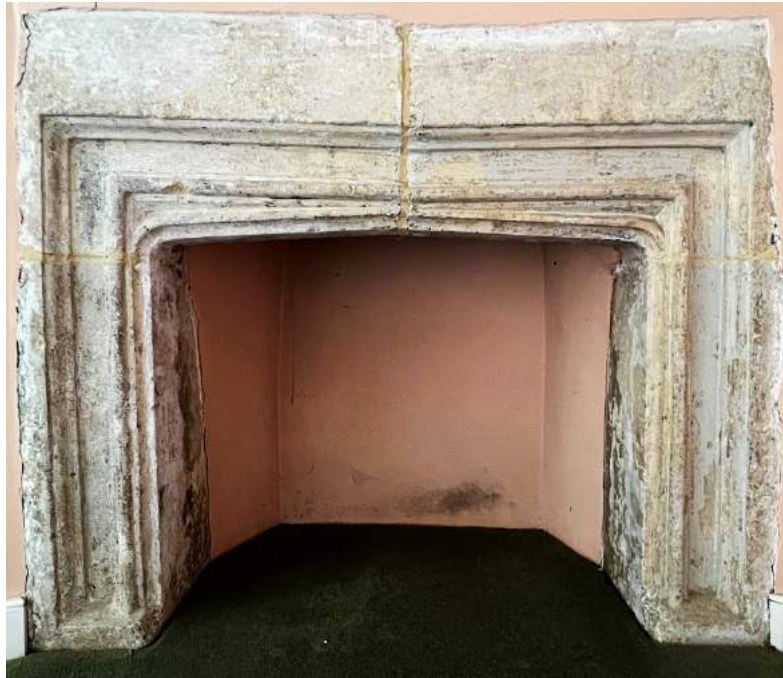
Figure 69 Late-16<sup>th</sup>/early-17<sup>th</sup> century fireplace in the north-west ordinal projection at second floor.

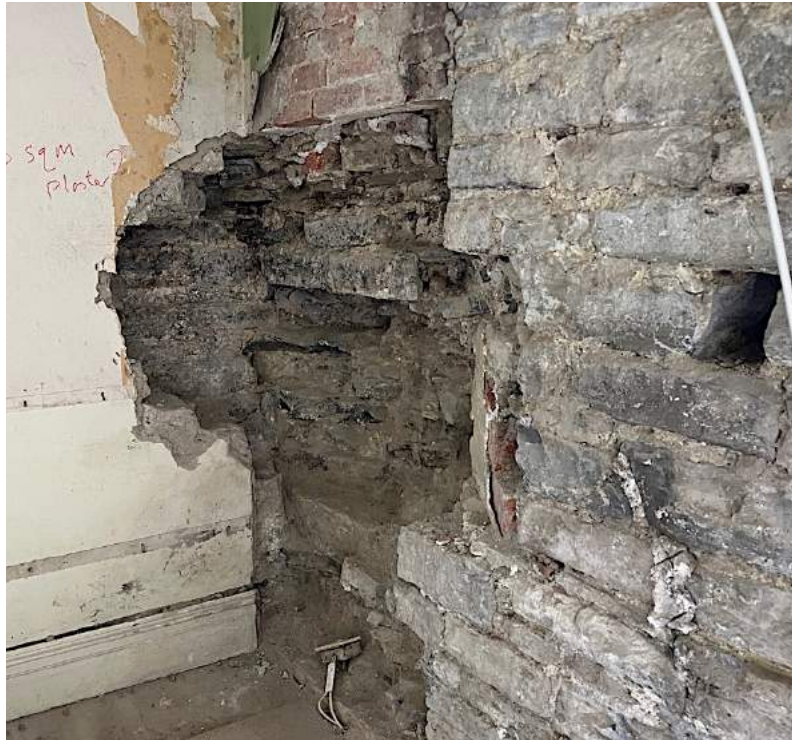
Figure 71 Dining room, detail of opening up in north-east corner.

5.82 There also appears to be a straight joint a little under half way between the corner & the present window reveal. It is possible that this may, potentially, indicate the original alignment of the inner face of the northern wall, allowing the depth between the two to contain a kitchen fireplace. However, in the absence of further investigation, the evidence remains more suggestive than definitive.

- 5.81 Limited exploratory work in the north-east corner to investigate the nature of the larger, north-east ordinal projection has indicated signs of earlier phases, although the evidence revealed is thus far inconclusive. However, on the northern wall there appears to be a flat face to the stone wall, potentially with some blacking, several inches behind the present face of the wall; this may indicate the back of the historic kitchen fireplace.

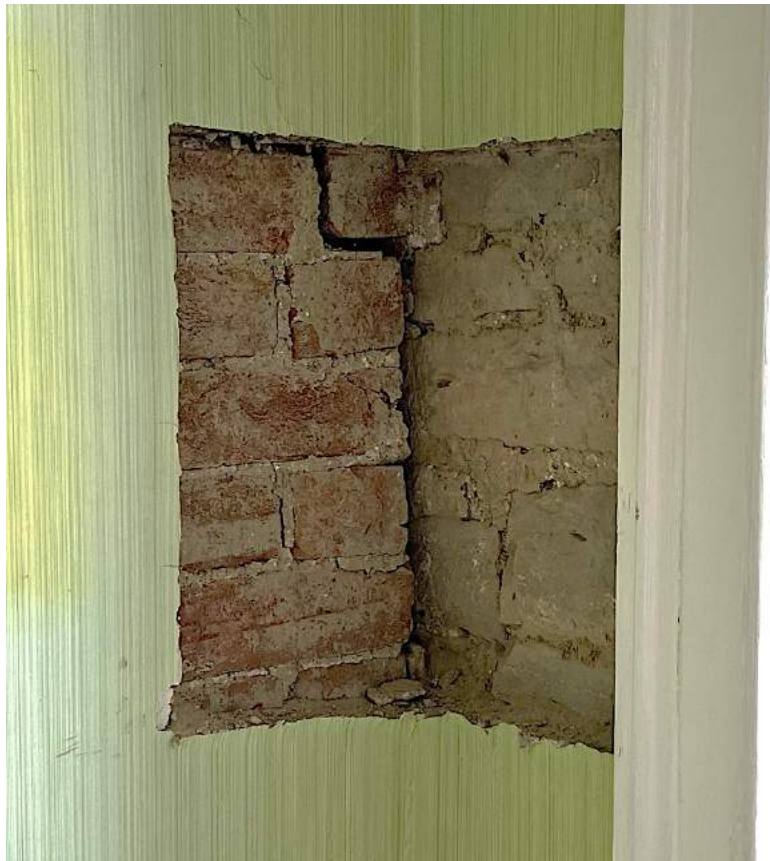
**Figure 77** Junction of brick wall dividing the two southern rooms (left) & the inner face of the south elevation.

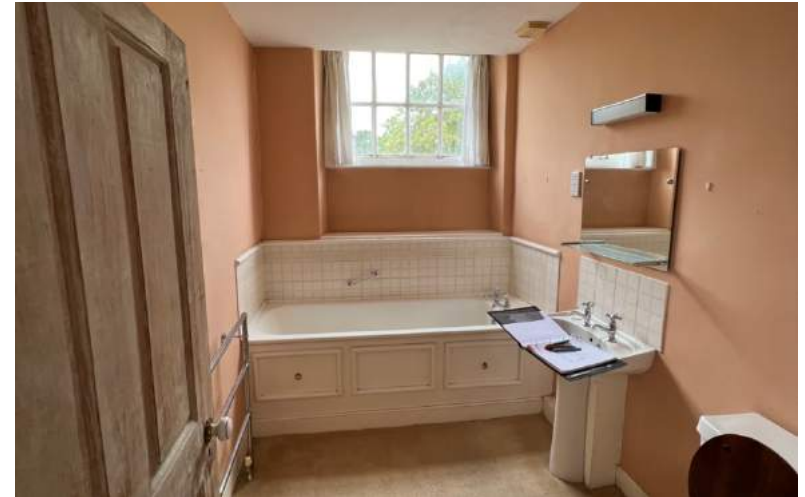
Figure 80 First floor bathroom, lit by the bottom sash of the stair window.

the first & second floors to illuminate two bathrooms, with the lower sash converted into a pivoting window.

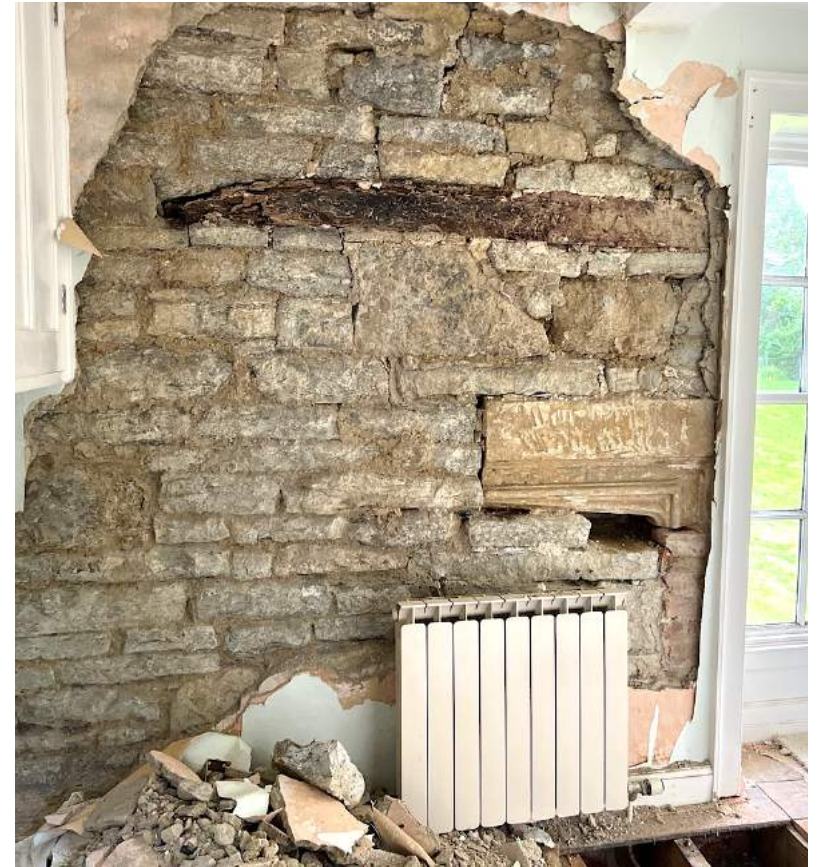
5.91 In the north-east room, however, part of an original fireplace has been revealed behind modern plaster.

Figure 83 North-east room, east wall, showing the right half of the fireplace head, & a relieving beam above.
