# WEST BRADLEY HOUSE.

Heritage Appraisal.

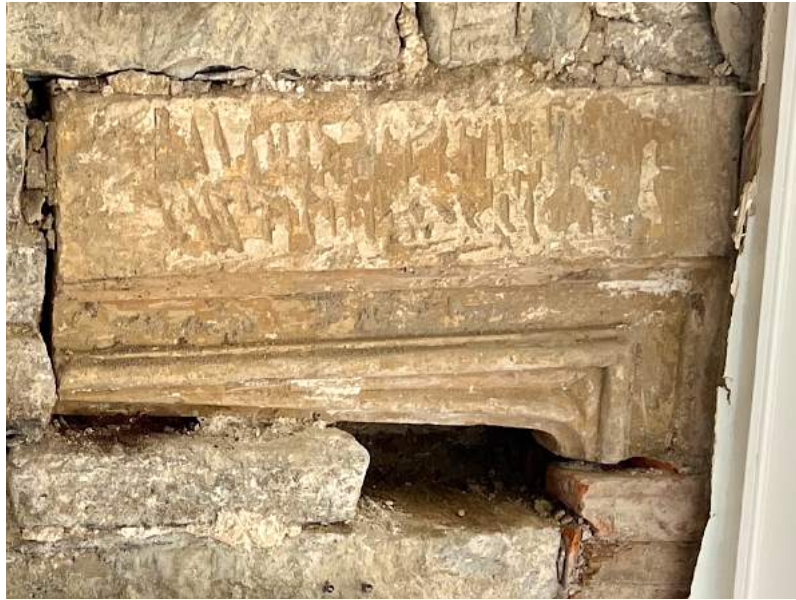
coursing of the adjacent stonework, the fragment does appear to be *in situ*. The use of stone rather than red brick for the infill may suggest that the blocking pre-dated the 19<sup>th</sup>-century works.

Figure 84 Detail of head of fireplace in north-east room.

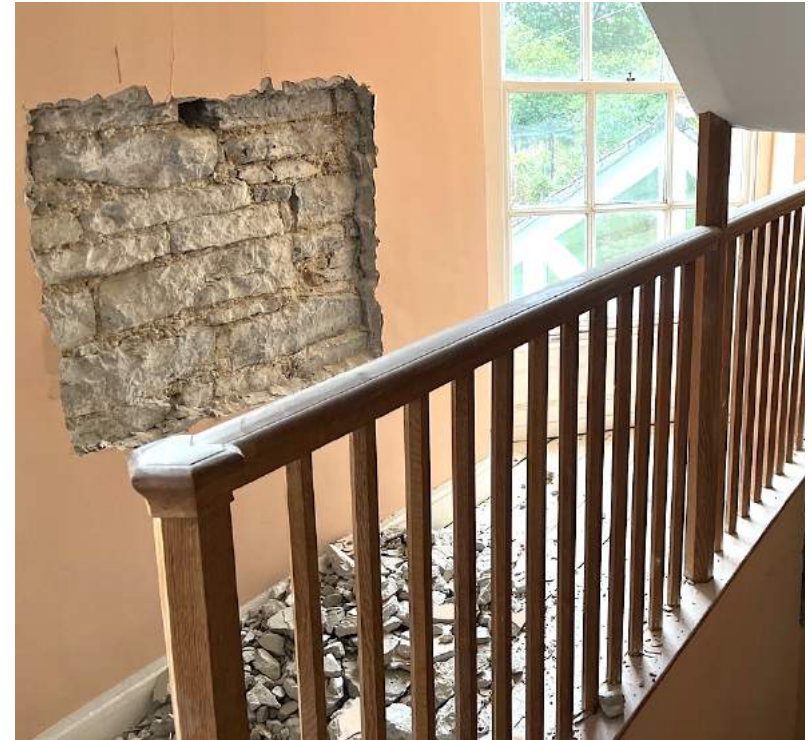
5.93 Investigations revealed no trace of a corresponding fireplace for the former north-west room, although given the care with which the coursed stone was inserted into the north-east fireplace, the former existence of a twin cannot be discounted,

Figure 85 Possible location of fireplace for former north-west room.

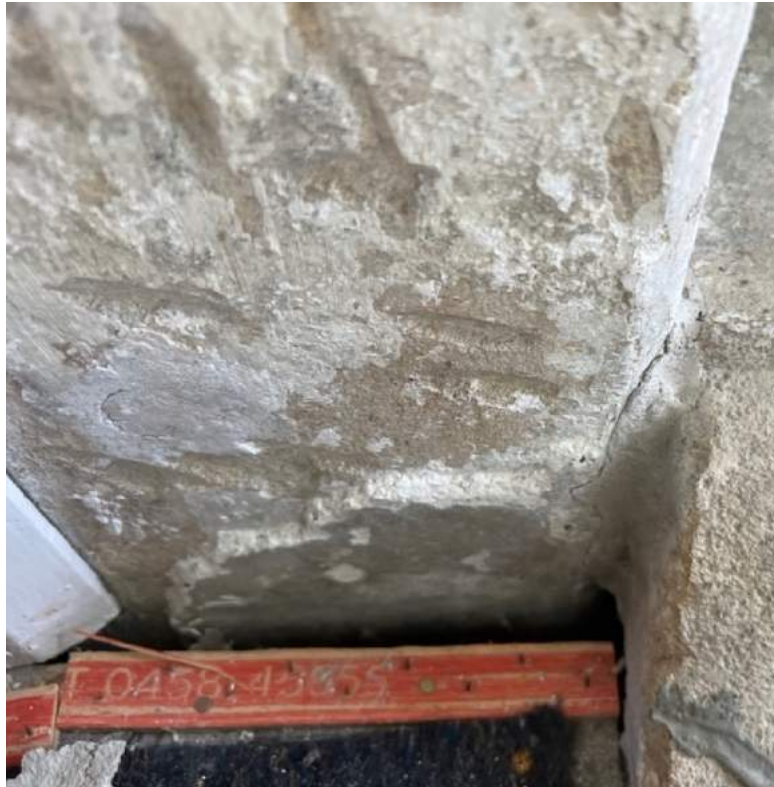
jamb a fine coat of lime plaster, continue down beyond the present floor level.

**Figure 86** Detail of left jamb of the south-west fireplace, showing the fine coat of plaster that extends down below the present floor level.

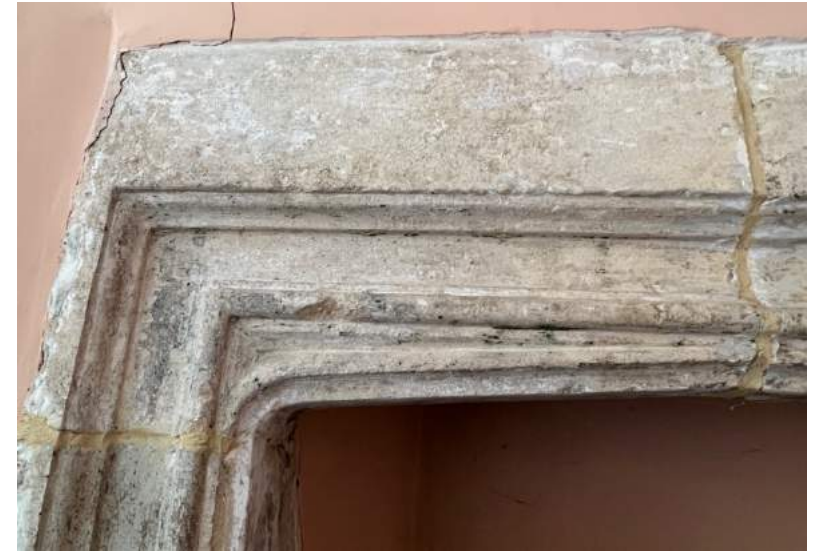
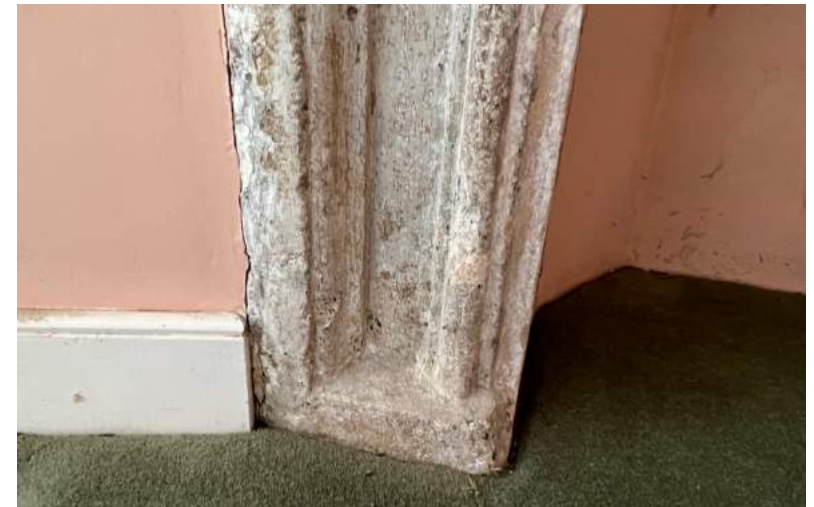
Figure 89 Detail of fireplace in north-west ordinal projection.

Figure 90 Detail of fireplace in north-west ordinal projection.

preserved fireplace in the north-west ordinal projection, now uncomfortably close to the 19<sup>th</sup>-century stair.

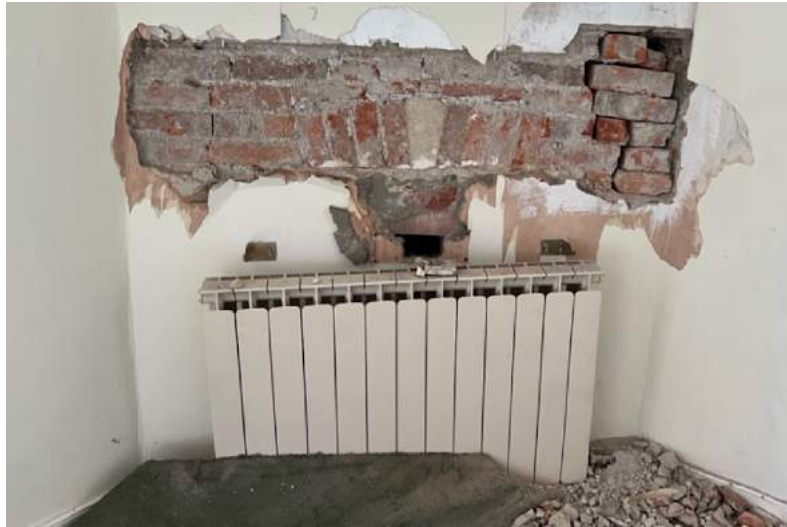
Figure 91 19<sup>th</sup>-century fireplace in the south-west projection.

5.97 Blocked fireplaces have also been uncovered in the south-east & south-west ordinal projections; however, these are formed from 19<sup>th</sup>-century red brick, & would have been concealed behind applied surrounds. No trace remains of the stone fireplaces that would certainly have originally existing in these locations. No evidence of a fireplace has yet been found in the north-east room.

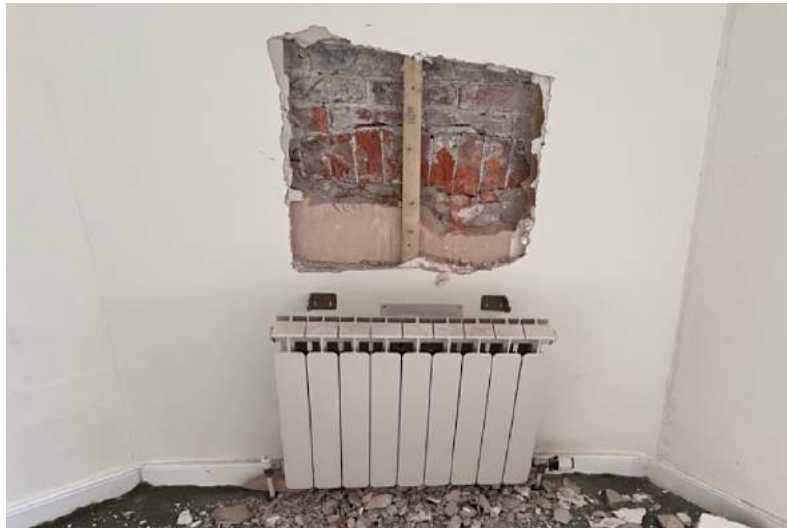
Figure 92 19<sup>th</sup>-century fireplace in the south-east projection.

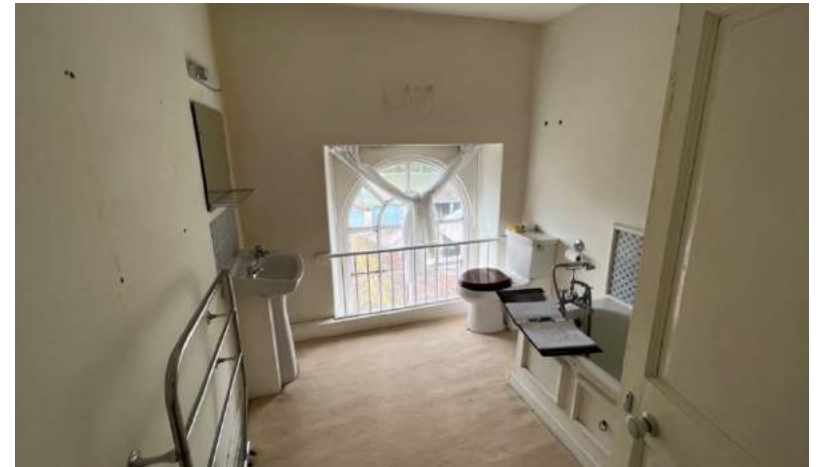
Figure 93 Second-floor bathroom, facing north.

- 5.98 The only element that can be definitively ascribed to the early-18<sup>th</sup> century phase of alteration appears to be the upper half of the stair window, which now lights the second-floor bathroom. This has the characteristic ovolo-moulded glazing bars, & a very fine semi-circular head.

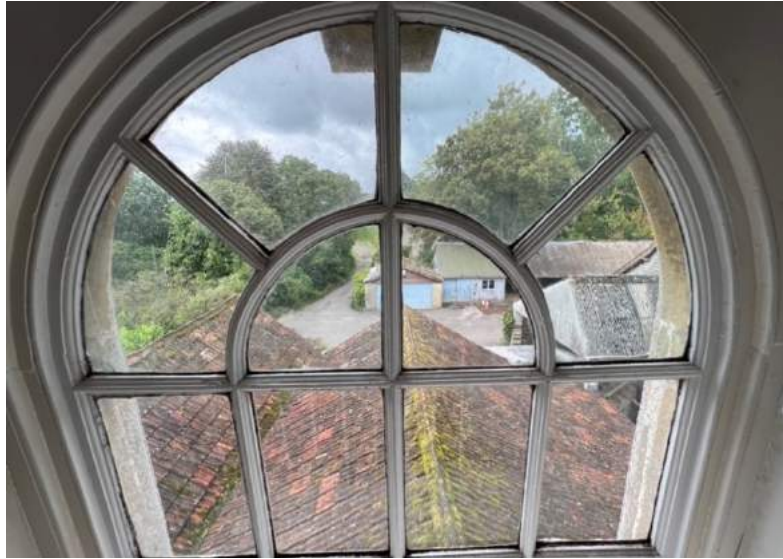
Figure 94 Detail of upper sash of the former stair window.

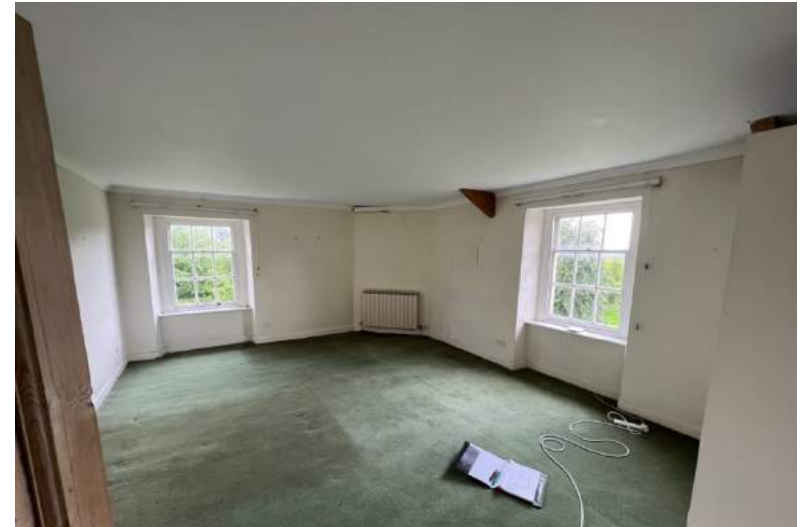
Figure 95 South-west room (with modern lowered ceiling).

5.100 The three second-floor rooms are plain, without window linings & with modern replacement sashes, presumably dating from the 1987 dropping of the sills.

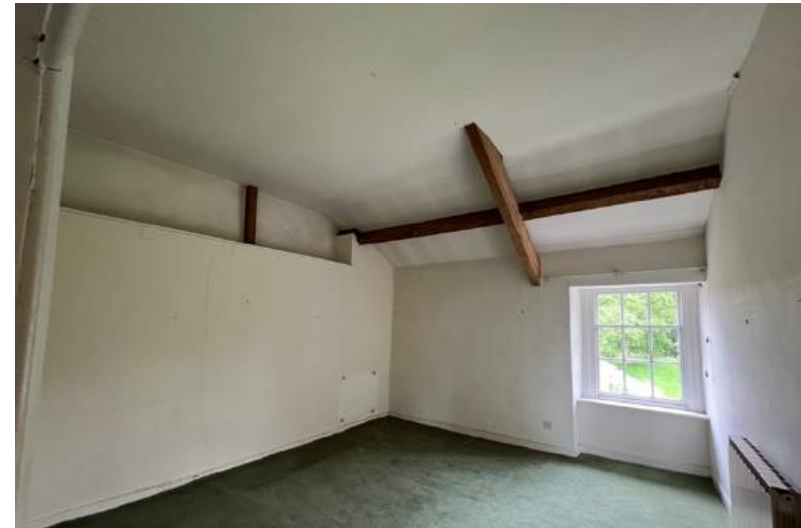
Figure 96 North-east room (with 19<sup>th</sup>-century ceiling height).

- 5.101 The north-east room has a high ceiling: to two southern rooms & the landing have modern false ceilings, but the higher ceiling survives above. This lath-&-plaster ceiling is above the height of the principal rafters, & thus appears to be contemporary with the current, 19<sup>th</sup>-century roof structure.

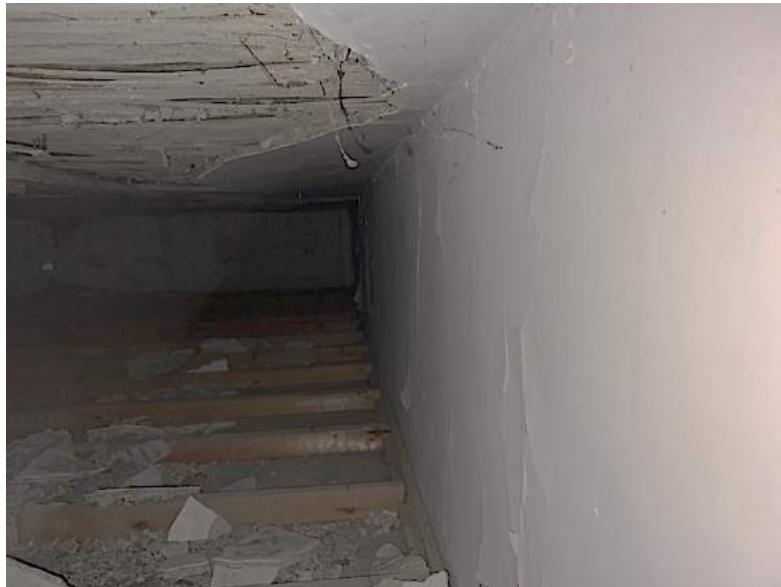
Figure 97 Void between modern false ceiling, & 19<sup>th</sup>-century lath-&-plaster ceiling.

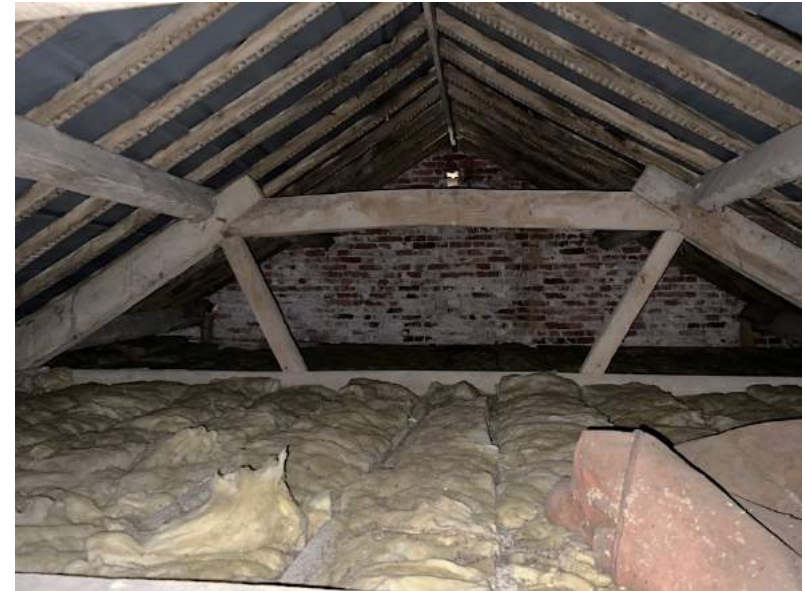
Figure 98 Within the roof, facing south.

- 5.102 The roof structure appears to have been replaced as part of the 19<sup>th</sup>-century refurbishment of the house, & comprises a single span supported on two trusses. These trusses are unusual, as the principal rafters continue no higher than the upper collar, & are braced back to the lower collar; this unusual arrangement is presumably due to the ready availability of timber at the time, as the length required, although considerable, is not excessive, & is not dissimilar to that of the lower collars.

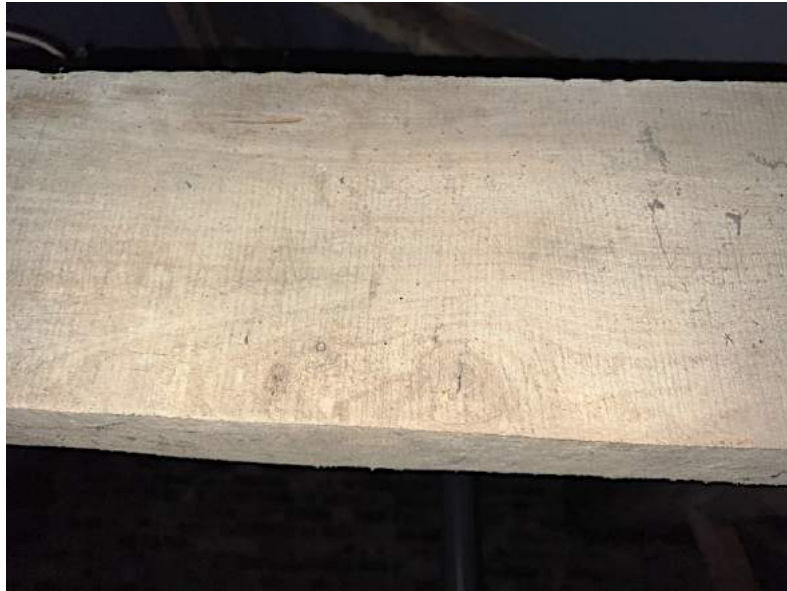
**Figure 99** Detail of collar, with characteristic markings for a timber that was pit-sawn.

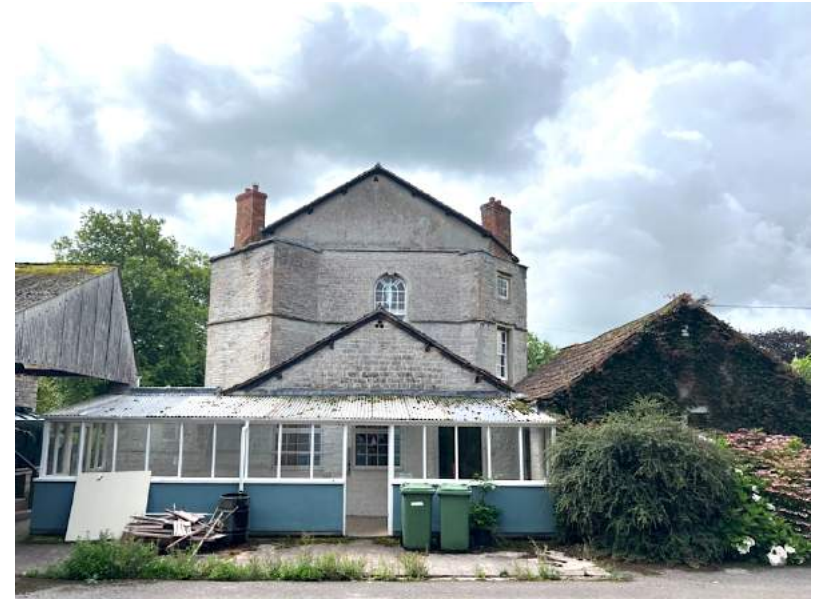
Figure IO4 North wing, north elevation.

- 5.106 The present lean-to along the north of the north wing is a replacement of that shown on the 1902-4 O.S. map.; it is constructed from softwood upon a concrete-block plinth wall, & projects further out, & is longer than its predecessor.
- 5.107 The elevation that has been covered by the lean-to also shows signs of alteration, including evidence that the north wing shown in 1885-6 was already the result of at least two phases.

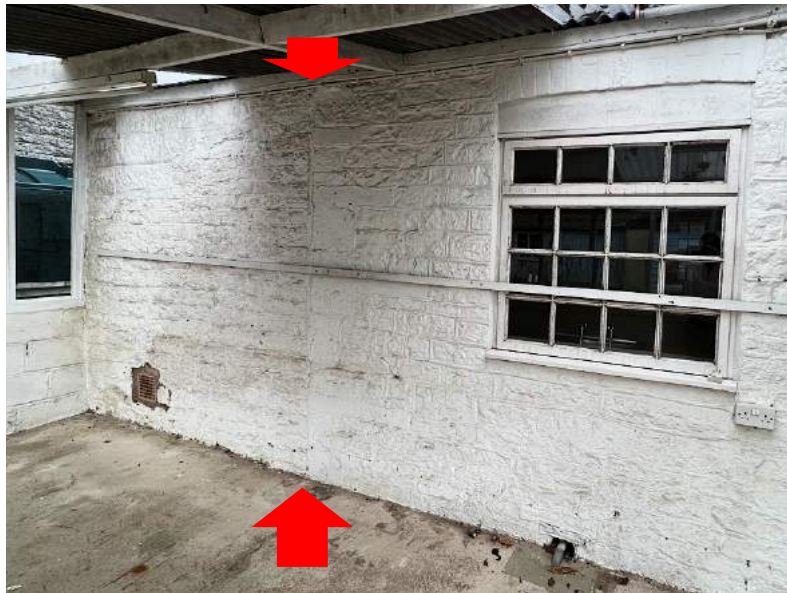
Figure 105 North elevation, showing straight joint & quoins.

- 5.108 The original north-east corner is clearly delineated by a straight joint & row of quoins, with the eastern projection (current pantry) built beyond this,

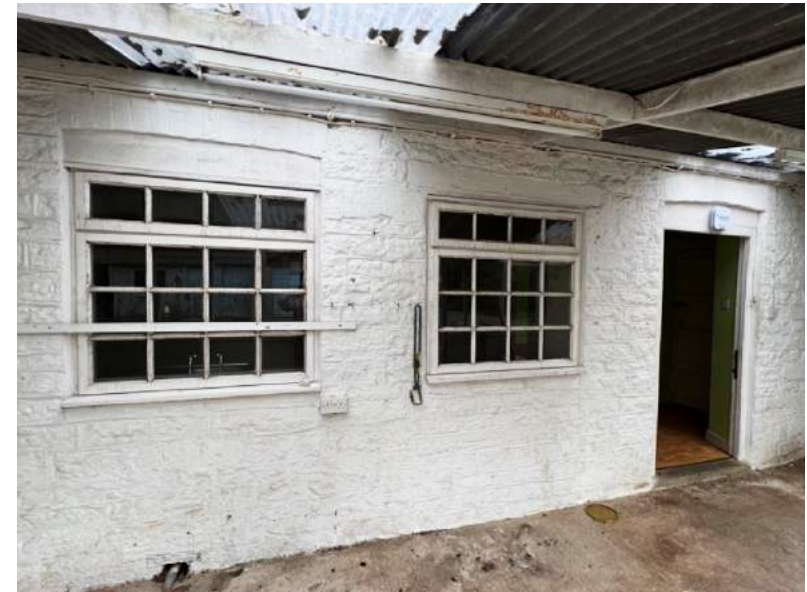
Figure 106 North elevation, fenestration.

- 5.109 To the west of this joint, are three openings, with a door in the westernmost. However, the masonry, & straight reveals, suggest that the middle opening was originally the door (the head may have been raised), flanked by a pair of windows.
- 5.110 The current doorway contains a good, early-18<sup>th</sup> century, six-panel, raised-&-fielded external door.

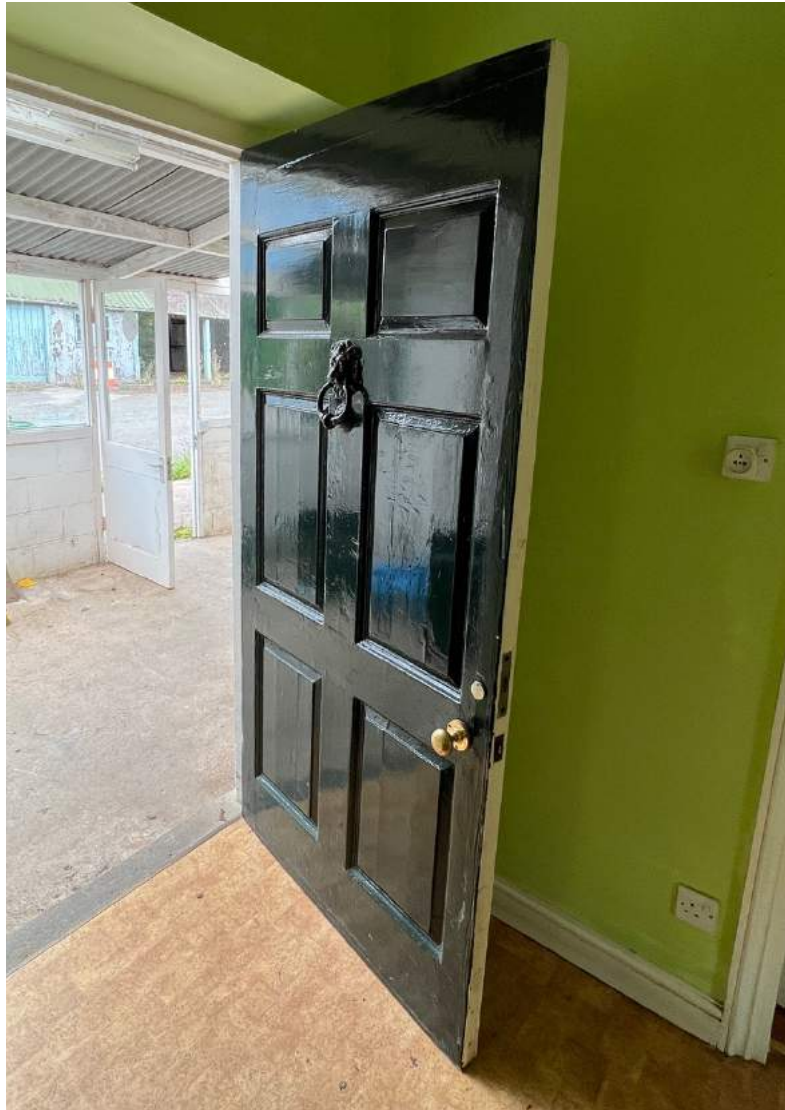
Figure 107 Reused 18th-century external door.

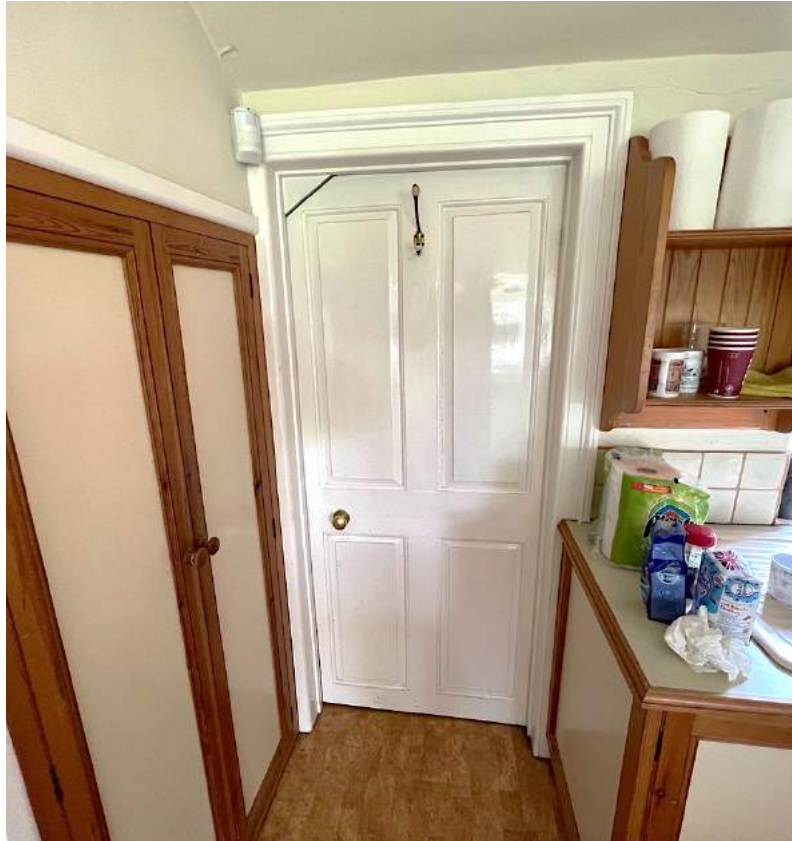
Figure I10 Salvaged 18<sup>th</sup> century door in north-east corner of kitchen.

- 5.112 Internally the north wing has been heavily modernised, the only visible historic features comprising a floor of large, coursed flagstones in the north-west room, & another salvaged 18<sup>th</sup>-century door (an internal, four-panel door, with one side raised-&-fielded), between the kitchen & pantry.

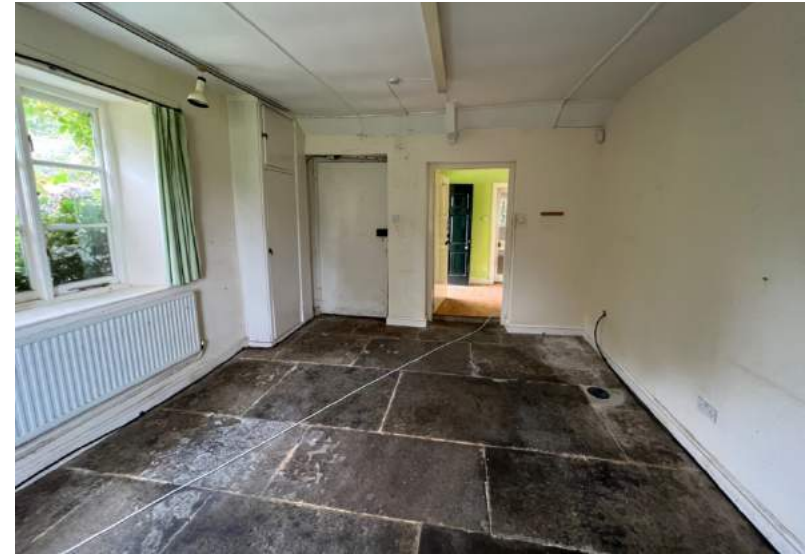
Figure I11 North-east room facing east, with retained stone floor.

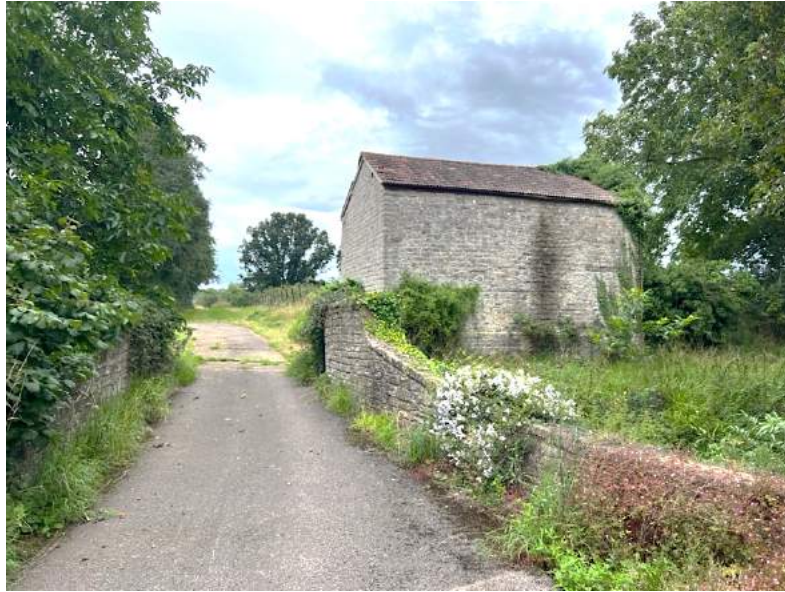
Figure 119 Little Stone Barn, from the south-west.

- 5.118 The Little Stone Barn comprises a simple rectangular structure, with a single, full-height opening on the north elevation. The south & west elevations, those most prominently seen from the house, are clad in stone; the north & east are red brick, & the interior is also red brick (now rendered) on all four sides.
- 5.119 The building retains two trusses, the western one altered, & the eastern one failing; the remainder of the roof structure is modern. The eastern end of the building, adjacent to the doors,

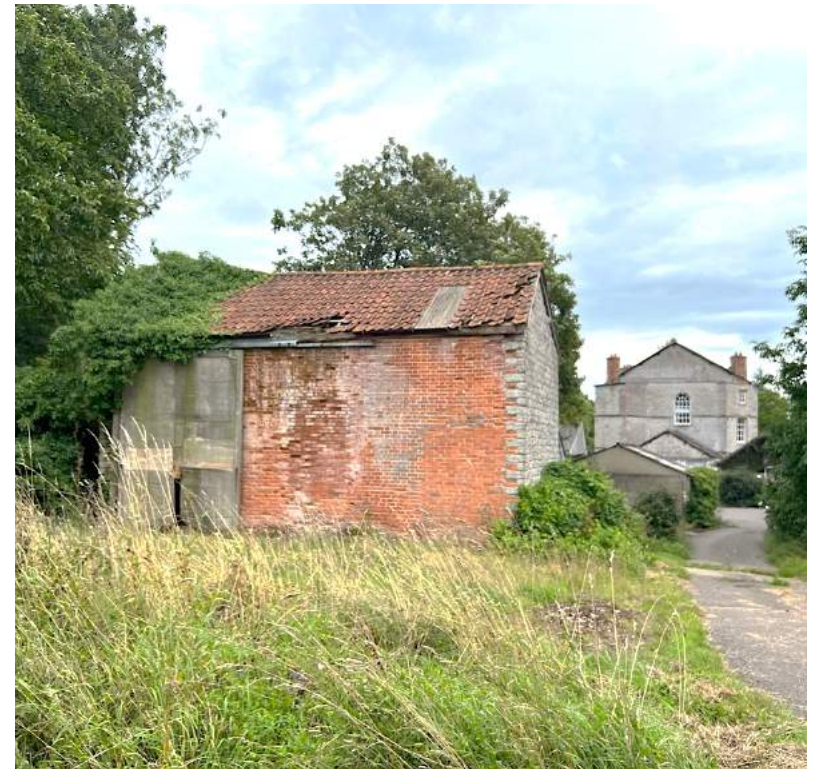
Figure 120 Little Stone Barn, from the north.

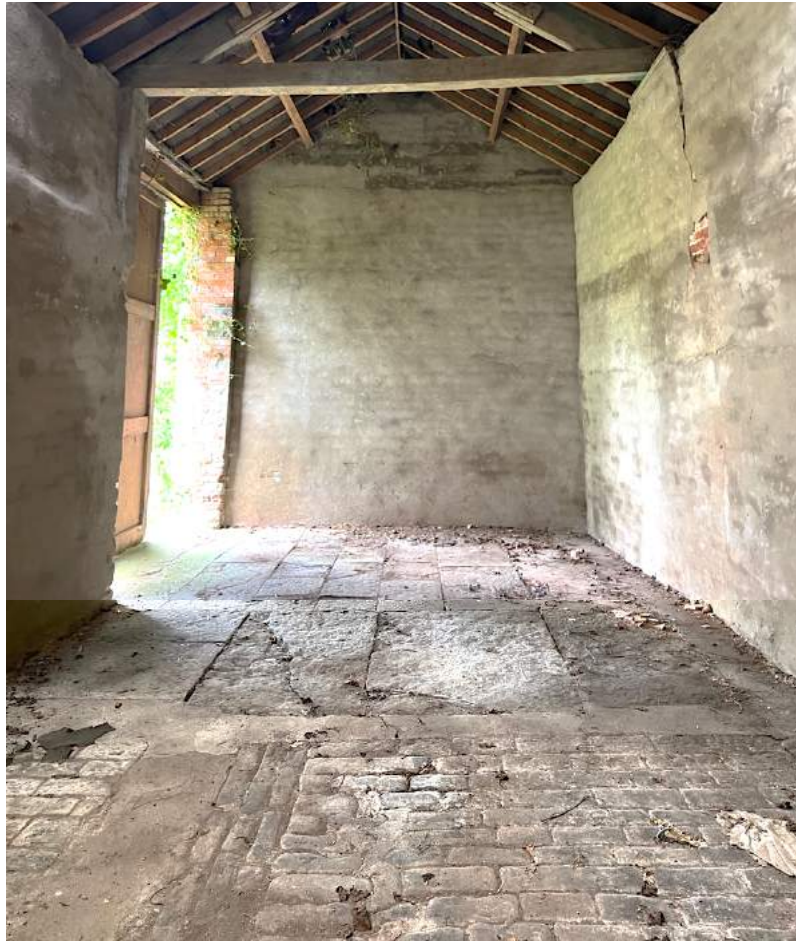
Figure 121 Little Stone Barn, interior facing east.

is paved in coursed stone flags; the centre of the building is a row of larger flags, & the western end of the building has a pattern of stone setts. There is also an area of now-overgrown sets to the north of the building.

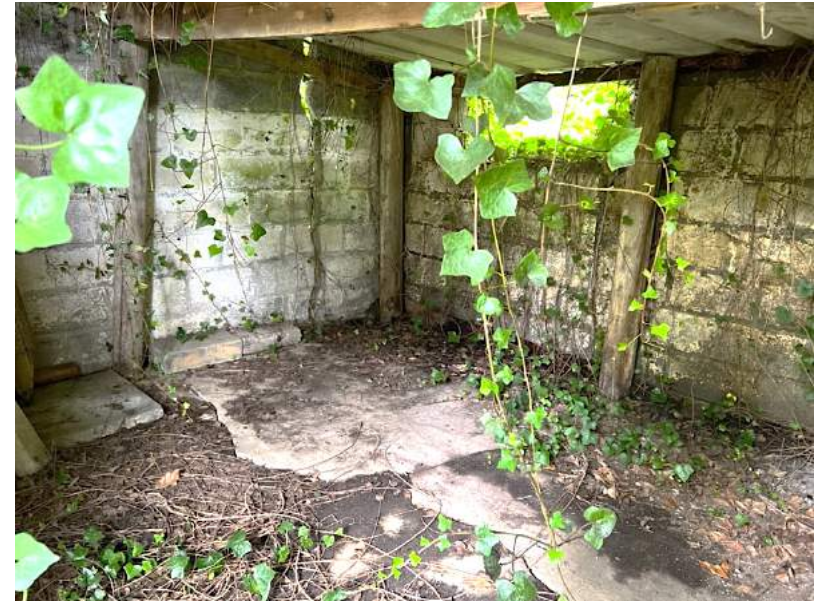
Figure 122 Little Stone Barn, eastern addition.

- 5.120 A concrete block lean-to on the eastern end of the building is modern.

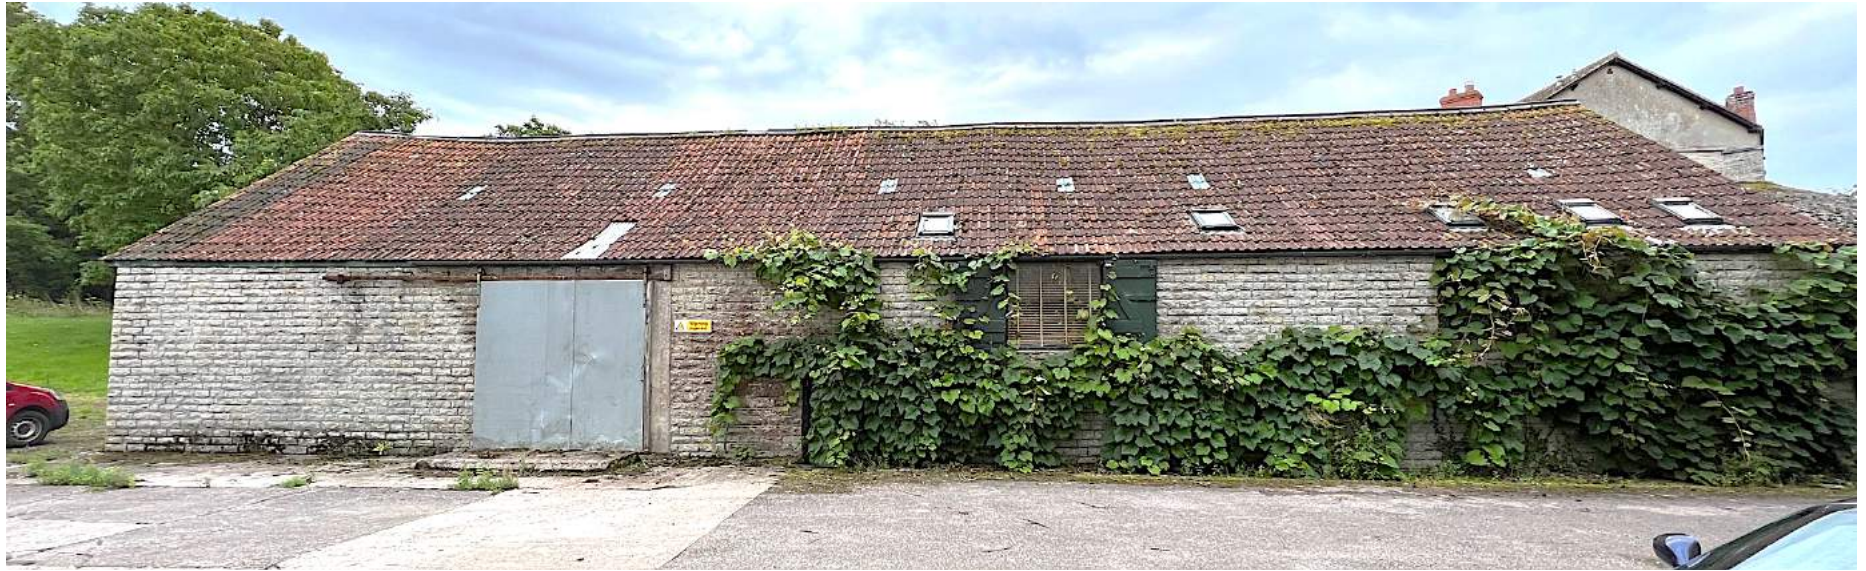
Figure 123 Apple Barn, north elevation.

- 5.121 The Apple Barn was originally erected between 1885-6 & 1902-4, & comprised a single linear range built from regularly coursed, rock-faced stone; the roof of double-Roman tiles, & 6 panels of double-Roman glass tiles, are likely to be contemporaneous.

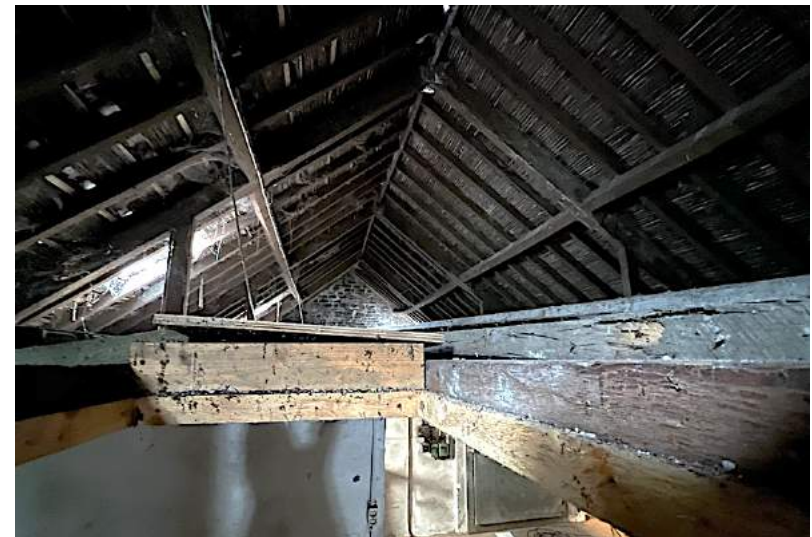
Figure I26 Apple Barn, roof structure in western half, facing east.

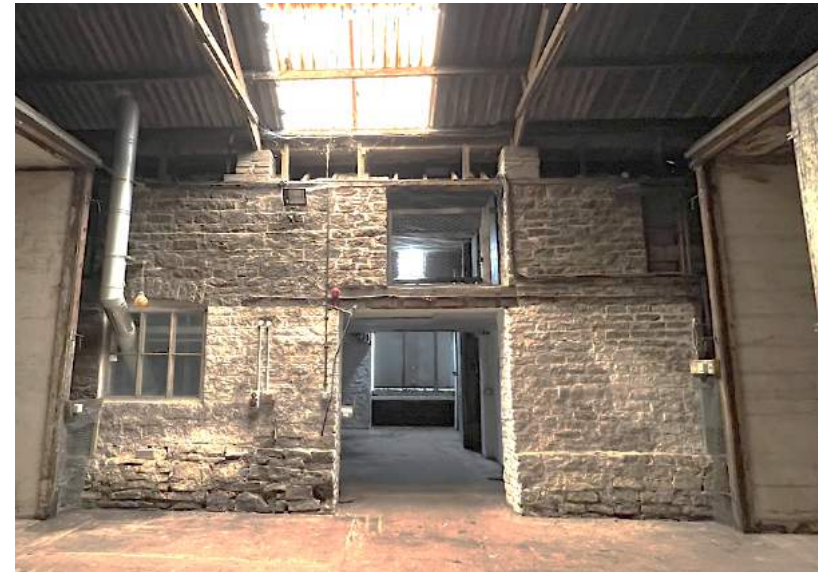
Figure 129 Original south elevation of Apple Barn, now within Concrete Barn.

- 5.125 The Concrete barn appears to have been added by the time of the 1921-43 map, in which it is depicted the full length of the building; it has now been cut back at the west end, presumably to lessen the encroachment upon the house.
- 5.126 The range is a utilitarian concrete block construction of little interest, although within it the original south elevation survives, albeit a little battered.

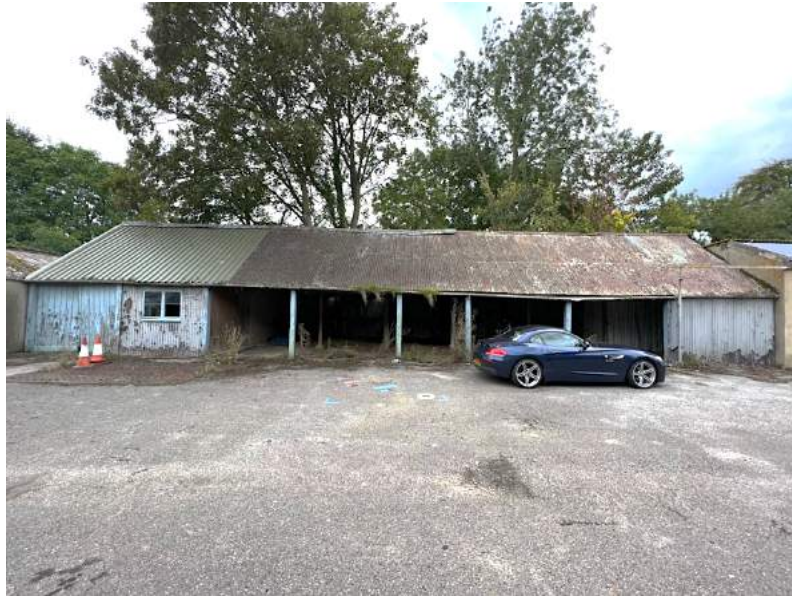
Figure 130 Cart /hed, south front.

- 5.127 The present range comprises three abutting structures, the centre of which comprises the Cart Shed, an open-fronted shelter shed, with one enclosed bay at the west, which was erected between the 1902-4 & the 1921-43 O.S. maps.
- 5.128 Whilst the overall form of the building is traditional, the construction is utilitarian, with machined timber posts (with no saddle stones) supporting basic trusses, the whole now clad in corrugated metal sheet.

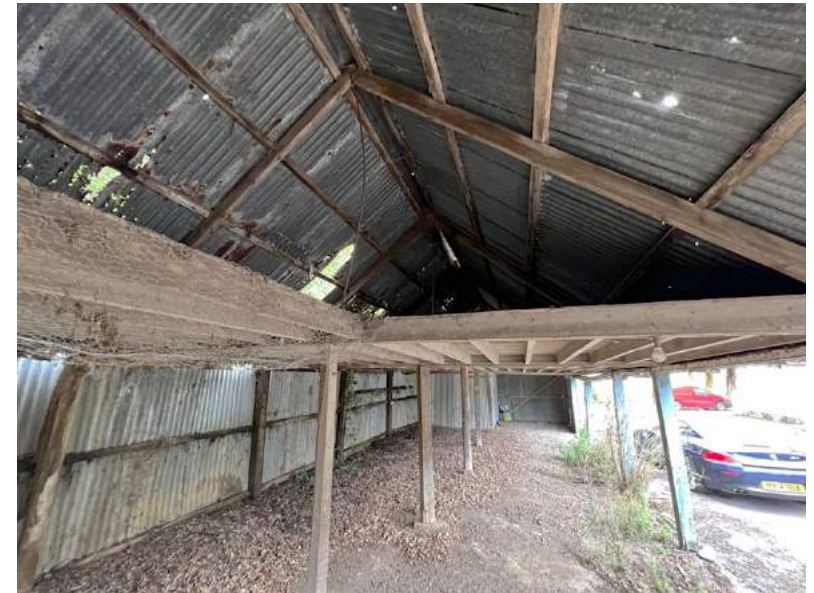
Figure 131 Cart /hed, interior facing east.

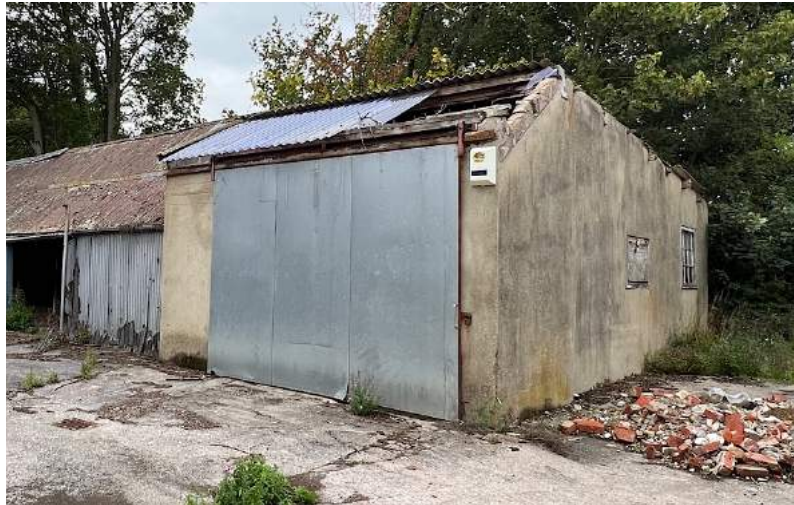
Figure 132 Cart/hed range, eastern modern agricultural shed.

- 5.129 To the east of this structure was originally a smaller, set-back structure behind two open pens, potentially pig-pens or kennels. This has been replaced by a utilitarian modern cement-rendered, concrete small agricultural shed.
- 5.130 At the western end, an enclosed garage structure has been added, also constructed from cement-rendered concrete block. Both eastern & western end appear to post-date the 1962 O.S. map.

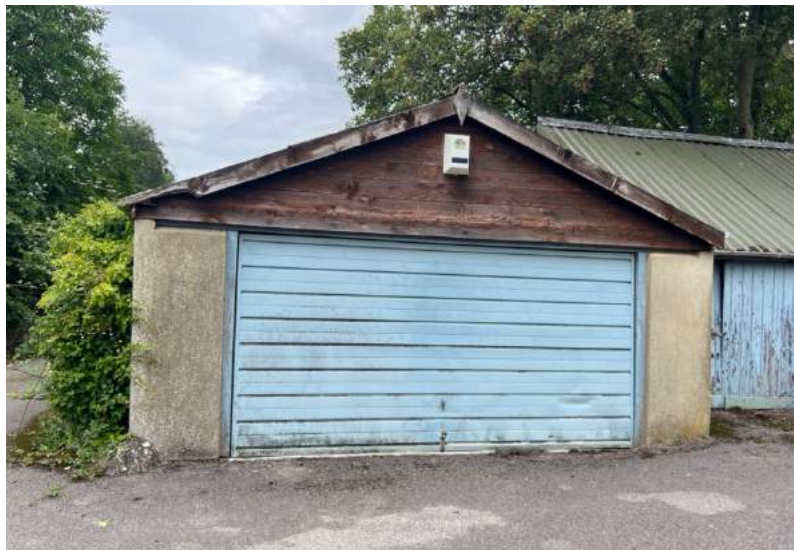
Figure 133 Cart/hed range, western modern garage.

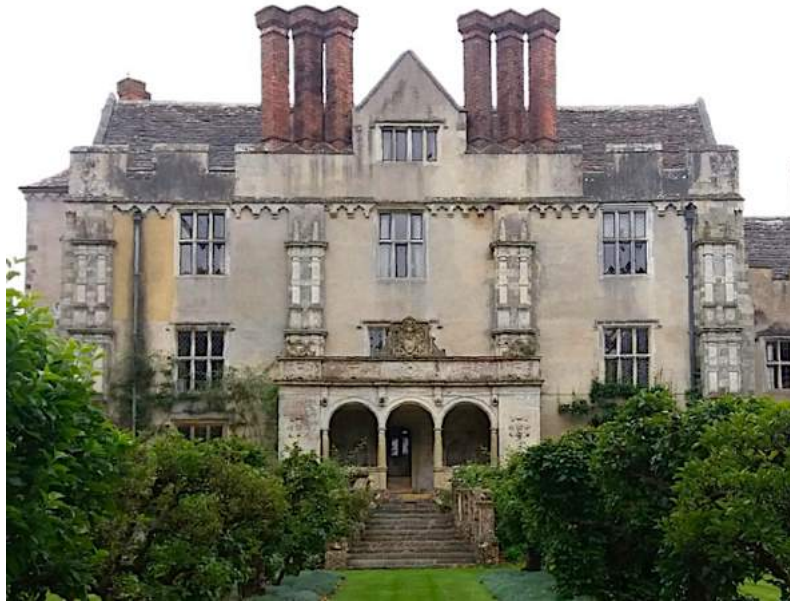
Figure 143 Cranbourne Manor, Dorset, north front, 1608-36.

- 11.12 In order to complement the established character of 45-degree angles at West Bradley, the stacks, one for each flue, would be turned, & to give adequate visual termination, would be given a projecting capping, both also characteristic of the time, as at Cranbourne Manor in Dorset.

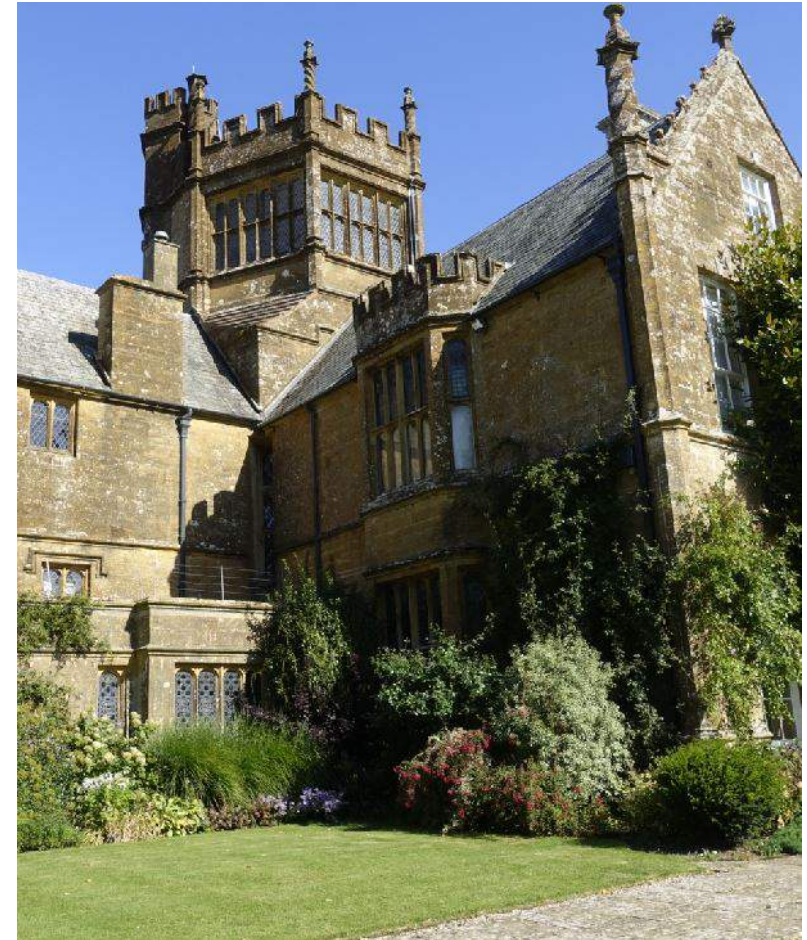
Figure 146 Hexagonal prospect room, Melbury House, Dorset, c.1530.

- 11.16 An early example of a prospect room survives at Melbury Hall in Dorset, although this does not sit at the centre of a coherent geometrical design.

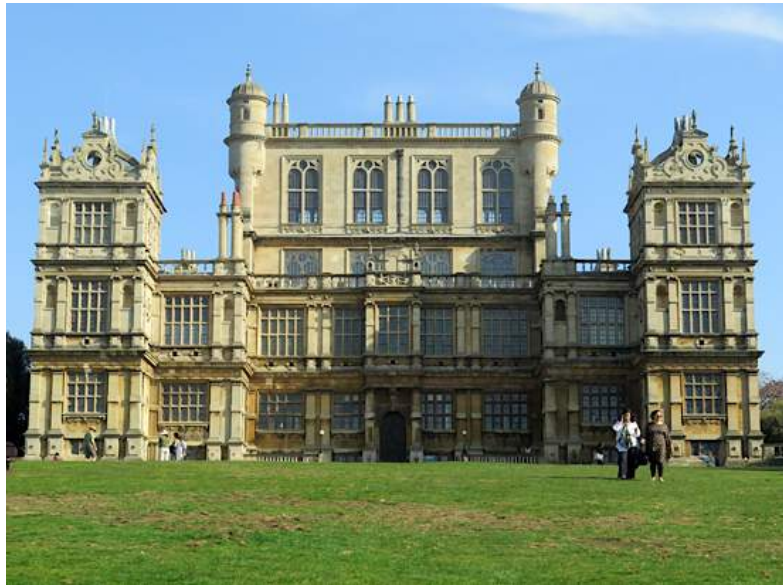
Figure 147 Central prospect room raised above the hall clerestory, Wollaton Hall, Nottinghamshire; Robert Smythson, 1580-.

- 11.17 However, towards the end of the century, with the increasing interest in geometry & complex allegorical meanings, prospect rooms tended to be placed more centrally, the greatest example being that at Wollaton Hall, where Robert Smythson raised it above the clerestory of the central great hall.

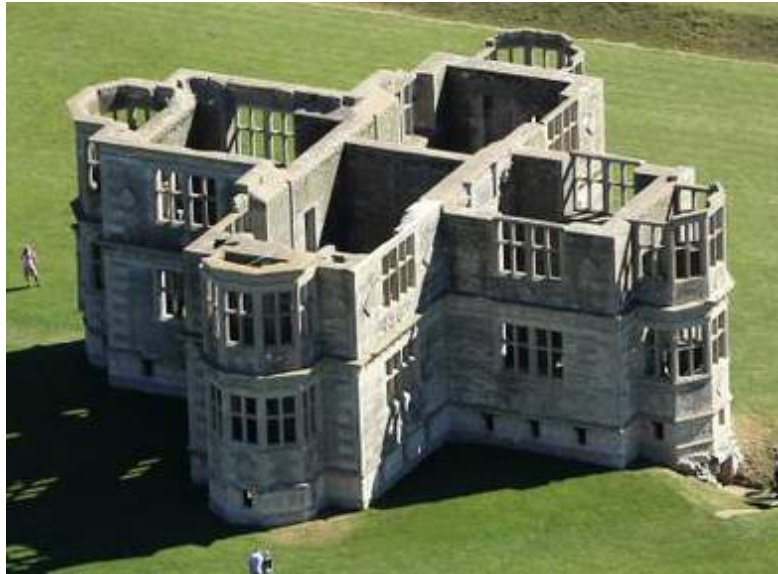
**Figure 149** Lyveden New Bield, Northamptonshire, started 1594, left incomplete 1605.

contain a stair, or it could have been a prospect room or roof-top banqueting house.

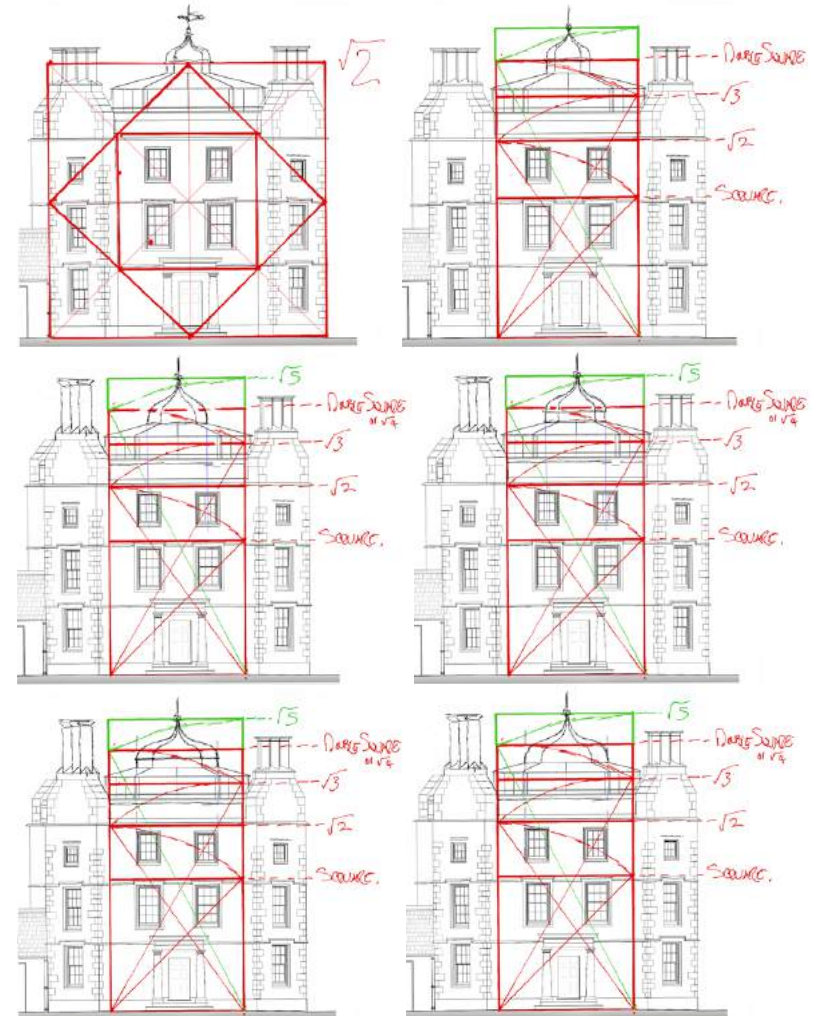
Figure 155 Some of the exercises undertaken to look at possible roof forms.

- 11.24 As the new roof was intended to evoke appropriate historic roofs in a sympathetically contemporary way, rather than form a speculative pastiche reconstruction, it is suggested, again taking inspiration for skeletal ogee domes, to 'deconstruct' the ogee to create more abstract silhouette.

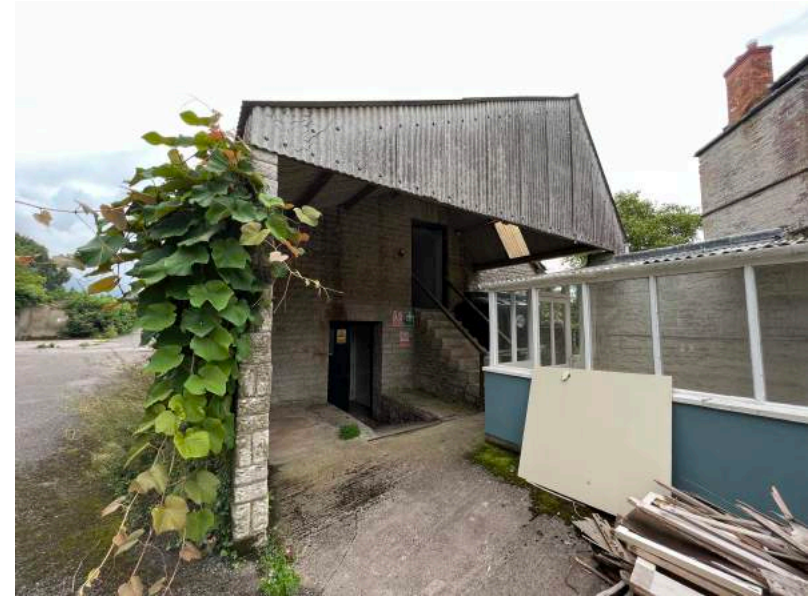
Figure 165 Existing Conservatory & link to Apple Barn.

11.40 It is also proposed to replace the existing link the north wing to the Apple Barn, which would then provide a scale of reception space that could not be benignly achieved within the historic house.

11.41 The replacement link, which would be lower & less visually dominant than the existing link although far higher quality, would be honestly contemporary, with a zinc roof & timber-clad elevations that would give it a lighter weight appearance that would be visually distinct from the flanking stone structures.

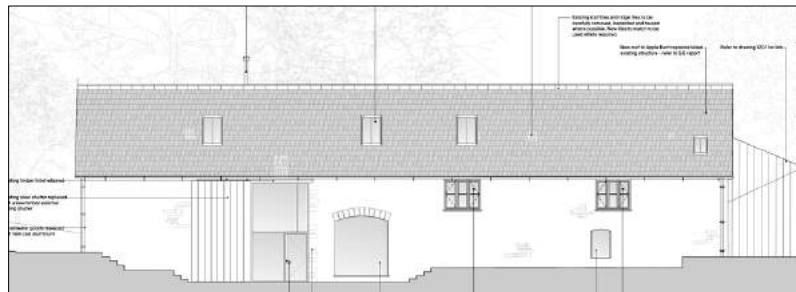
Figure 167 Apple Barn, proposed north elevation.

11.48 The roof structure of the barn is also suffering from lack of maintenance & is structurally compromised (see structural engineers report); the proposal is to repair & replace as necessary in order to ensure the survival of the curtilage-listed building.
