**Bat Survey Report for
Dower House garage, Chastleton,
Moreton-in-Marsh, GL56 0SU**

Dower House garage, Chastleton, Moreton-in-Marsh – Bat Survey Report

Report Number: 3988-CWS-01

Date: 6th February 2022

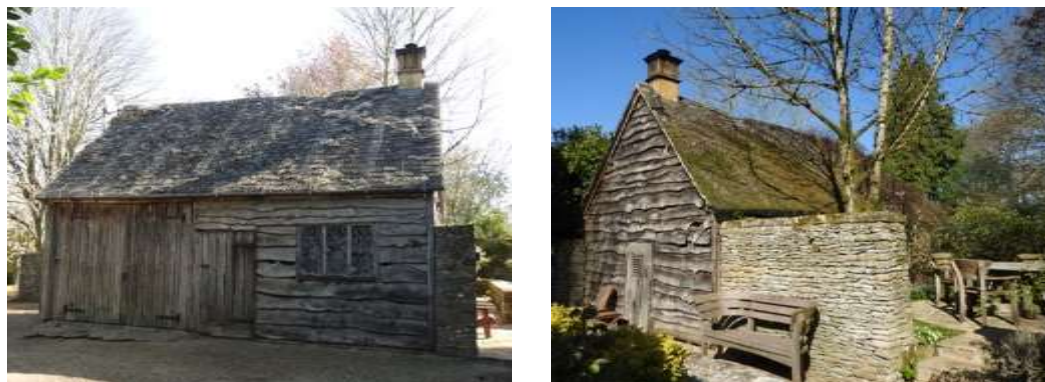
Figs. 1 & 2 Aspects to the front (L) and rear (R)

The survey site comprised a detached, pitched roofed garage (Figs. 1 and 2).

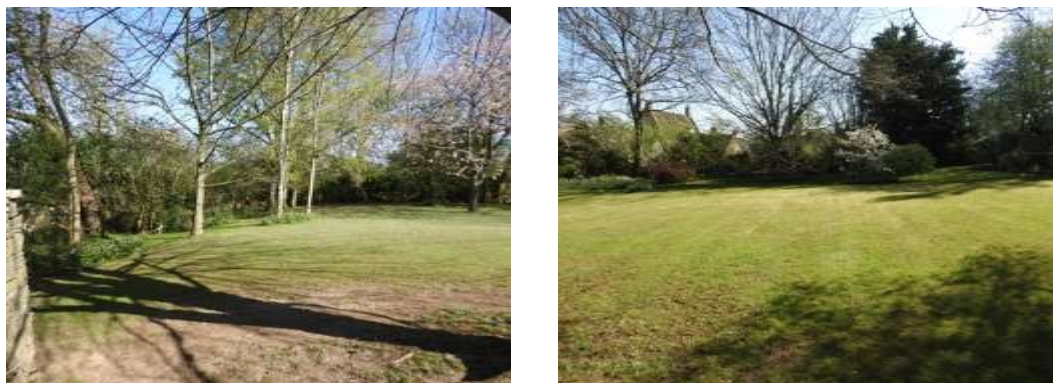
Figs. 3 & 4 Views of the rear garden

The rear garden was laid to lawn with mixed shrubs and large mature trees on the boundaries (Figs. 3 and 4 – overleaf).

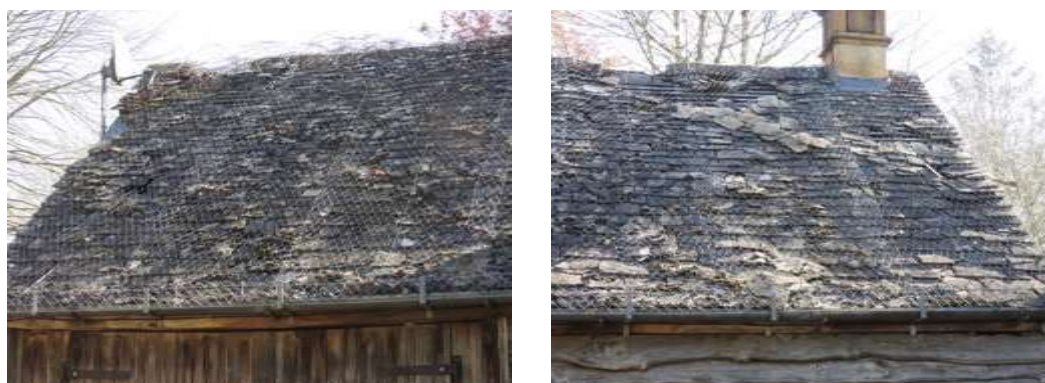
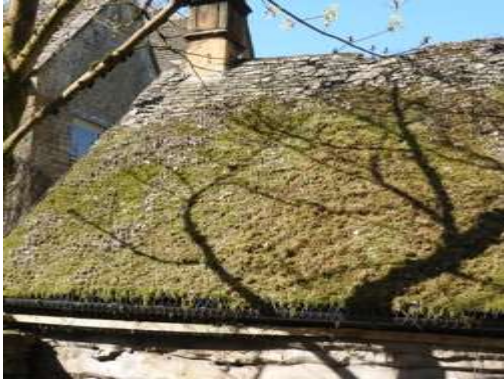
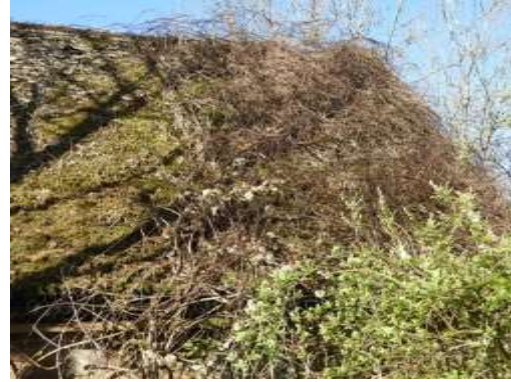
The ridge had some ridge tiles missing and there were gaps. The roof tiles were mainly tightly overlapping, although broken, dislodged and missing tiles were , whilst the whole roof was covered with chicken wire to stop the roof tiles falling off (Figs. 5-8).

Figs. 5 & 6 Ridges and roof tiles to the front

Figs. 7 & 8 Ridges and roof tiles to the rear

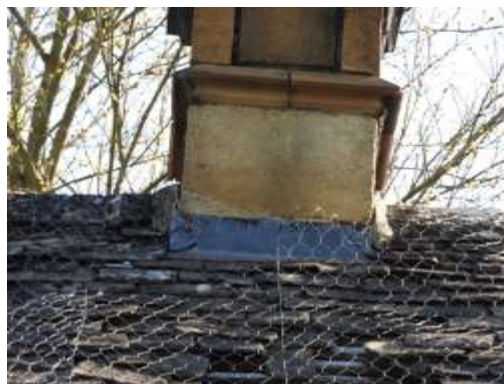
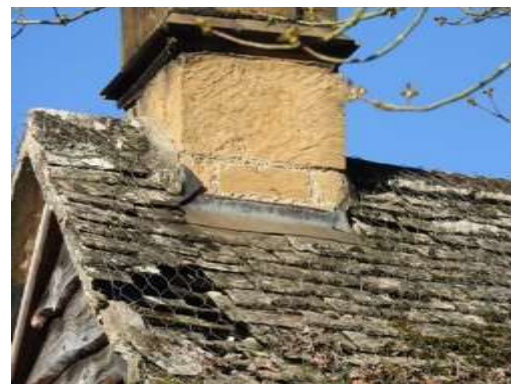
Figs. 9 & 10 Tightly moulded lead flashing

The chimney was sealed with tightly moulded lead flashing (Figs. 9 and 10).

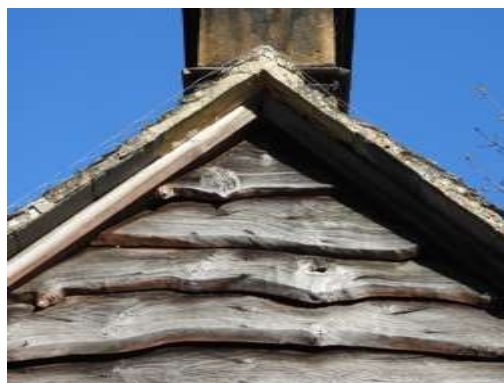
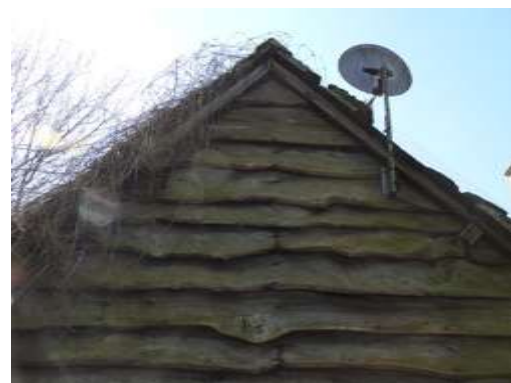
Figs. 11 & 12 Gables with crevices and gaps

Both gables were finished with the roof verges cement sealed to the gable wall plates, although gaps were observed at the gables (Figs. 11 and 12).

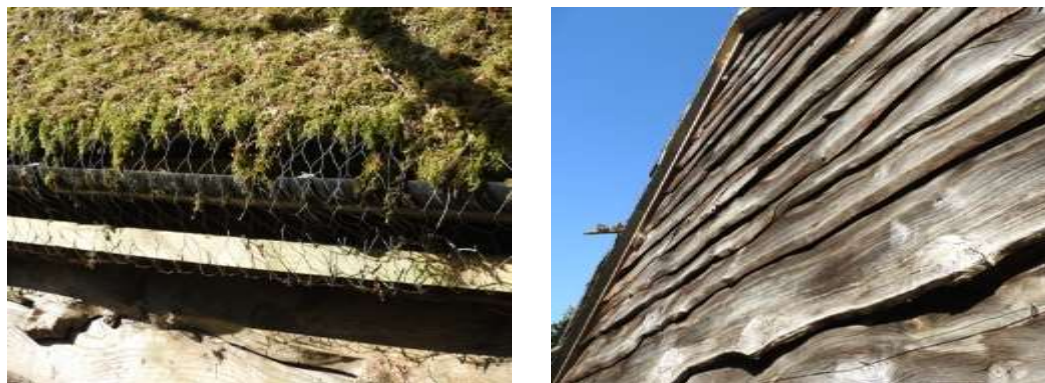
Figs. 13 & 14 Sealed eaves

The clipped eaves were finished with the roof ends tightly fitting against the timber wall plates all round (Fig. 13 – overleaf).

The feathered edged timber walls had numerous gaps and lifted boards (Fig. 14 – overleaf).

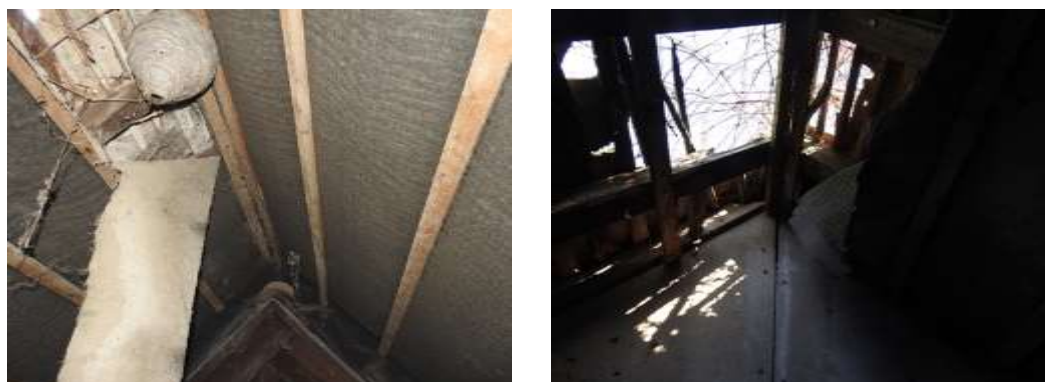
Figs. 15 & 16 Cobwebbed ridge and hole in the roof

Internally the garage section was open to the tarred felt lined roof. The ridge and gable ends were cobwebbed, whilst a section of missing roof tiles was noted (Figs. 15 and 16).

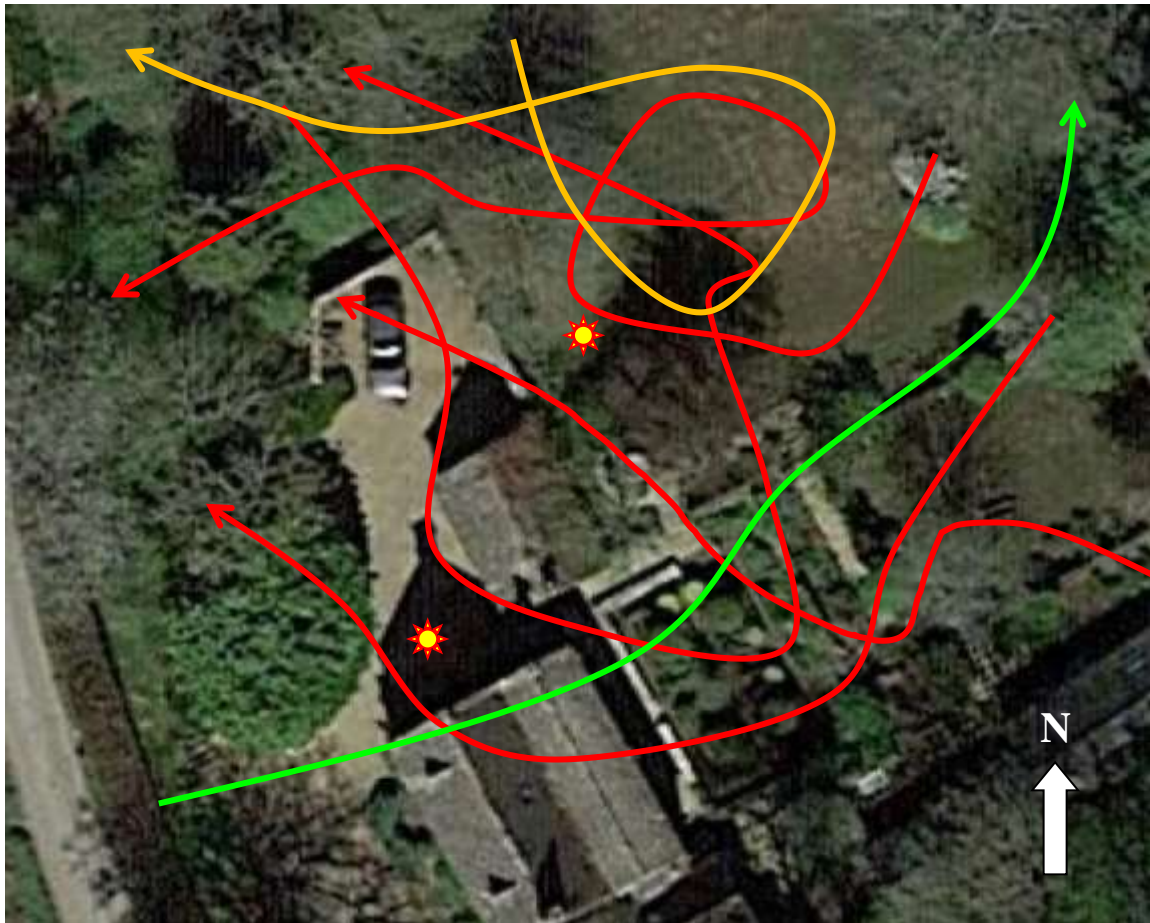
Plan 1 Bat flight paths at emergence on 8th June 2021

A single Common Pipistrelle Bat was seen to emerge from the garage, with moderate Common Pipistrelle activity in the area. Single passes from Soprano Pipistrelle and Noctule Bats were also recorded.

Time	Observation
21.38	Common Pipistrelle (CP) foraging in the rear garden
21.39	2 x CP flew over the garage from the east
21.40	2 more CP flew over the garage
21.44	CP flew over
21.47	CP emerged from the cladding on the north gable end of the garage
21:53	CPs flying around having come from the east
21.58	SP foraging in the garden
22.10	Noctule flew over the site
22:34	Intermittent CP activity around the garden
22:45	Intermittent CP activity but less frequent
23:00	No further detections were made and survey ended

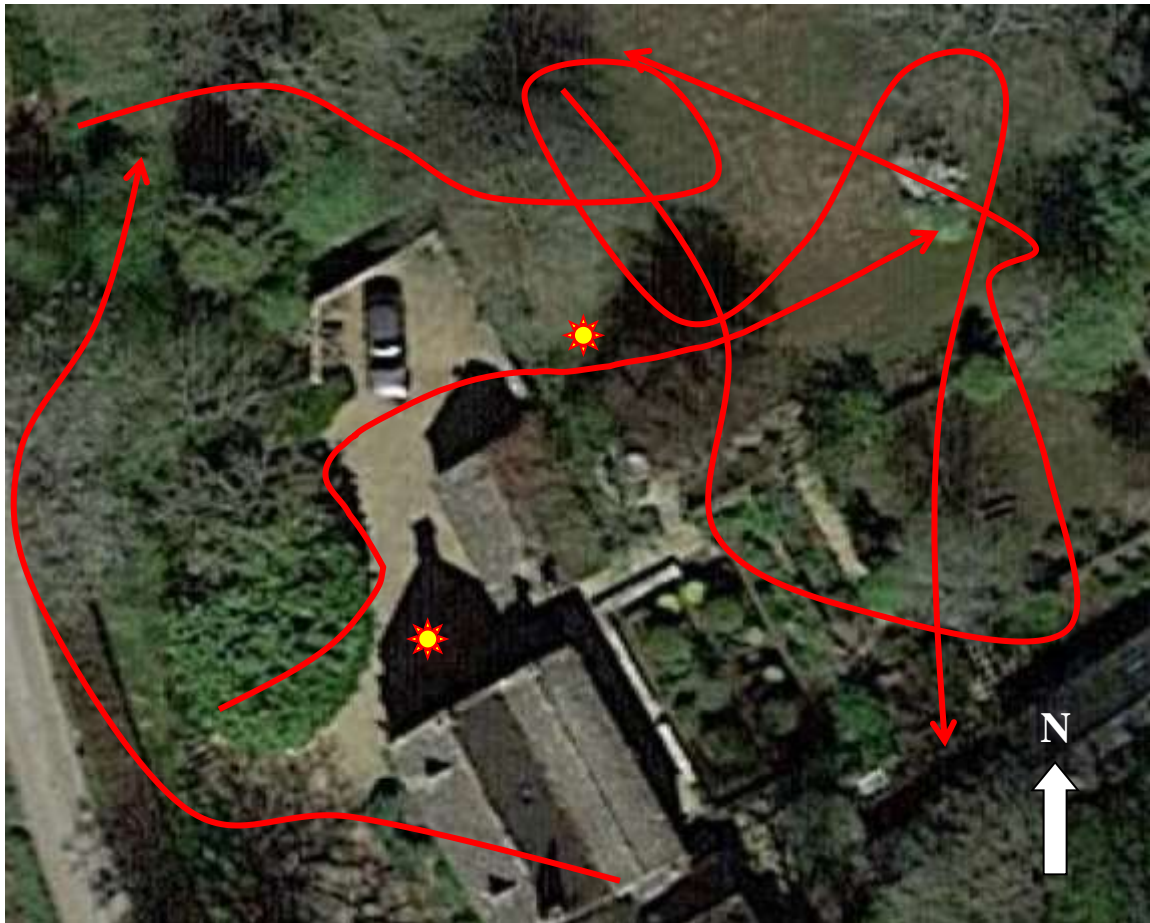
Plan 2 Bat flight paths at dawn re-entry on 23rd June 2021

No bats returned to roost inside the garage, although foraging Common Pipistrelles were noted in the area until quite late, suggesting they were roosting somewhere nearby.

Time	Observation
02.58	Common Pipistrelle (CP) heard but not seen
03.23	CP flew across the garden
03.45	CP foraging in the rear garden
04:04	CP heard but not seen along the lane
04.17	CP heard in the distance
04.22	CP foraging in the garden
04.31	CP flew along the driveway
04.33	CP heard along the lane
04.36	CP flew over the garage
04.47	No further detections were made, and survey ended

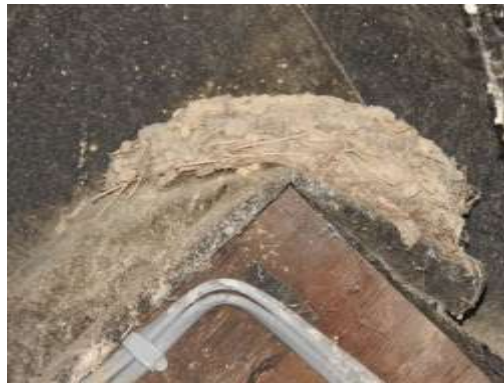
Fig. 17 Barn Swallows' nest

A Barn Swallows' nest was found inside the garage (Fig. 17).

Since all in-use bird's nests and their contents are protected from damage or destruction, any works which affect the building should ideally be undertaken outside the period March to August inclusive. If this time frame cannot be avoided, a close inspection of the building will be undertaken prior to clearance.

Work will not be carried out in close proximity to any in-use nest, and a minimum buffer of 5.0 metres will be established, although this could be more depending on the sensitivity of the species.

Any in-use nest will be allowed to fledge before it is disturbed.
