Bat and Barn Owl Assessment

24 New Street
Penzance
Cornwall
TR18 2NE

CEC4673
4th April 2024

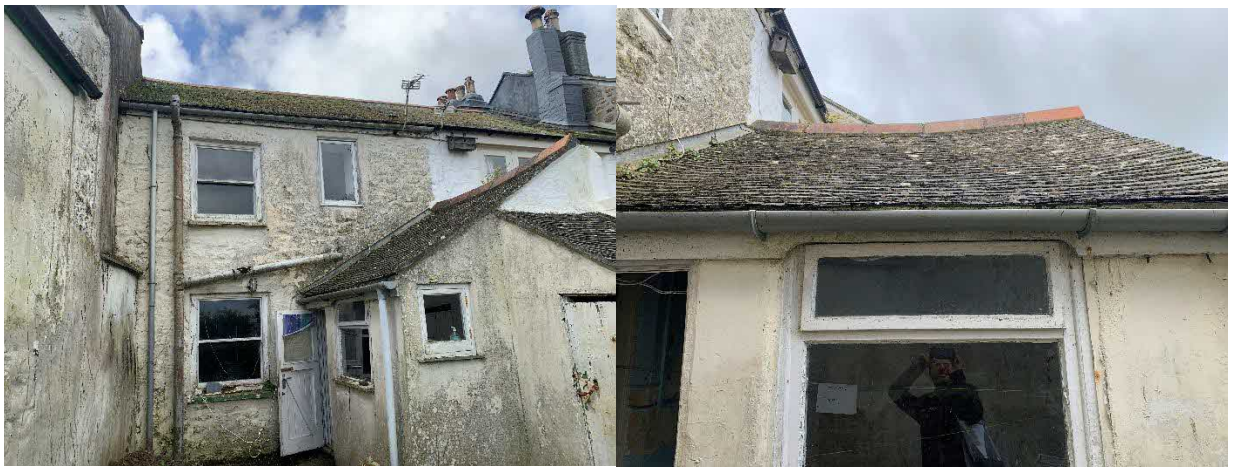
Figure 3: North-western elevation (left) Conservatory (right)

- 3.2.1. The property is an unoccupied, terraced, two storey, residential house with a small ground floor conservatory on the north-eastern elevation. The main building and extension are constructed from rendered stone walls, a slate roof with no felt layer and wooden fascia boards.

- 3.2.2. The exterior of the building was searched, including the walls, windowsills and ground around the building. Gaps can be seen under the fascia boards on the north-eastern elevation and there were several damaged tiles on either side of the main roof.

- 3.2.4. No signs of bats were present at the time of the survey. The gaps between the exterior walls and slipped tiles visible from the loft interior give the building a low potential for bats. As all sections of the buildings could be searched and no signs of bats were found, no further bat surveys are recommended.

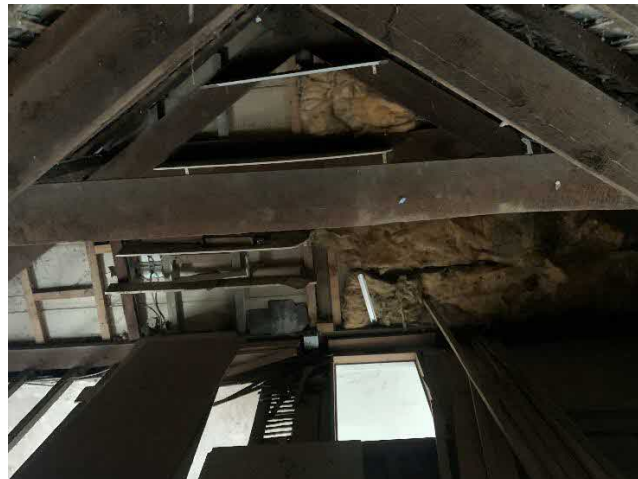
Figure 4: Building interior

- 3.2.3. The interior has no loft space and the upstairs ceiling was removed in 2022. There is a partition wall between the neighbouring property on the north-western elevation constructed from plasterboard and timber frame. The chimney breast is within the building on the south-eastern elevation. The ground floor conservatory also has no internal ceiling. The building was searched, including the walls, floors, rafters and floorboarding stored on top of the joists.
