**Clive Road, Canton
Proposed Residential Development
Supplementary Geo-Environmental &
Geotechnical Report**

Report Reference: ESP.8711.4040 Rev3

Clive Road, Canton Proposed Residential Development Supplementary Geo-Environmental & Geotechnical Report

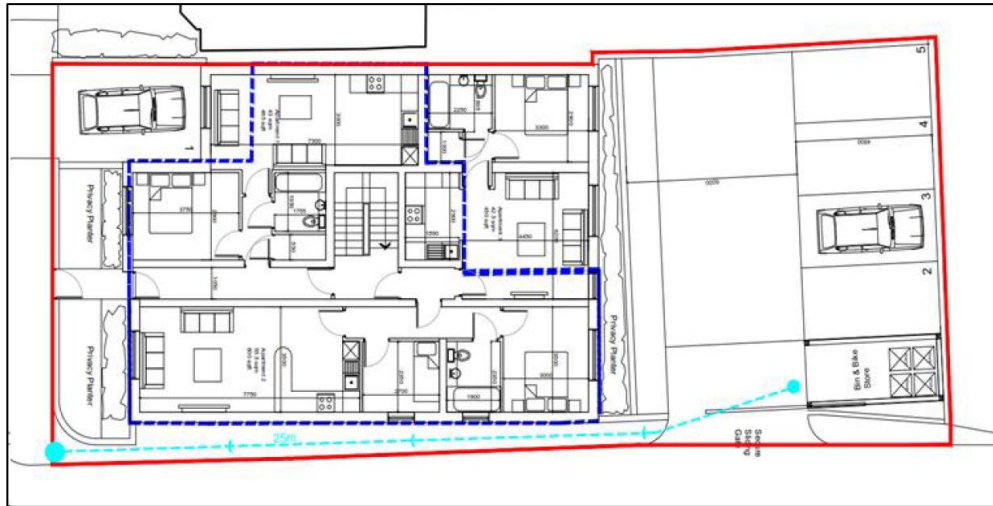
Insert 2: Proposed Layout (Provided by Client)

We have been provided with planning drawings for the site, with the outline scheme design, presented as Insert 2. We understand that the development is to comprise a traditional residential development with external areas of hardstanding and landscaping.

- Assessment of ground conditions beneath former building footprint (see blue boundary on Insert 2).
- Further contamination assessment below former footprint and reassessment of whole site in line with current guidelines.
- Dependant on the above, provision of remedial advice.
- Review of previous foundation and floor slab recommendations.

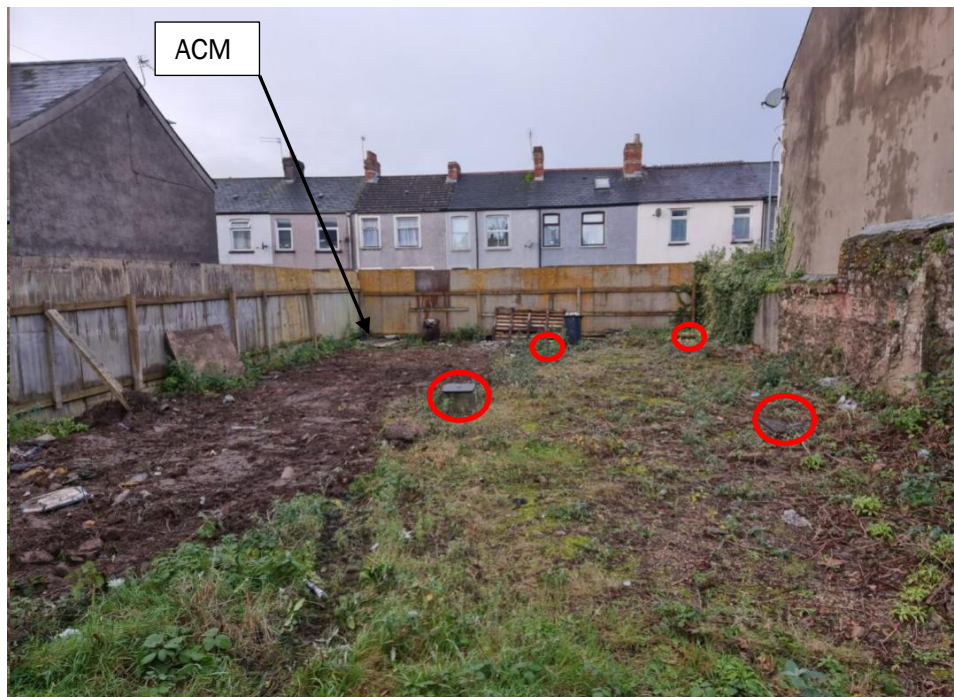
Insert 3: View of current site conditions (ESP 2023)

Insert 3 below, shows the general appearance of the site as viewed from the east boundary. The location of manholes (circled red) and asbestos containing materials (ACMs - see Section 4.0) are indicated. It should be noted, further manholes are present out of view.

It should be noted that a sheet of potentially asbestos containing materials was encountered in the south east corner of the site. A sample of this material was collected and tested at the laboratory. The testing has identified the material as chrysotile asbestos cement.
