Your Ref: DC/23/04344
Date: 11/04/2024

Fuel tank validation, The Pine House, Stowlangtoft.

The objective of this letter is to confirm that two former underground fuel tanks have been removed and the surrounding soils analysed to confirm that no contamination has occurred.

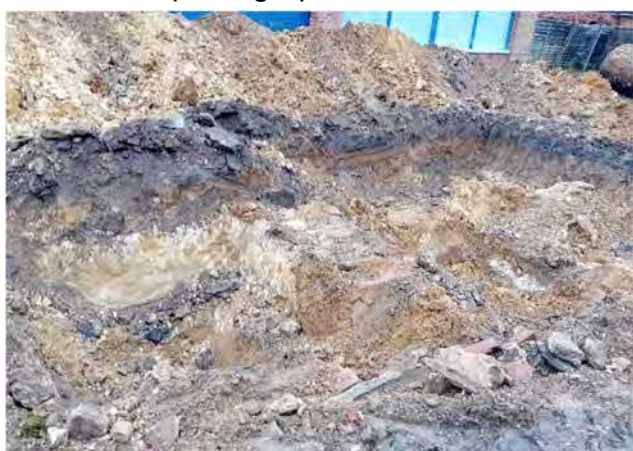
Excavation post tank removal

The area where the UST's were located was then excavated into a regular shape with excavated soils assessed with a PID. No volatile organic compounds were noted above the level of detection.

Sampling was then carried out with one sample taken from each side wall and two samples from the base directly beneath each tank location.

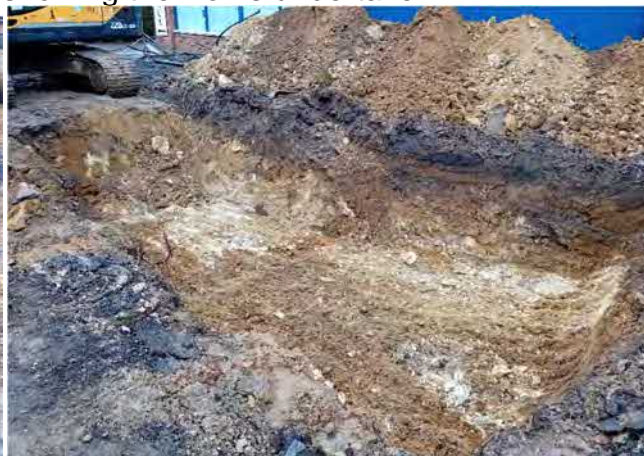
Excavation shaped

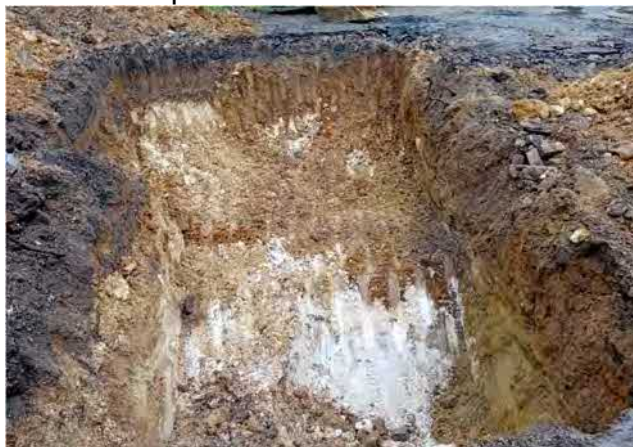
View of excavation

It was deemed that after considering the results of the testing and the PID readings the excavated soils could be replaced in the base of the excavation.

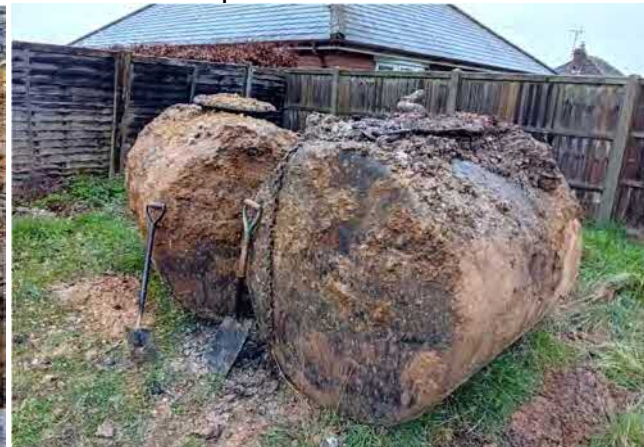
Two 500 gallon tanks removed

On 4th April 2024 under the supervision of Mr I Brown of Norfolk Partnership Laboratory the concrete surfacing above the UST area was removed. Two approximately 500 gallon tanks were seen present. The fuel lines were then disconnected and were found to be free from any fuel. The UST's were then opened to allow inspection. Both tanks were seen to be dry. The lids were then replaced and the UST's in turn removed from the excavation. The UST's were seen to be in good condition with no hydrocarbon odour noted and no staining was seen in the adjacent soils.

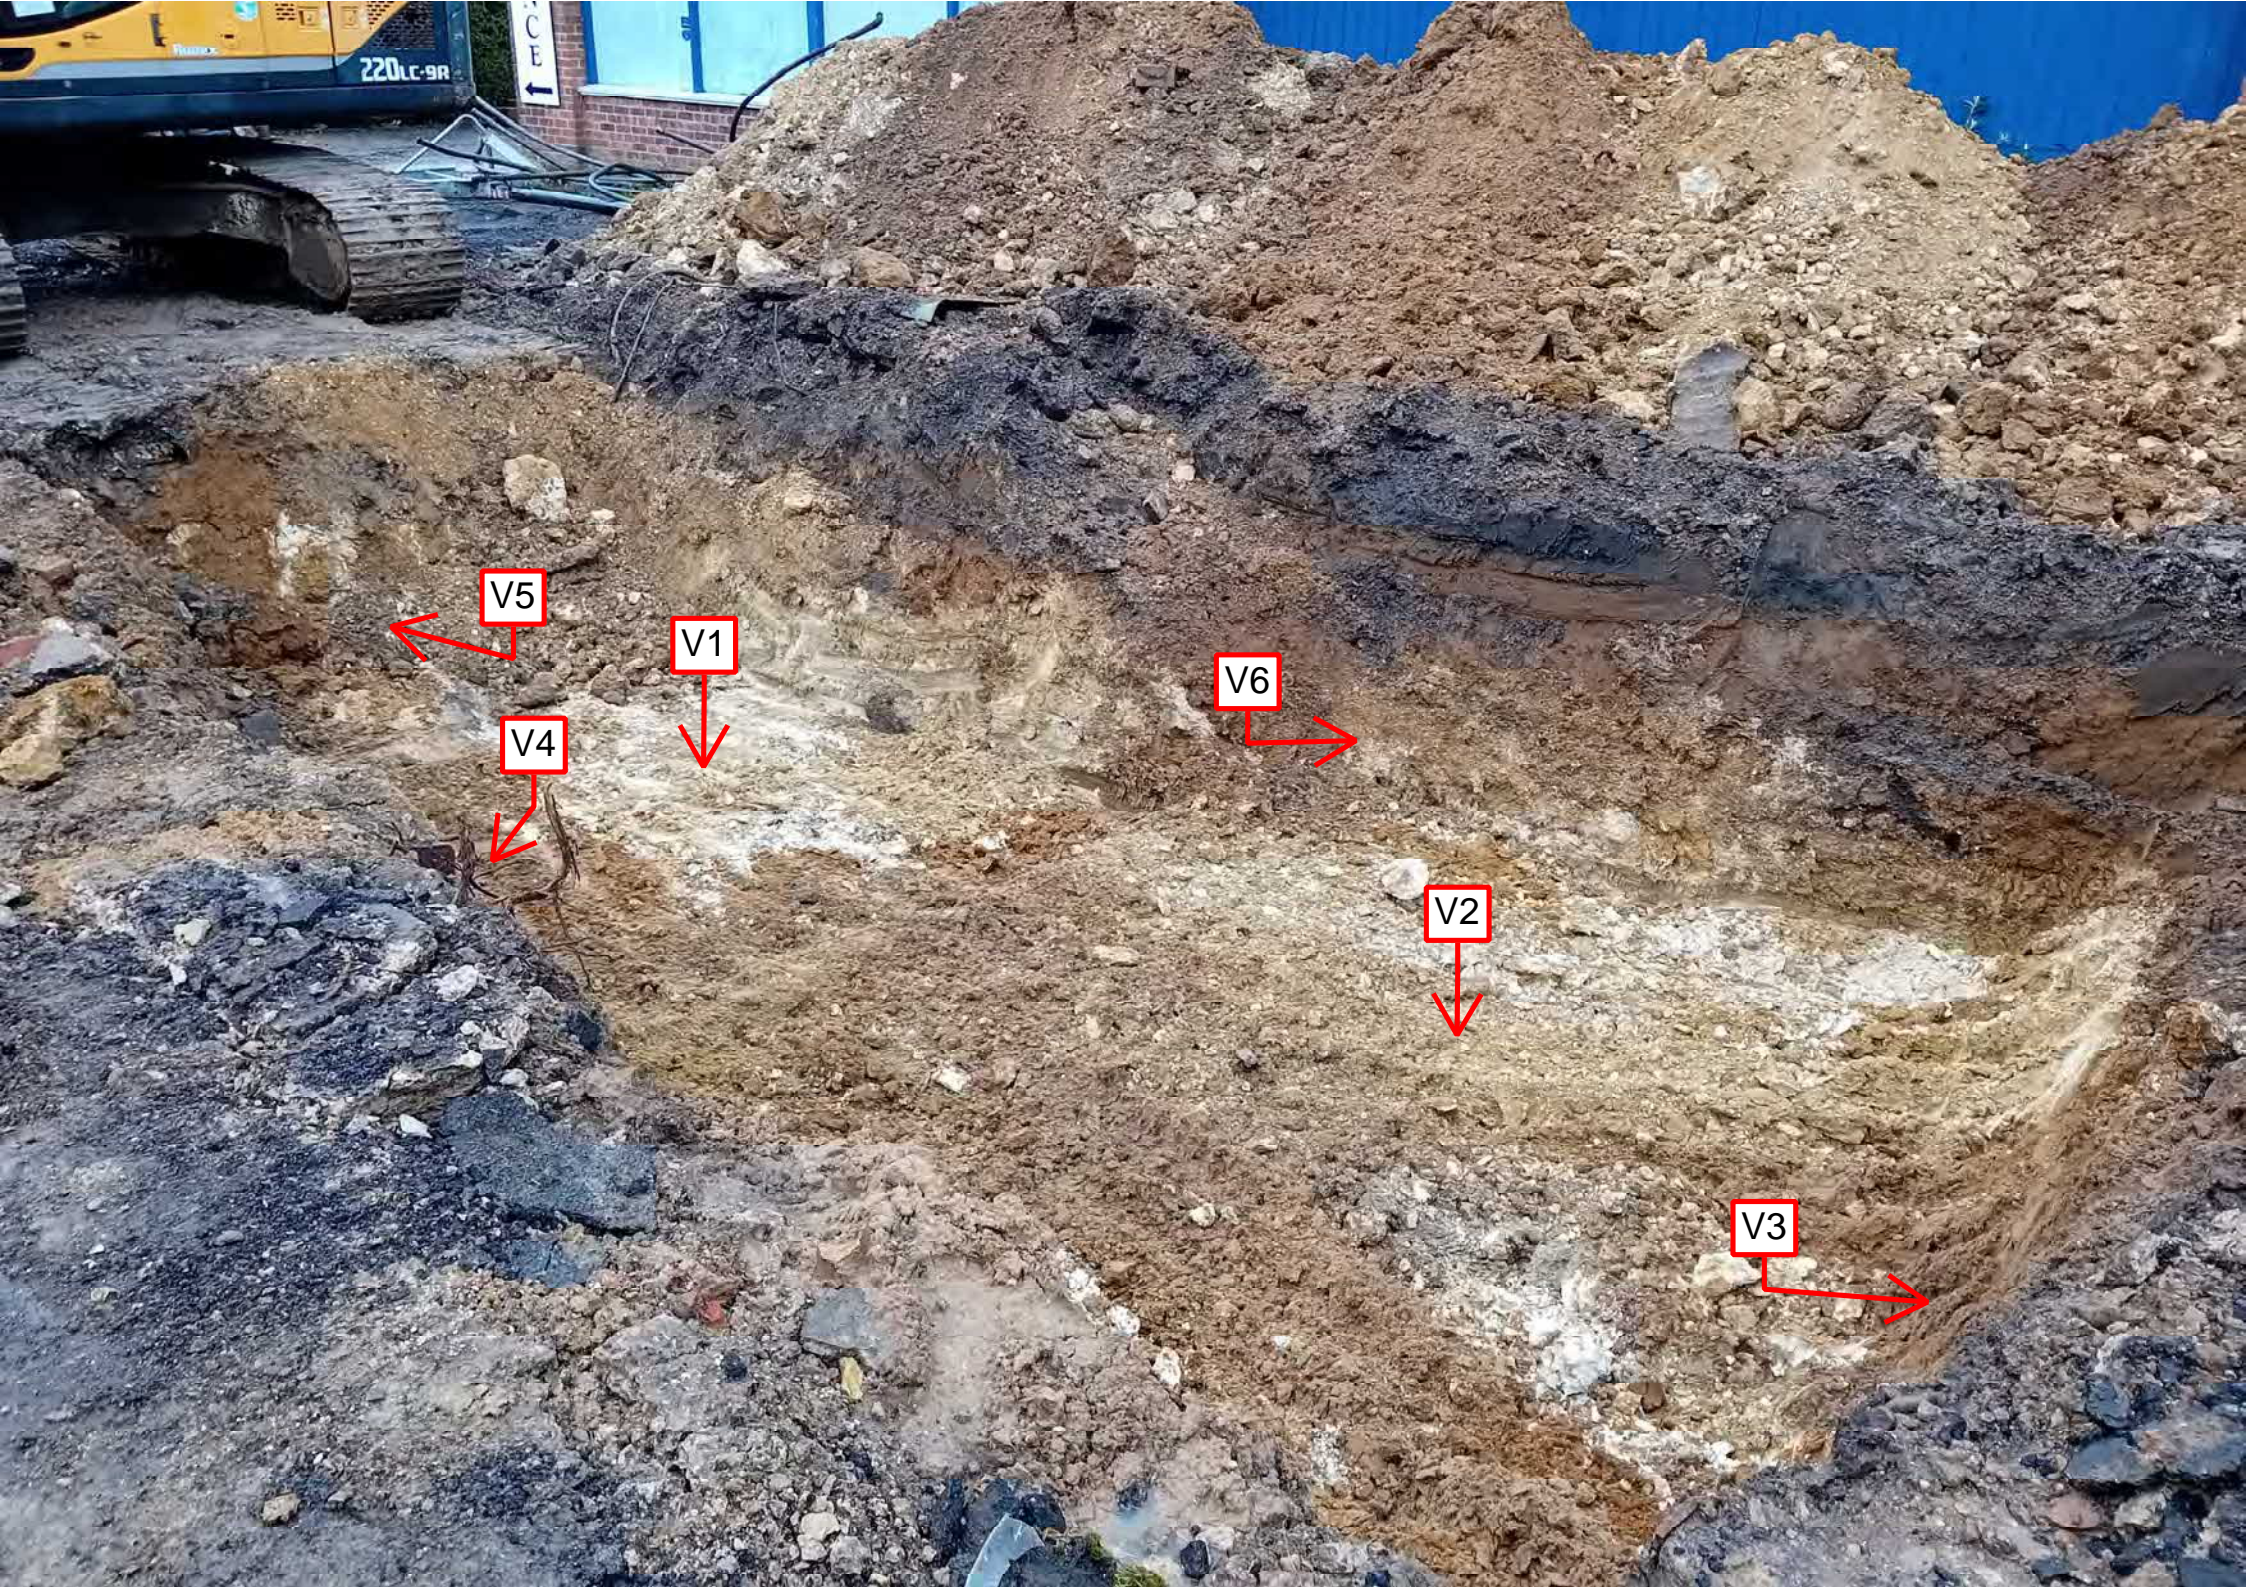
V5

V1

V6

V4

V2

V3

Location	Depth (m)	Tests
V1	1.70	Speciated TPH to WGC UK
V2	1.70	Speciated TPH to WGC UK
V3	1.60	Speciated TPH to WGC UK
V4	1.40	Speciated TPH to WGC UK
V5	1.50	Speciated TPH to WGC UK
V6	1.55	Speciated TPH to WGC UK

All the sample results were found to be within the most stringent threshold values for residential land use and lower than the limits of detection. A copy of these test report can be found within this submission.
