Bat Survey of Little Owl Lodge Norton

**John Dobson B.Sc
Essex Mammal Surveys**

August 2023

As part of a planning proposal involving a building at Little Owl Lodge, Ashfield Road, Norton, Bury St Edmunds, Suffolk IP31 3NN, a site visit was conducted on 1st September 2023 to determine whether the site had the potential to be occupied by bats, which would be affected if any proposed development were to go ahead.

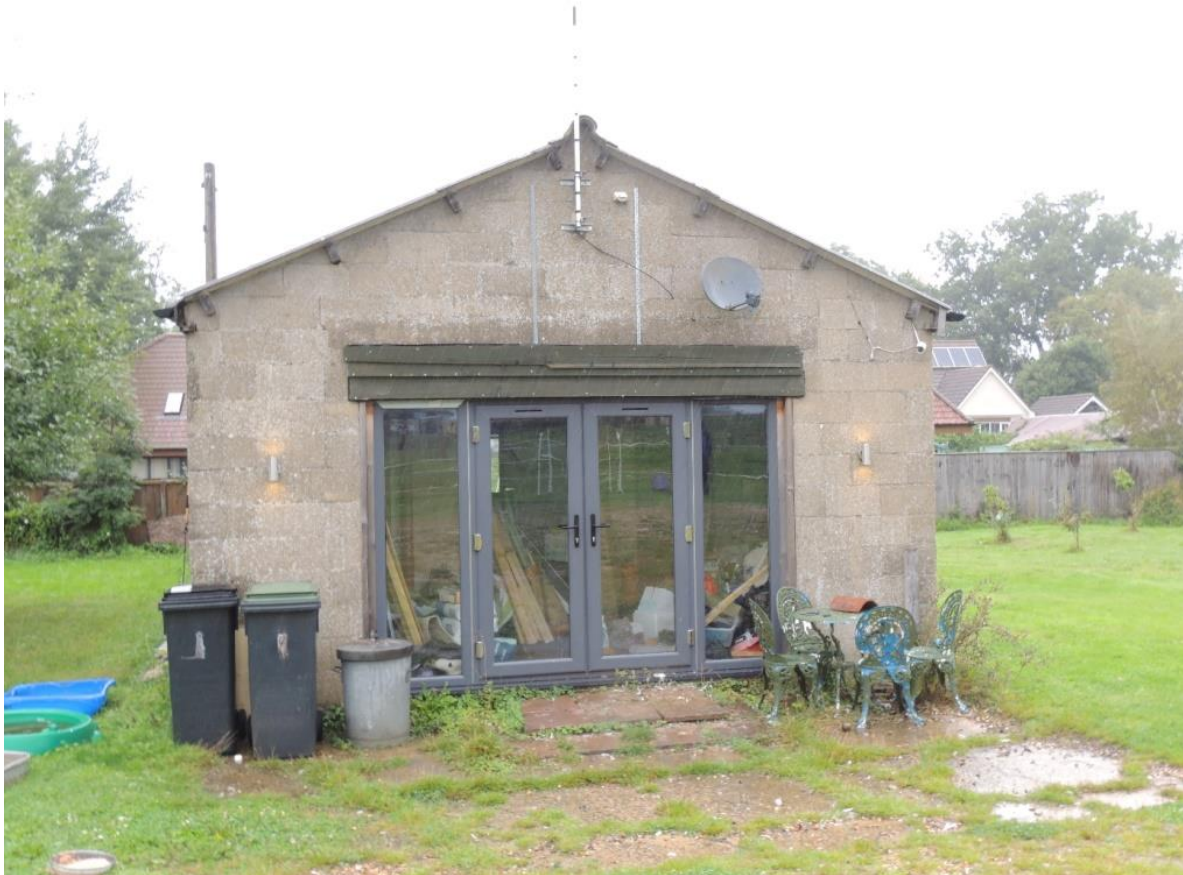
Photo 1: Southern elevation

The survey building is a detached, single-storey building with block walls and an unlined corrugated asbestos roof. The building is aligned approximately N-S. The survey found that the ground floor received daylight illumination from five windows in both the eastern and western walls, and from a glazed door to the south (see Photo 1). In such conditions, bats seek out dark areas or crevices in which to roost and the lack of such features in the plastered internal walls meant that this part of the building was unsuitable as a roosting place for bats. The loft was accessed via a hatch at the southern end of the building. No evidence of the presence of bats was found on the floor of the loft or along the internal eaves of the building. Externally, there was a tight seal to the eaves and gables, and no cavities in the walls that might offer potential roosting places for bats. There was also no evidence such as staining or droppings found on the pale walls where the presence of bats would have been readily apparent.

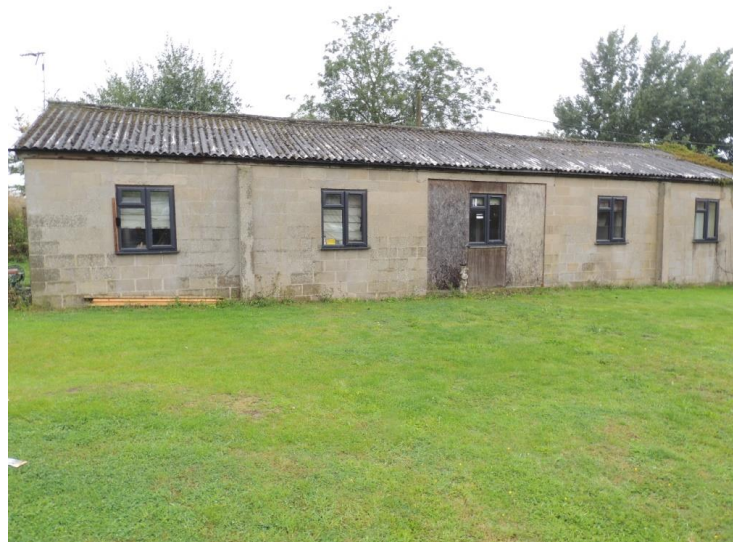
Photo 2: The eastern elevation

The survey building is a detached, single-storey building with block walls and an unlined corrugated asbestos roof. The building is aligned approximately N-S. The survey found that the ground floor received daylight illumination from five windows in both the eastern and western walls, and from a glazed door to the south (see Photo 1). In such conditions, bats seek out dark areas or crevices in which to roost and the lack of such features in the plastered internal walls meant that this part of the building was unsuitable as a roosting place for bats. The loft was accessed via a hatch at the southern end of the building. No evidence of the presence of bats was found on the floor of the loft or along the internal eaves of the building. Externally, there was a tight seal to the eaves and gables, and no cavities in the walls that might offer potential roosting places for bats. There was also no evidence such as staining or droppings found on the pale walls where the presence of bats would have been readily apparent.

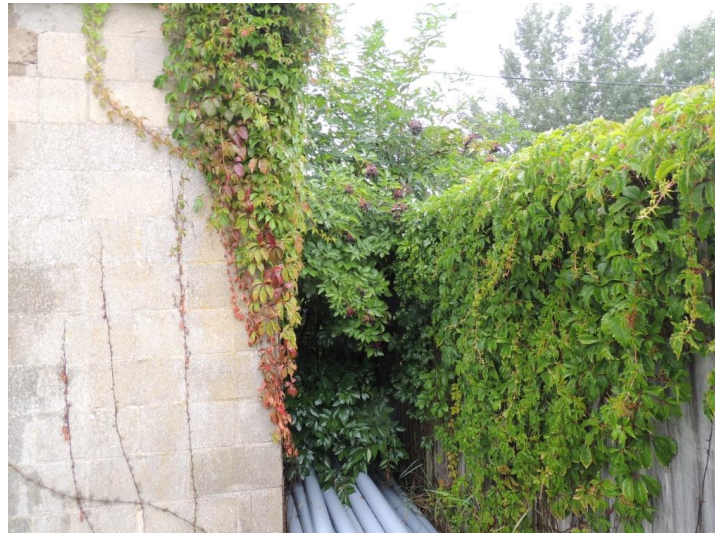
Photo 4: The northern elevation is obscured by a Virginia creeper and an Elder

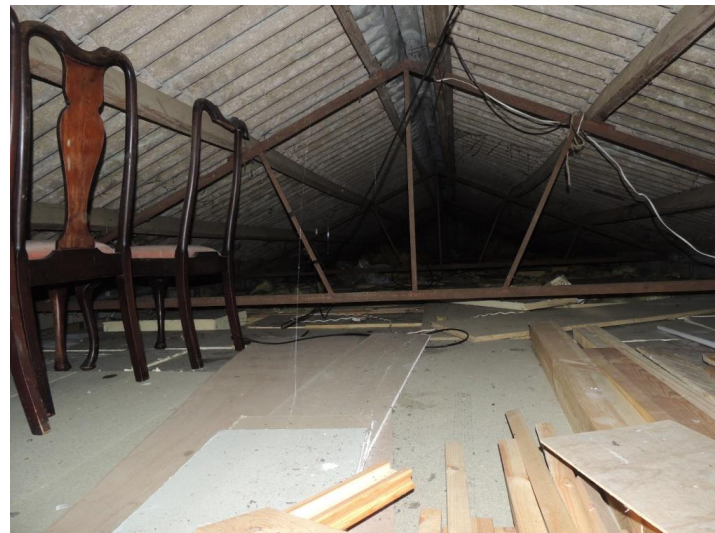
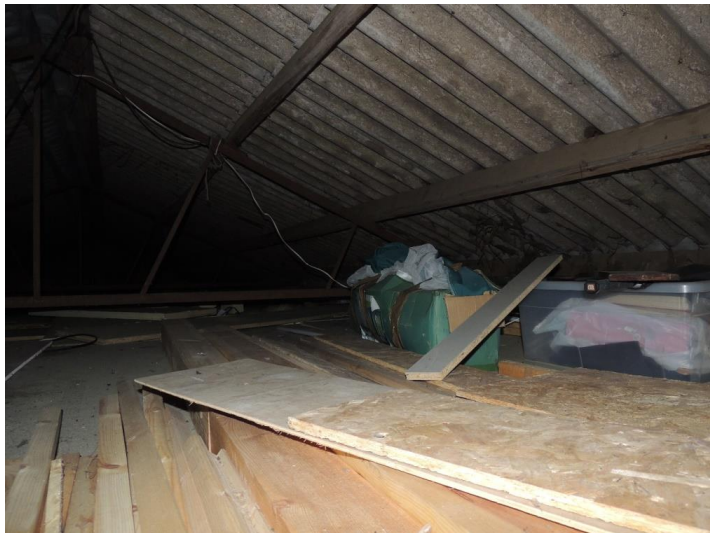
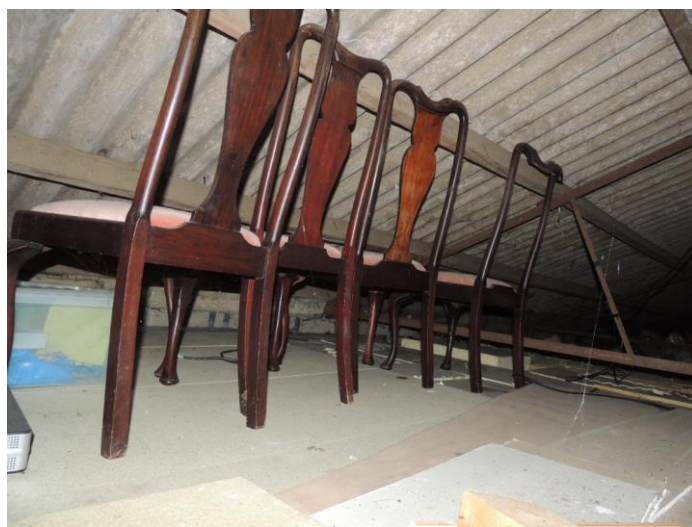
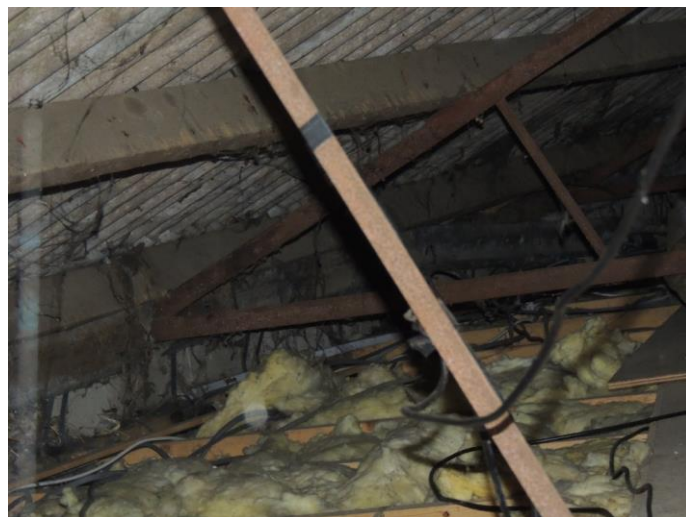
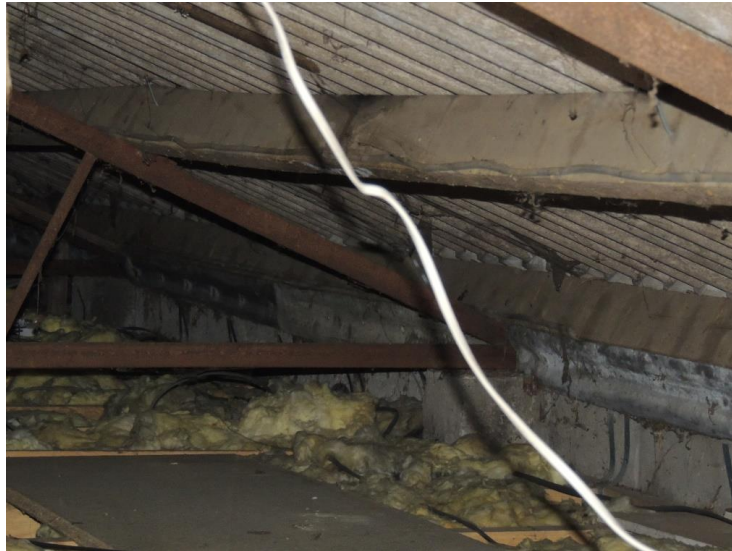
Photo 5: Note lack of evidence of bats on floor of loft

Photo 6: Note lack of evidence of bats on floor of loft

Photo 7: Note lack of evidence of bats on floor of loft

Photo 8: Note lack of evidence of bats on floor of loft

Photo 9: Note lack of evidence of bats on floor of loft

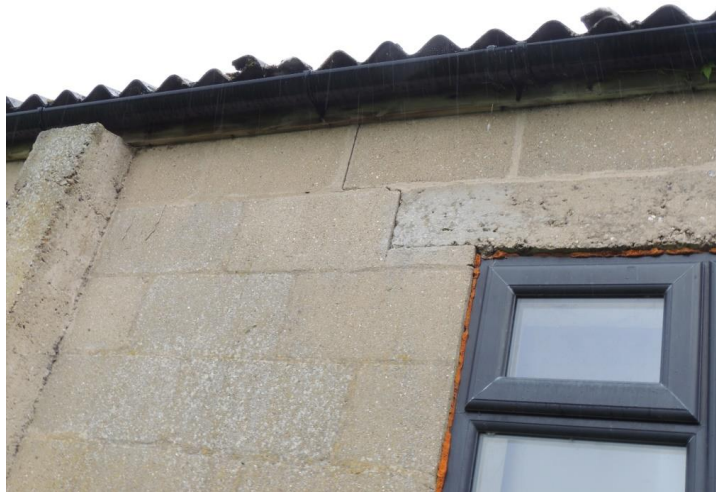
Photo 10: Typical section of eaves showing tight seal

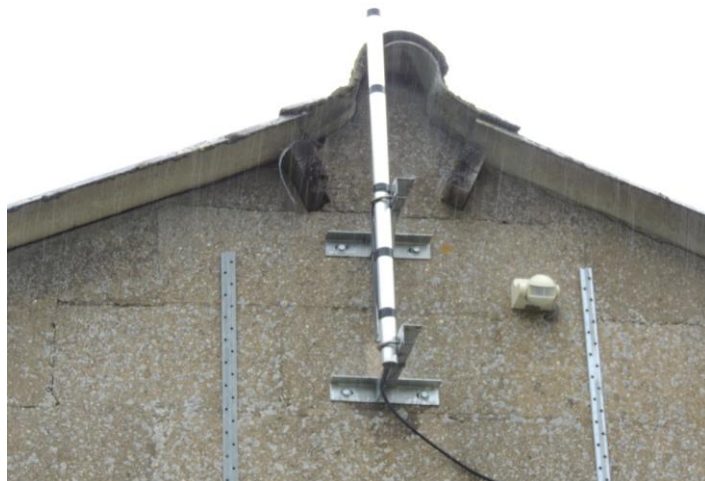
Photo 11: Showing tight seal to gable

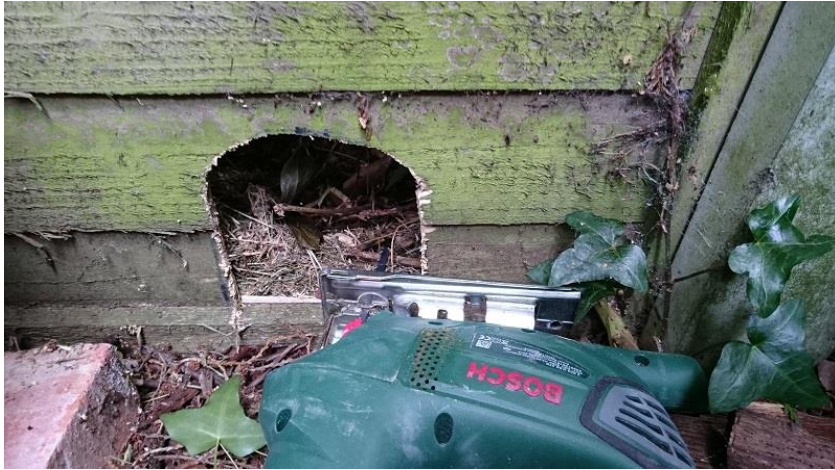
Photo 12: Hedgehog pathway at base of fence

A gap 13cm by 13cm is sufficient for any hedgehog to pass through. This will be too small for nearly all pets.

- Remove a brick from the bottom of the wall
- Cut a small hole in your fence if there are no gaps
- Dig a channel underneath your wall, fence or gate
