# **No. 95A Eltham High Street, London SE9 1TD**

## **Written Scheme of Investigation**

**April 2024**

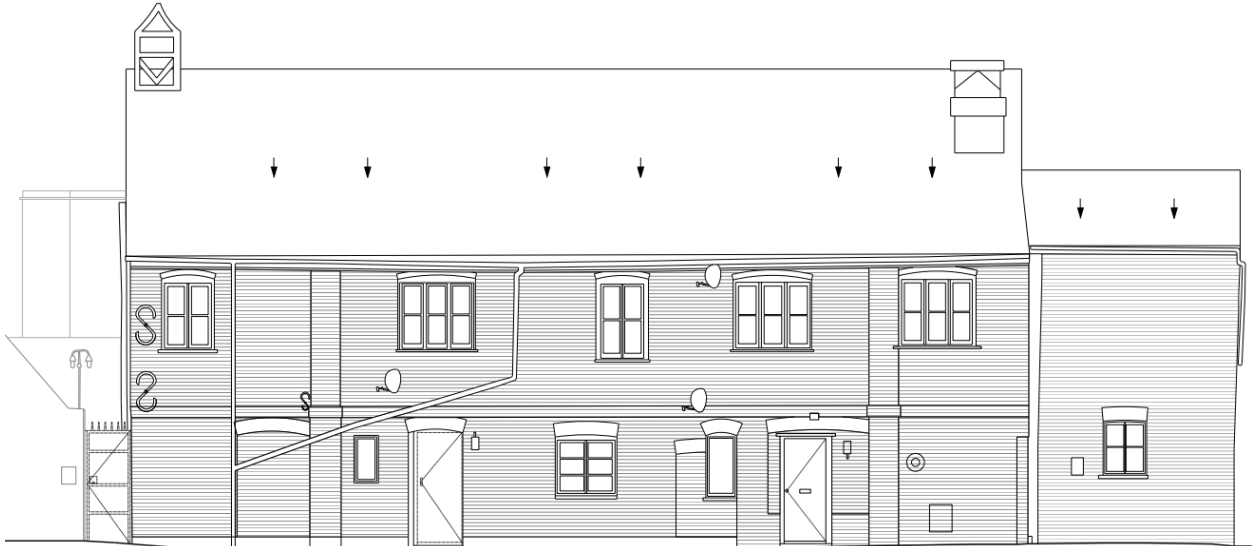
Figure 1: Existing front (east) elevation of no. 95A Eltham High Street.

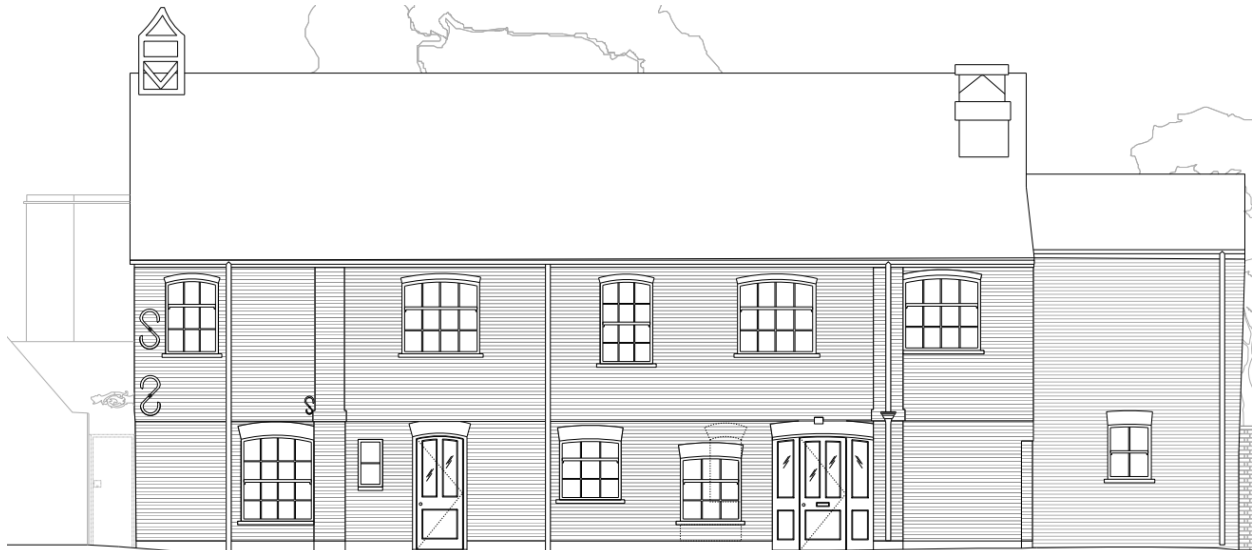
Figure 2: Proposed front (east) elevation of no. 95A Eltham High Street.

- 3.2.1. **Alterations and repair-work** [Figure 2 & Figure 4]: As set out in the condition survey, schedule of repairs and methodology statement, the proposals involve sensitive repair-work to the brickwork. The repair-work would therefore involve minimal intervention, with any necessary replacement fabric using like-for-like red brickwork and lime-based mortar, and traditional building techniques. The existing sash windows would similarly be repaired according to those principles. The existing casement windows would be replaced with timber-framed sashes. In addition, sash windows would be reinstated to the existing bricked-up window openings to the west and east elevations. The new windows to the south elevation at ground floor level would involve minimal loss of historic fabric. Scarring to the brickwork of the east elevation indicates that the north door has been relocated – and the proposals would involve the reinstatement of the door to its former location. The existing modern idiom doors would be replaced with Victorian-style timber doors.

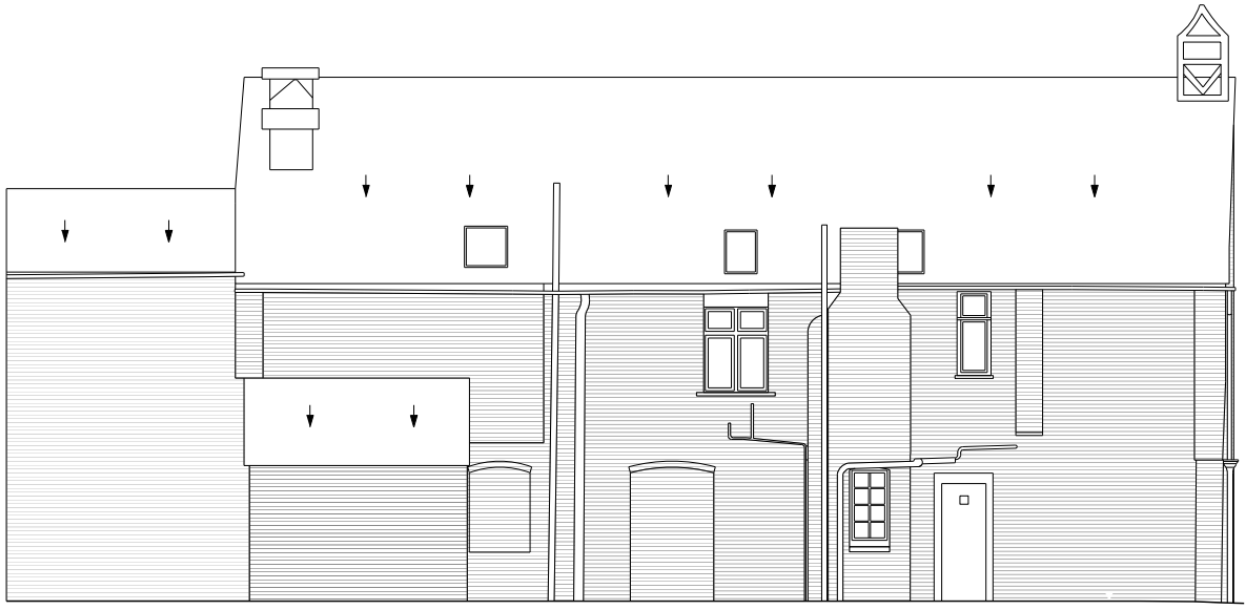
Figure 3: Existing rear (west) elevation of no. 95A Eltham High Street.

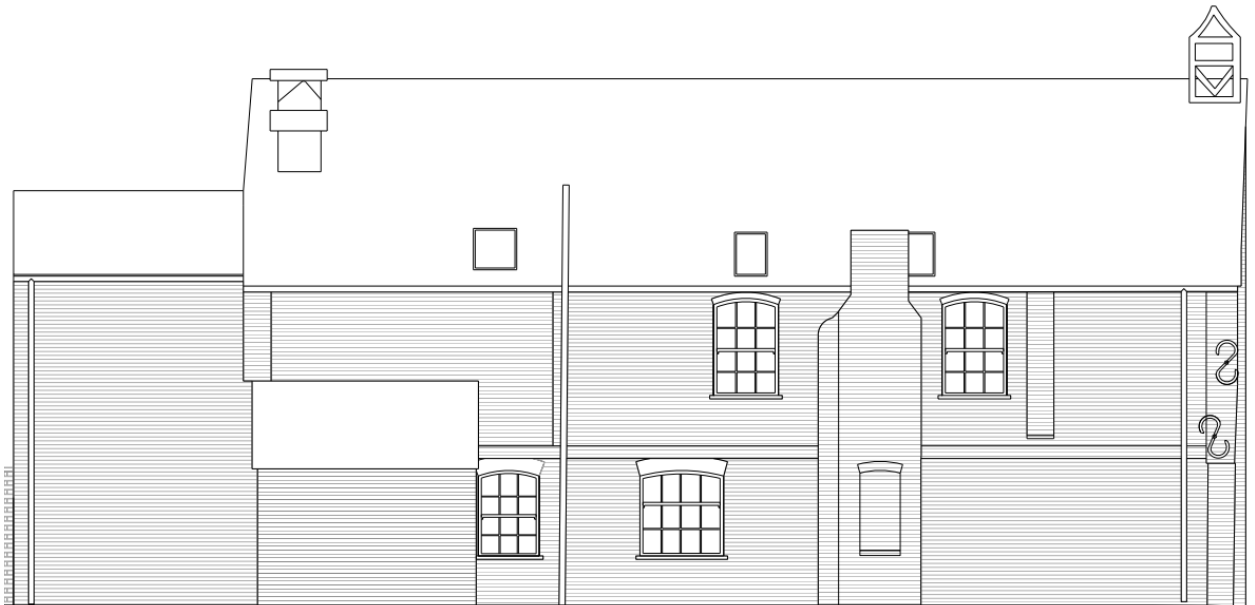
Figure 4: Proposed rear (west) elevation of no. 95A Eltham High Street.

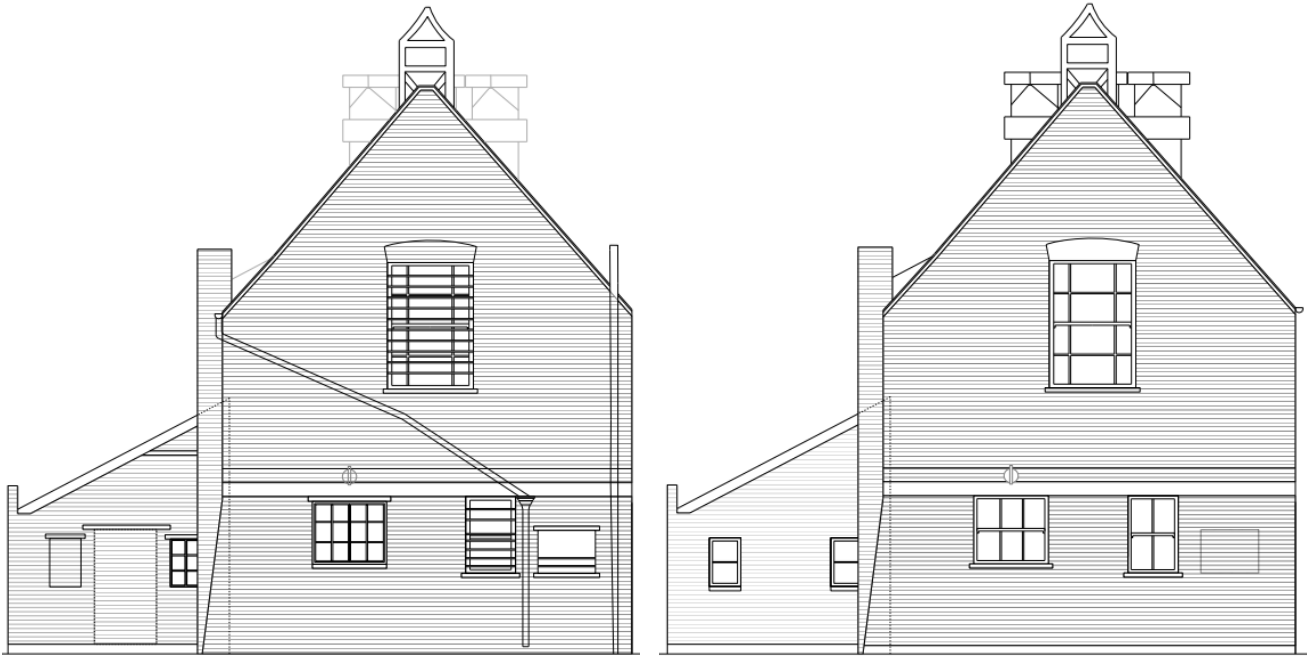
Figure 5 (left): Existing south elevation of no. 95A Eltham High Street.

Figure 6 (right): Proposed south elevation of no. 95A Eltham High Street.

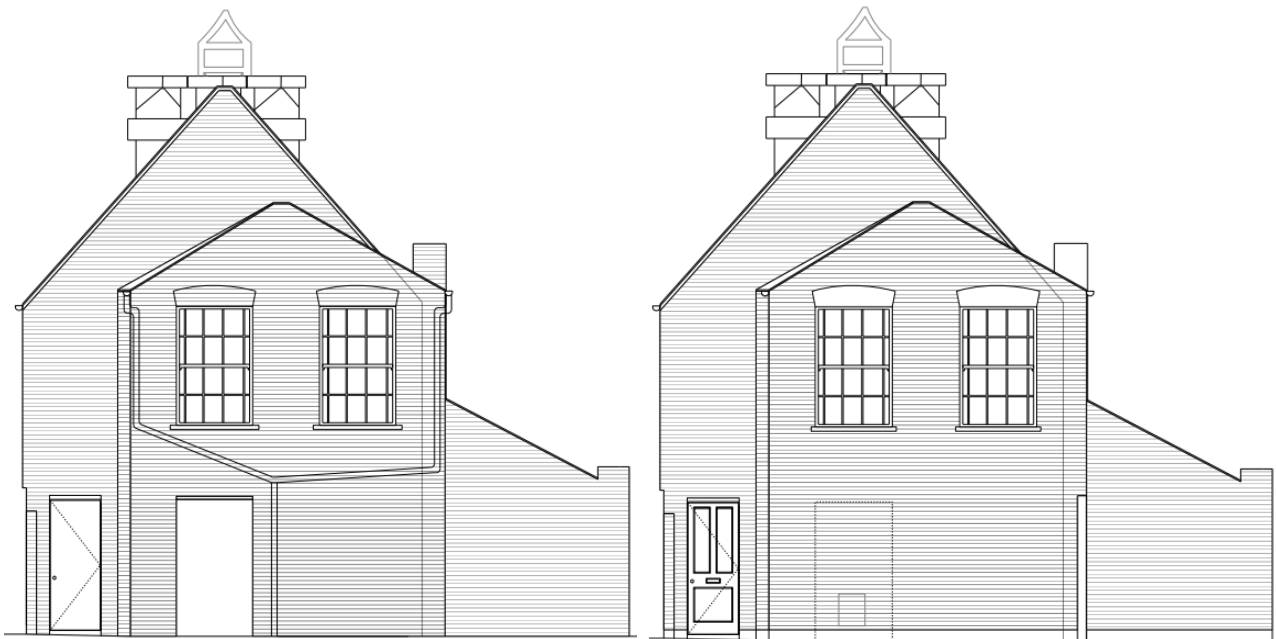
Figure 7 (left): Existing north elevation of no. 95A Eltham High Street.

Figure 8 (right): Proposed north elevation of no. 95A Eltham High Street.

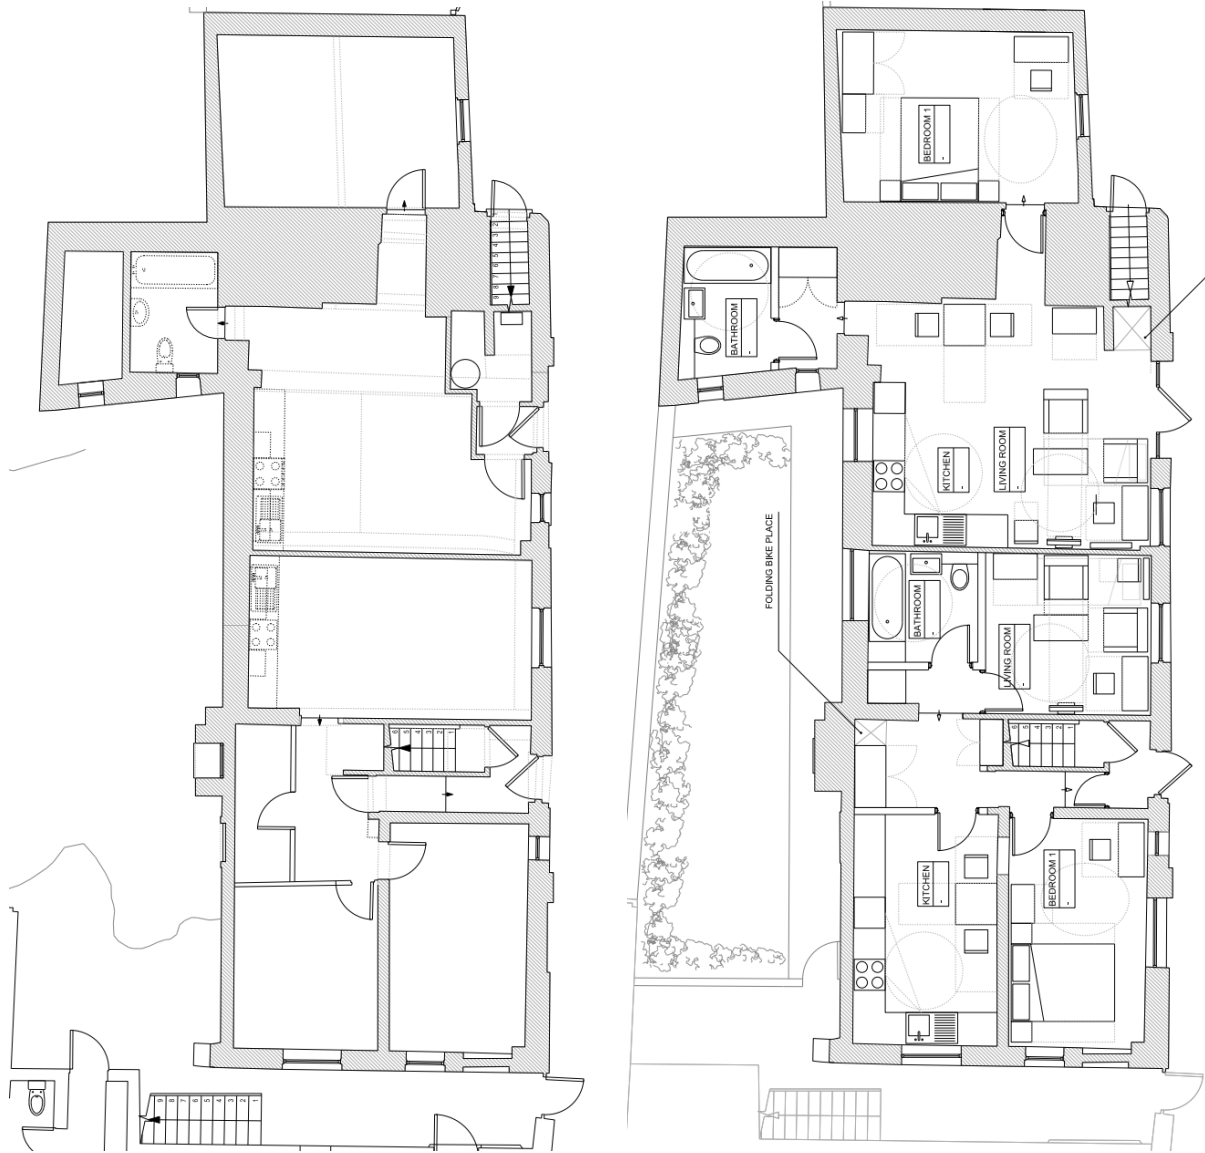
Figure 9 (left): Existing ground floor of no. 95A Eltham High Street.  
Figure 10 (right): Proposed ground floor of no. 95A Eltham High Street.

- 3.3.2. **North flat at ground floor level** [Figure 10]: The proposals involve the retention of the exiting modern planform, save for the removal of the modern stud walling by the front entrance. There would also be some alterations to the small single-storey west extension (i.e. the bathroom), which was likely a later addition to the original building to the north elevation to provide a storage space, and which is thus considered to be of secondary significance. Within the existing bathroom, the boxing-in would be removed in order to enlarge the room, a new window opening would be created in the enlarged space, some stud walling would be provided (which would be easily reversible). The modern door to the existing bathroom

would be removed, and a new door would be fitted within the new door opening within the new stud walling. The door to the existing bedroom would be re-fixed so that it opens the other way. The original width of the front door opening would become more easily legible due to the removal of the modern brickwork, replacing it with a new Victorian-style door with timber-framed glazed panels either side of it. This would not cause any loss of historic fabric.

- 3.3.3. **South flat at ground floor level** [Figure 10]: The proposals involve the reinstatement of the sash windows to the bricked-up openings to the front (east) and rear (west) elevations. The existing planform of the building is likely modern, and its alteration would therefore not cause any harm to the historic interest of the building. The modern partition walling which forms the somewhat curious, “b-shaped” room on the west side would be removed, and new partitioning and doors would be added, in order to reconfigure the hallway, and create a new kitchen. In addition, some partition walling and doors would be added to the room on the north side to create a bathroom, a living room and a lobby area. The new partition walling would be easily reversible, without causing any damage to historic fabric.

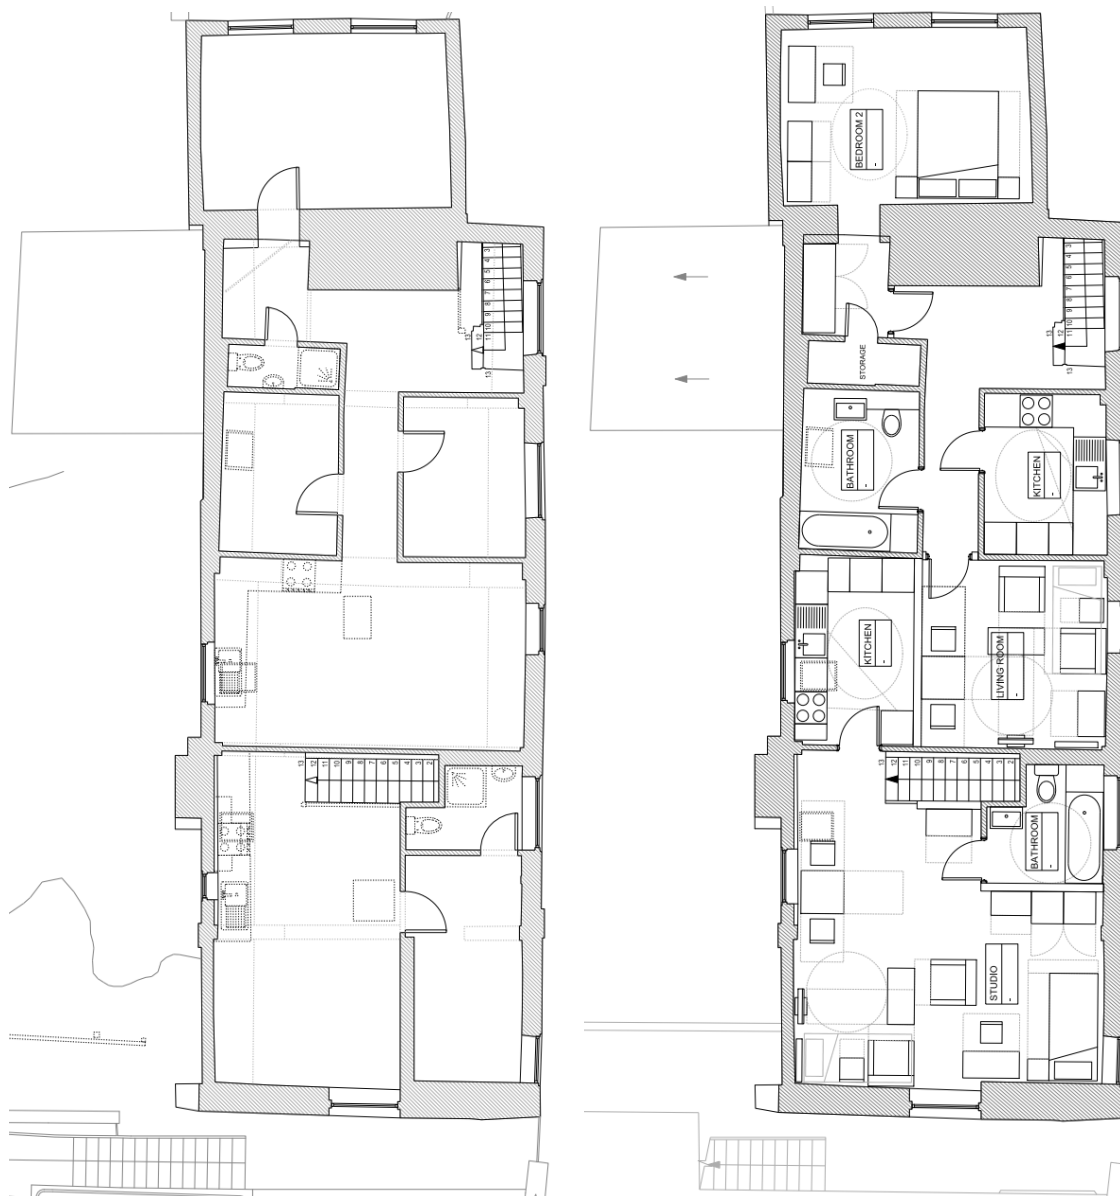
Figure 11 (left): Existing first floor of no. 95A Eltham High Street.

Figure 12 (right): Proposed first floor of no. 95A Eltham High Street.

- 3.3.4. **North flat at first floor level** [Figure 12]: Given that the internal planform of the building is modern, it is considered that the reallocation of some space at first floor level from the north flat to the south flat, would not impact upon the historic and/or architectural interests of the building. This would be the only notable alteration to the north flat – involving the provision of some new partition walling, which would be easily reversible without damaging any historic fabric. In addition, there would be some minor alterations to the door openings – i.e. relocating the door opening to the north bedroom to the corridor, providing a new door between the corridor and south room, and re-fitting the door to the east room so that it opens the other way. None of these alterations would cause any loss of historic fabric.

- 3.3.5. **South flat at first floor level** [Figure 12]: Given that the internal planform of the building is modern, it is considered that the reallocation of some space at first floor level from the north flat to the south flat, would not impact upon the historic and/or architectural interests of the building. This would involve the creation of a new door opening within the existing modern stud walling (causing no loss of historic fabric). The planform of the south flat would also be reconfigured via the removal of some walling which is unlikely to be historic and some modern stud walling, and the provision of some new partition walling and doors (which would be reversible).

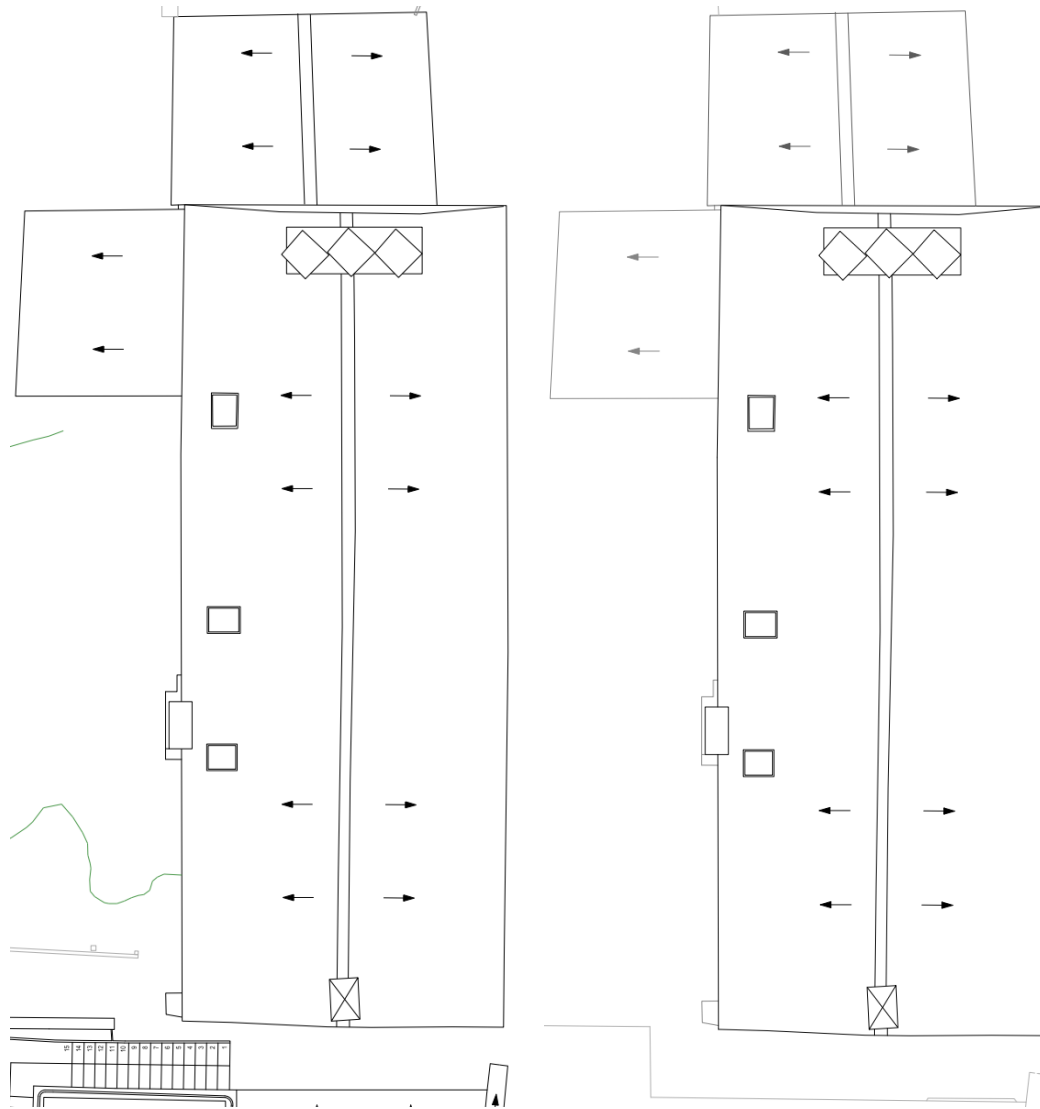
**Figure 13 (left): Existing roof of no. 95A Eltham High Street.**  
**Figure 14 (right): Proposed roof of no. 95A Eltham High Street.**

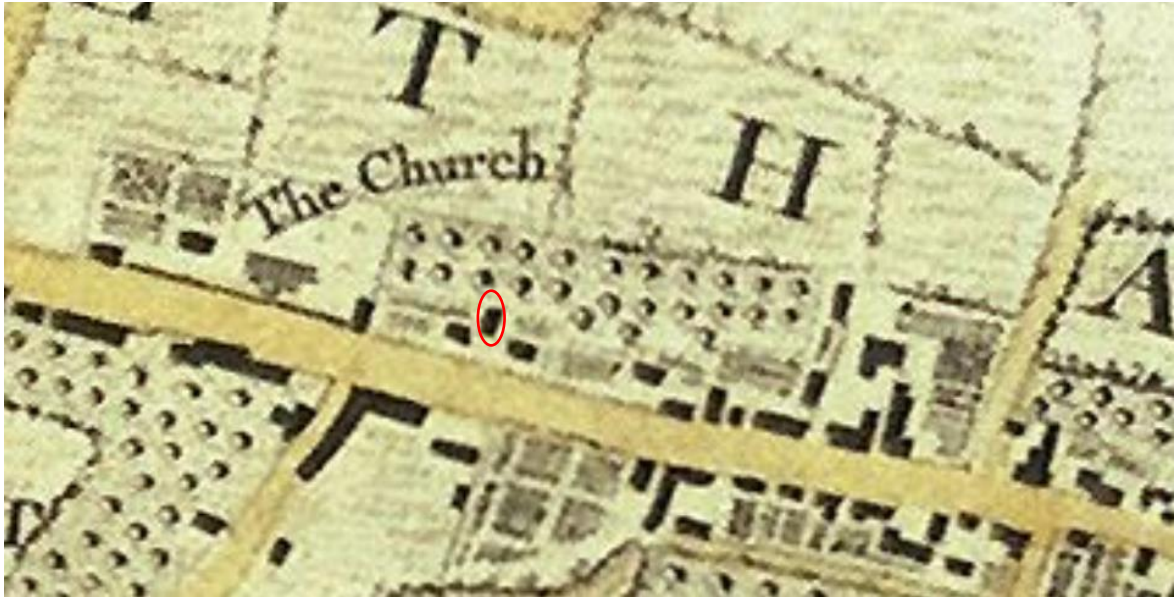
Figure 15: 1761 map (Rocque). Subject site is circled in red.

- 2.1.1. **18<sup>th</sup> century:** Cartological evidence indicates that by the mid-18<sup>th</sup> century, the north side of Eltham High Street comprised some large detached houses with front gardens and large plots to the rear (some including what look like orchards). These include Cliefden House, which was built c. 1720 as a private house (and later used as a military academy for young gentlemen), and what appears to be an ancillary building within the subject site [Figure 15]. This building may, however, pre-date Cliefden House.

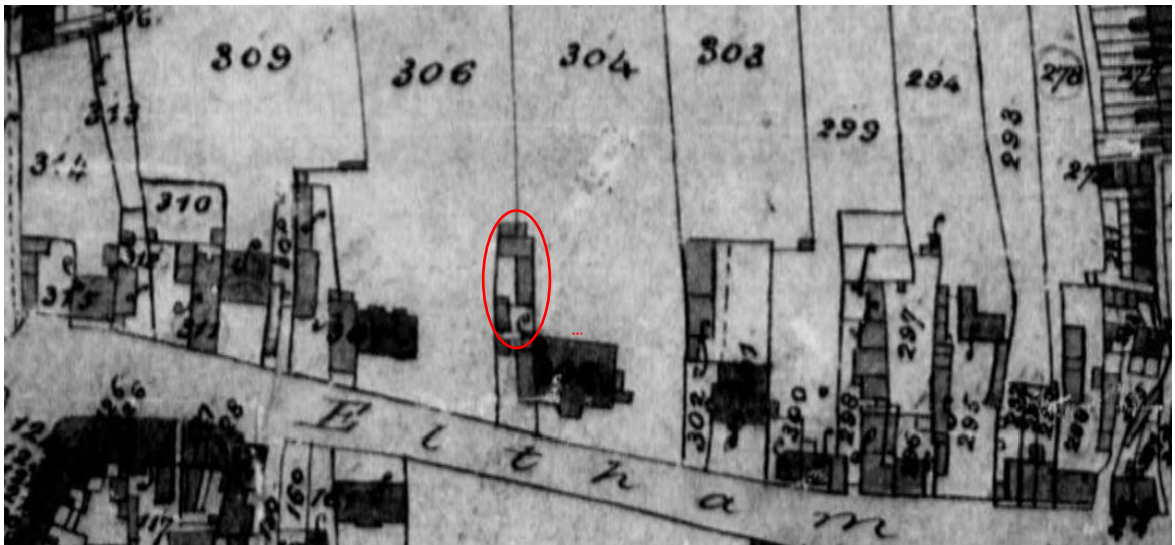
Figure 16: 1839 tithe map (National Archives, IR 30/17/129). Subject site is circled in red.

- 2.1.2. **19<sup>th</sup> century:** The 1839 tithe map [Figure 16] indicates that Cliefden House and its ancillary building (i.e. the subject site) were within a large plot stretching back as far as today's Orangery Lane. The map shows some other outbuildings within this plot, which have since been demolished. The 1862 OS map [Figure 17] shows the footprint of the building within the subject site, and the landscaped gardens to the north of it.

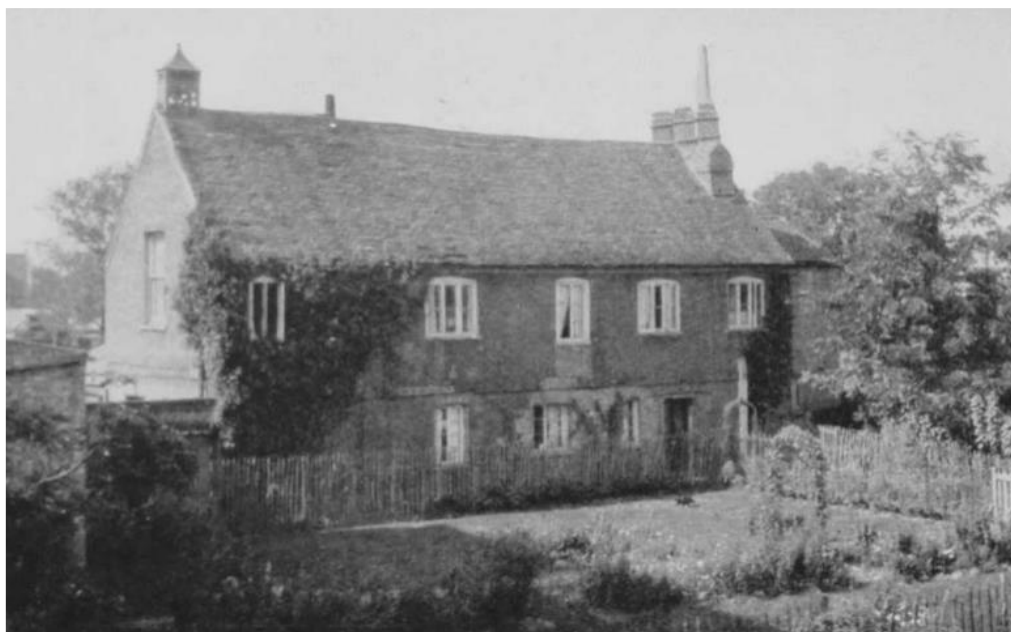
Figure 20: c. 1930 photograph of the east elevation of the subject site. (National Archives.)

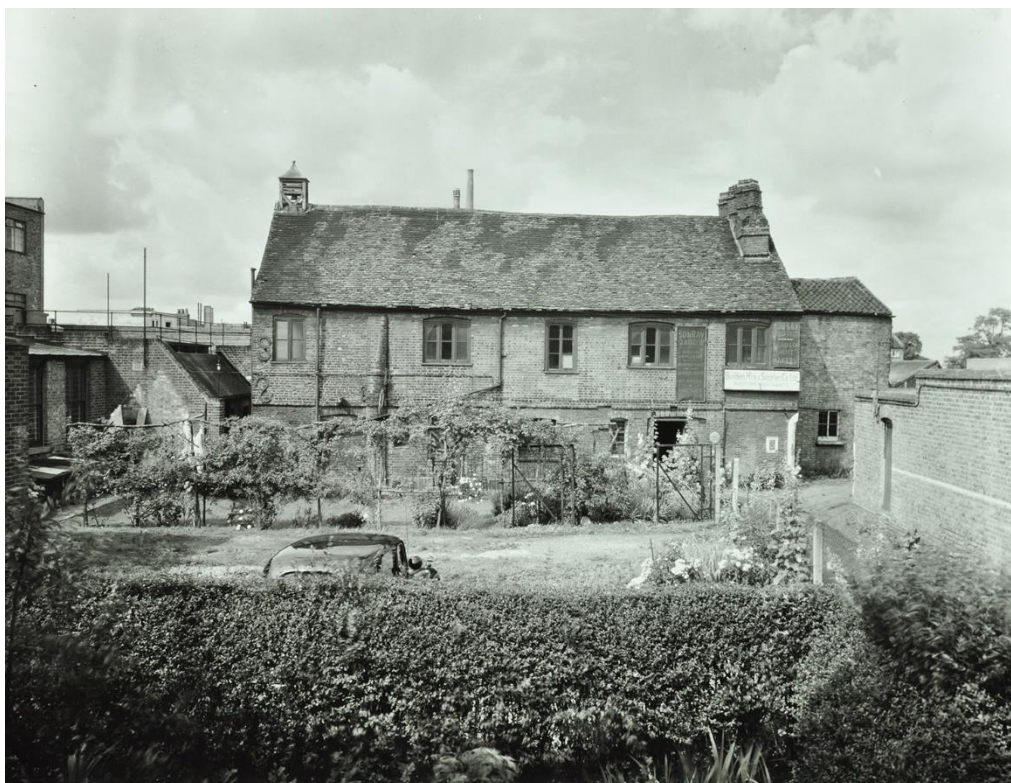
Figure 21: 1962 photograph of east elevation of the subject site. (LMA, 144584.)
