**Re: Hawkenbury – Interim Verification Report for Plots 174-175**

This letter report provides an interim statement on verification inspections for Plots 174-175 located *outside of the former landfill area* of the site and presents a factual account of the findings of verification inspections carried out by LEAP on 13<sup>th</sup> December 2023.

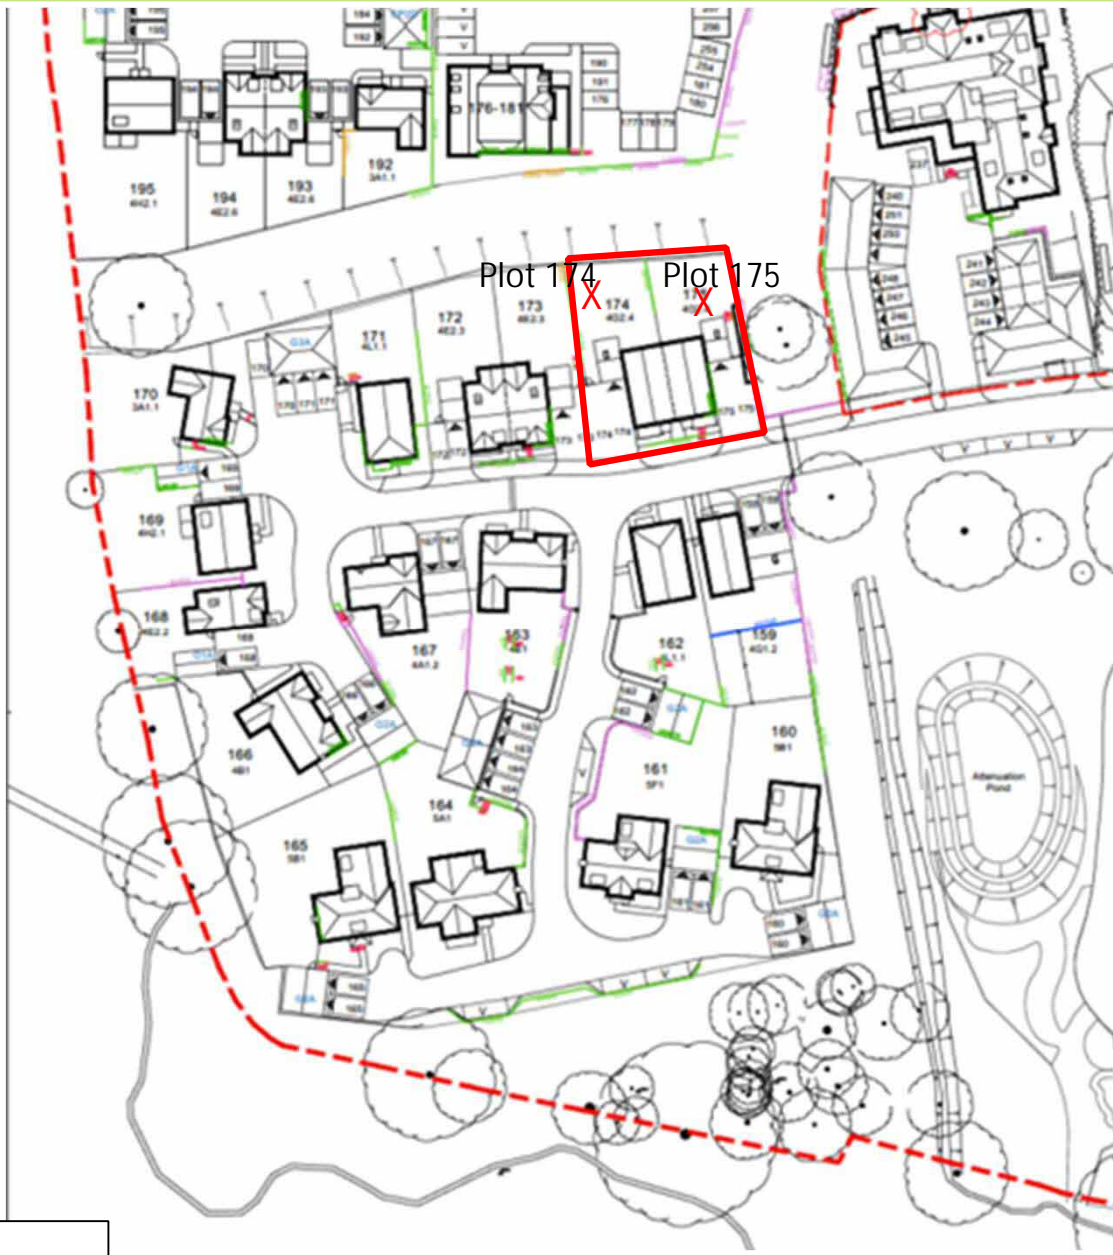
Client:	Berkeley Homes Eastern Counties	Date:	27/03/2023	Project ID:	LP1234
	Project:	Hawkenbury, Tunbridge Wells	Title:	Inspection locations	Fig. No.	3

The hand auger locations are shown in Figure 3, Appendix B, together with selected photographs (Appendix D). The chemical analysis results are included in Appendix C.

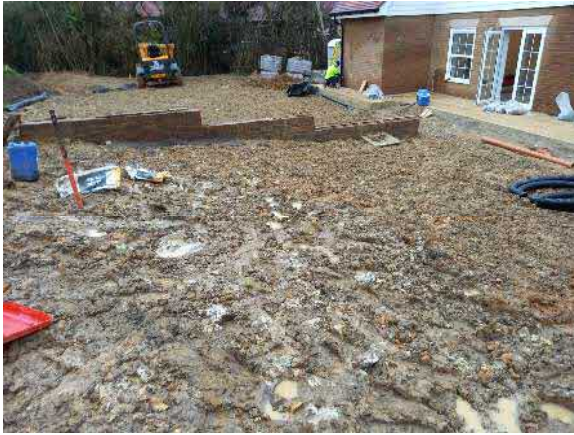
Plate 1 – Subsoil in rear garden of Plot 174 looking to 175, taken 13/12/2023.

Ground conditions generally comprised orange brown very gravelly sandy clay. With gravel of flint, sandstone, and rare wood proven to 450mm.

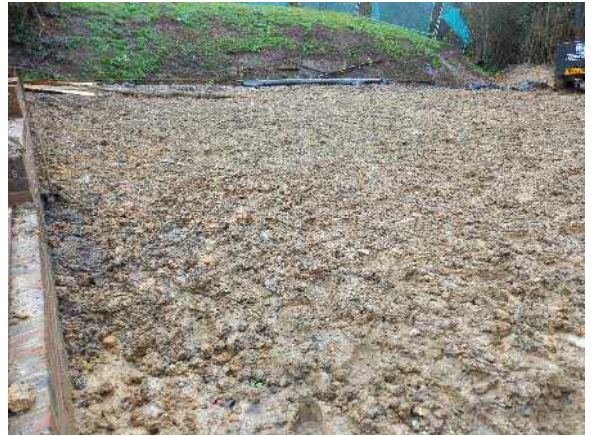
Plate 2 – Subsoil in rear garden of Plot 175, taken 13/12/2023.

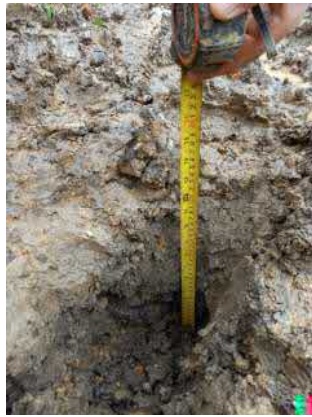
Plate 3 – Example of 350mm diggable soils in rear garden of Plot 174 with space for 150mm topsoil on top, taken 13/12/2023.

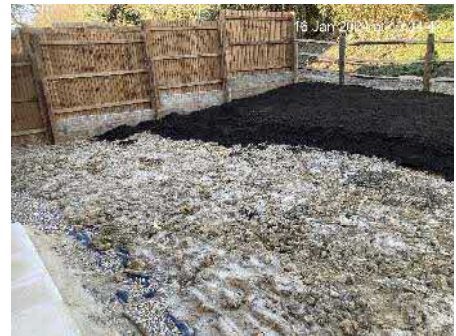
Plate 4 – Example of topsoil being placed in plot 175, marks on fence posts indicate 150mm topsoil has been placed, taken by the client 16/01/2024.

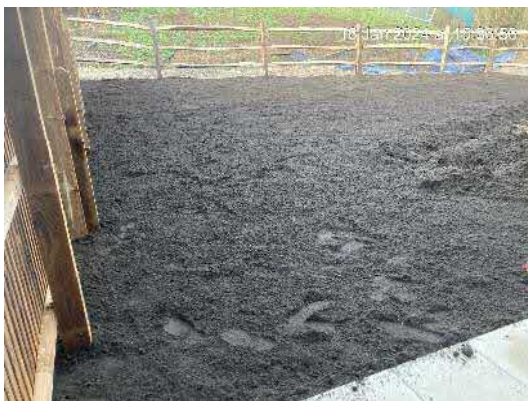
Plate 5 – Rear garden of plot 175 with topsoil placed. Taken by the client 16/01/2024.

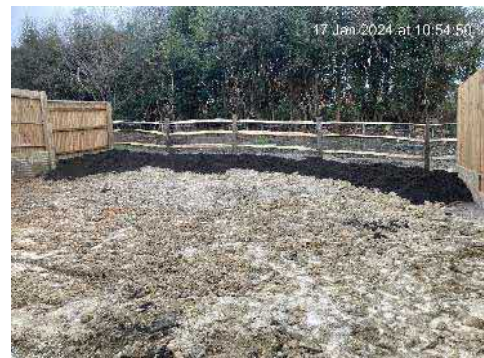
Plate 6 – Example of topsoil being placed in plot 174, marks on fence posts indicate 150mm topsoil has been placed, taken by the client 16/01/2024.
