**REPORT ON
GROUND INVESTIGATION
AT
LAND TO THE WEST OF
MISWELL LANE,
TRING**

Client:	Montpelier Estates
Report Title:	Report on Ground Investigation at Land to the West of Miswell Lane, Tring
Report Number:	AG3261-21-AM39
Report Status:	Validated Issue 2
Details of Change	Amendments to report following supplementary works.
Date:	October 2021

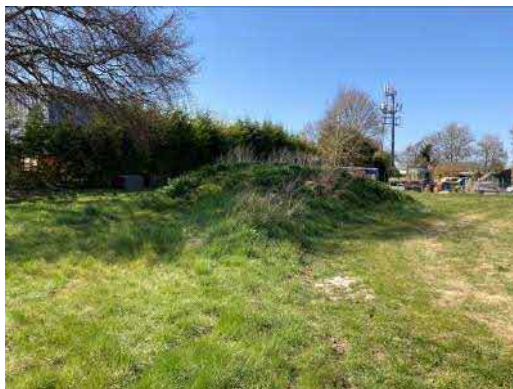
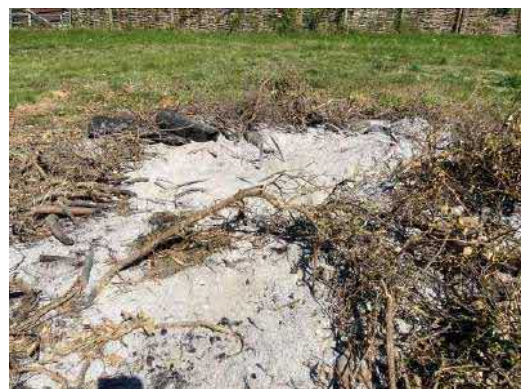
Photographs showing the stockpiled mound of soil in the west of the site and the remnants of a bonfire in the east.

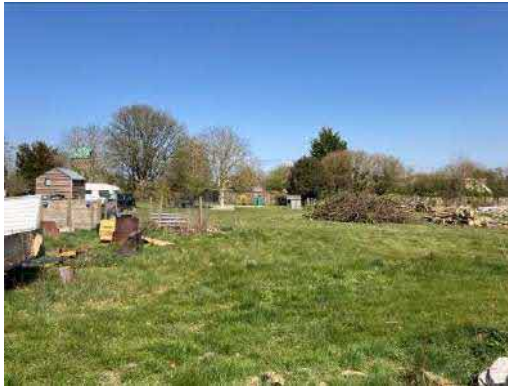
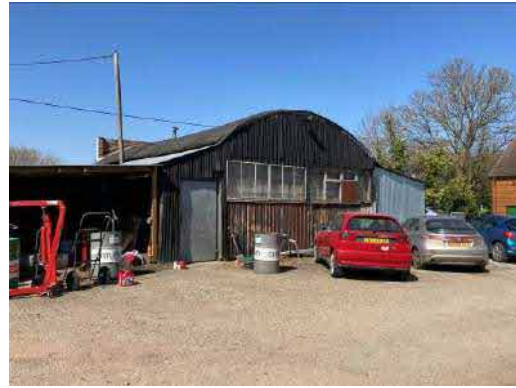
Photographs showing the stockpiled debris (wood and rubble) and the stored farm equipment in the north-western corner and central regions of the site and Morningside Motors with oil drums c.60m north/north-west of the site.

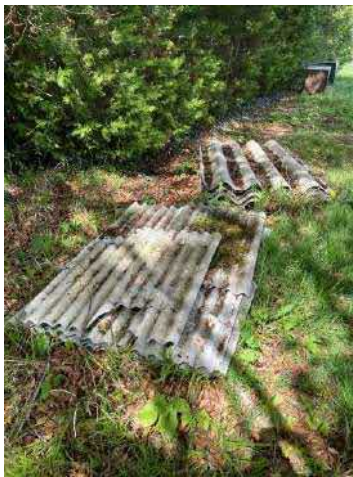
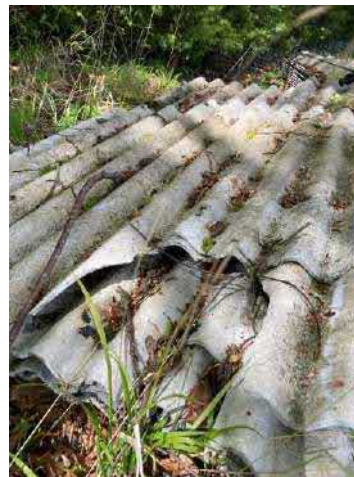
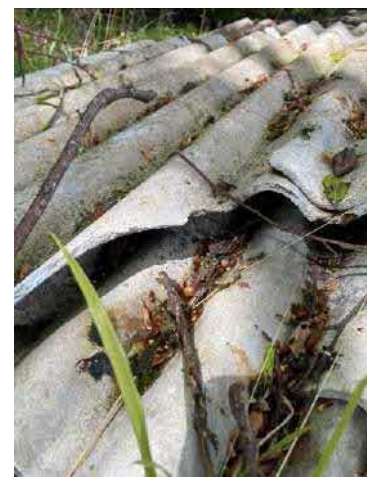
Photographs showing the stockpiled suspected corrugated cement-based asbestos sheeting/roof materials which were noted along the western boundary of the site, to the adjacent west of the stockpiled mound.

Laboratory screening for asbestos did not detect the presence of Asbestos Containing Materials (ACM) within any of the samples tested, including the sample from the stockpiled Made Ground (TP7 at 0.30m bgl) where cement-based sheeting was noted.

Whilst the laboratory screening for asbestos did not detect the presence of ACM within any of the samples tested, visual suspected ACM was encountered within TP7, which was undertaken on the stockpiled mound of Made Ground in the west of the site. Similar corrugated cement-based (possible asbestos) sheeting/roof materials were stockpiled to the adjacent west of the mound, as documented in Section 2.1 above. As the stockpiled Made Ground will likely be disposed of as part of the development, it is recommended that further subsampling and testing is undertaken by an appropriately qualified person. In order to mitigate disposal costs, it is recommended that the stockpile be turned over with the aid of an excavator and where any visible ACM is encountered (as per TP7), the ACM should, where feasible, be separated from the soils by hand by a qualified contractor and then be disposed of at an appropriate landfill.

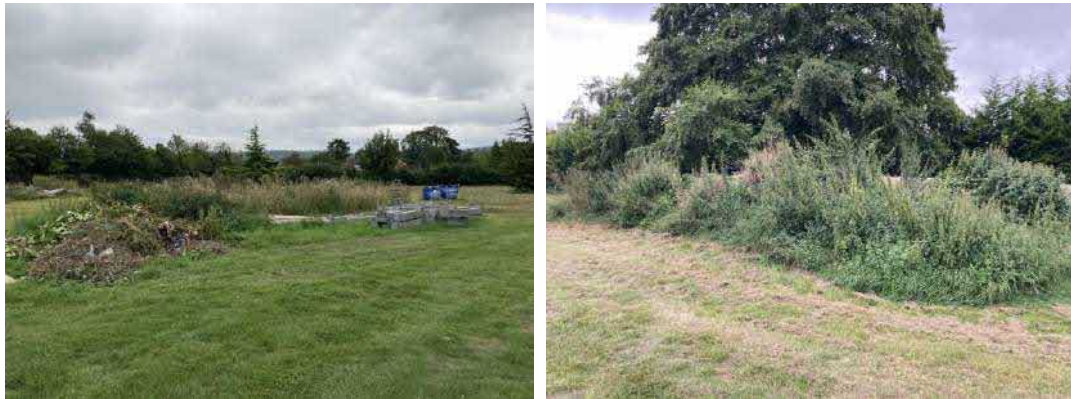
Photographs showing the stockpiled debris (wood and rubble) in the central regions of the site and the stockpiled mound of Made Ground in the west of the site.

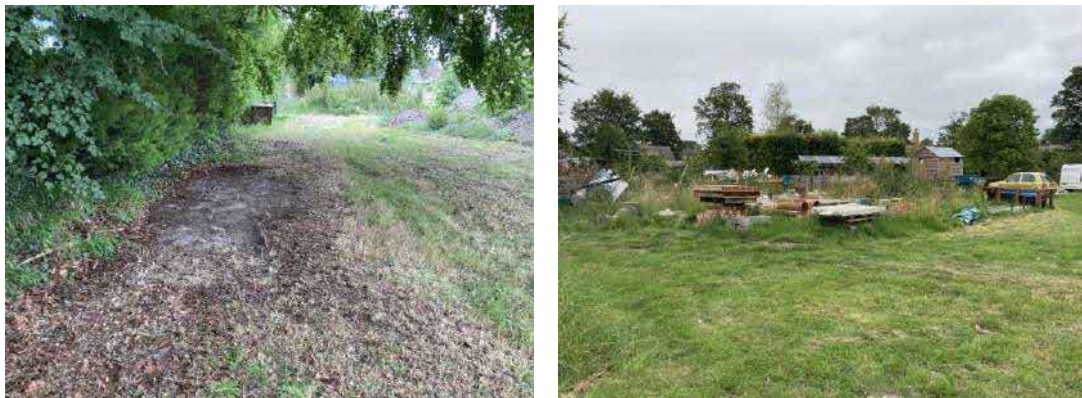
Photographs showing the absence of the cement based asbestos sheeting and recent Topsoil scrape and the farming equipment, skips and construction materials in the north-western corner.

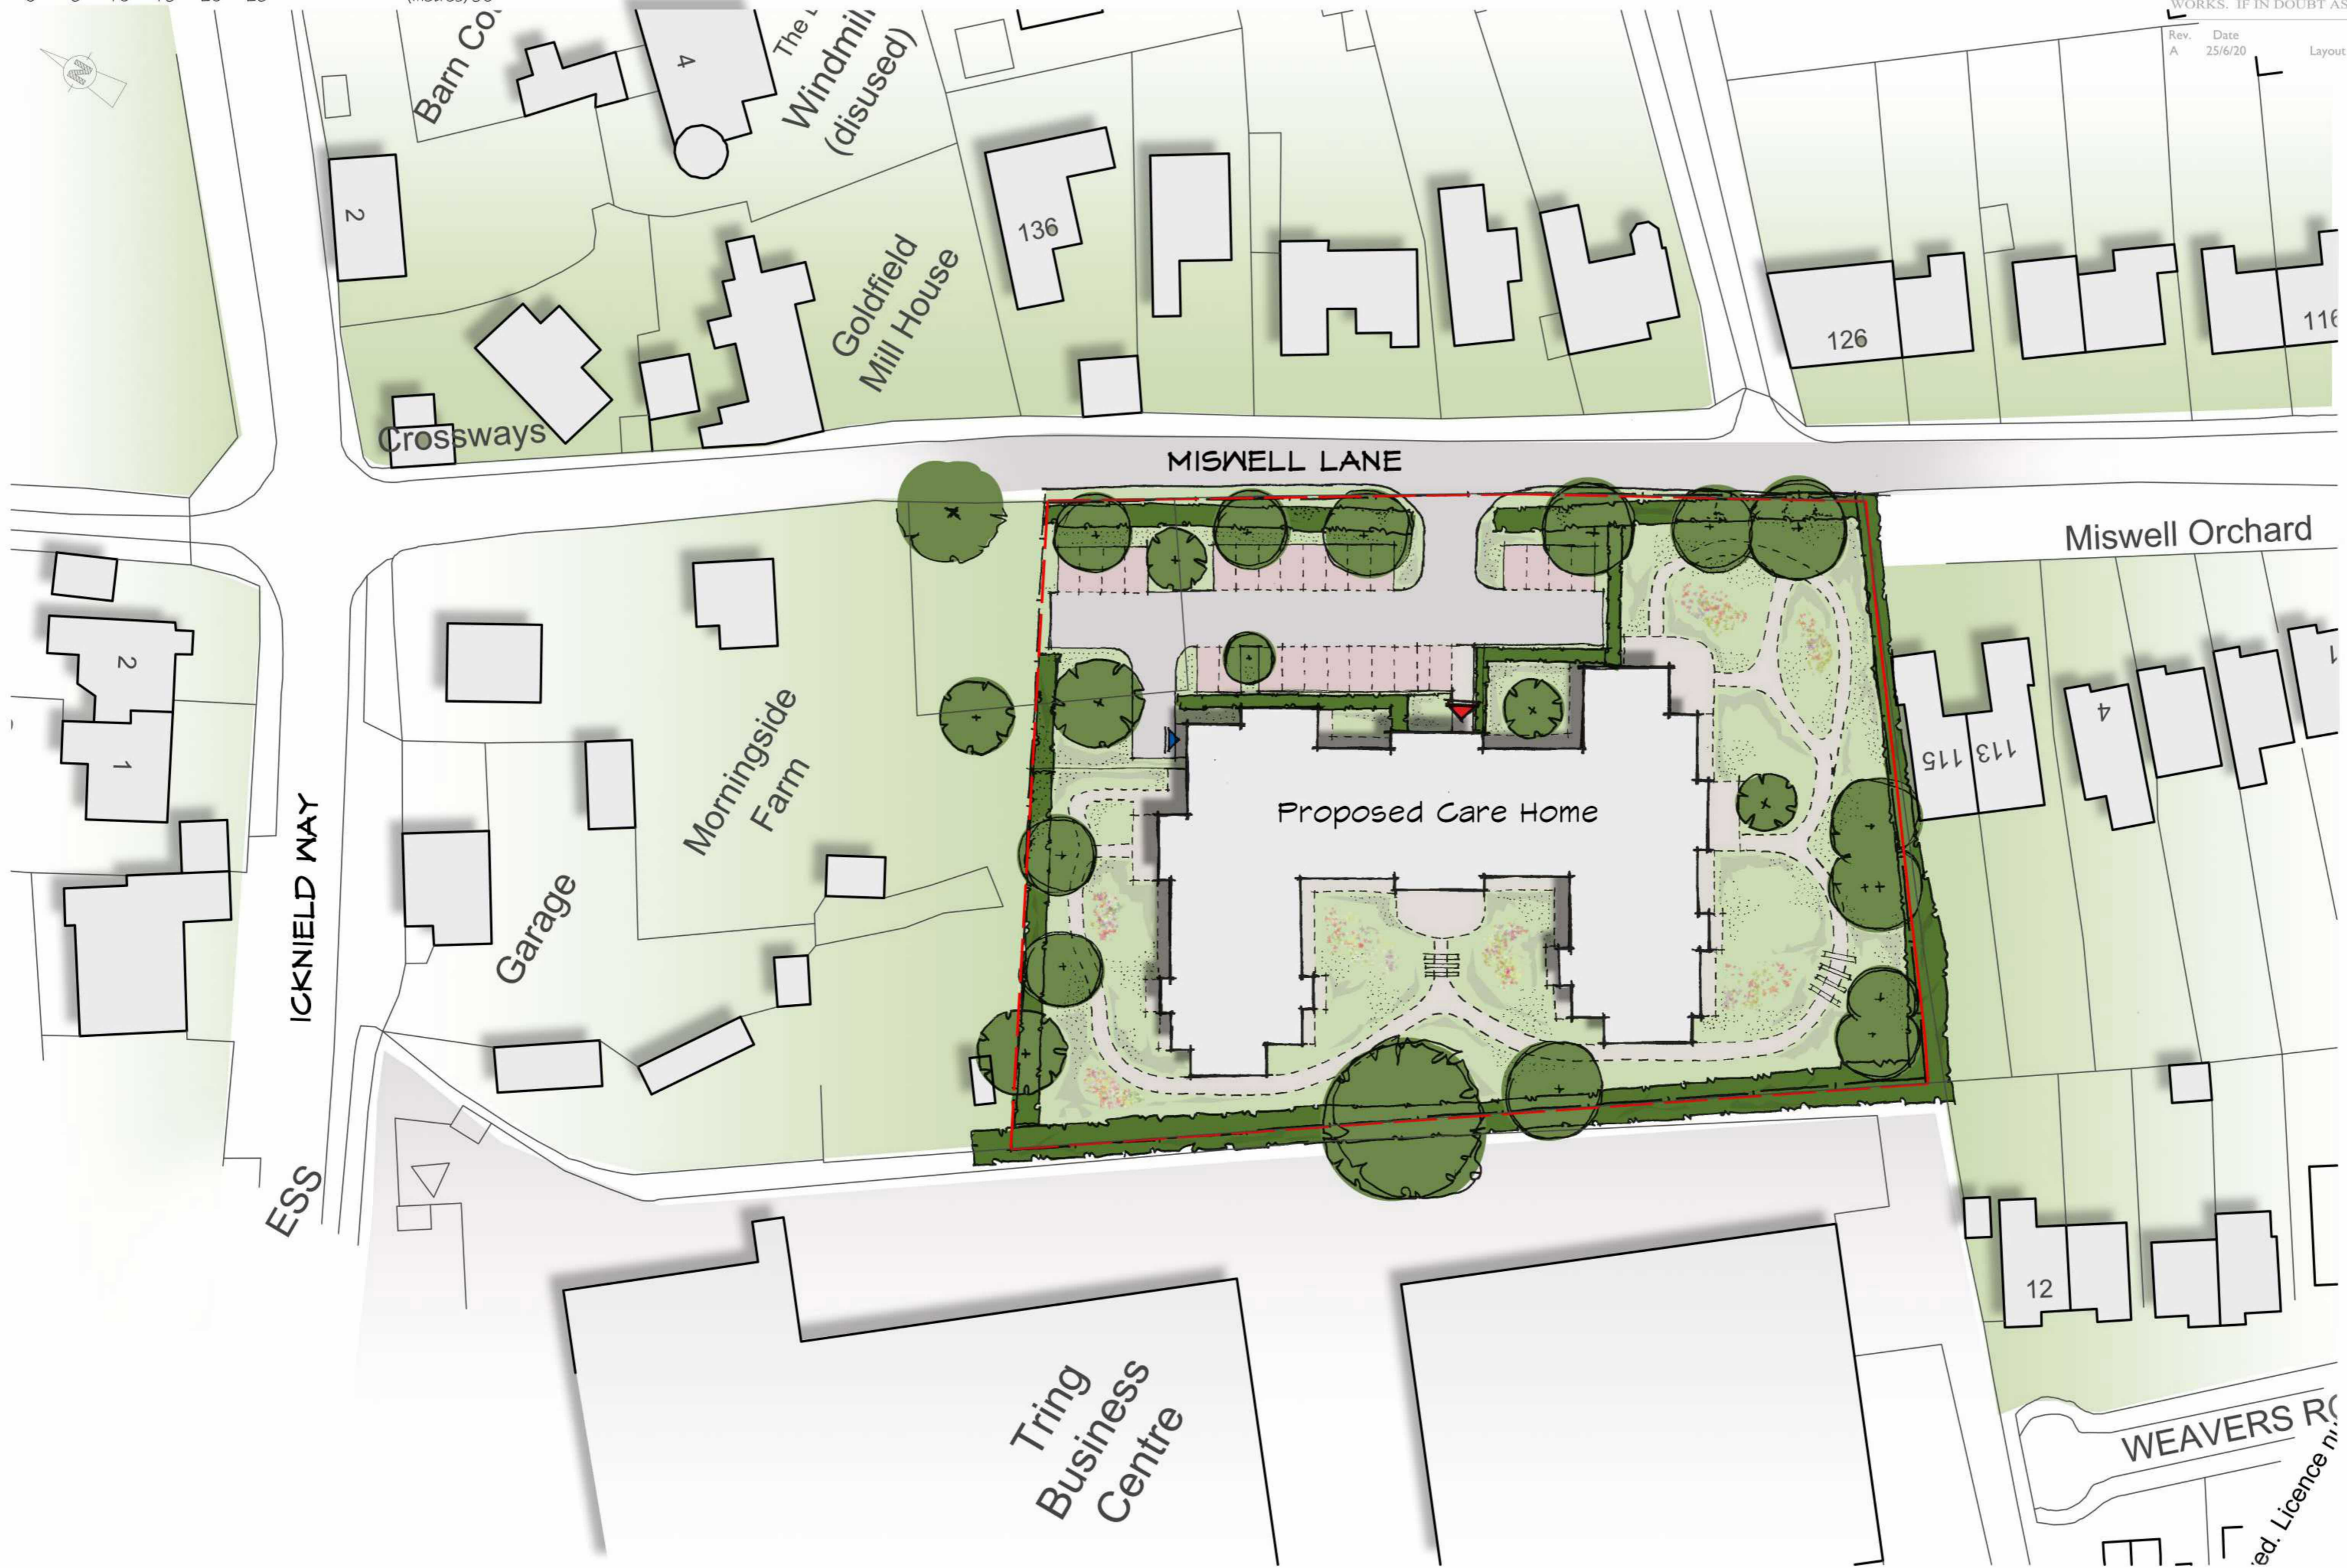
Drawn By: JS	Checked By: MS	Paper Size: A3
Scale: 1:500	Date: 30.04.2021	
Drawing No: AG3261-21-02	Revision: 0

Title: **EXPLORATORY HOLE LOCATION PLAN**
