Preliminary Ecological Appraisal and Bat & Protected Species Survey

Dean Denver
Dean Street
Liskeard
Cornwall
PL14 4AE

Planning Reference:		Report Reference:	240101 rev02
Client/s:			
Architect/Agent:	Restormel Architectural Services		
Survey Date/s:	9 th January 2024		
Report Date:	May 2024	OS Grid Ref:	SX 24911 64563
Report Author:	Megan Hobbs & Aby Sampson BSc ACIEEM		
Approved By:	Erin Reardon BSc PhD MCIEEM		
Surveyors:	Aby Sampson & Megan Hobbs

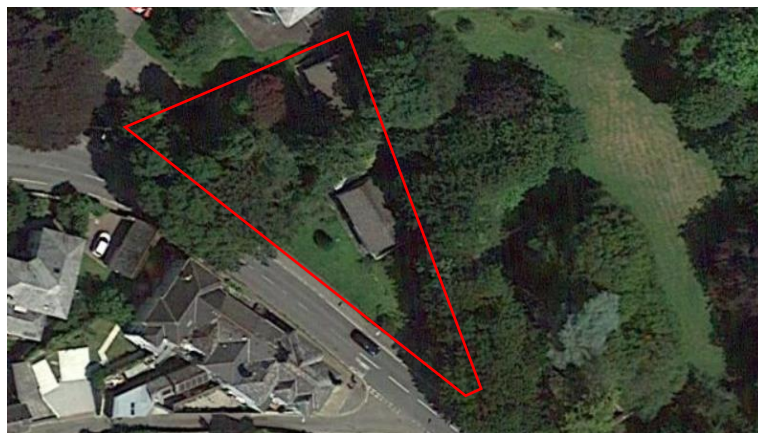
Figure 2.1. The site boundary (outlined in red) at Dean Denver

The site was located in the south-western extent of the town of Liskeard. The site was bordered by residential properties with associated gardens and the B3254 (Figure 2.1). The surrounding landscape comprised residential buildings, commercial properties, carparks, agricultural land, hedgerows, and pockets of woodland. The A38 was located approximately 0.3 miles south of the site.

The survey site was approximately 0.1 ha and comprised four buildings surrounded by areas of hardstanding, modified grassland, sparsely vegetated urban land, introduced shrubs, and trees. The site was enclosed by walls, a hedgerow and lines/pockets of trees.

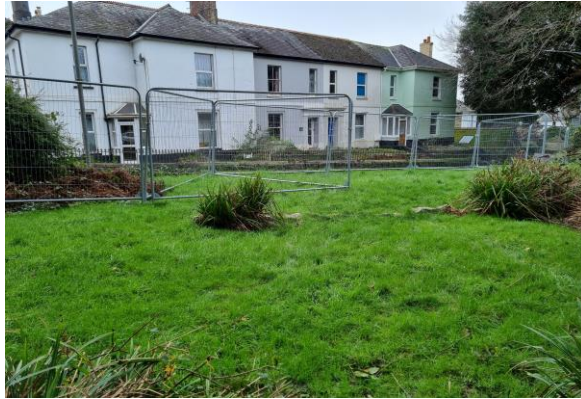
Figure 4.1 Modified grassland (A5)

largely comprised flowering plants and included common daisy, wild strawberry, creeping buttercup, herb-Robert, ground elder, ivy, broad leaved dock, crested dog's tail, broadleaved willowherb, lesser celandine, germander speedwell and wood avens. The species diversity of this parcel was low (poor condition). However the other criteria for this habitat are met (>20% herbs, presence of >1 non-intensive grass species and <30 % cover of perennial rye-grass and clover).

The modified grassland was in poor condition due to the low species diversity and unvaried sward height present.

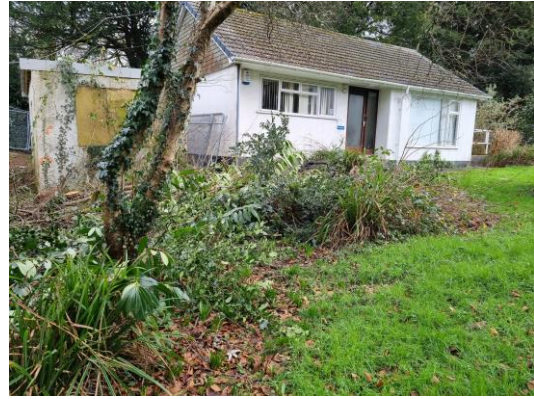
Figure 4.2 Introduced shrub within parcel A5

An area of introduced shrub was located within parcel A5 (Target Note 1, Appendix 1; Figure 4.2). Species identified included bramble, holly, cherry laurel, pendulous sedge, wild strawberry, and buddleia.

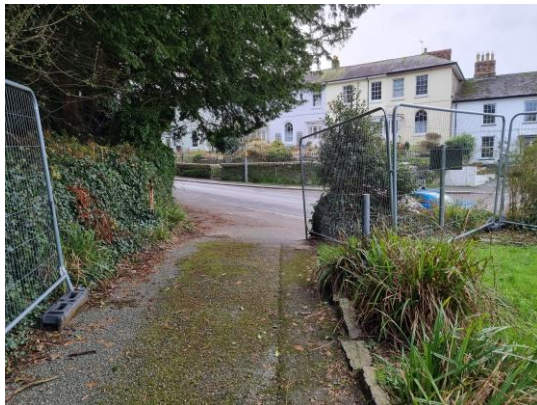
Figure 4.3 Tarmac road within the south-eastern extent.

Areas of hardstanding (A2) were present around the buildings, which consisted of a tarmac parking area and concrete pathways (Figure 4.3).

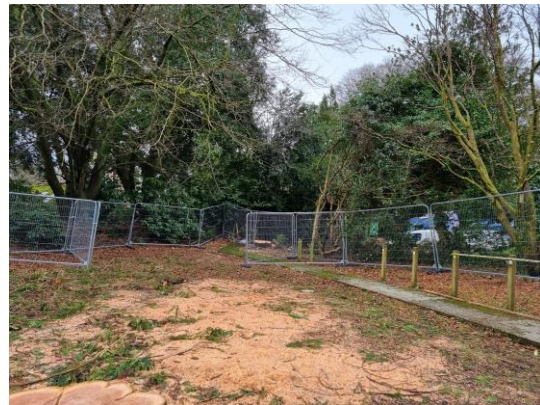
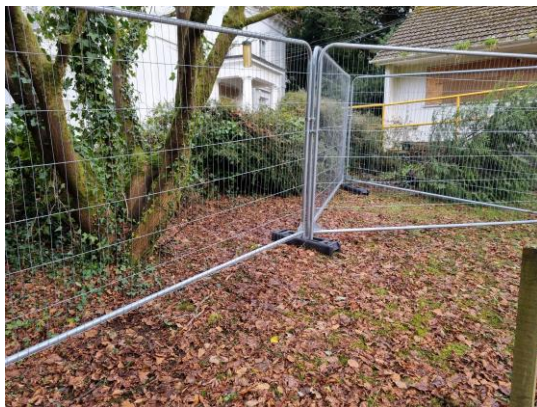
Figure 4.4 Sparsely vegetated urban land within the north-western extent.

The north-western extent of the site comprised an area of scattered wood chippings and sparse vegetation (Figures 4.4 & 4.5). The area (A3 & A4) appeared to have previously been hardstanding. Species noted included lesser celandine, dandelion, primrose, common daisy, ivy, daffodil, germander speedwell, wood avens and harts-tongue fern. The vegetation cover was estimated to be approximately 40%.

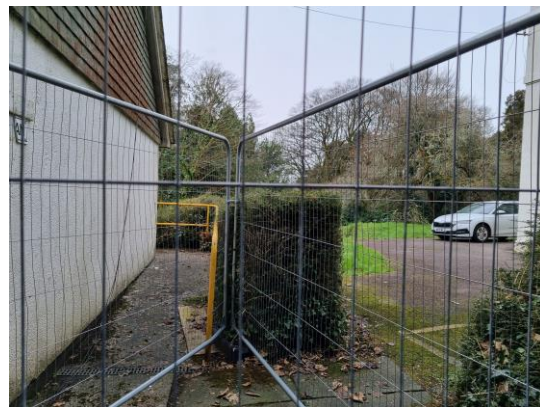
Figure 4.6. Non-native ornamental hedgerow on the north-western boundary.

A non-native ornamental hedgerow (H1) formed the north-western boundary and measured approximately 0.7 m wide x 1 m high (Figure 4.6). The hedgerow predominantly comprised small-leaved honeysuckle with cherry laurel, cherry plum, holly and rhododendron present within the southern extent of the hedgerow. Other species noted included pendulous sedge.

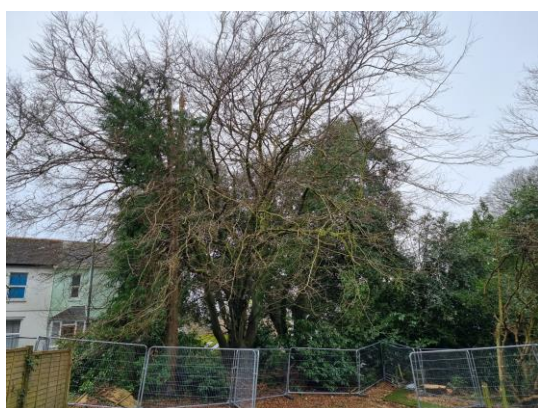
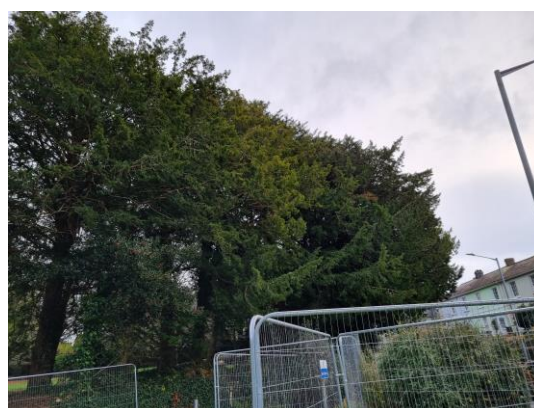
Figure 4.7. Line of trees (H3) located at the western corner.

A line of trees was present within the western corner of the site (H2) and along the north-eastern boundary (H3) (off-site). Tree line H2 was mixed broadleaved and conifer woodland, approximately 6 m in height. Species noted included beech, Japanese laurel, lawsons cypress and holme oak (Figure 4.7). Tree line H3, was located off-site adjacent to the north-western boundary. It was mixed broadleaved and conifer (mainly conifer) and was approximately 6 m in height. The tree line was predominantly yew with bay, cherry laurel, sycamore, holly, and Japanese laurel also noted (Figure 4.8).

The lines of trees were in moderate condition as there was little or no damage noted to the trees, the canopy was continuous and ecological niches were present.

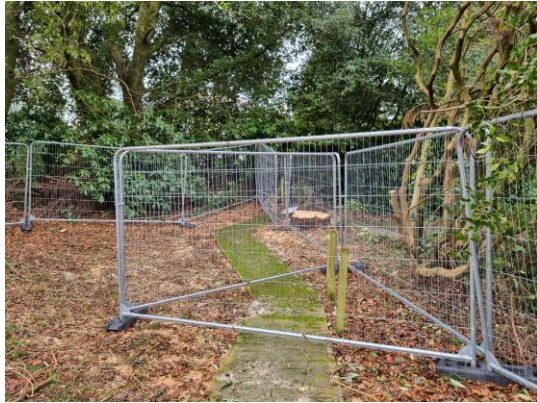
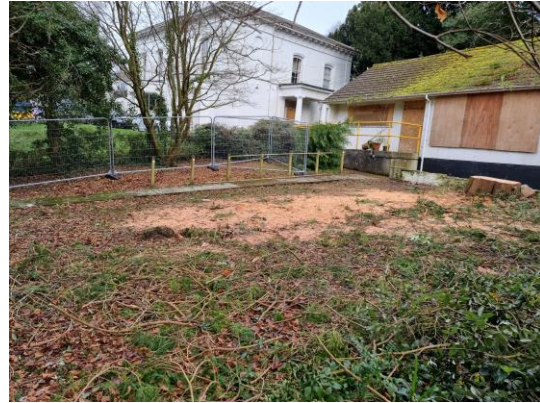
Figure 4.9. Stump of T3a within parcel A4

Two Lawsons cypress trees (T3a & T3b) that had recently been removed were noted within parcel A3. These trees were considered to have been in good and moderate condition, respectively. This was based on the species and the remaining tree stumps, which indicated the size of the trees (large and medium).

Trees T3a and T3b had been removed prior to the survey (Figures 4.9 & 4.10). These trees were considered to have been in good and moderate condition, respectively. This was based on the species and the remaining tree stumps, which indicated the size of the trees (large and medium).

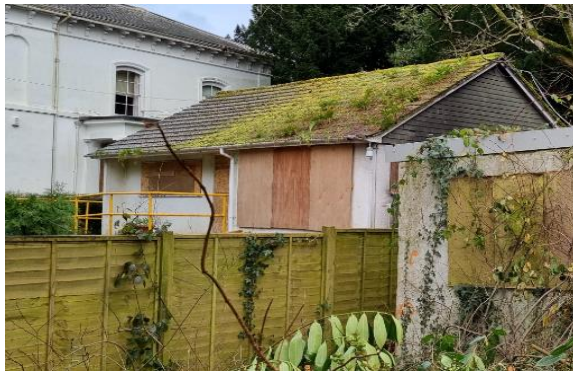
Figure 4.11 South-eastern elevation of Building 1

Building 1 (B1) was located within the northern extent of the site (Figure 4.11). The walls of the building were constructed from rendered concrete panels and the pitched gable roof was covered with concrete roof tiles. Hanging concrete tiles covered the gable ends and the eaves were surrounded with uPVC soffit boxes. One loft void was present within the building which measured approximately 2 m high x 9 m long x 6.5 m wide with bitumen felt underlay (Figure 4.12).

Approximately 10-20 small-sized bat droppings, morphologically characteristic of pipistrelle species, were found scattered within the loft of building 1.

A bat emergence survey (comprising three survey visits) will be required for Buildings B1 and B2 to confirm the impact of the proposed works. Mitigation, compensation and enhancement measures required for bats will be determined upon completion of the further surveys.

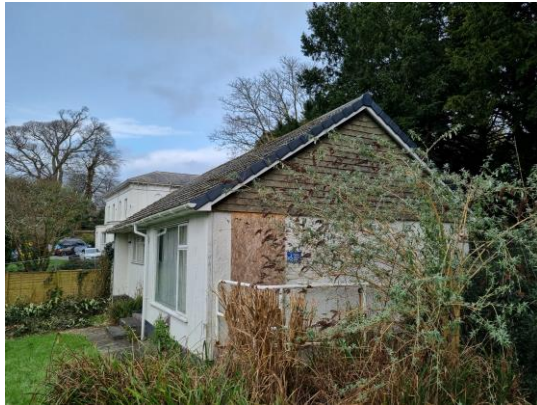
Figure 4.13. South and eastern elevations of Building 2

Building 2 (B2) was located centrally within the site (Figure 4.13). The walls of the building were constructed from rendered concrete panels and the pitched gable roof was covered with concrete roof tiles. Hanging concrete tiles covered the gable ends

and the eaves were surrounded with uPVC soffit boxes. The verges of the roof were capped with plastic fittings. A loft void was present within the building which measured approximately 2 m high x 10 m long x 6 m wide with bitumen felt underlay (Figure 4.14).

Several clusters of medium-sized bat droppings (~300), morphologically characteristic of long-eared species, were noted in the loft space of building 2.

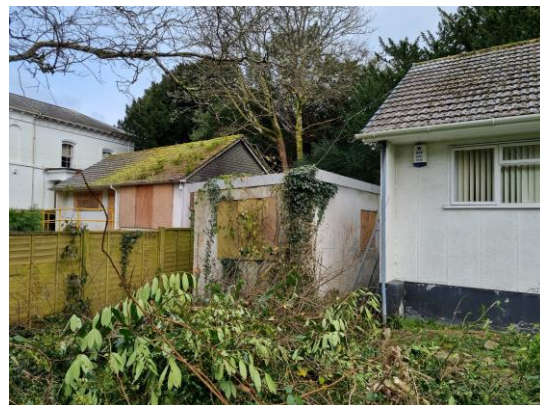
Figure 4.16. Southern and eastern elevations of Building 4

Building 4, a garage, was located immediately north of Building 2 and centrally within the site (Figure 4.16). The walls of the building were constructed from externally rendered concrete block. The shallow single pitched roof was covered with corrugated metal. The building was inaccessible at the time of the survey.

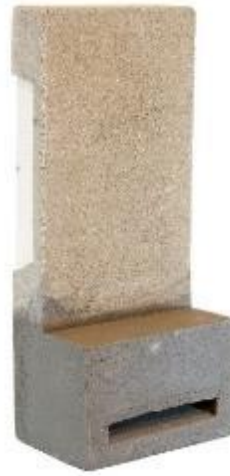
**Schwegler 1FR Bat Tube**

Material: Woodcrete (75% wood sawdust, concrete and clay mixture)

Position: Within external walls in place of a standard block on a southerly aspect, beneath eaves or at a minimum height of 4 m

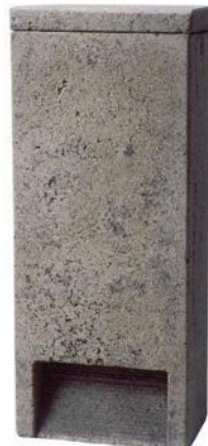
**Green & Blue Bat Block**

Material: Cast concrete (75% waste materials from Cornish China Clay Industry)

Position: Within external walls in place of a standard block on a southerly aspect, beneath eaves or at a minimum height of 4 m

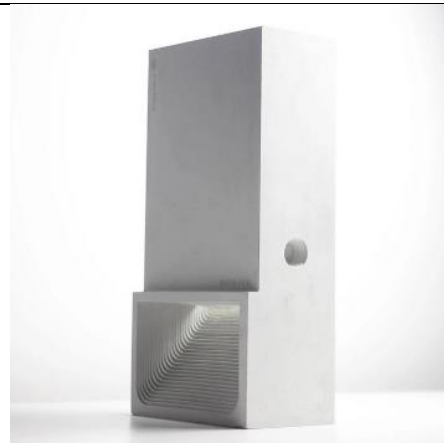
WoodStone Build in Open Nest Box

Suitable for: robins, wrens and blackbirds.
Material: Woodstone
Height: 180 mm
Width: 220 mm
Depth: 180 mm
Weight: 4.2kg

Position: Within external walls, at a minimum height of 3 m

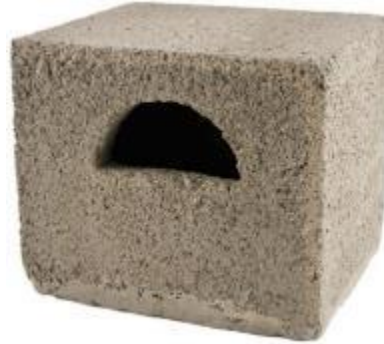
**Vivara Pro Estelle House Sparrow Terrace**

Suitable for: House sparrows and individual blue & great tits
Material: Woodstone

Height: 210 mm
Width: 290 mm
Depth: 160 mm
Weight: 7.5 kg

Position: Within external walls, at a minimum height of 3 m

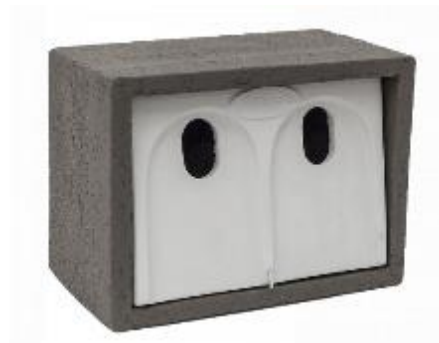
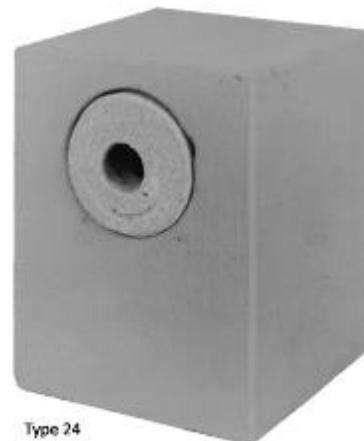
**Schwegler Brick Nest Box (Type 24)**

Suitable for: House sparrows, great tits, blue tits and nuthatches
Material: Woodcrete

Height: 235 mm
Width: 180 mm
Depth: 180 mm
Weight: 2.8 kg

Position: Within external walls, at a minimum height of 3 m

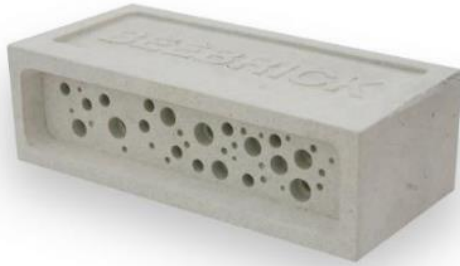
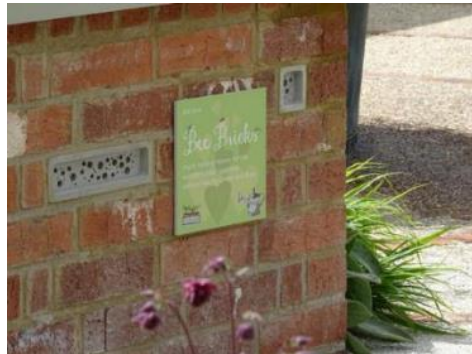
Each bee brick includes nesting compartments for solitary nesting bees, including for egg laying and hibernation.

Bee bricks to be positioned within southerly elevations, which includes part or full sun, at approximately 1m above ground level, and ideally facing garden or boundary habitats.

Bee Brick - case in concrete: 215mm x 105mm x 65mm
