THE NATIONAL TRUST - KNOLE:

GARDEN WALLS NEW GARDEN WALL BUTTRESSES REVISED BUTTRESS DETAILING

HISTORIC IMPACT ASSESSMENT & DESIGN AND ACCESS STATEMENT

DATE: MARCH 2024

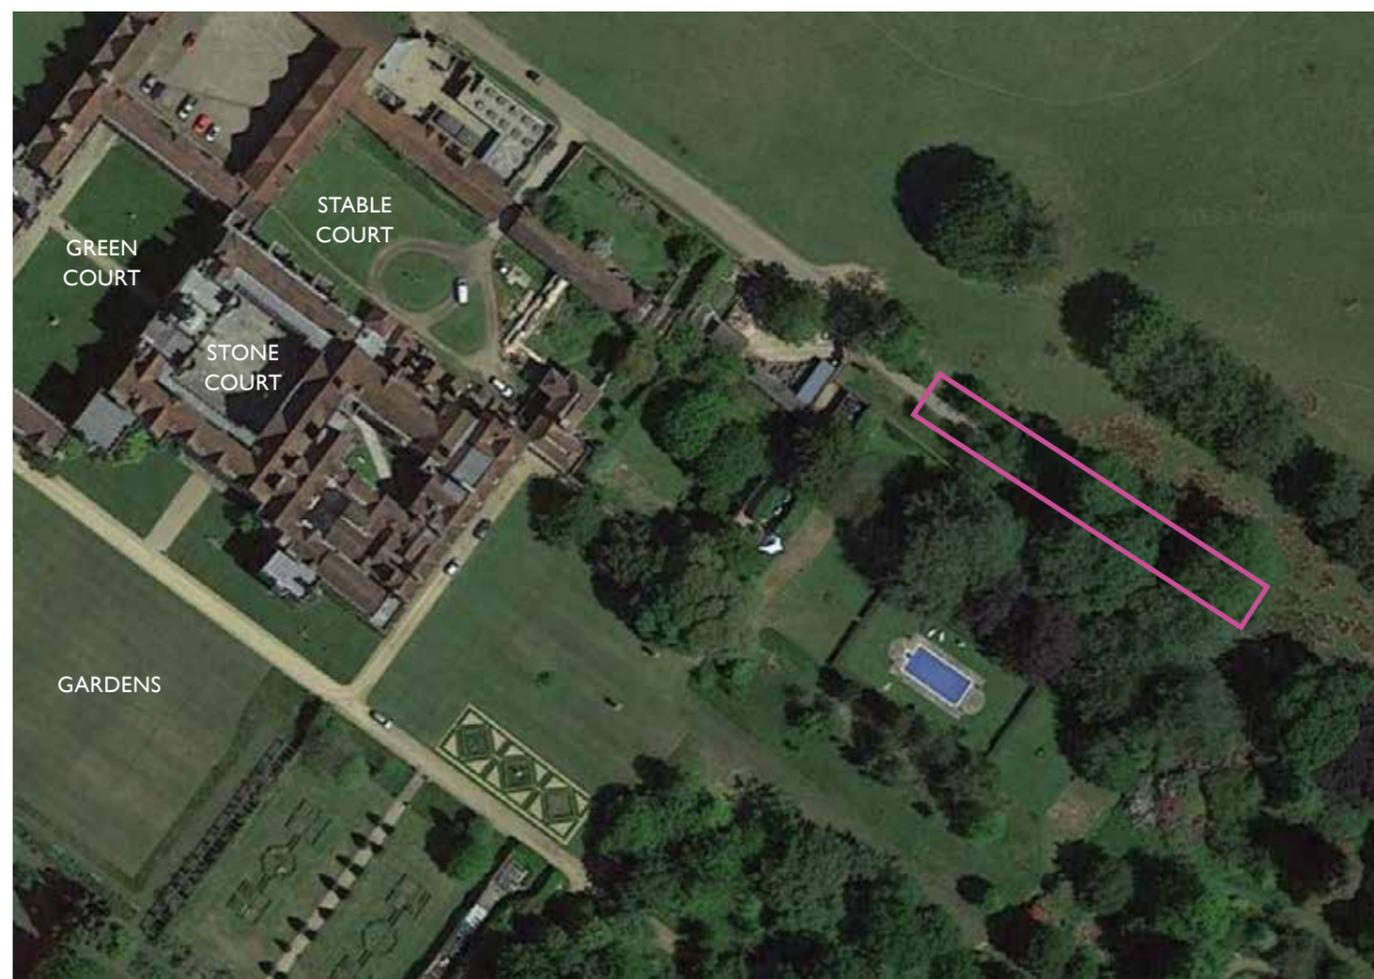
Figure 1.1 (Above): Aerial Photograph of Knole illustrating the location of the garden walls where the new buttresses are proposed within wider context of the House.

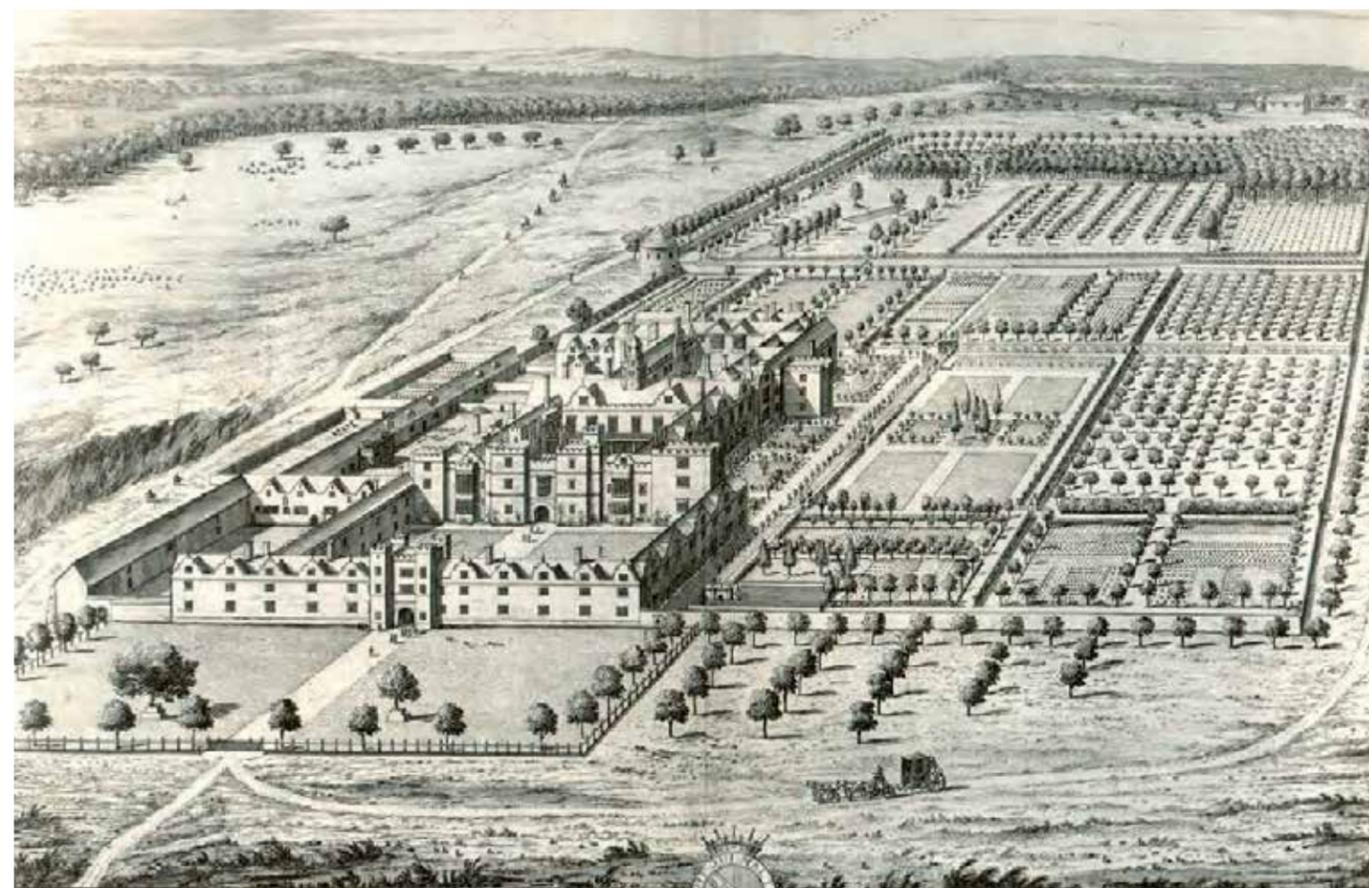
Figure 2.2.1 (above): A bird's eye view of Knole and its gardens engraved in 1707/8 during the time of Lionel, 1st Duke of Dorset. The engraving is one of a set of views of English Houses drawn by Jan Kip and Leonard Knyff in the late 17th and early 18th Centuries. The garden walls that pertain to this application can be seen towards the back of the house.

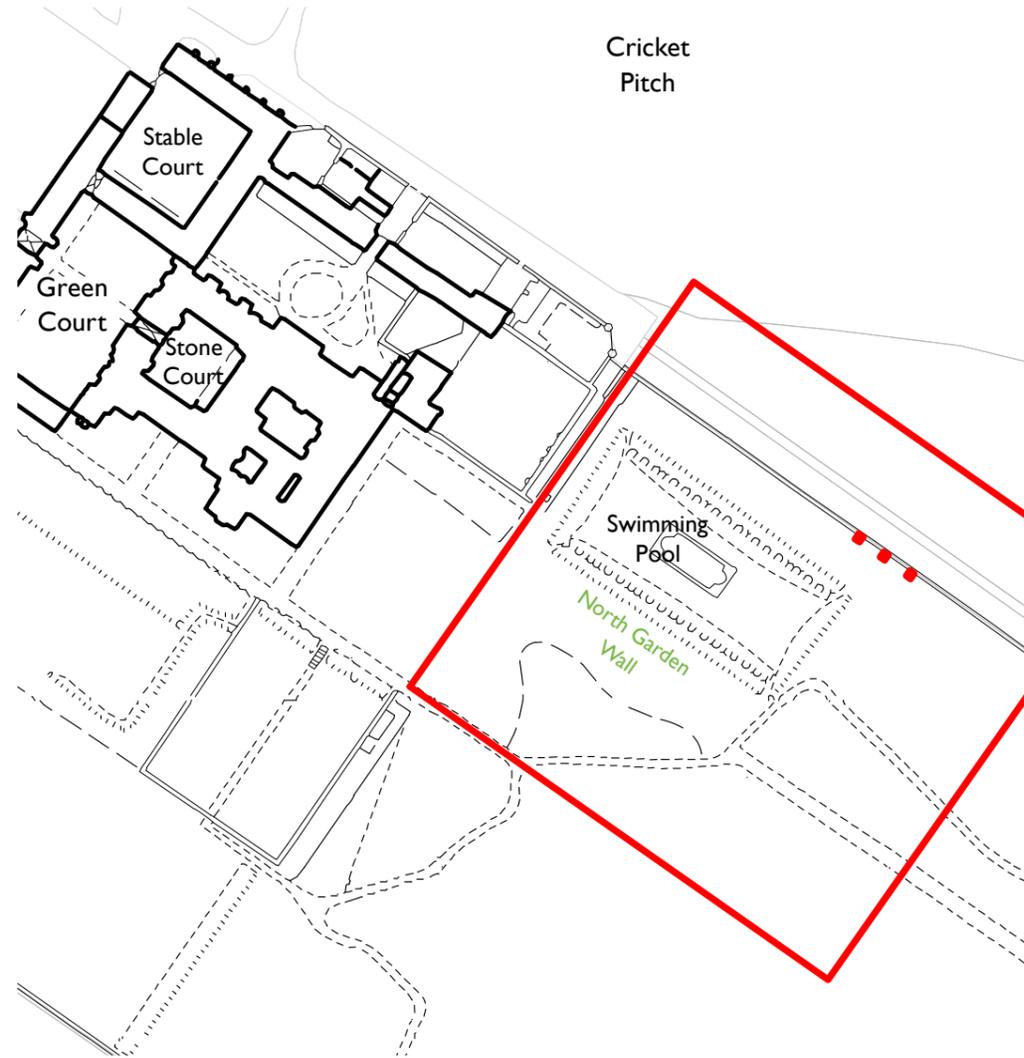
Figure 3.0.1 (above left): A plan showing the location of the north garden wall and proposed buttresses.

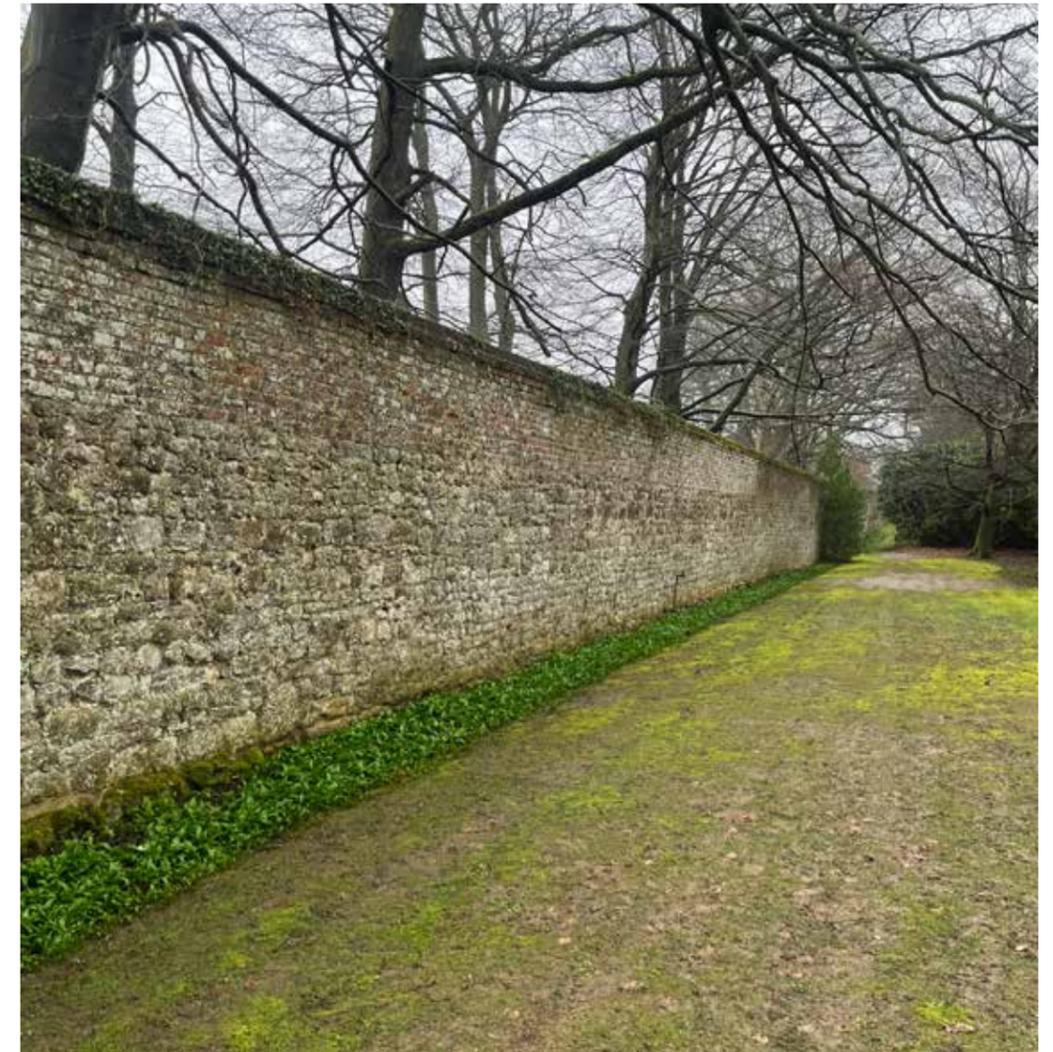
Figure 3.0.2 (above): The southwest garden wall to which the proposals pertain.

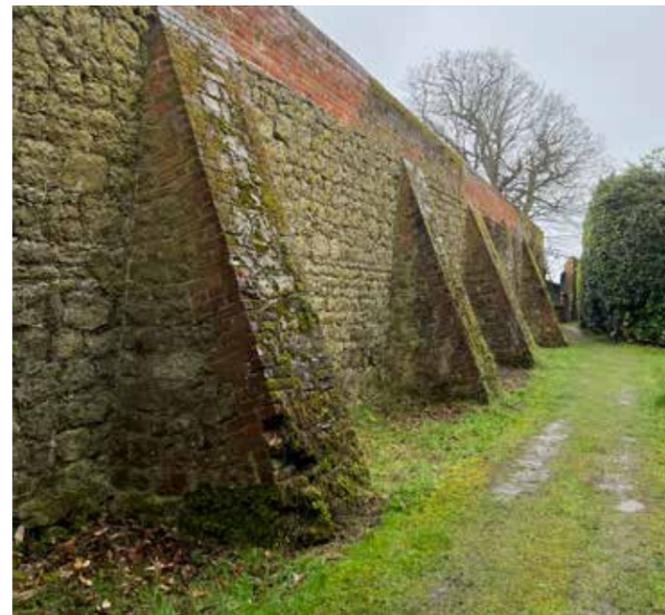
Figure 3.0.3 (far left): Photo showing the existing original stone buttresses with brick quoins.

The original design of the three buttresses was based upon existing buttresses along the east walls - see figure 3.0.3 (right). These comprise traditional brickwork quoins with rough course Kentish Ragstone between. These precedents are, however, somewhat larger than the buttresses proposed by TMP.

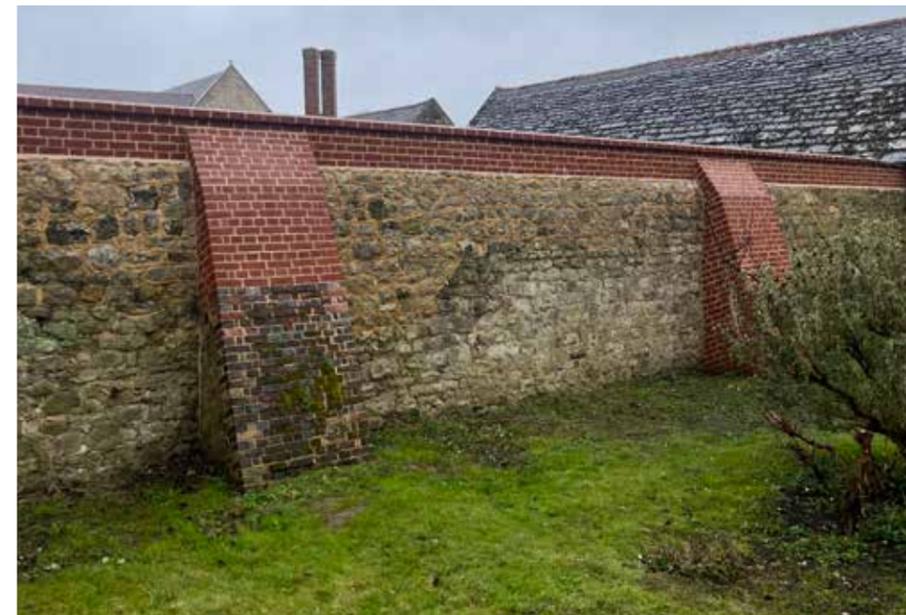
Figure 3.0.4 (left): Photo showing the buttresses in Laundry Court. The upper section of which has been rebuilt, but note that the lower section of the buttresses are entirely brickwork.

We decided instead to proceed using an alternative design used in the Laundry Court as a precedent - see figure 3.0.4 (right). These are entirely faced in traditional handmade brickwork, by Lamb's Brickworks.

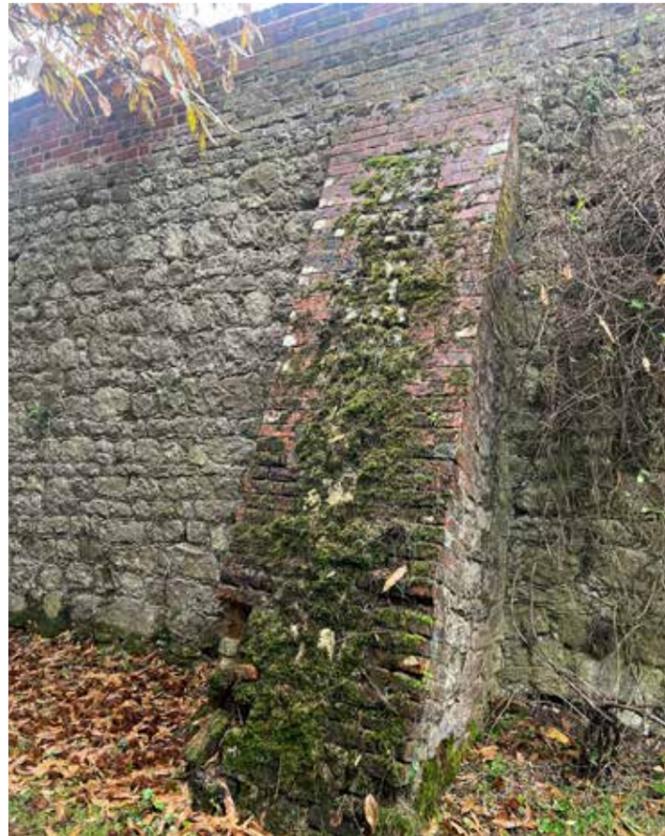
Figure 3.0.5 (above left): A view of the buttresses on the East Garden Wall, a mix of traditional brick and Kentish Ragstone.

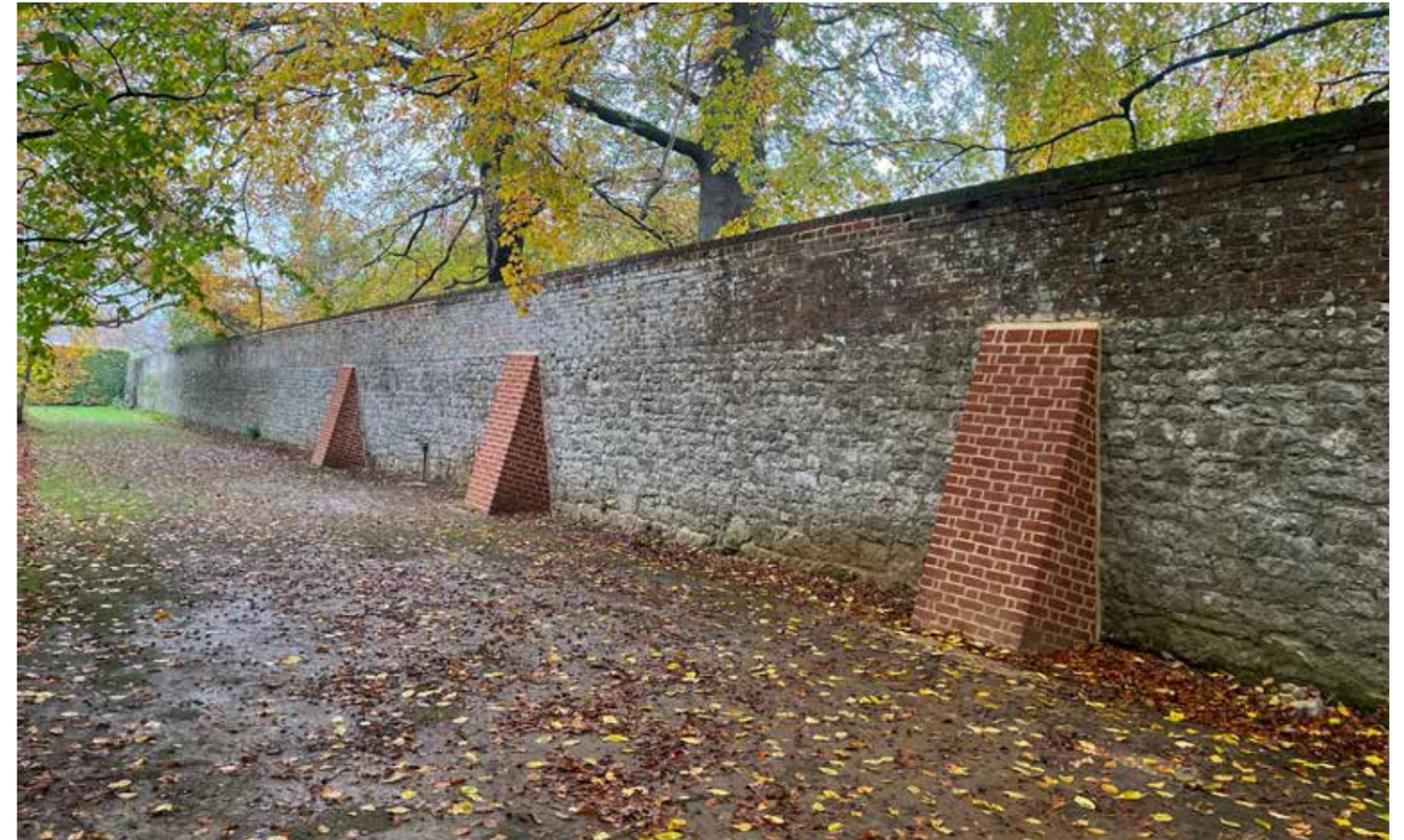
Figure 3.0.6 (above right): A view of the inside elevation of the North Garden Wall, showing the three new buttresses finished with traditional handmade bricks from Lambs.

The new buttresses have been constructed using Lambs traditional handmade bricks, used elsewhere around the garden walls for repairs. They are clearly identifiable as a contemporary repair.

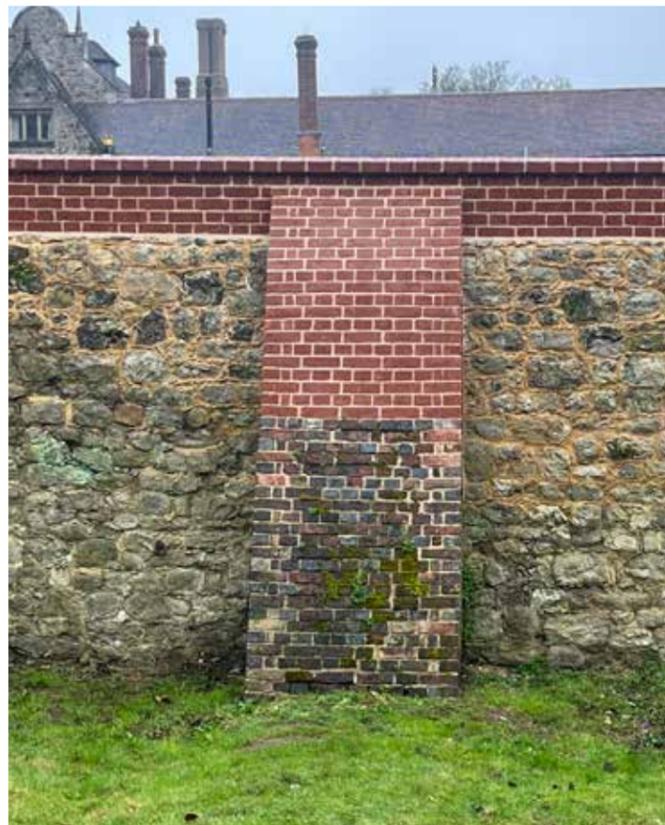
Figure 3.0.7 (below left): A buttress on the Laundry Courtyard wall, the upper section recently re-constructed. Note the lower original works entirely in traditional brickwork.

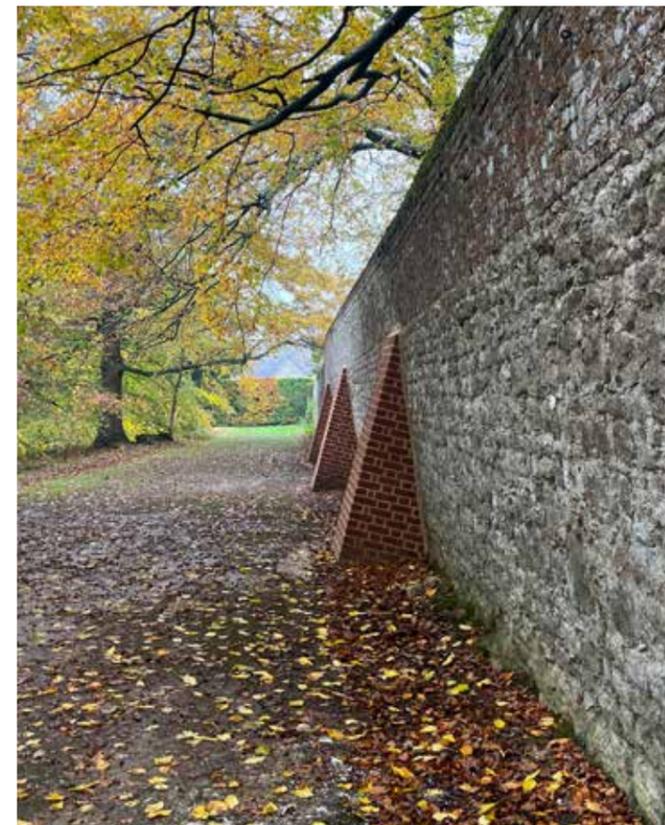
Figure 3.0.8 (below centre): Detail showing the side elevation, showing how little space would be left for the Ragstone, if the quoin detailing was used.

When the core of the buttress was set out, it became apparent that they are much smaller than our proposed precedent. At this scale the quoins would leave only very small pockets for Ragstone, and it was felt that this would look clumsy and ill-considered.

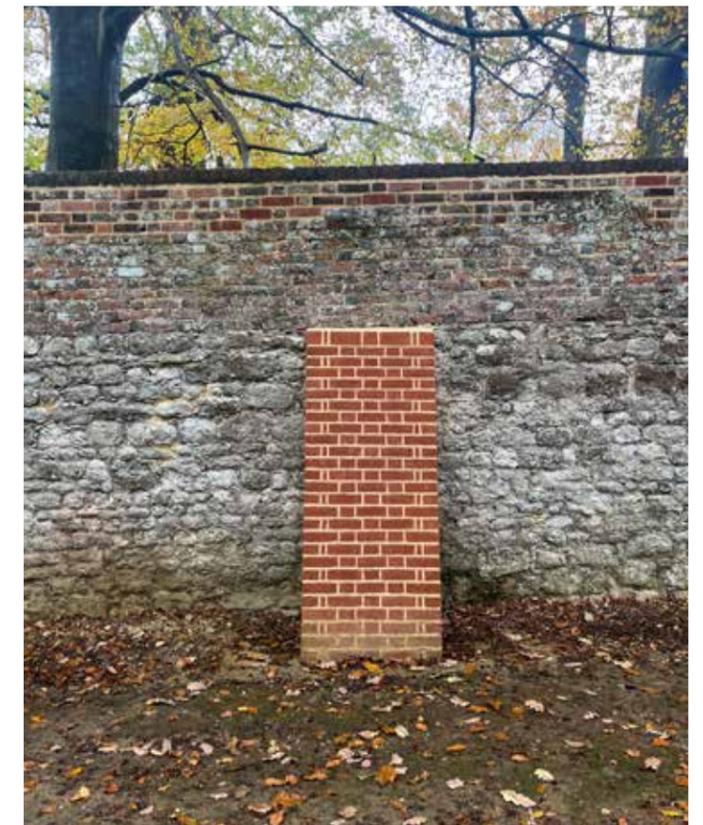
Figure 3.0.9 (below right): Detail showing the front elevation of the completed buttress.

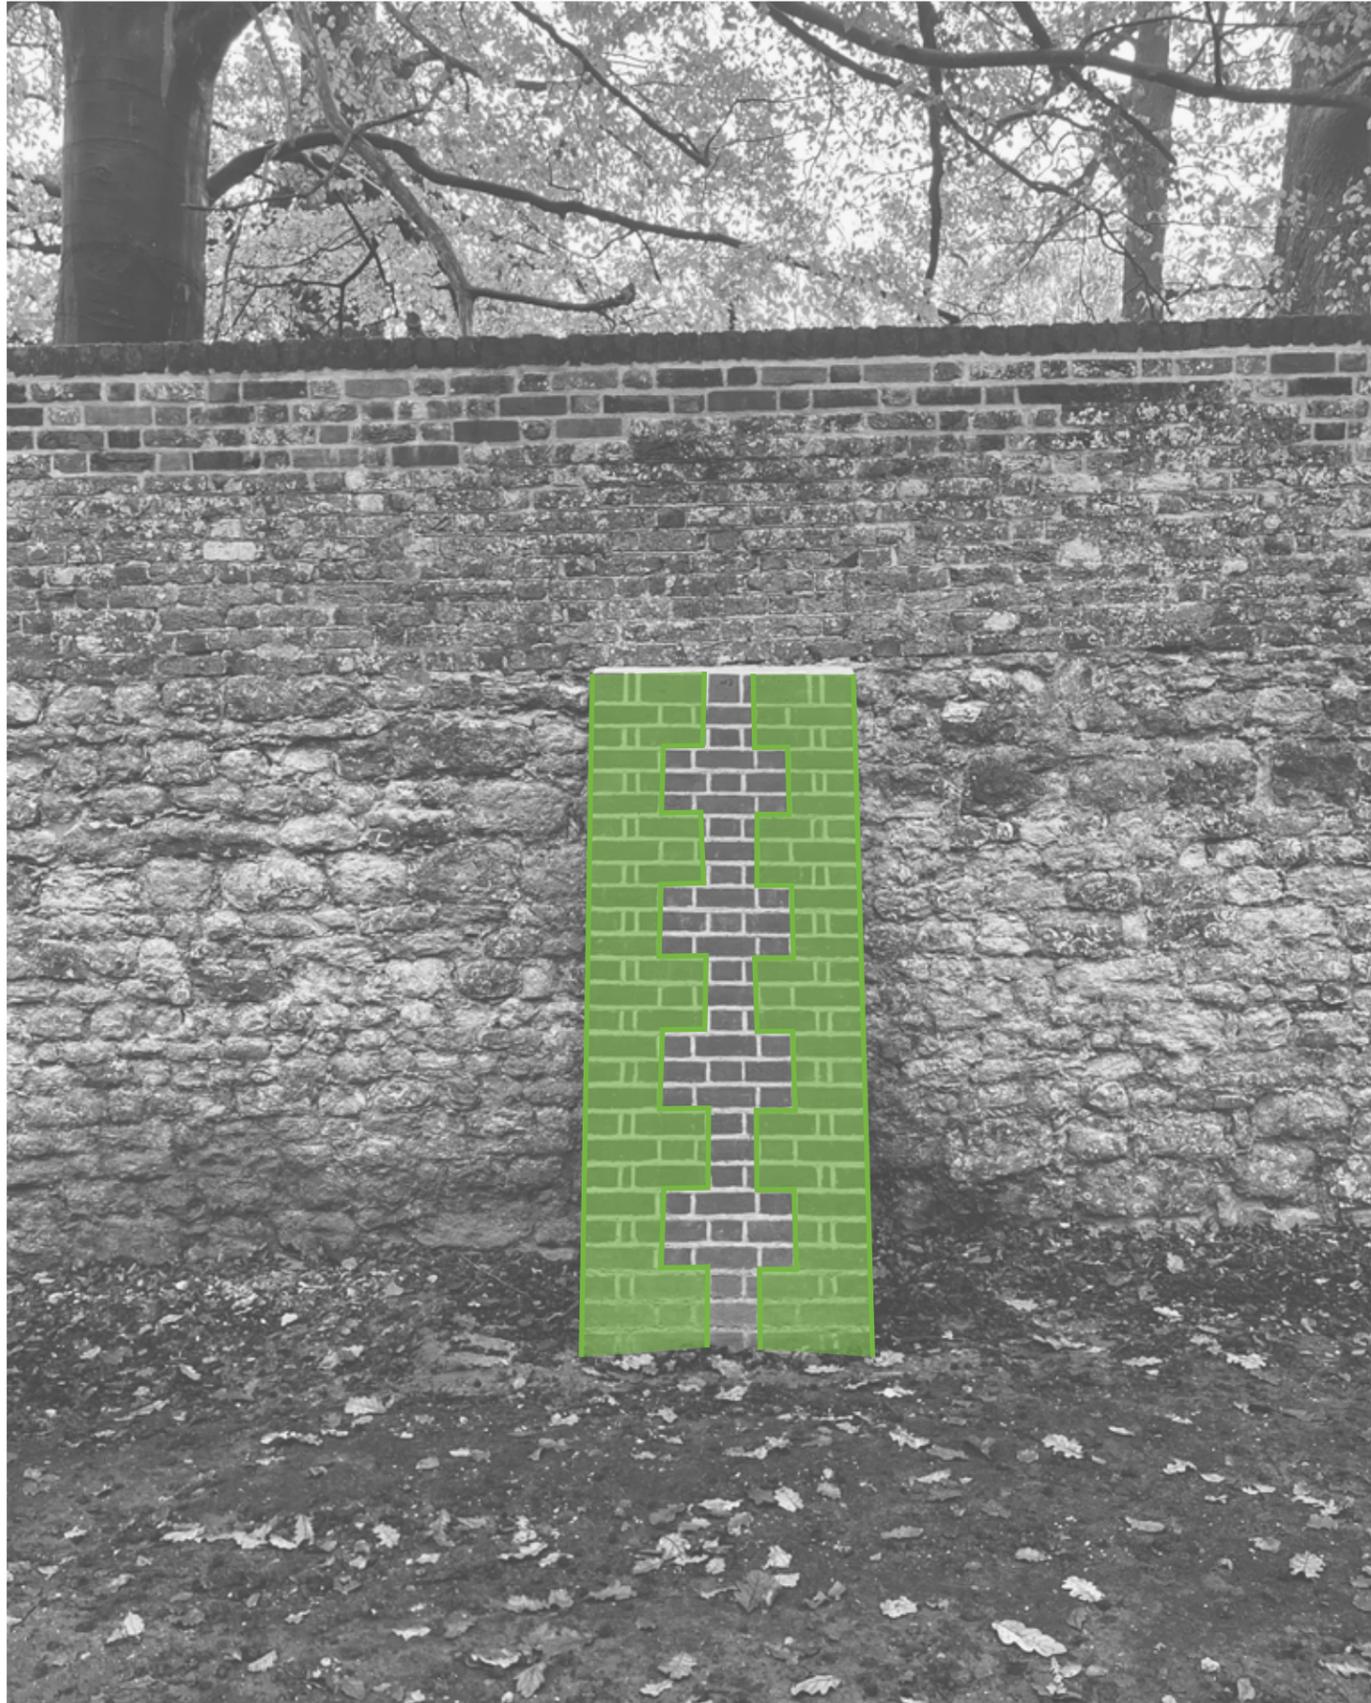
Figure 3.0.10 (left): A view of the buttresses showing the extent of the brickwork quoins, had the original proposals been followed. The resulting spaces are too small for Kentish Ragstone to look appropriate.

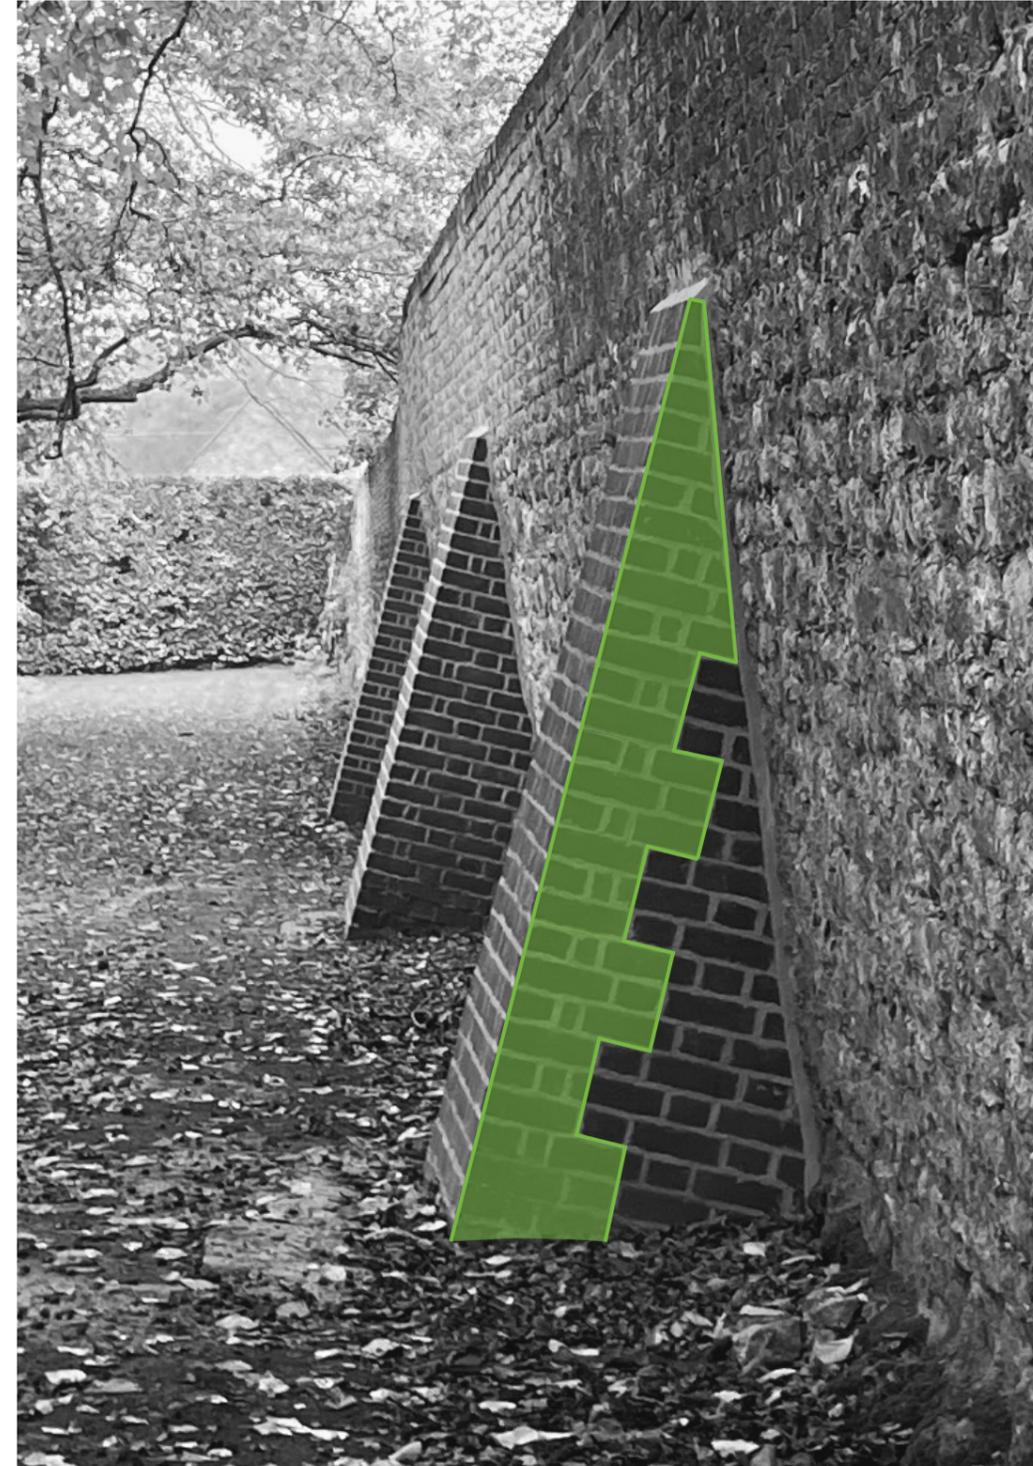
Figure 3.0.11 (above): A detailed view of the side elevation (this image is probably the best at illustrating the lean of the existing garden wall).

On this occasion we established that the wall consists of stone and "rubble", overall thickness 750mm and a height of 3300 from the lower side which the inside of the grounds. Outside ground level measured to top of the wall 2140mm, therefore wall retaining 1160mm height of earth. The wall was checked for out of plumbness and was noted to be about 450mm as shown on attached sketch.

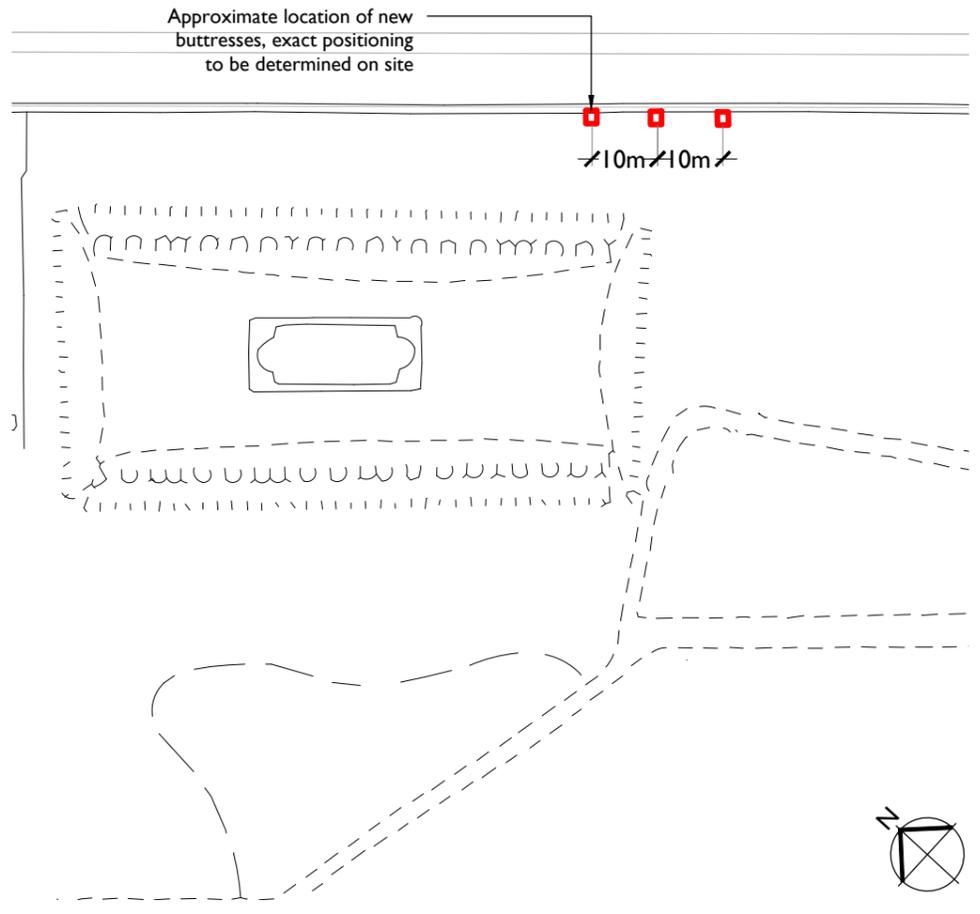
2 Site Plan
0001 1:1000 @ A3

Approximate location of new buttresses, exact positioning to be determined on site

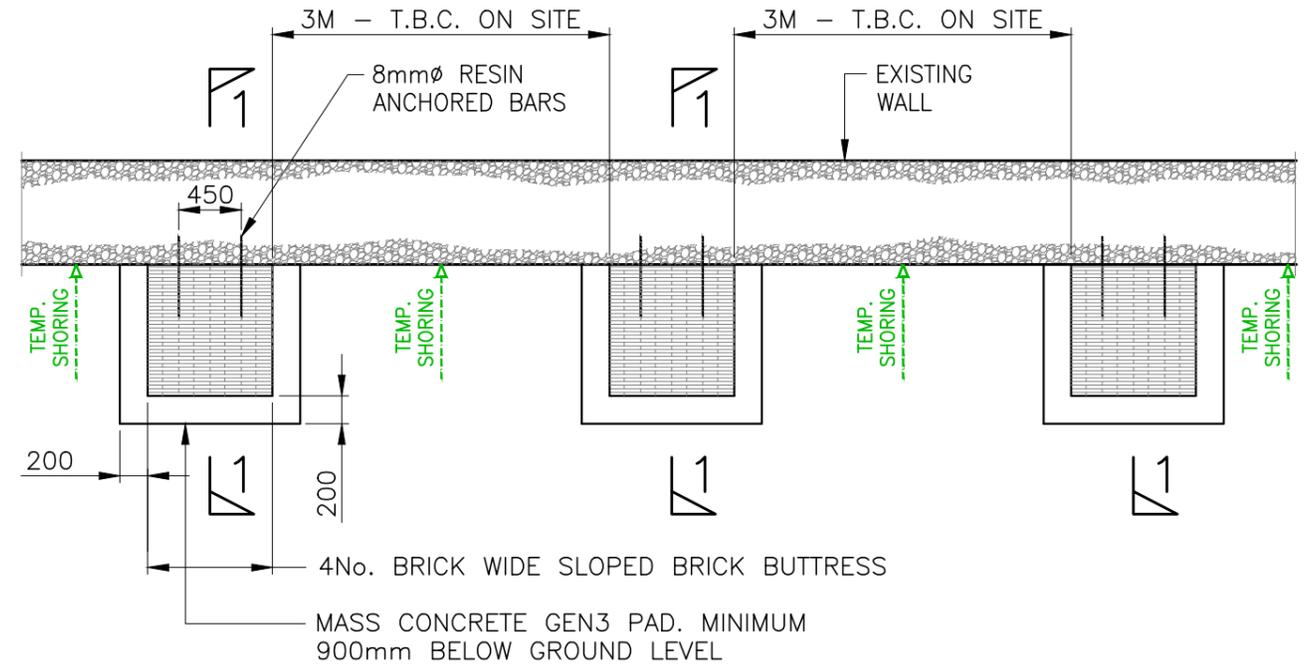
GROUND LEVEL PART PLAN

MASS CONCRETE GEN3 PAD TO EACH BUTRESS. DEPTH OF PAD TO BE AT FOUNDING LEVEL OF EXISTING FOUNDATION (MINIMUM 900mm BELOW GROUND LEVEL) OF FIRM BEARING STRATA. ALLOW FOR LOCALISED COMPACTION

TEMPORARY SHORING TO BE INSTALLED PRIOR TO ANY EXCAVATION WORKS COMMENCING
