**49 Wellsworth Lane,
Rowlands Castle,
PO9 6BX**

Phase 1 Daytime Bat Assessment

19th March 2024

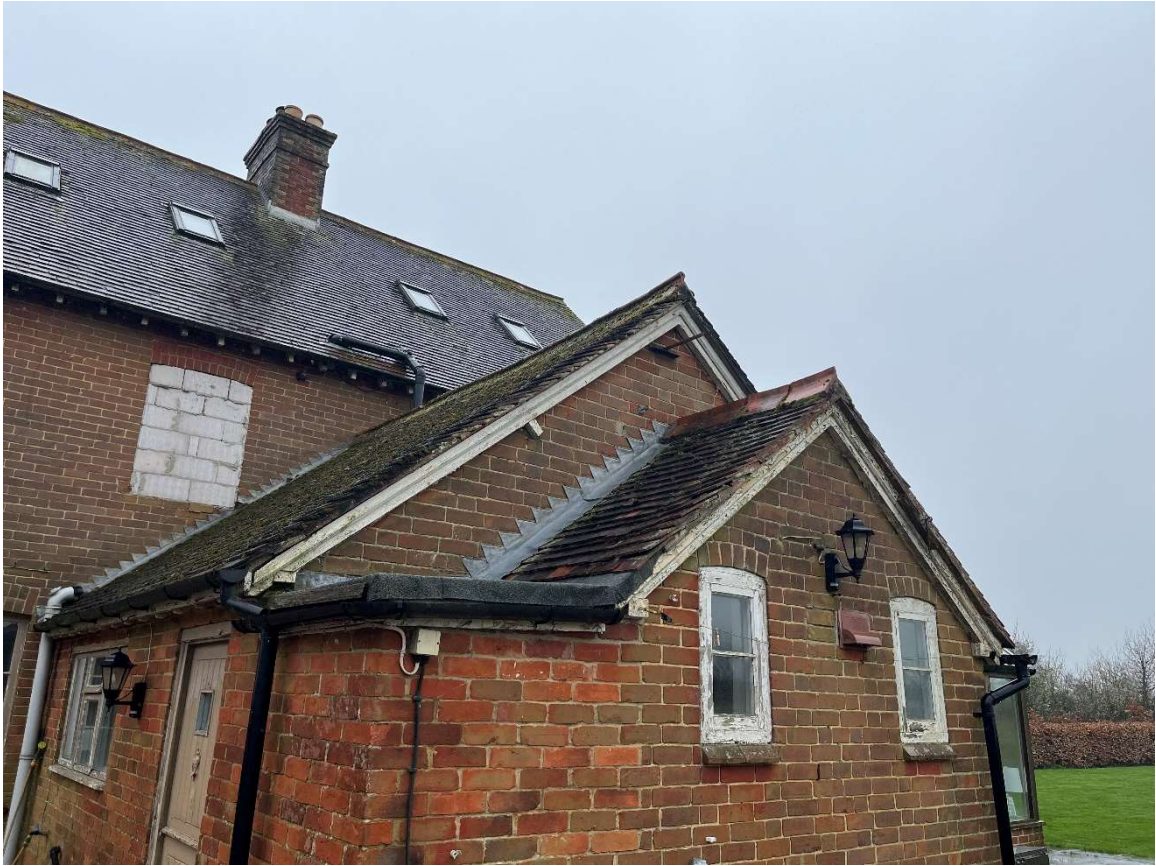
The house dates to the mid-20th Century and is brick built with a pitched roof of clay tiles and single storey extensions off the rear also with pitched roofs faced with similar tiles (See figures 2-3 and 7). There are no gaps numerous openings into the under-tile spaces on the roof and into the wooden fascias are close fitting with no gaps behind (see figures 2-4).

Figure 2. Northern elevations looking southwest.

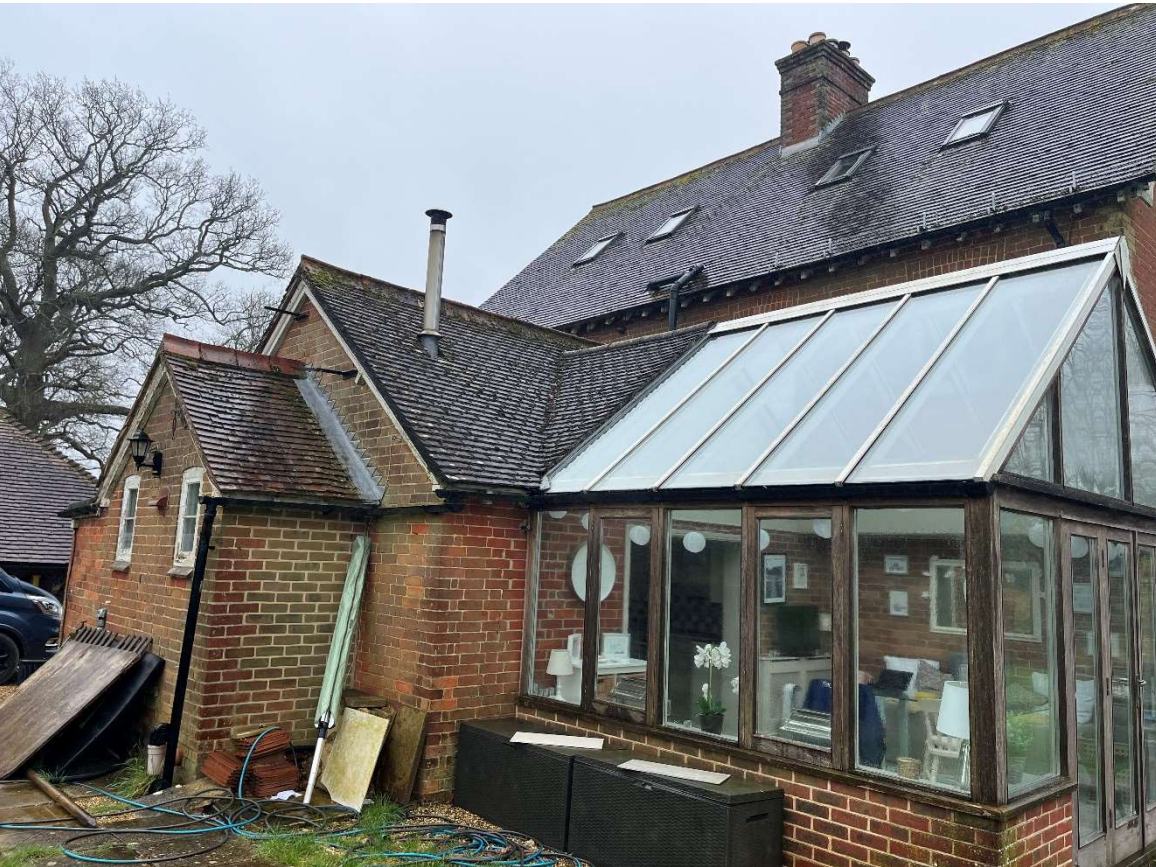
The loft above the northern extension was accessed via a hatch in the utility room. The roof is lined with bituminous felting which is in excellent order with no external light visible within. The floor is covered in glass fibre insulation and partly used for storage (see figure 5). There was no sign of any bat activity on the floor of the loft. There is a small glass roofed conservatory off the west end of the northern extension (see figure 3). This has no enclosed voids and negligible potential for bats.

Figure 3. Northern and western elevations looking southeast.

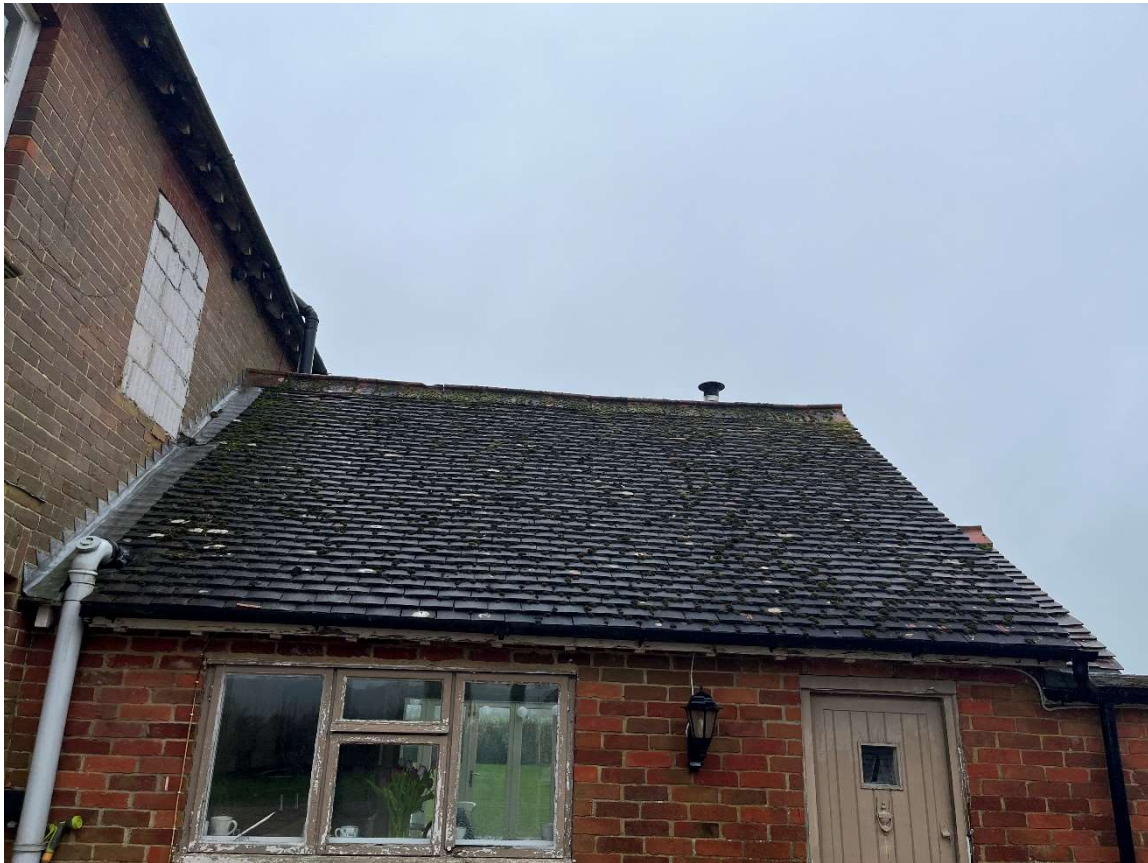
Figure 4. Eastern face of northern elevation looking west.

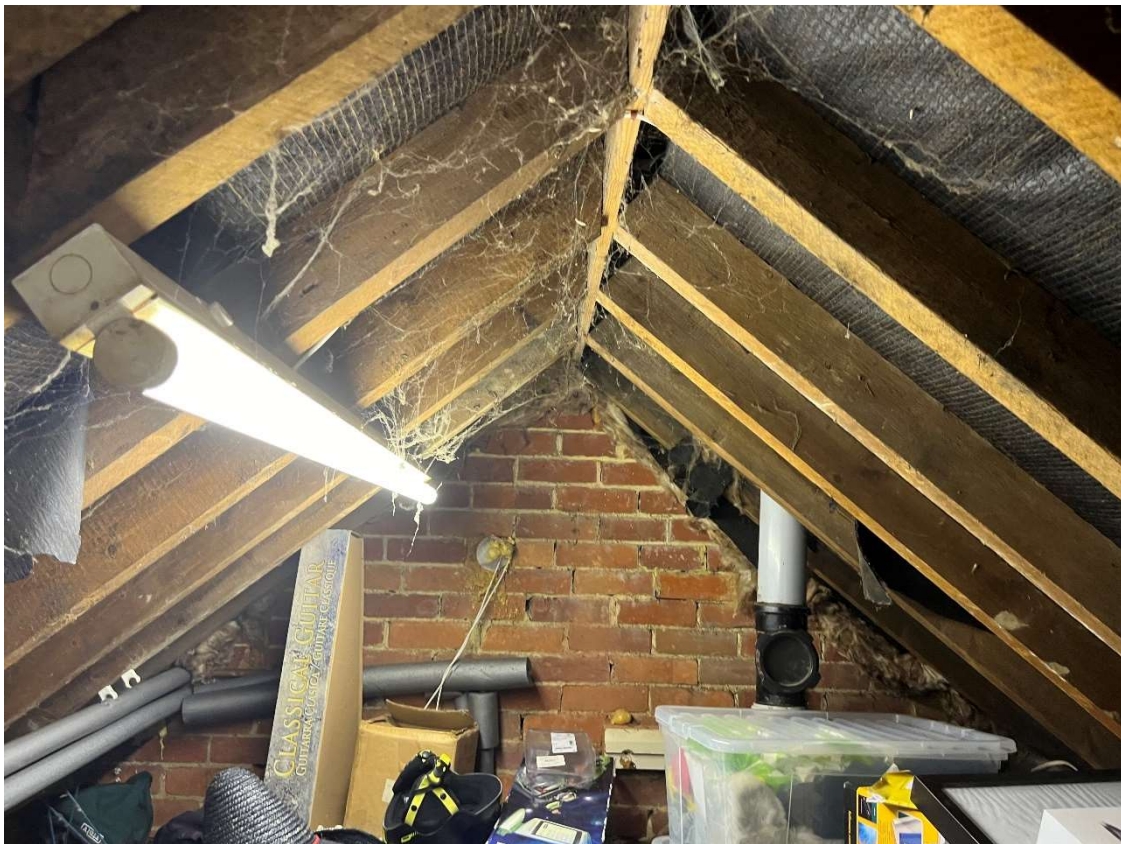
Figure 5. Extension loft looking north.

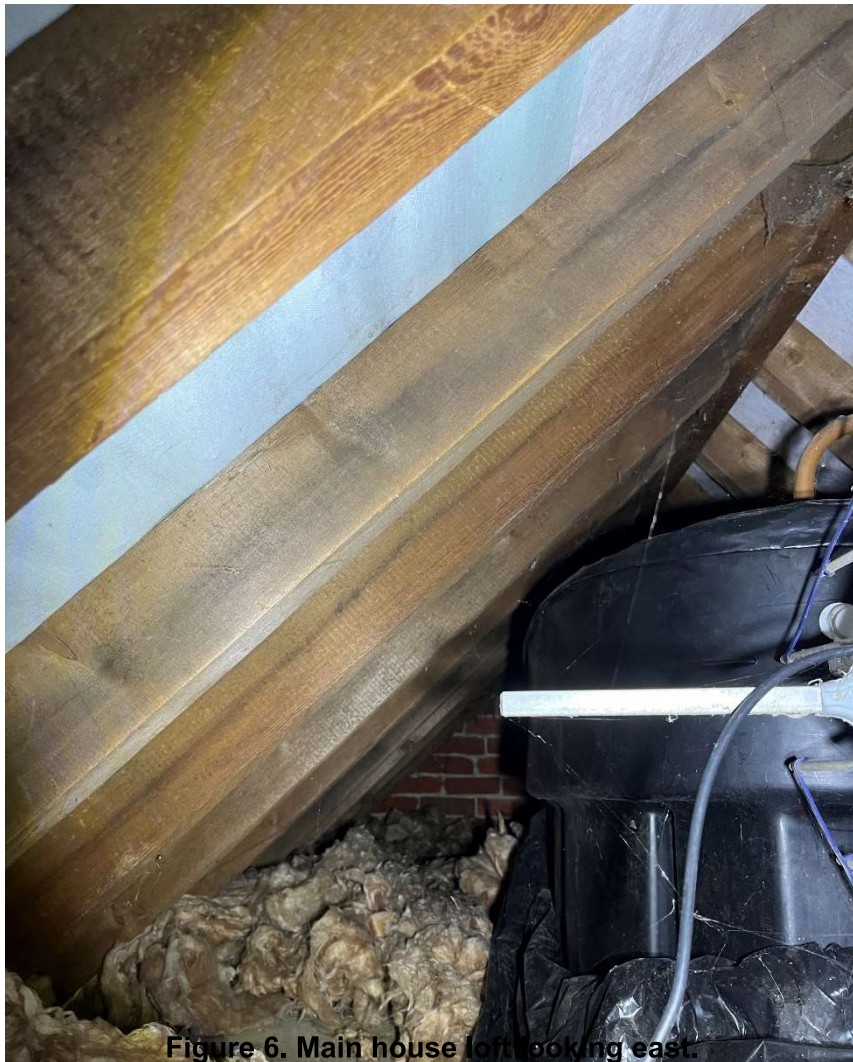
The proposed revised rear extension would tie into the northern face of the main roof. The loft is largely integral to form a third storey illuminated via skylights. The small loft above this space was accessed via a hatch in an upstairs bedroom. The roof (which was renewed in 2007) is lined with breathable membrane (see figure 6).

Figure 6. Main house (left) looking east.

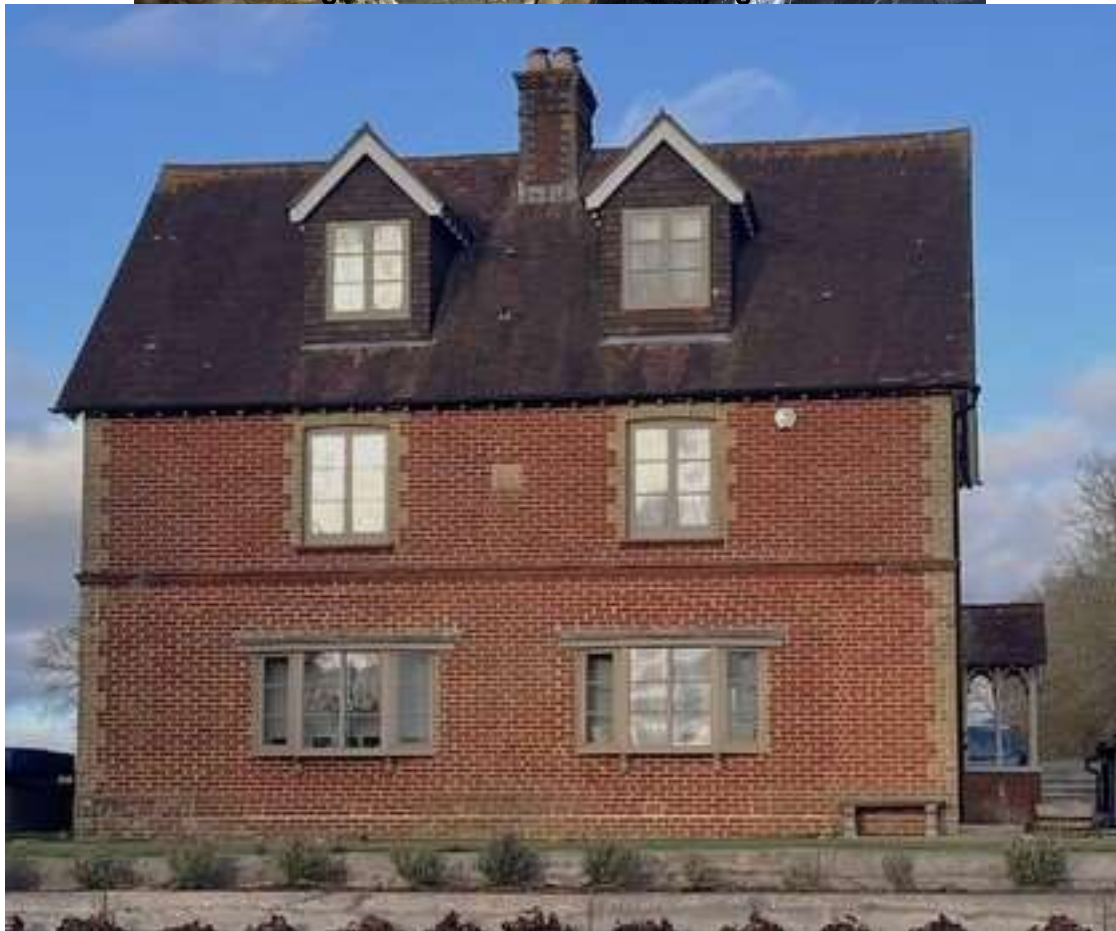
Figure 7. Southern elevations of house looking north.
