RE: Marrick, Bunts Lane, Seaton – Householder Ecological Assessment

I inspected the garage and carport on the 8th May 2024, which is located at grid reference SY 23668 90317 (What3Words: lighters.parading.areas). The survey was undertaken primarily for bats which was consistent with current good practice guidelines (Collins, 2023¹), whereby the buildings were assessed for their potential to hold roosting bats using the criteria in **Table 1**, using ladders, binoculars, torch and endoscope where appropriate. Other protected species such as nesting birds were also taken into account.

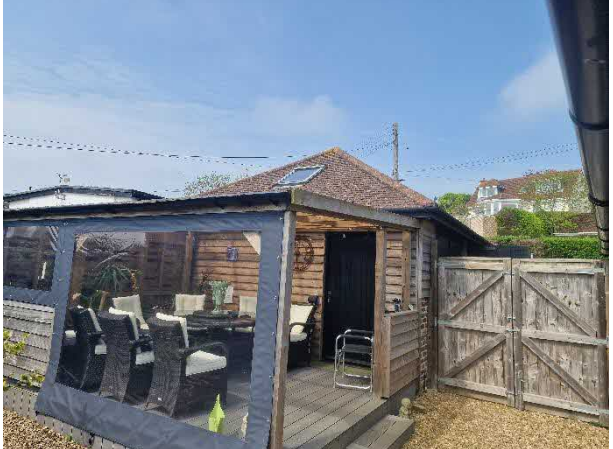
Notes	Photograph
Garage southeast elevation.

A photograph showing the exterior of a wooden garage. The garage has a gabled roof and a covered patio area with a table and chairs. A wooden gate is visible on the right side. The sky is blue with some clouds.
Garage internal.

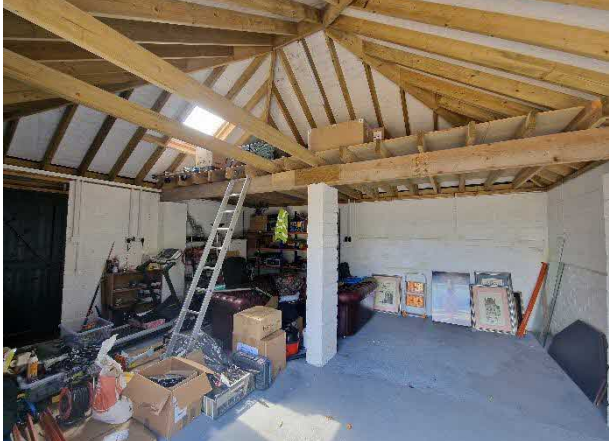
There are no suitable features for roosting bats in the car port. The garage hip and roof tiles were all tight with no suitable gaps for bats to access. There were no gaps under the eaves on any elevation and the timber cladding had no gaps behind where bats could access. Internally there was no evidence of bats anywhere inside the garage.

A photograph showing the interior of a garage. The ceiling is made of exposed wooden beams. There are various items, including boxes, a ladder, and tools, scattered on the floor. The walls are white.

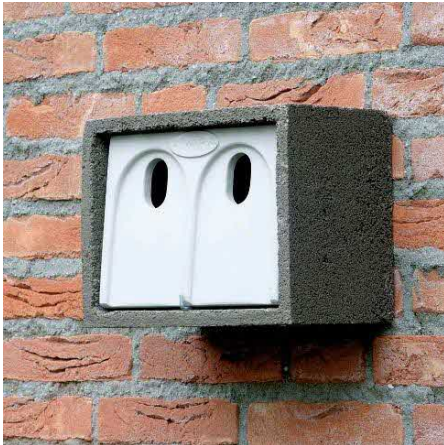
Vivaro Woodstone sparrow nest box. Available from Wildcare [Woodstone Sparrow Nest Box \(wildcare.co.uk\)](http://wildcare.co.uk), NHBS or other suppliers.

As a measure of good practice and in line with national and local planning policy, biodiversity enhancements should still be incorporated into the design to achieve a biodiversity net gain. In this case two house sparrow terraces can be mounted on the northeast elevation as proposed (see **Appendix 3**).
