Drawing Rafter Repair General Assembly

Project The Cottage, 3 Low Green.

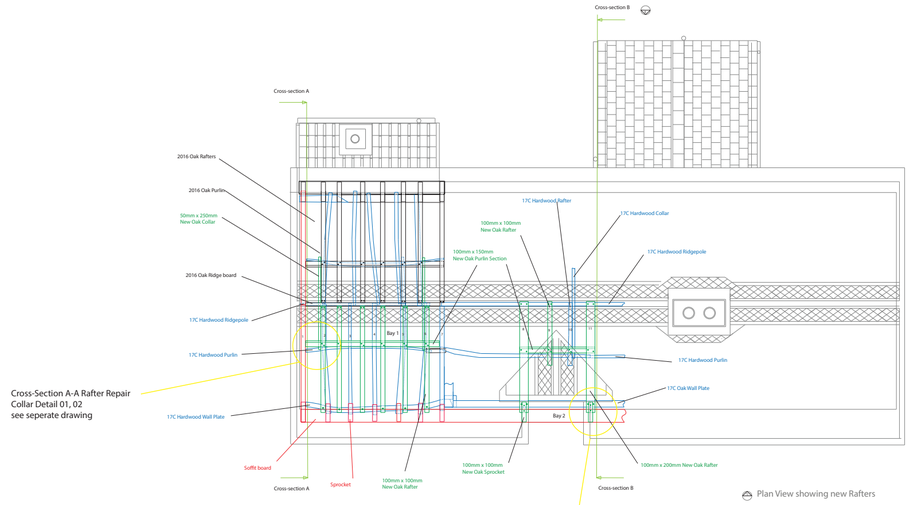
Cross-Section A-A Rafter Repair
Collar Detail 01, 02
see seperate drawing

Cross-Section B-B Rafter Repair
Sprocket Detail 01, 02, 03
see seperate drawing
