Document: Remediation Verification Report

Project: Needham Markey Quarry

Reference No.: GN17820_RV32

NEEDHAM MARKET QUARRY (Plots 61-64)

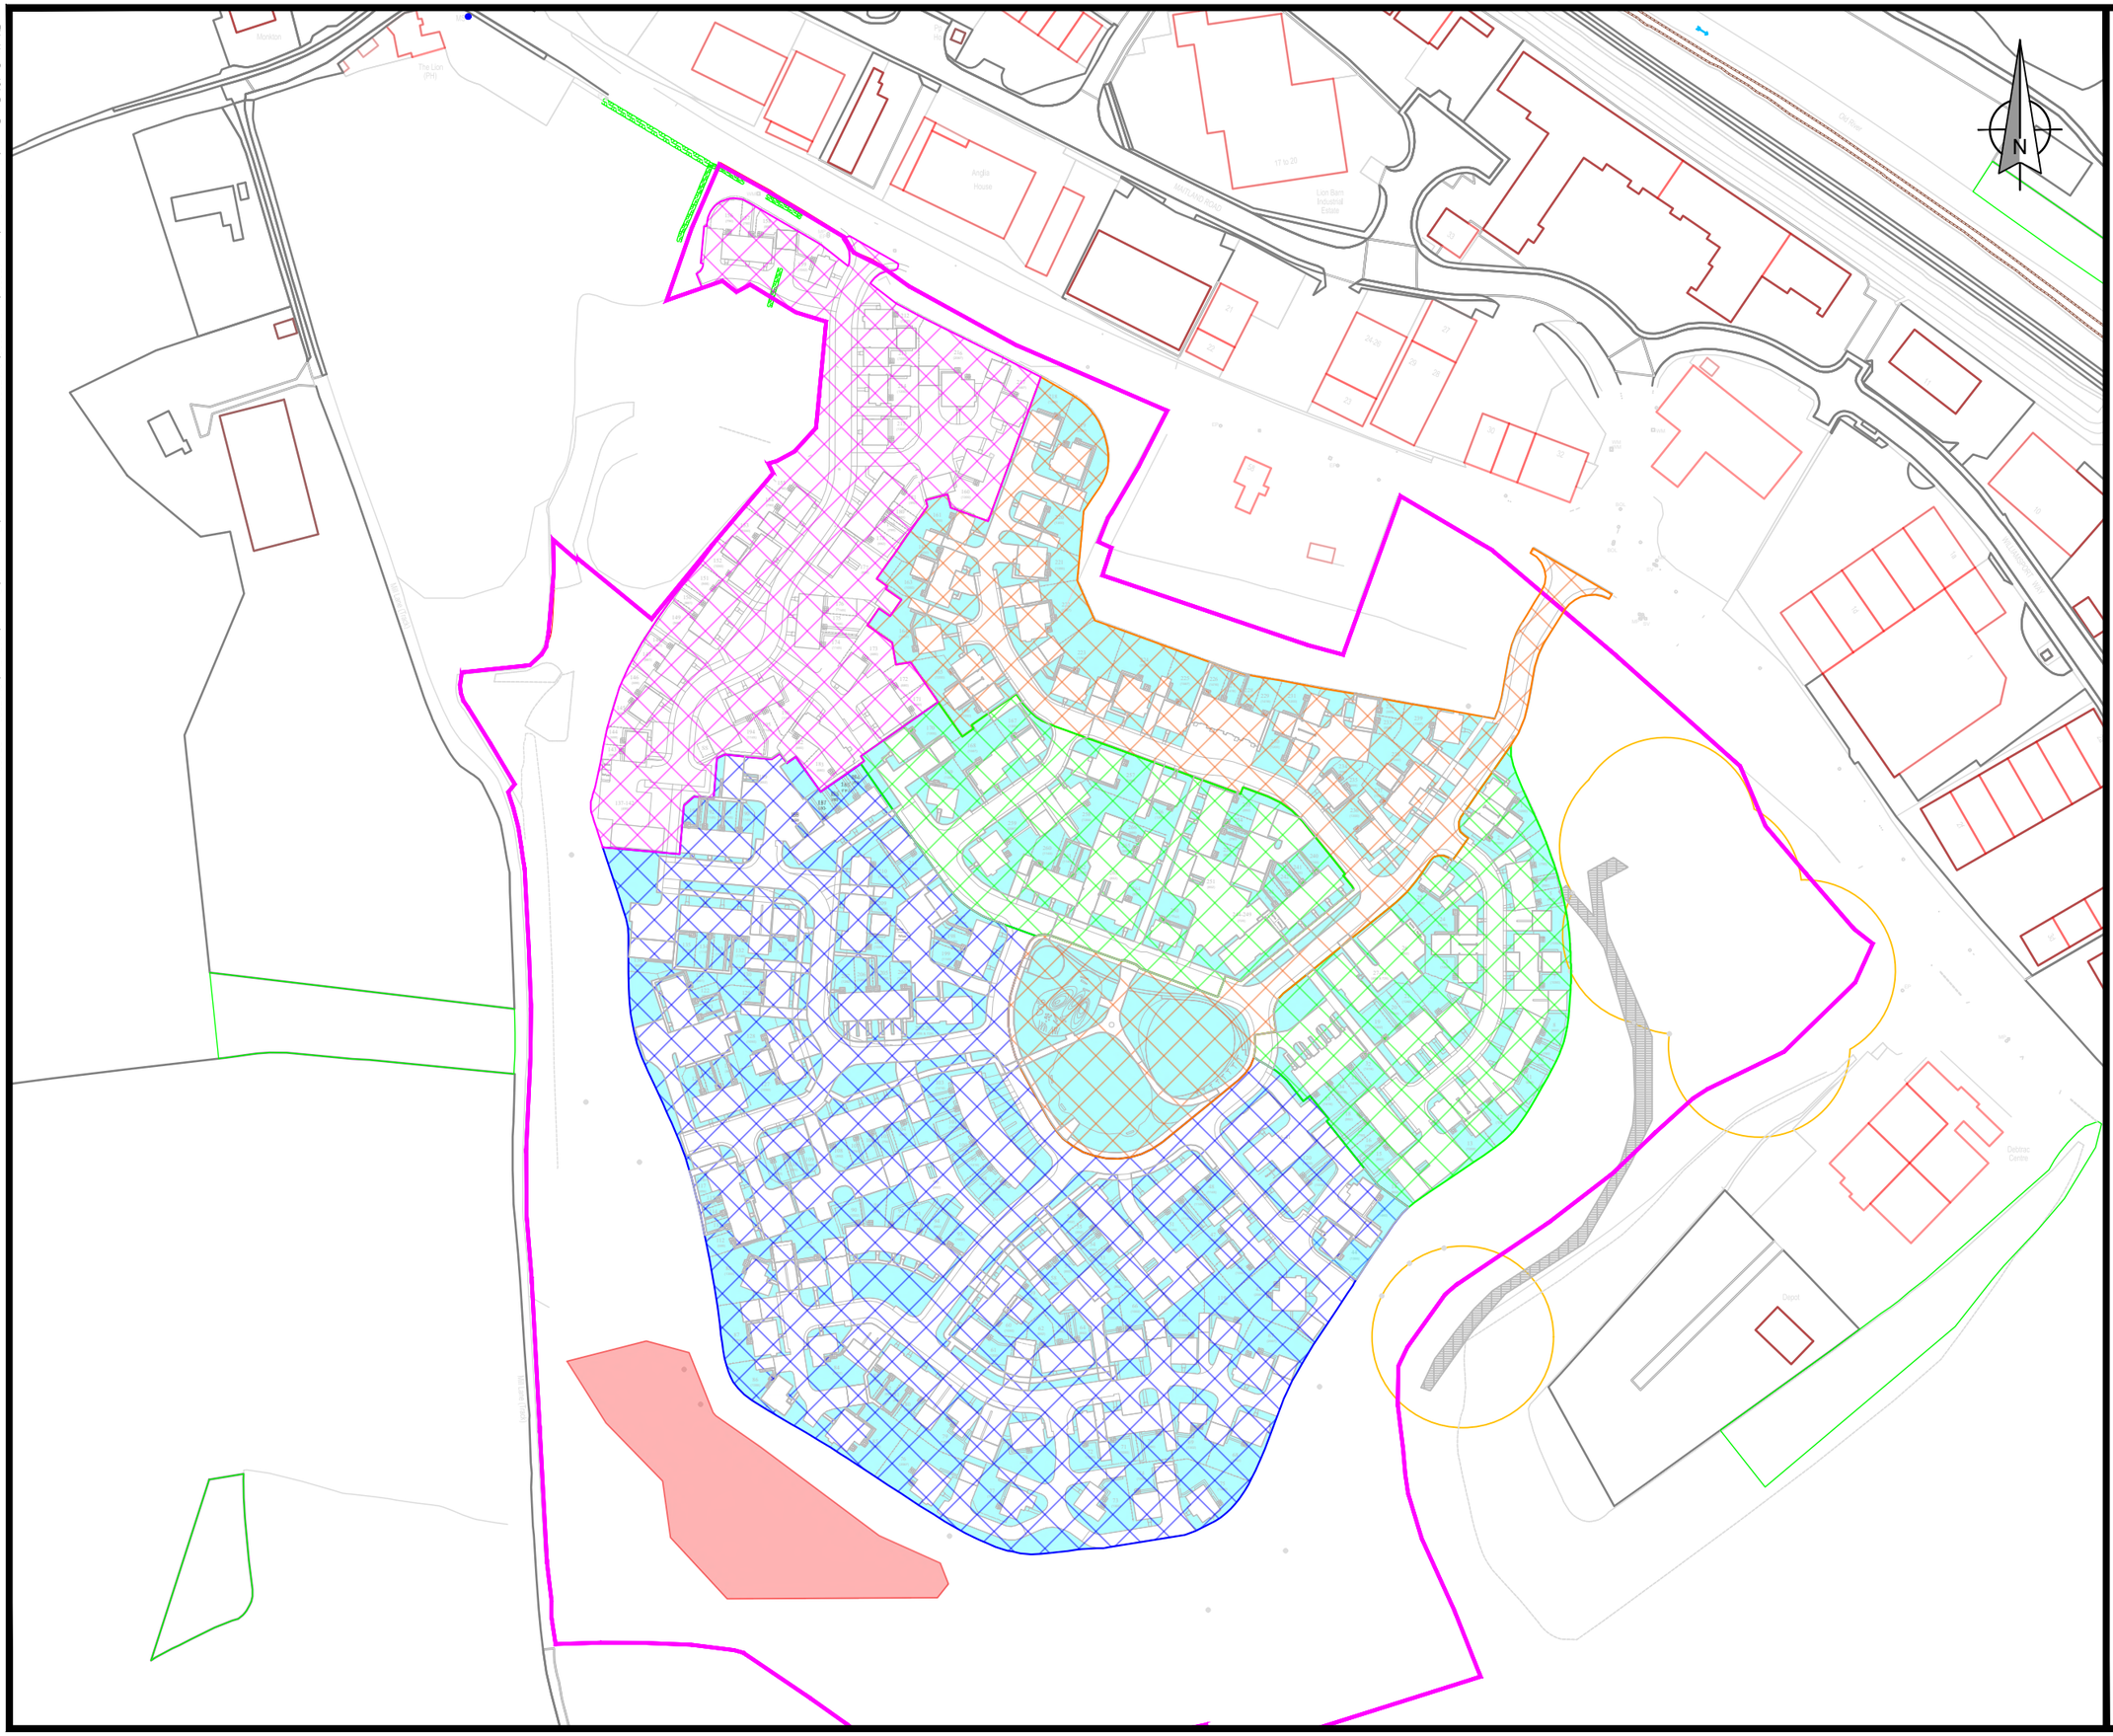
Drawing No : GN17820 - DR402

The plots which require validation of the suitability of the soils in gardens and soft landscaping can be identified in drawing GN17820_DR402 (appended to this VR), which highlights the development phasing plan (phases 1A, 1B, 2 and 3). Specifically, plots which require confirmation of the suitability of the near-surface soils, and the need for a soil cover, includes plot numbers 1-136, 161-170, 184-193, 197-211, 218-266 and soft landscaping areas in these development phases.

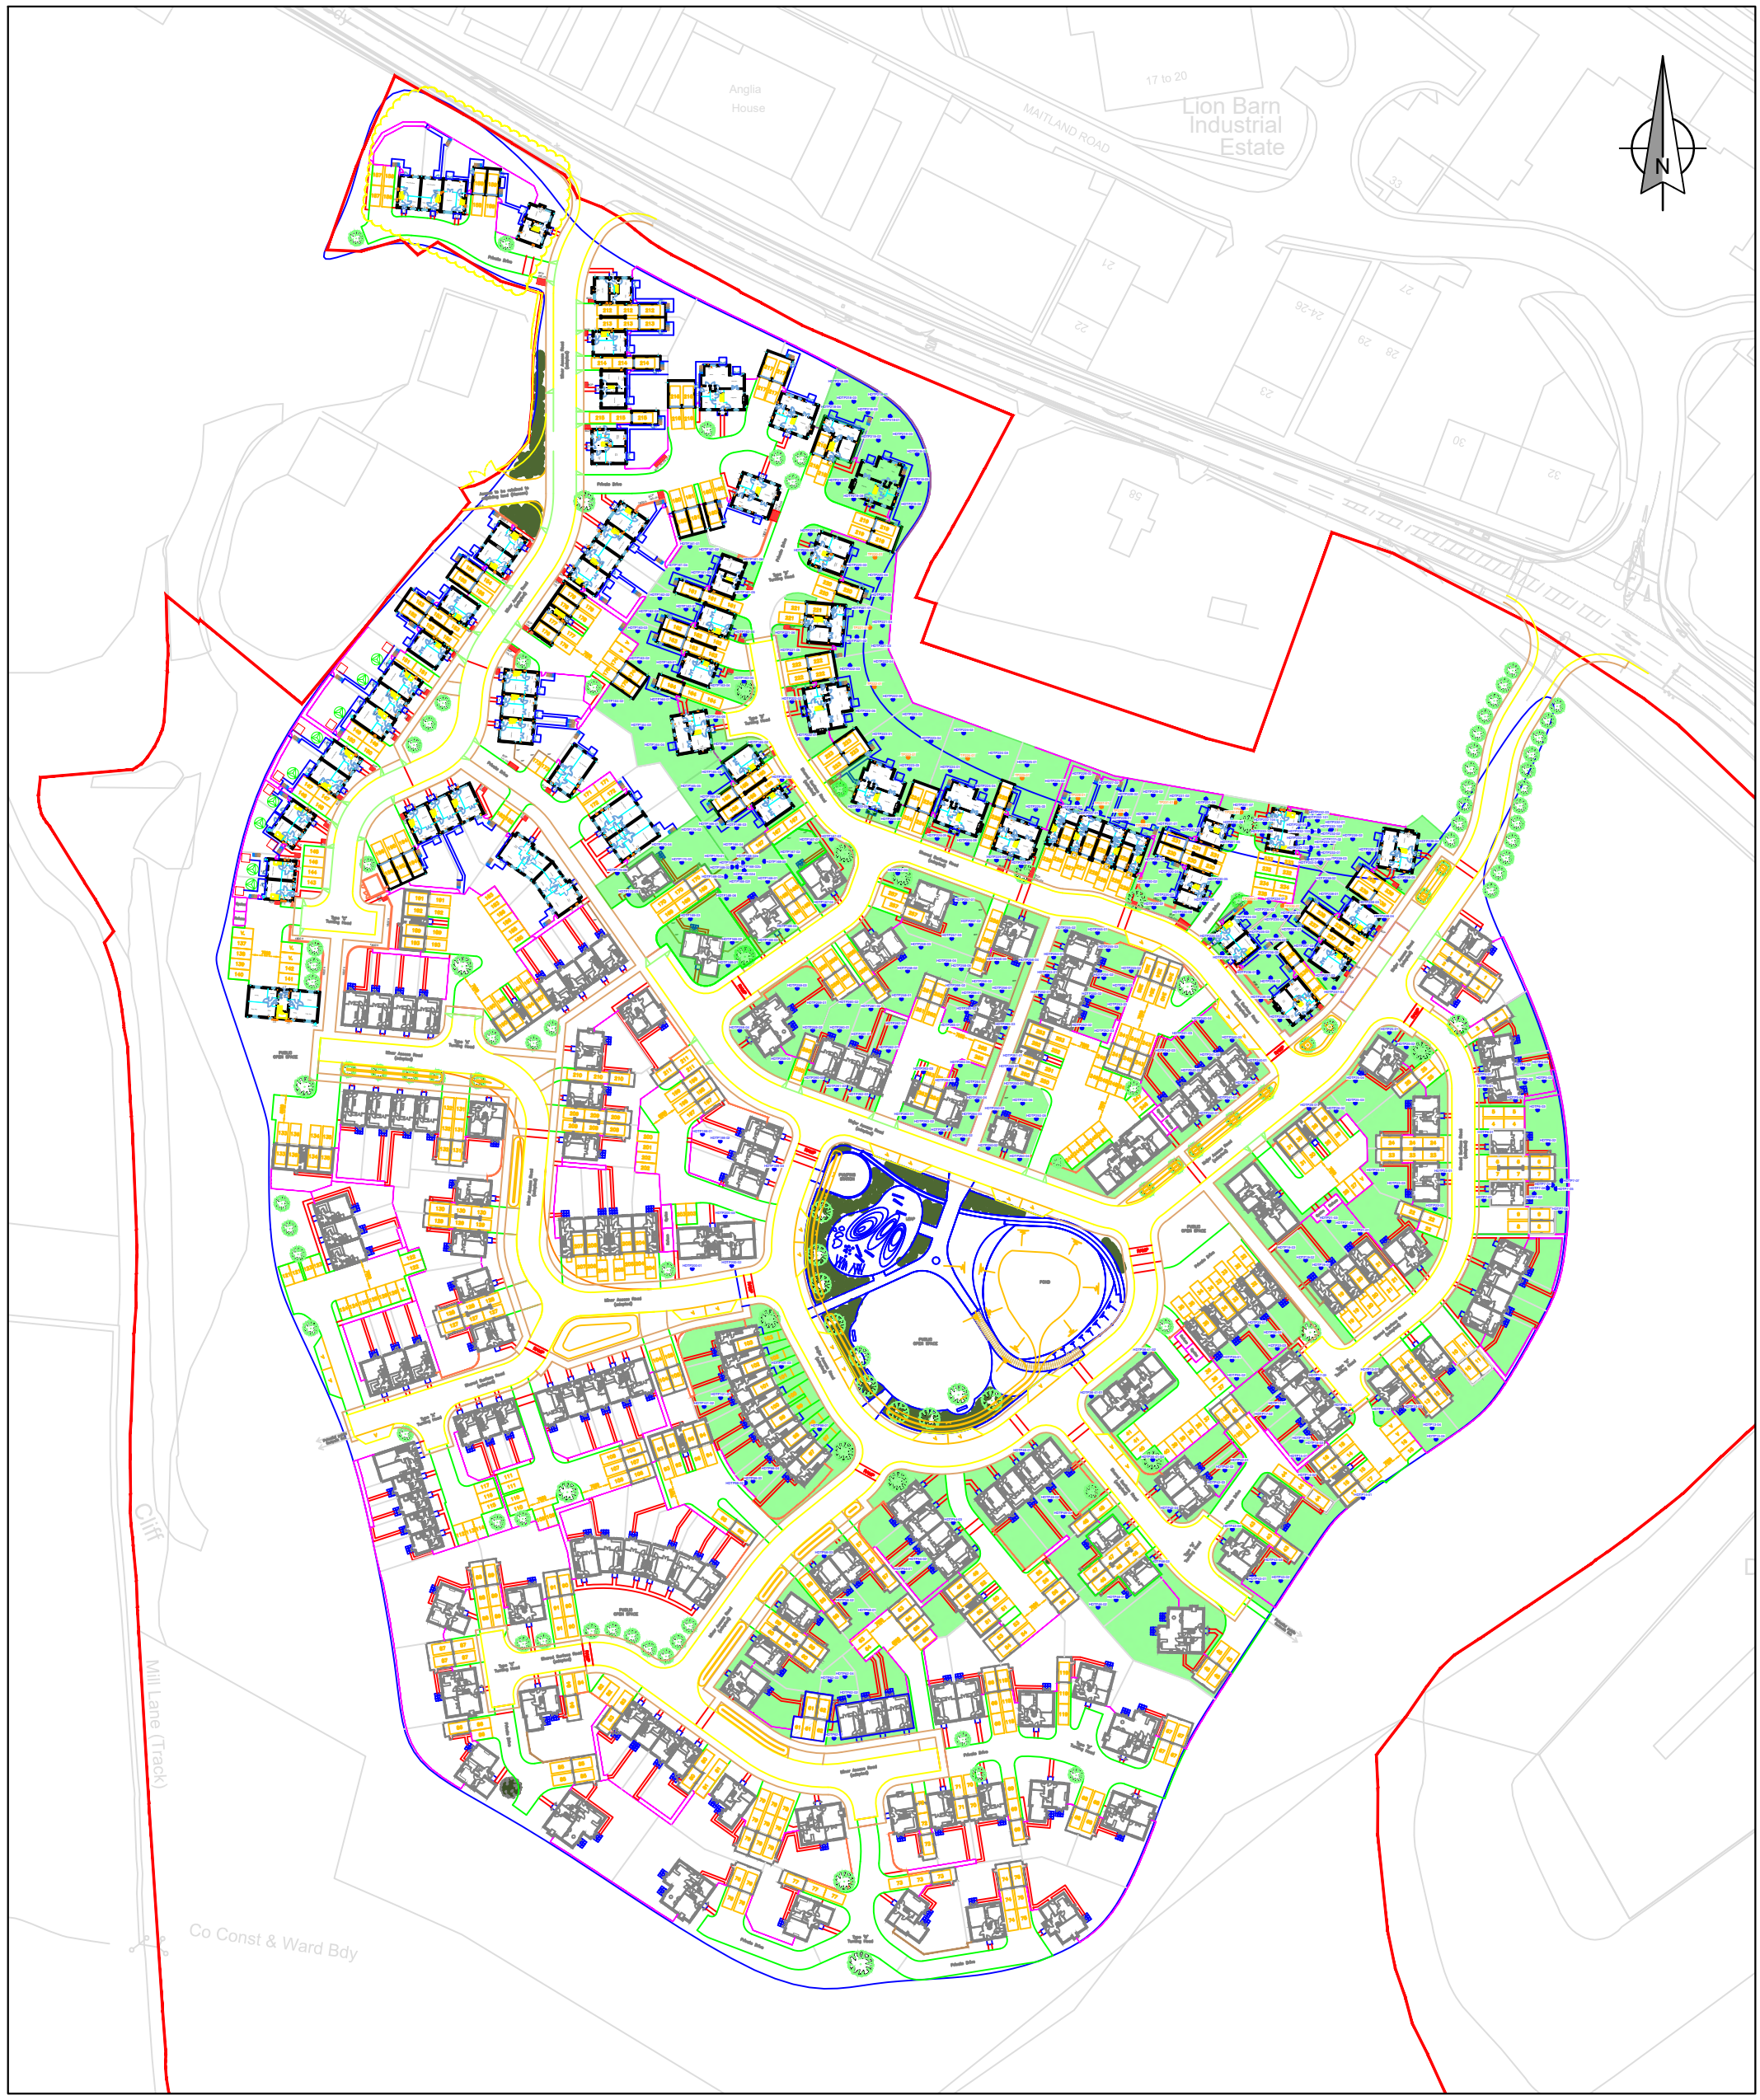
Client :	Hopkins Homes Ltd
Project :	Needham Market Quarry
Job No : GN17820	Date : July 2021
Drawing Title :	Fieldwork Location Plan
Drawing No :	GN17820 - DR502
Scale :	1:1500 @ A3
Drawn by : RW	Checked by : MR
Eastings : 609480	Northings : 254090

Plots 3-60, 97-103, 161-170, 218-266 have previously been validated and are shown as green on appended drawing GN17820-DR502 which shows a summary of the validation completed to date. The requirement for remediation in other plots is currently being assessed and the remediation undertaken as appropriate. Further remediation verification reports are in production for additional affected plots/areas on the whole development, as each area is built and remediated. These include plots 1, 2, 65-96, 104-136, 184-193 and 197-211.

Rev	Date	Revision Data
R31	07/07/2022	Fieldwork locations for Plots 57-60 added
R32	12/08/2022	Fieldwork locations for Plots 62, 198 & 200 added
