**Proposed works to
the barn at
Kemyel Crease
Paul
Condition report**

25 November 2020

Peggy Rickaby
BA Dip Arch RIBA Chartered Architect

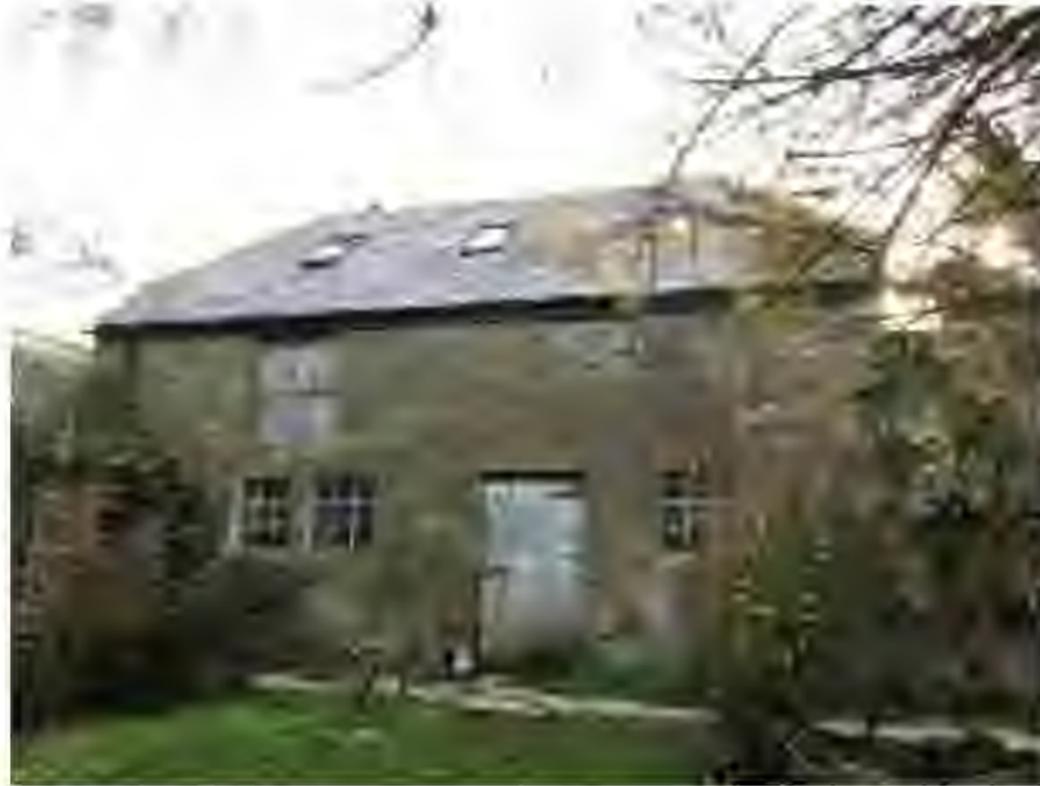
North elevation

The external walls are solid granite with a rab / rubble core and are about 600mm thick. They are in good condition for their age and exposure but all need repointing. The gutter to the adjoining building against the north elevation has lost its stop end and rain water is washing down the wall causing further damage to the pointing and threatening the core of the wall.

The gutter to the adjoining building needs to be repaired to stop water damage to the wall to the left of the shower room window in the north elevation.
