MANCHESTER OPERA HOUSE.

DESIGN, ACCESS AND HERITAGE STATEMENT

**FOR THE INSTALLATION OF PAVEMENT LIGHTS AND REPLACE-
MENT OF EXISTING STEEL BEAMS**

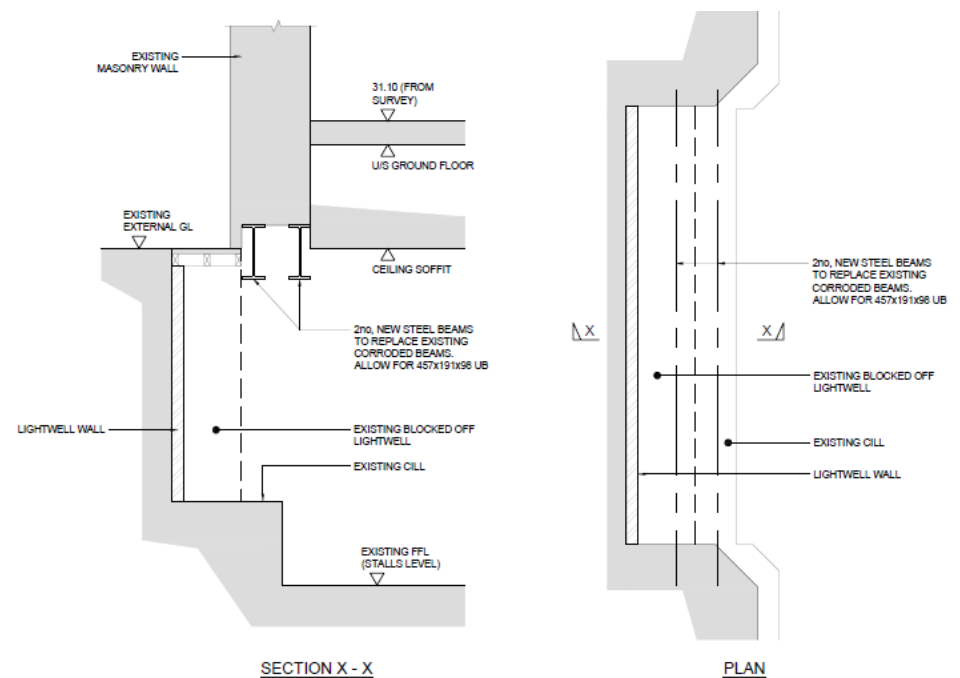
Steel replacement proposals

As can be seen from the photo the steels are heavily corroded and in need of replacement. This opening up has been achieved by the removal of the existing window and the temporary propping of the beams.

'In our opinion the corroded outer beam is no longer adequate and should be replaced. The inner beam and the concrete infill is likely forming a steel and concrete composite section, and removal of

the outer beam will compromise this system. As such, we recommend allowance is made to replace the inner beam and infill structure also.'

It is therefore proposed that the two existing beams will be removed and 2 No. new steel beams to be installed in their place with infill between as recommended by the structural engineer.

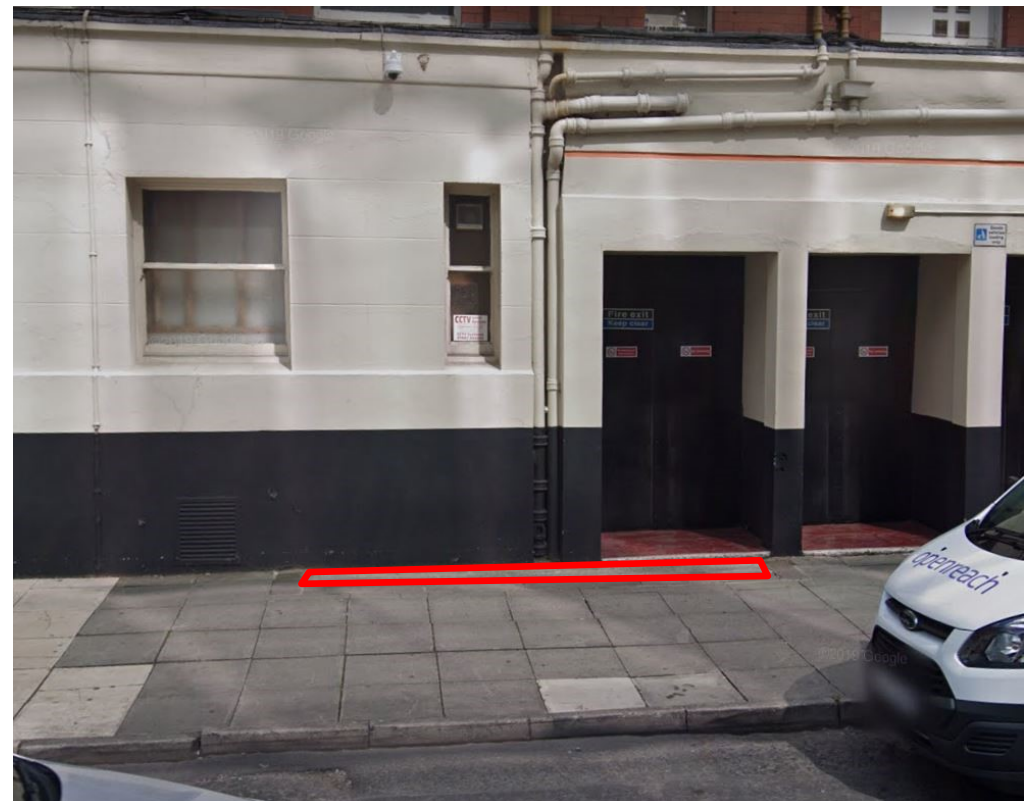
The corrosion of the steels in this areas was caused by moisture in this confined space. The provision of ventilation tiles would help to alleviate this problem. The photograph below opposite shows an example of a concrete pavement lights systems, with both the square glass lenses and the inclusion of ventilation tiles.

It is proposed that this concrete fill be replaced with new reinforced concrete pavement lights with both glass lenses and ventilation tiles. The photograph opposite shows the

The installation of pavement lights will provide two main benefits, firstly these will provide natural daylight into the lower ground bar area. Secondly this will provide the opportunity for the installation of ventilation tiles as part of the new system.

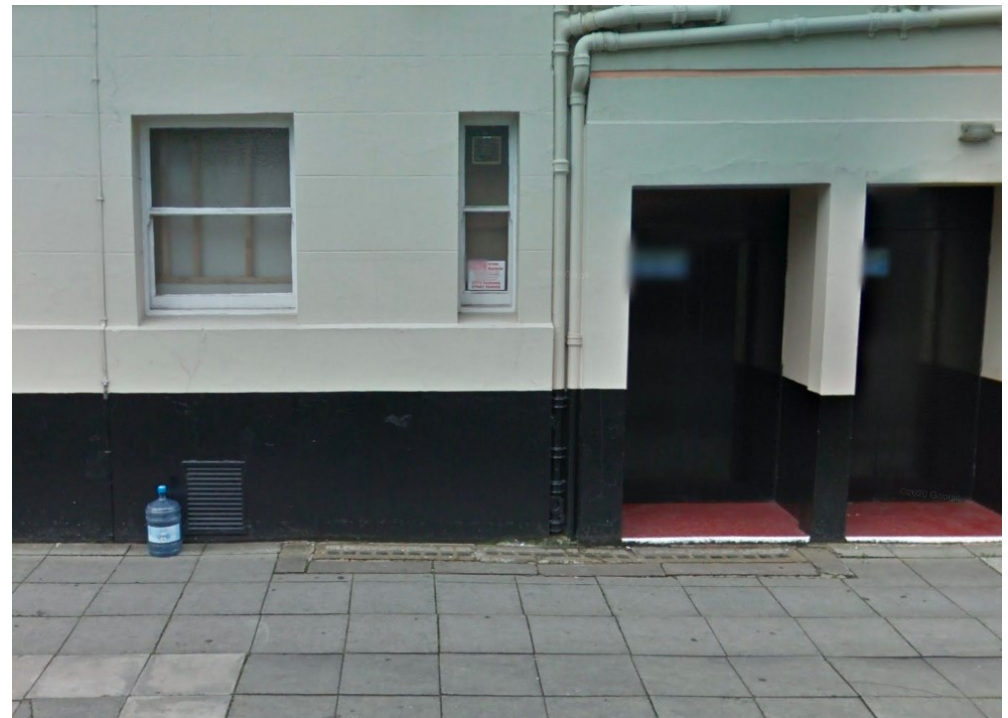
The existing concrete fill on the pavement to Byrom Street is a relatively new addition installed sometime in 2016/2017 and had been installed to block up the opening for previously removed pavement lights installed in its place. The opposite image show the previously existing pavement lights which were in place. It is noted that these pavement lights were concrete lights and were presumably already replacements of original cast iron pavement lights.

The proposed pavement lights will be a reinforced concrete system. This would match the previously existing concrete system as evident in the photograph below. In addition the pavement light system provides a ventilated tile option which would allow the ventilation reduction of moisture within the light well area. This will would help to alleviate problems with corrosion occurring in the future.
