HBL ASSOCIATES
**PHASE 1 COMPLETION REPORT &
RECOMMENDATIONS**

**STALLS BAR LIGHTWELL STEELWORK
MANCHESTER OPERA HOUSE**

AMBASSADOR THEATRE GROUP

HBL Ref: 8283

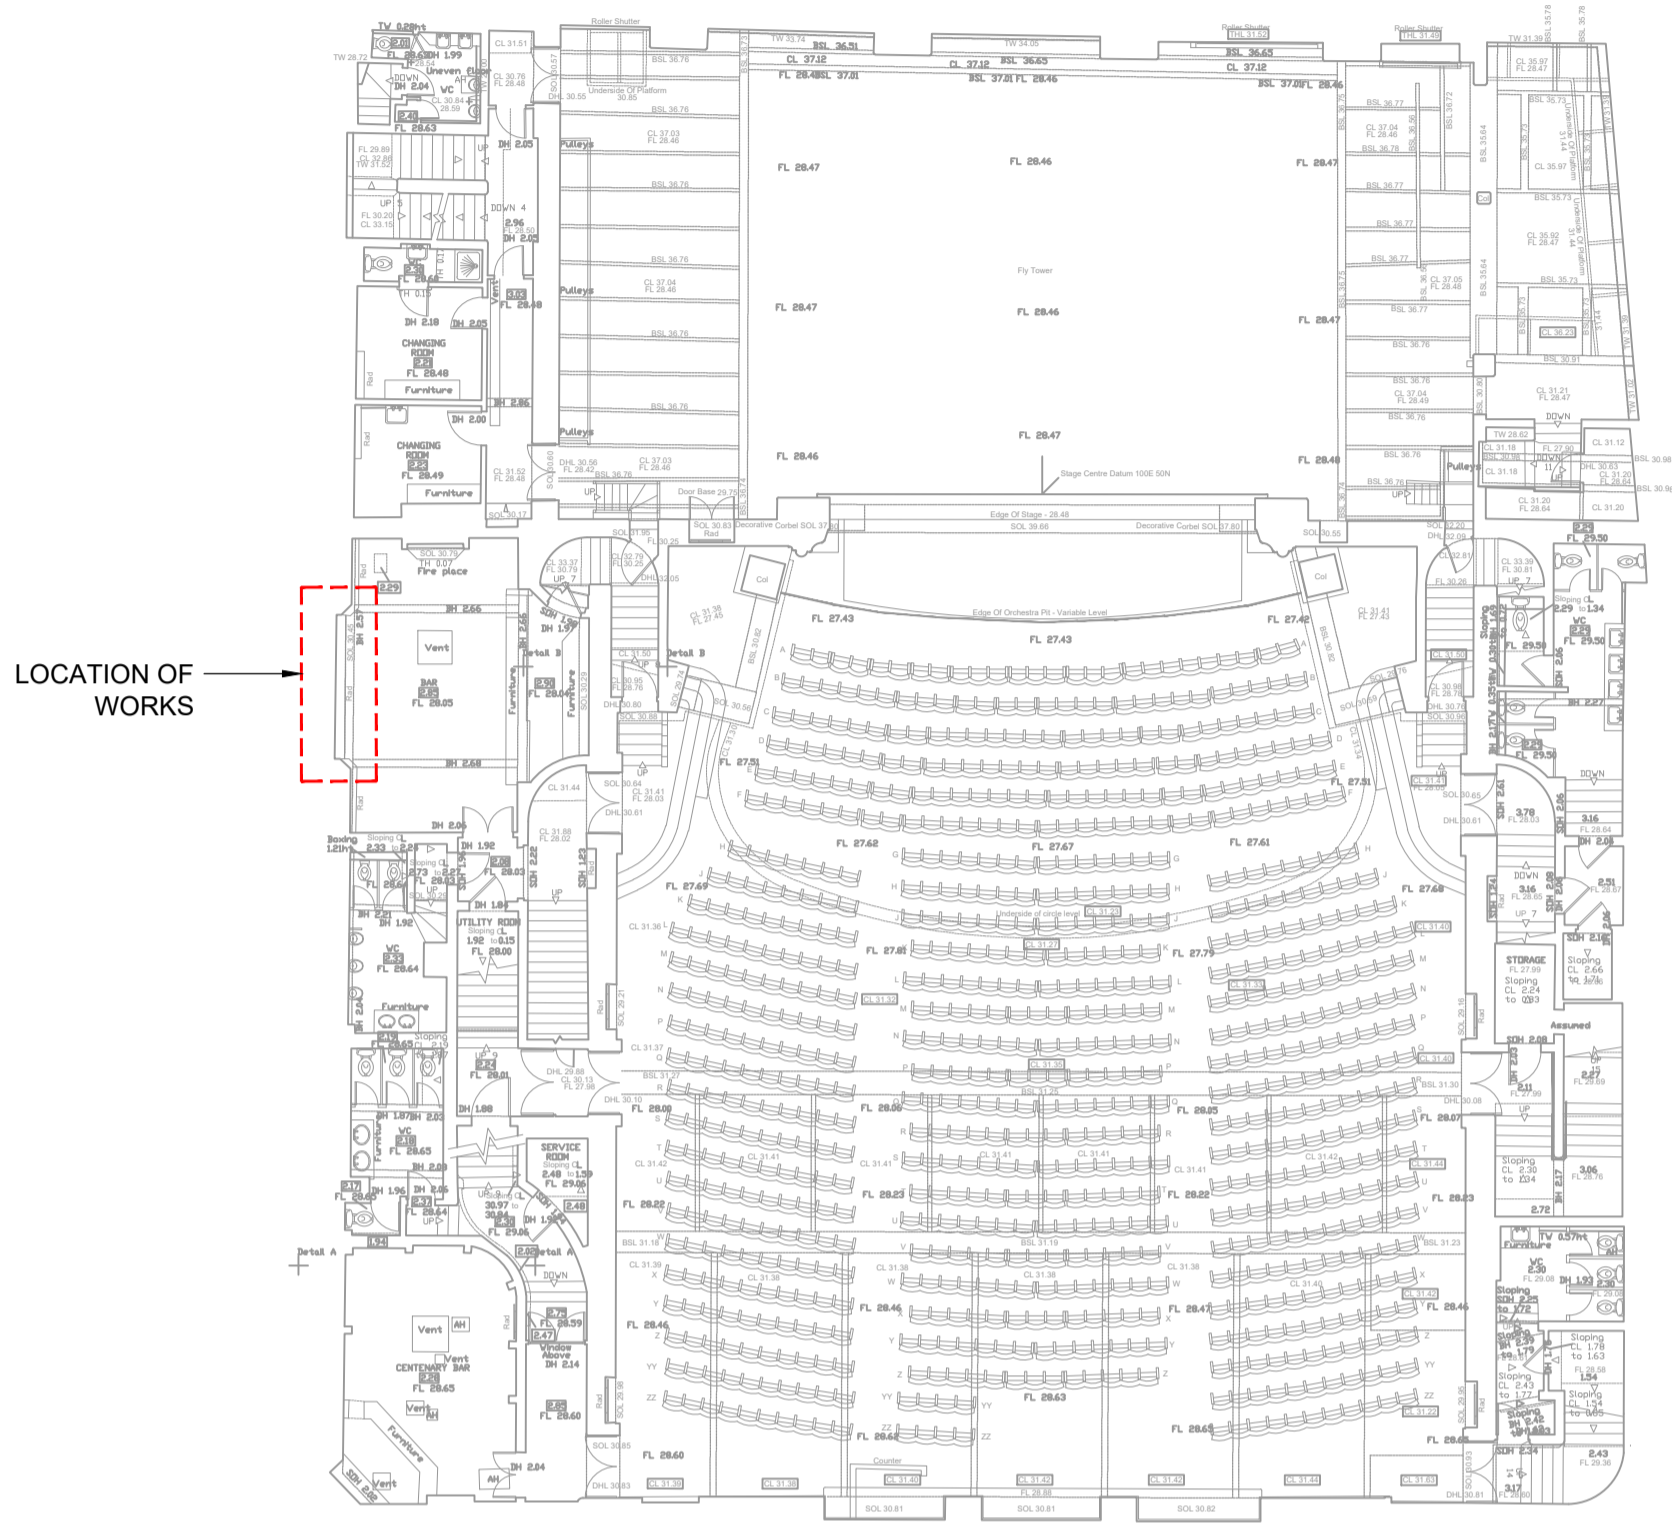
KEY PLAN
SCALE 1:200

PHASE 2 - PERMANENT WORKS
SCALE 1:25

NOTE:
ALLOW FOR 3No. 457x152x82kg UKB's WITH 2No.
SPLICE CONNECTIONS PER BEAM
CONTRACTOR TO ALLOW FOR DEVELOPMENT
OF PROPPING SOLUTION TO INSTALL BEAM.
ALL STEELWORK TO BE GALVANISED
