Arboricultural Consultancy for Lloyds Bank

| Insured | Mr Terence Redhead and Mrs Rachel Redhead | Address | 89 West End March, Cambridgeshire, PE15 8DJ | | |
| Report Date | 12/02/2020 | | | | |

Scope of Report: To survey the property and determine significant vegetation contributing to subsidence damage, make recommendation for remedial action and assess initial mitigation and recovery prospects. The survey does not make an assessment for decay or hazard evaluation.

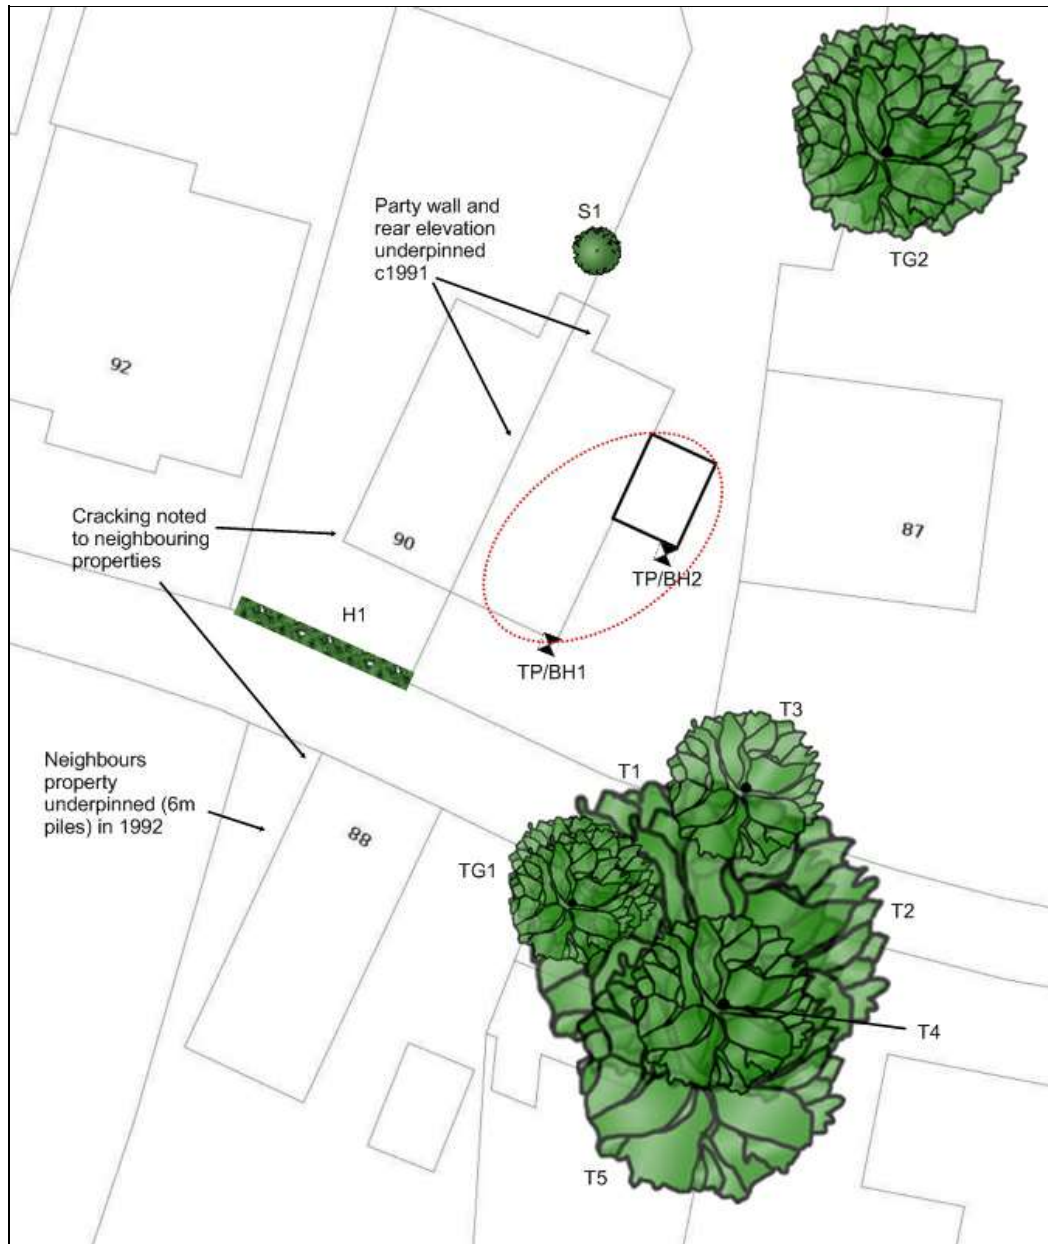
7. Site Plan

Based on our observations on site and with due regards to species profile, the Ash trees (T1 & T2) are considered the dominant features proximate to the area of movement, the source of the roots recovered and accordingly where vegetation is determined to be causal we have identified their collective / cohesive influence as the primary cause of any clay shrinkage subsidence damage.

Considering engineers conclusions and in order to mitigate the current damage thereby allowing soils beneath the property to recover to a position such that an effective engineering repair solution can be implemented, we recommend a program of vegetation management as detailed by this report.
