Existing architectural fabric schedule

**26 Lower Belgrave Street
January 2021**

1.1 Overview

1.2 Purpose of the report

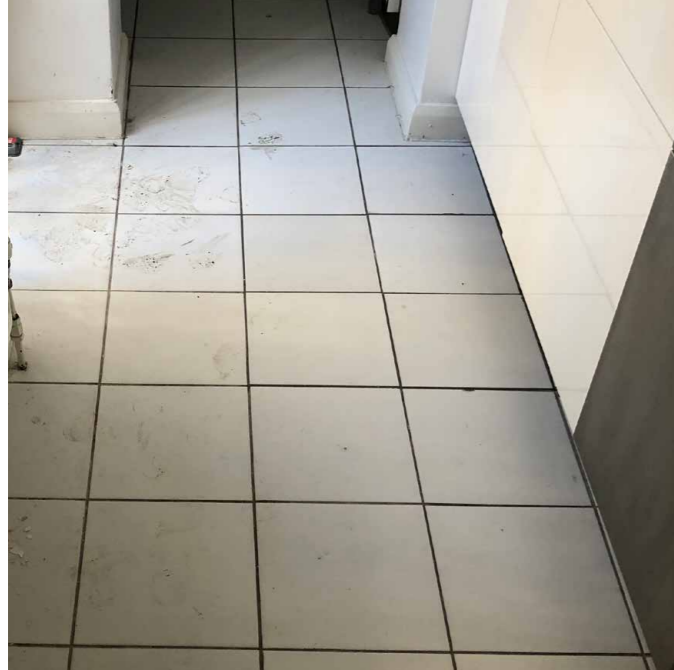
existing floor finish

Substrate:
concrete- presumed

Condition:
chipped and raked in places

Proposed intervention:
strip out existing finish

Proposed specification:
rubber (sheet/ tile format)

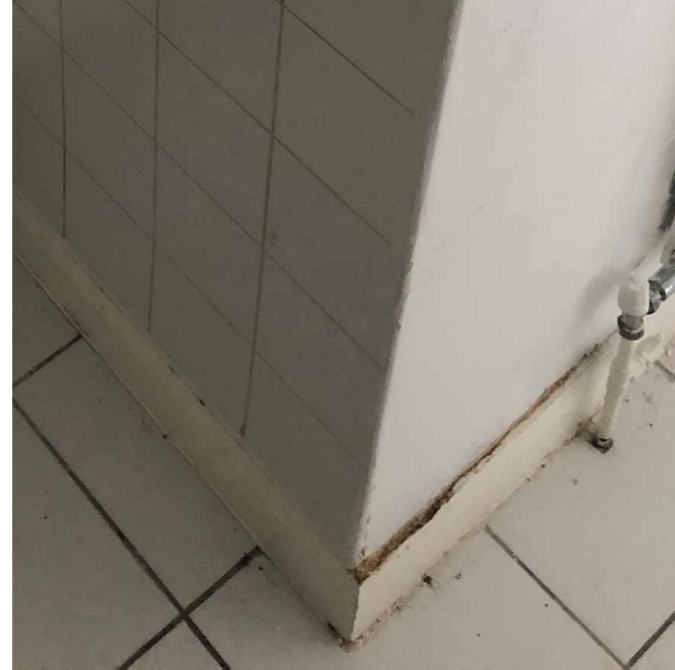
existing skirting board

Substrate:
masonry wall

Condition:
very poor- warped, cracked and splitting

Proposed intervention:
strip out

Proposed specification:
straight profile MRMDF, painted

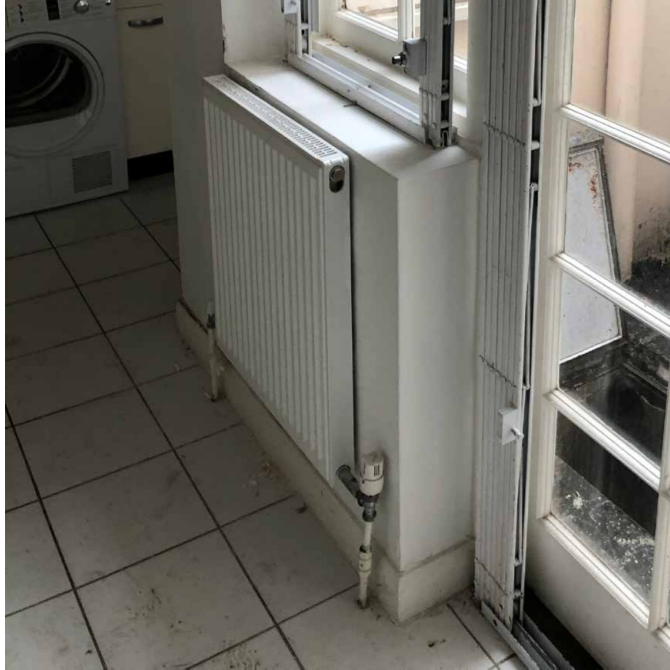
existing radiator and case ((RB.01)

Specification description:
modern, ribbed steel panel

Condition:
externally- fair
performance- could not be tested

Proposed intervention:
strip-out radiator; retain pipework

Proposed specification:
flat panel steel radiator

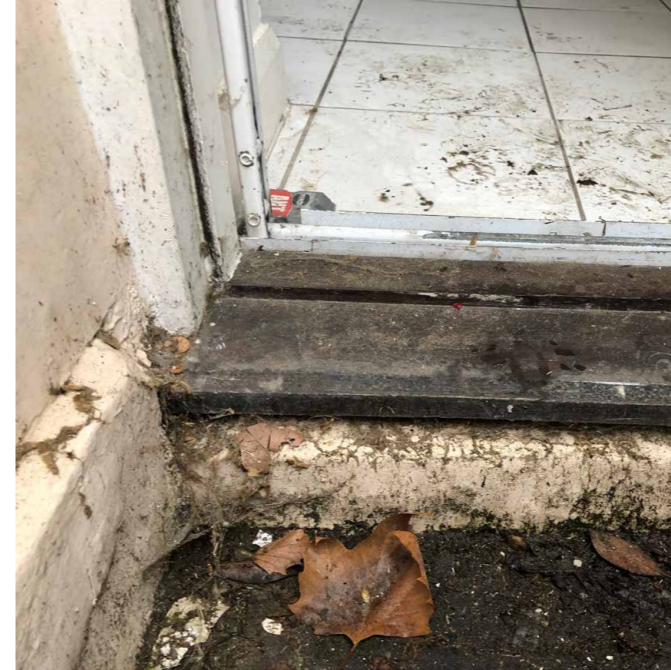
existing door (DB.02)

Specification description:
timber frame, single glazed

Condition:
damaged to base of the door, due to water ingress

Age:
unknown (not original- likely to be installed as part of enclosure below the entryway bridge, and subsequently replaced in modern times)

Proposed intervention:
remove door leaf and frame

Proposed specification:
hardwood, 4-panelled to match style of DG.01 to increase security;
new ironmongery and hardware

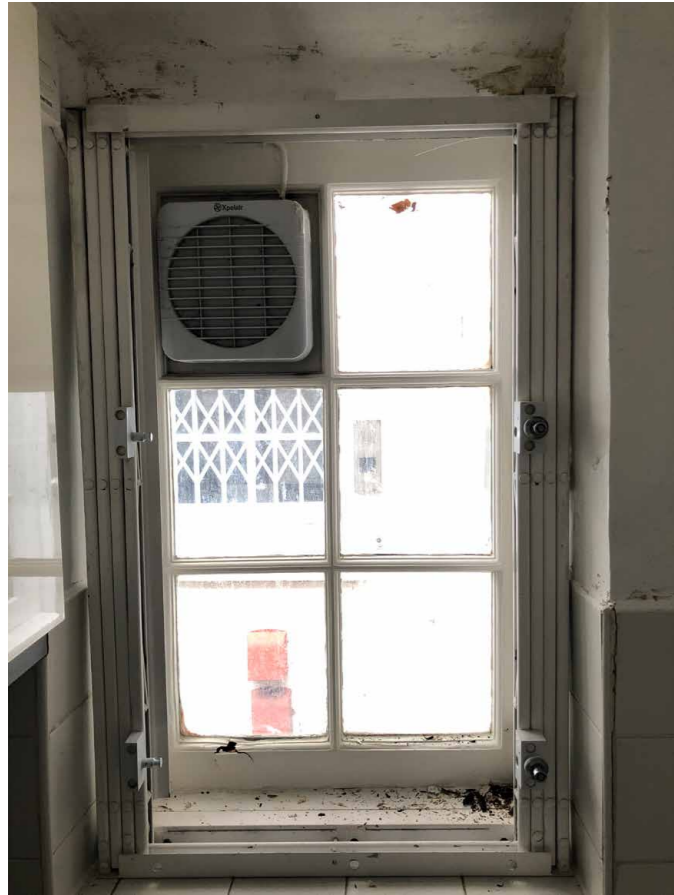
existing window (WB.01)

Condition:
frame rotten due to dampness in the masonry wall;
window vent in lieu of 1no pane

Age:
unknown (not original- likely to be installed as part of
enclosure below the entryway bridge, and subsequently
replaced in modern times)

Proposed intervention:
remove casement and frame

Proposed specification:
Red Grandis, 6.4mm laminated single glazed, mullion
detail to match existing, fixed lower casement with fan-
light above to provide ventilation;
wedi skirt & wedi bar;
new ironmongery and hardware

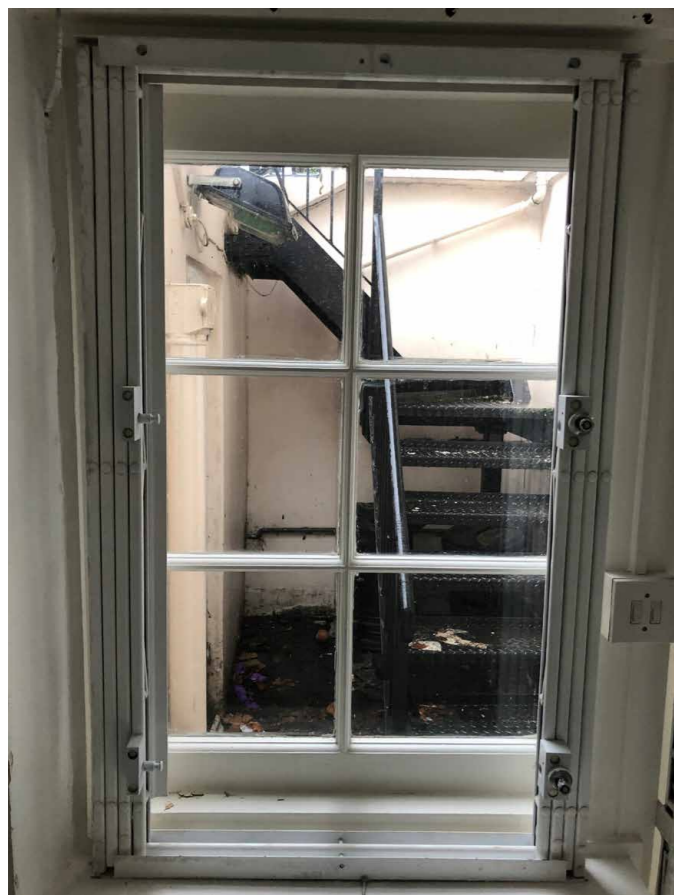
existing window (WB.02)

Condition:
frame damaged due to dampness in the masonry wall;
frame splitting and warping

Age:
unknown (not original- likely to be installed as part of
enclosure below the entryway bridge, and subsequently
replaced in modern times)

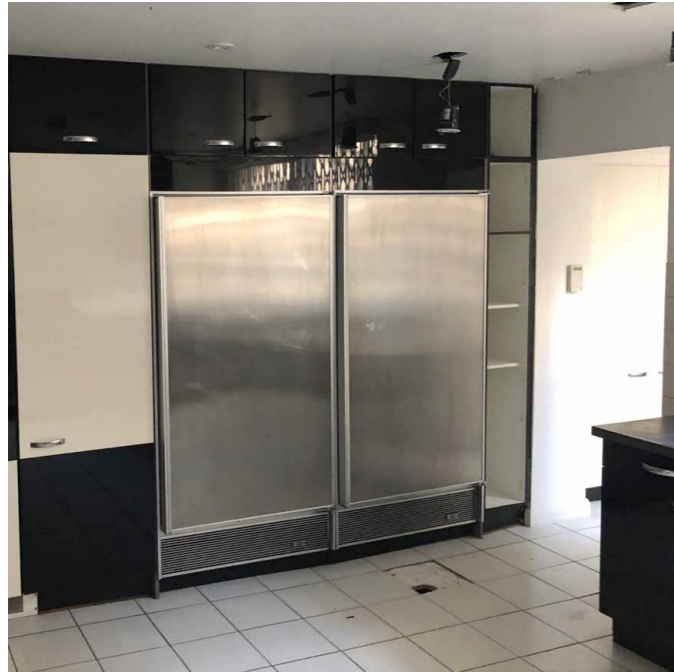
existing floor finish

Substrate:
suspended timber joists, ply over, no insulation visible, no signs of original finish

Condition:
chipped and racked in places
There is a disjunction between Kitchen & rear bedroom substrates and damp issue affecting the kitchen.

Proposed intervention:
strip out existing finish & deck

Proposed specification:
As part of the works, the suspended system is proposed to be insulated and waterproofed to remedy existing building issues within this area.
finish: rubber (sheet/ tile format)

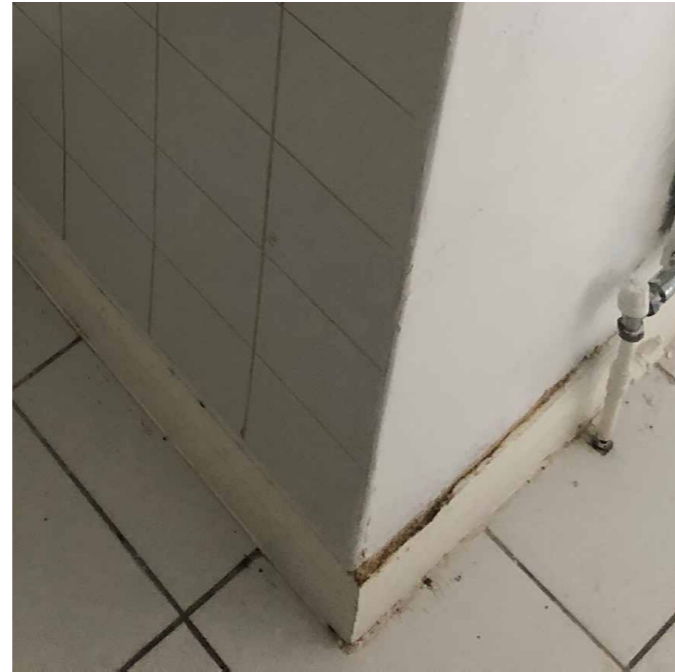
existing skirting board

Substrate:
masonry wall

Condition:
very poor- warped, cracked and splitting

Proposed intervention:
strip out

Proposed specification:
straight profile MRMDF, painted

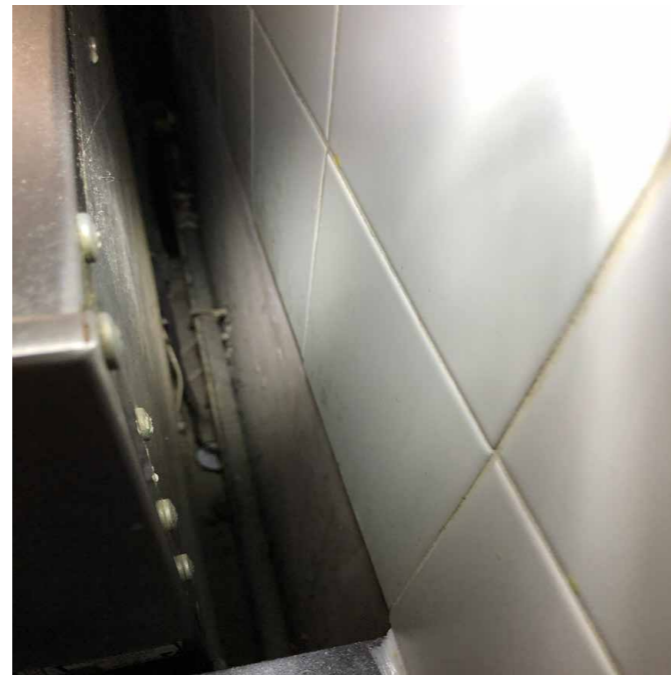
existing fireplace

Condition:
blocked-up

Age:
unknown (likely to be formed part of alterations c.20 years ago)

Proposed intervention:
lightweight structure infill to right hand side alcove to form plumb, continuous wall surface

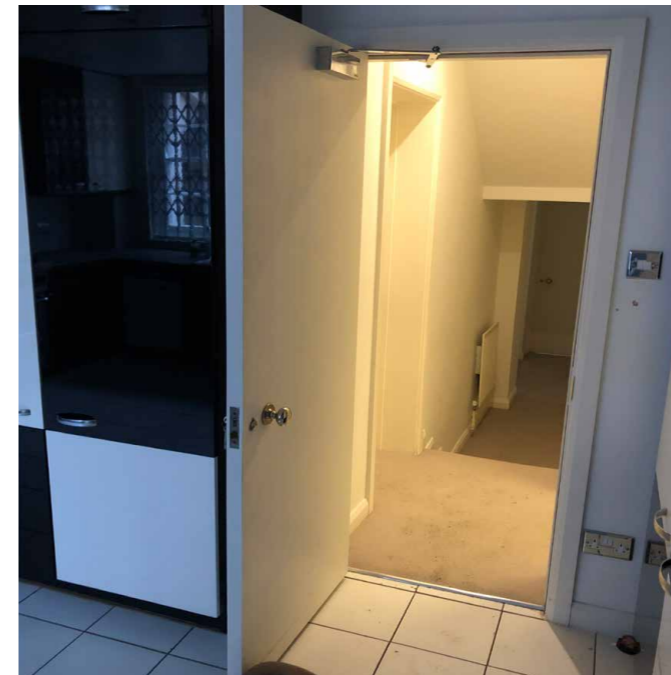
existing door (DB.03)

Specification description:
plain blank

Condition:
fair

Proposed intervention:
remove door leaf and frame

Proposed specification:
frameless opening

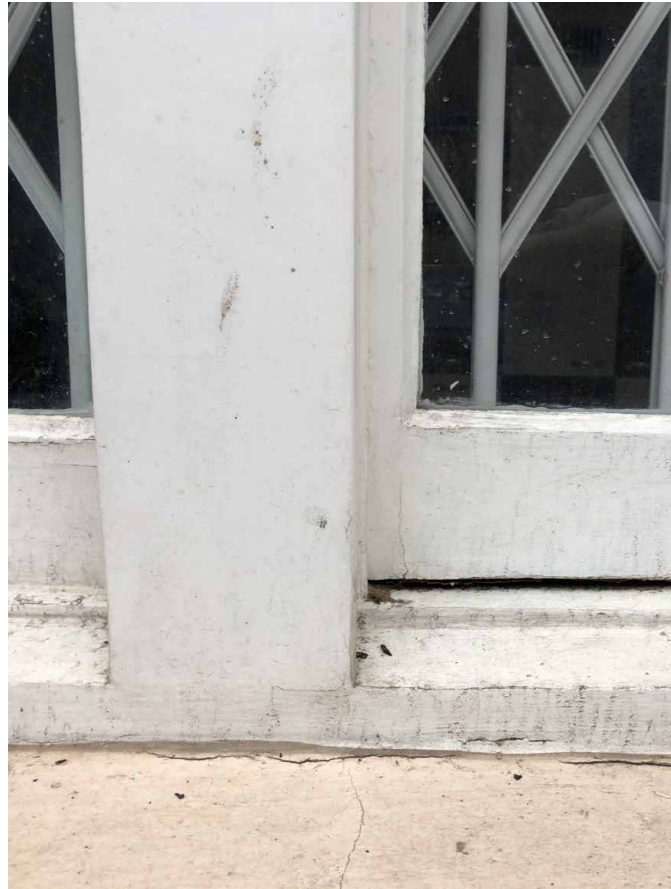
existing window (WB.03)

Condition:
acceptable;
some warping and paint peeling externally; both sashes are sealed and are currently unopenable

Proposed intervention:
release caulking/paint to reinstate sliding of the sashes;
new draft proofing- staff & parting beads; new pully & cord;
new ironmongery

Proposed specification:
redecorate to match

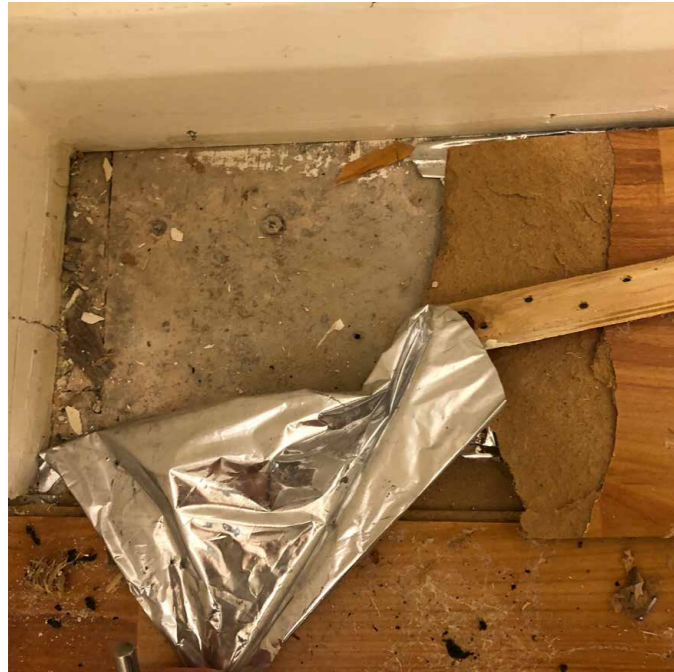
existing floor finish

Substrate:
anticipated suspended timber floor- as in Kitchen

Condition:
acceptable

Proposed intervention:
strip out

Proposed specification:
As part of the works, the suspended system is proposed to be insulated and waterproofed to remedy existing building issues within this area.
finish: rubber (sheet/ tile format)

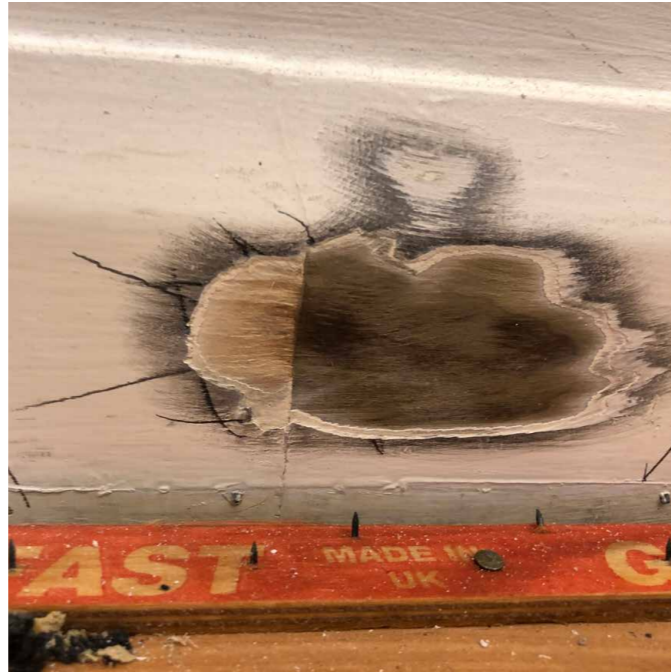
existing skirting board

Substrate:
masonry wall

Condition:
fair

Proposed intervention:
strip out

Proposed specification:
straight profile to match existing, painted

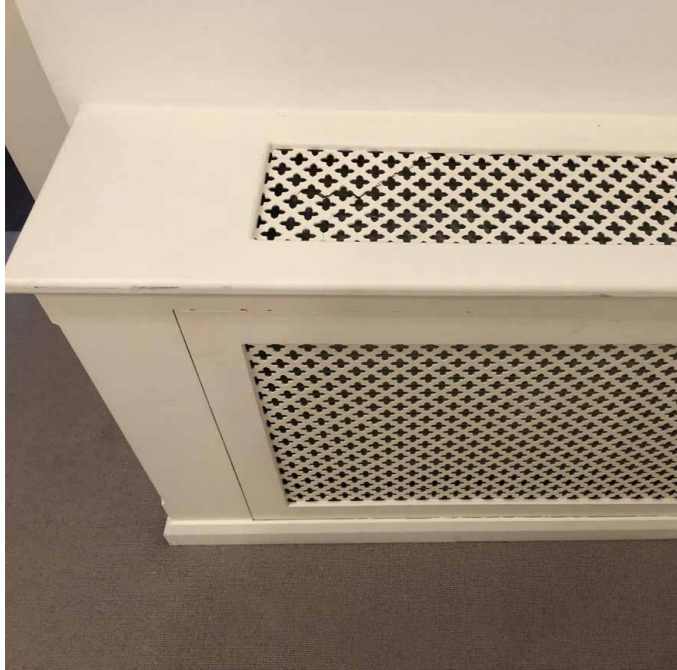
existing radiator and case (RB.02)

Specification description:
ribbed steel panel radiator, within timber case

Condition:
could not be tested

Proposed intervention:
strip out

Proposed specification:
new flat panel steel radiator enclosed within timber case in vicinity

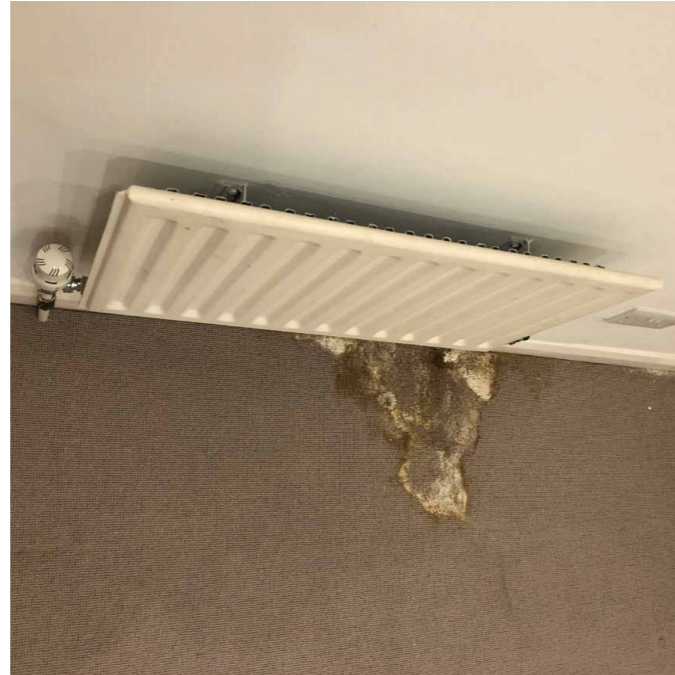
existing radiator and case (RB.03)

Specification description:
ribbed steel panel radiator

Condition:
poor- could not be tested, appears to have leaked

Proposed intervention:
strip out

Proposed specification:
none

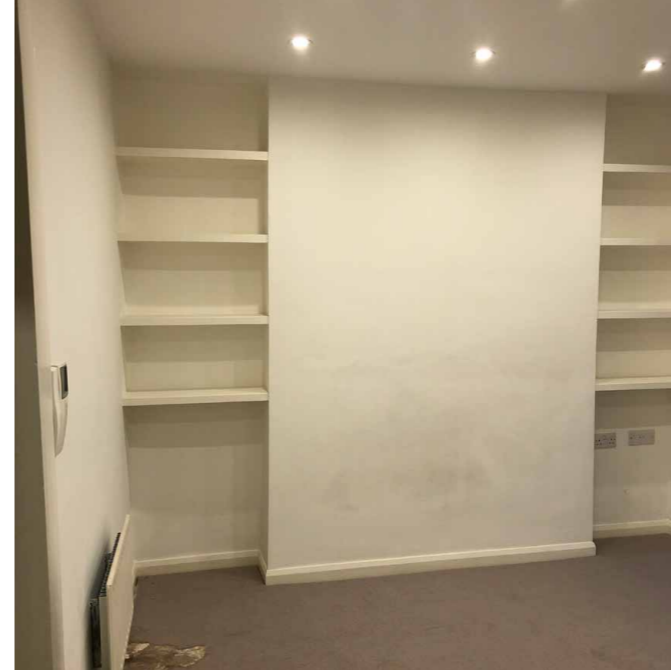
existing fireplace (FP.B1)

Condition:
blocked-up

Age:
unknown (likely to be formed part of alterations c.20 years ago)

Proposed intervention:
install small power outlets to service wall-mtd TV

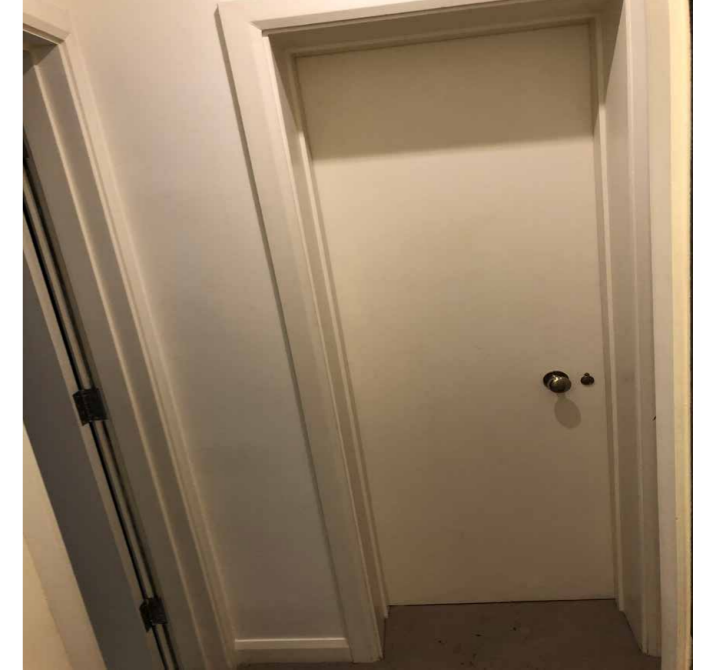
existing door (DB.05)

Specification description:
plain blank

Condition:
acceptable

Proposed intervention:
retain

Proposed specification:
new hardware & ironmongery

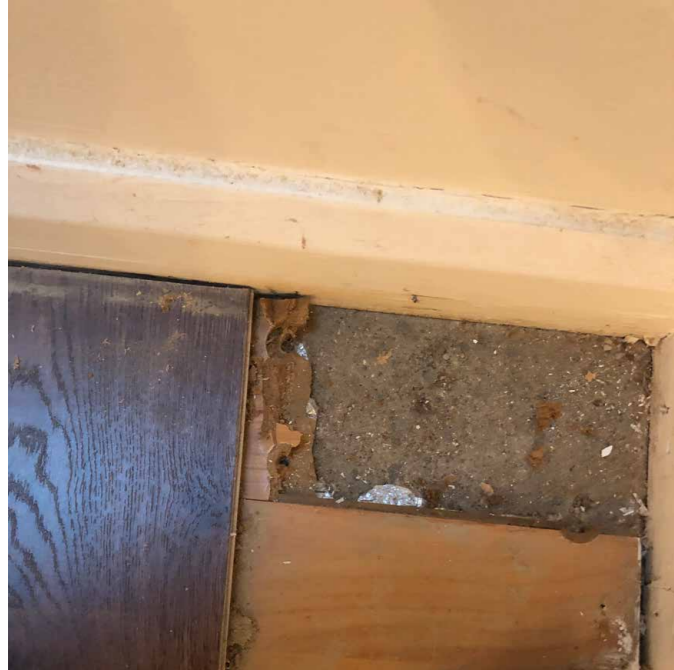
existing floor finish

Substrate:
concrete

Condition:
acceptable

Proposed intervention:
strip out

Proposed specification:
self levelling screed, hardboard, rubber (sheet/ tile format)

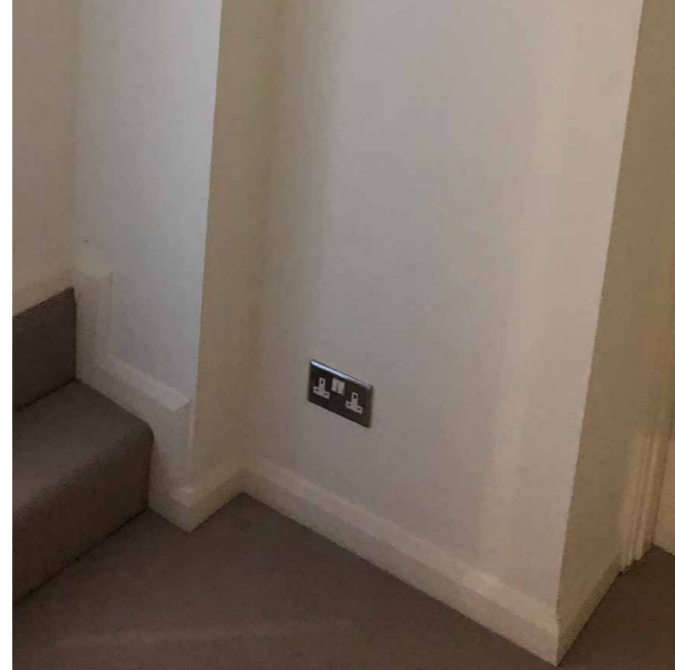
existing skirting board

Substrate:
masonry wall

Condition:
fair

Proposed intervention:
strip out

Proposed specification:
straight profile to match existing, painted

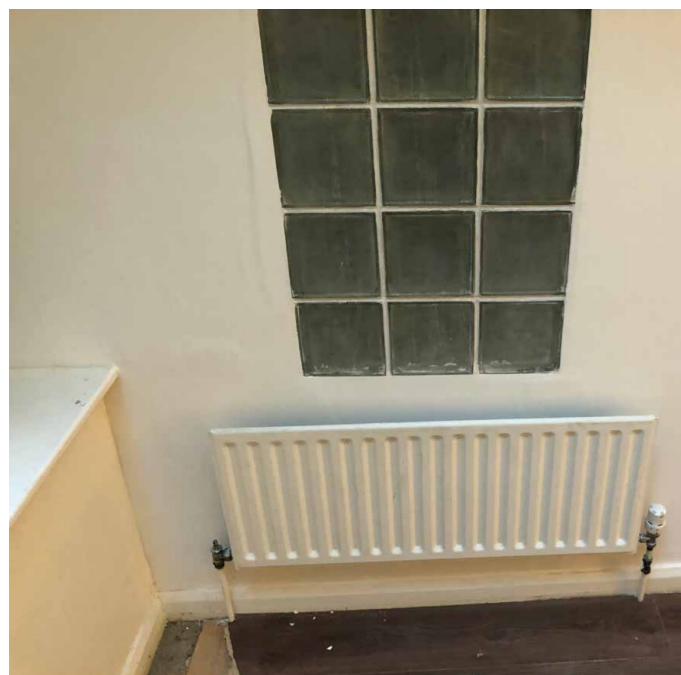
existing radiator and case (RB.02)

Specification description:
ribbed steel panel radiator

Condition:
could not be tested

Proposed intervention:
strip out

Proposed specification:
new flat panel steel radiator enclosed within timber case

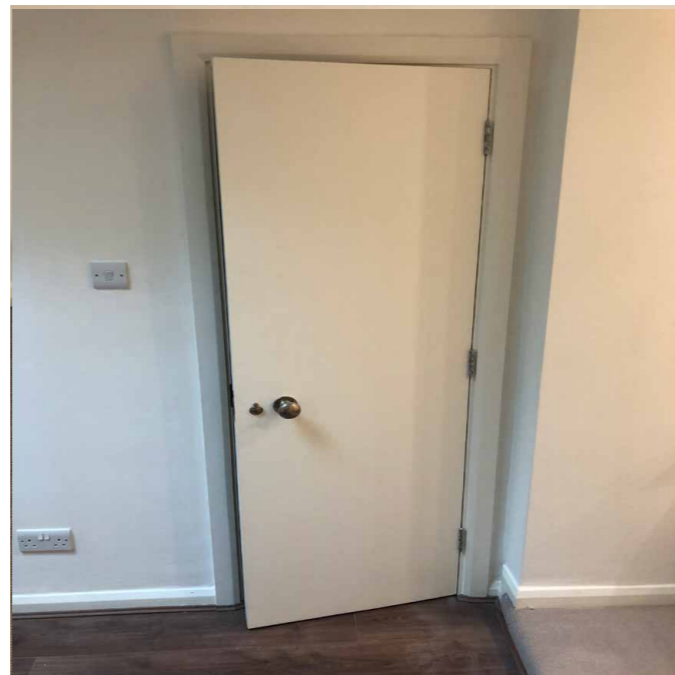
existing door (DB.06)

Specification description:
plain blank

Condition:
acceptable

Proposed intervention:
retain

Proposed specification:
new ironmongery and hardware

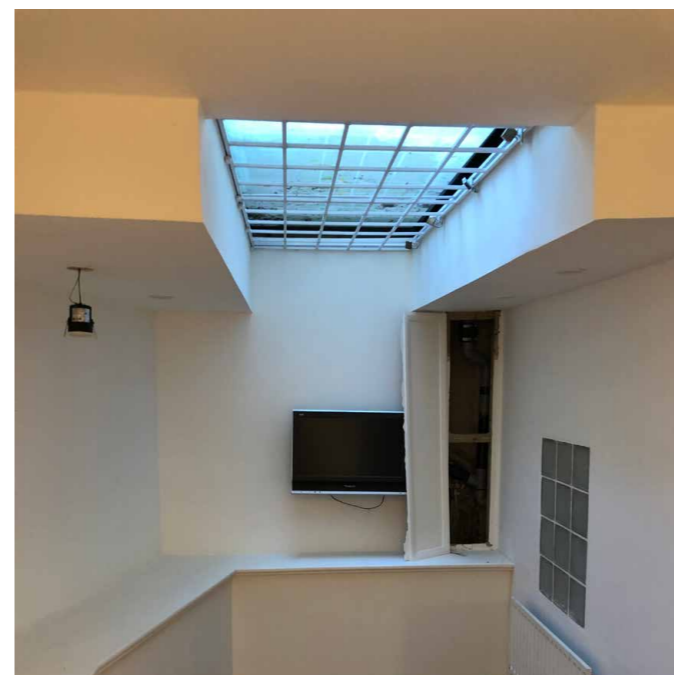
existing ceiling

Substrate:
concrete podium forming Patio;
presumed suspended timber joists locally below (forming bulkheads)

Condition:
good

Proposed specification:
plasterboard and skim;
new roller black-out blind to skylight.

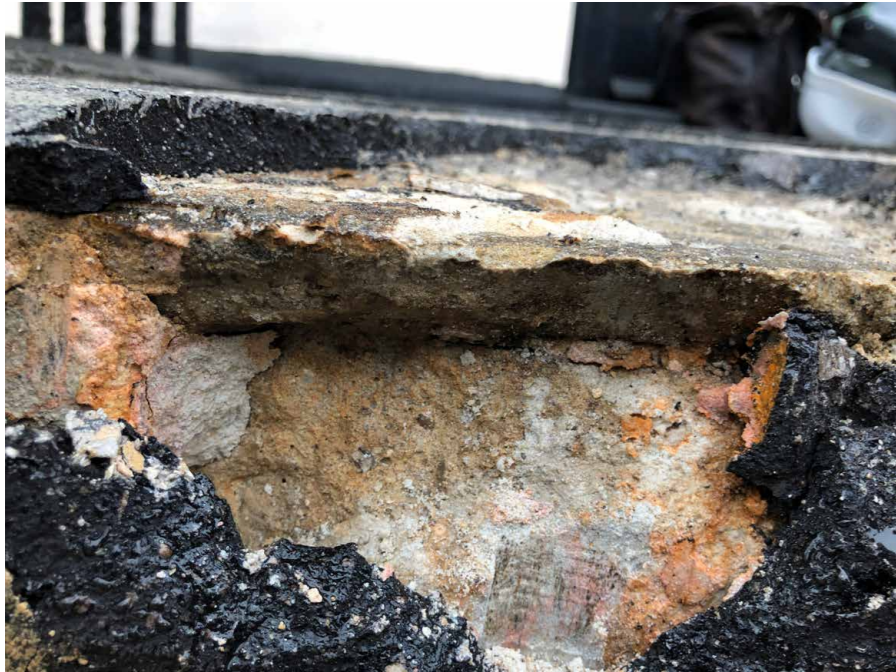
existing floor finish

Condition:
fair

Proposed intervention:
strip out finish build-up down to waterproofing

Proposed specification:
repair waterproofing, lay new Portland stone with bullnose treads; contrast black inlay board to landing in granite
(ref. to drawing RAI055_PL_DT.02 for further details)

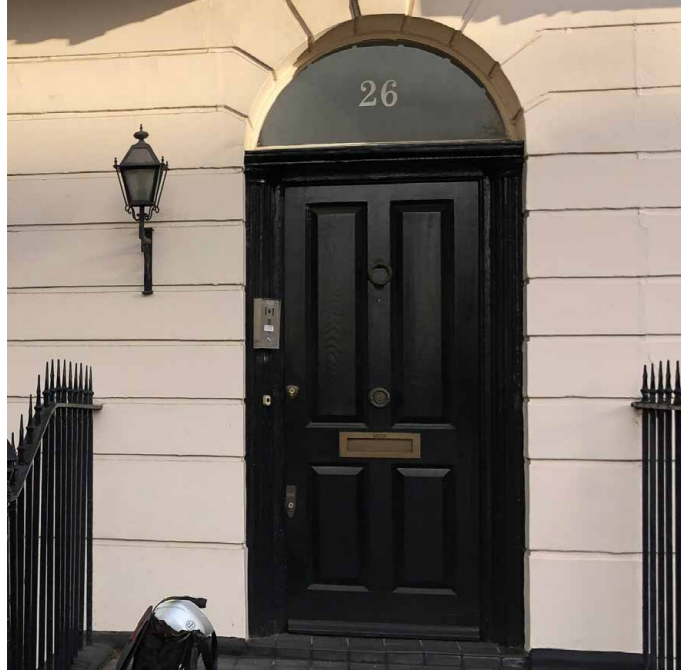
existing door (DG.01)

Specification description:
panelled timber, painted
brass ironmongery

Condition:
good

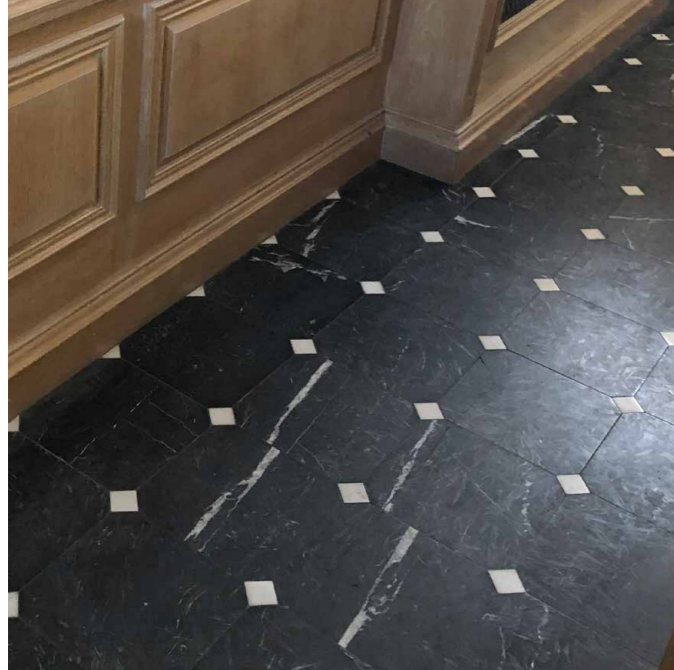
existing floor finish

Substrate:
suspended timber joists, below ply

Condition:
good

Proposed intervention:
strip out floor finish and deck

Proposed specification:
level floor as required, lay new deck and marble tiles
with contrast inlay;
recessed coir mat to door area

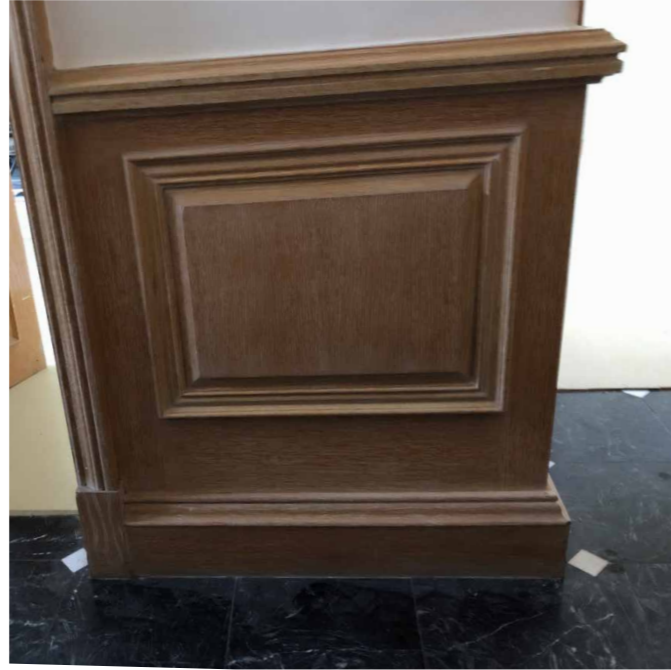
existing skirting board

Specification description:
timber ogee profile, varnished

Condition:
good

Proposed intervention:
retain

Proposed specification:
infill section on either side of radiator case and where
DG.02 is to be moved; profile to match existing;
paint over

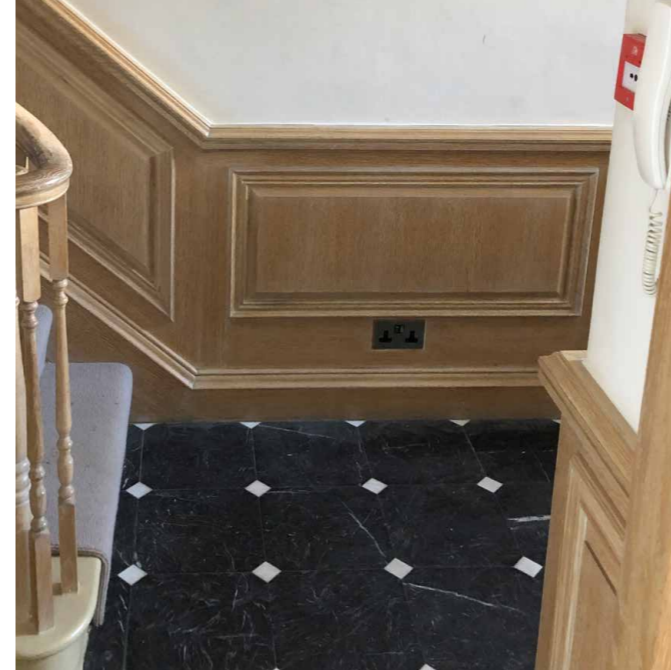
existing wainscoting

Specification description:
timber fielded and raised

Condition:
good

Proposed intervention:
retain

Proposed specification:
infill section on either side of radiator case and where
DG.02 is to be moved; profile to match existing;
paint over

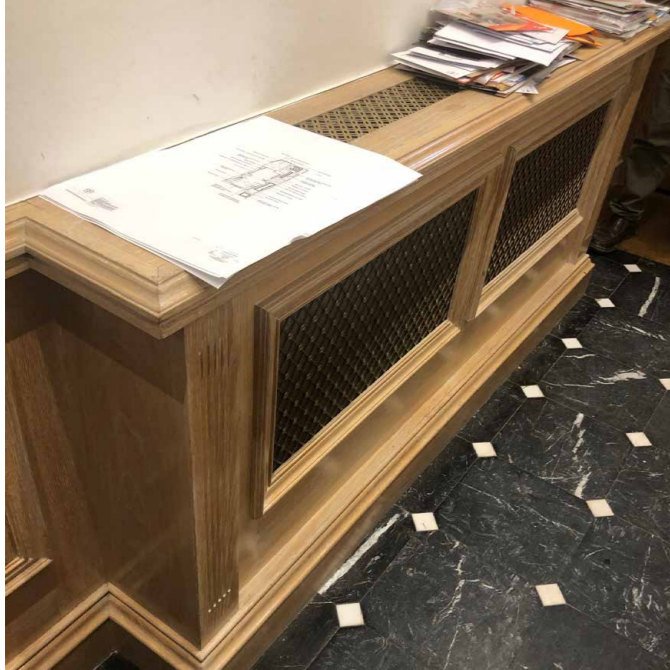
existing radiator and case

Condition:
good

Proposed intervention:
remove

Proposed specification:
new case to reduced size; style to match existing, metal mesh replaced with timber slats and top panel formed in marble;
paint over

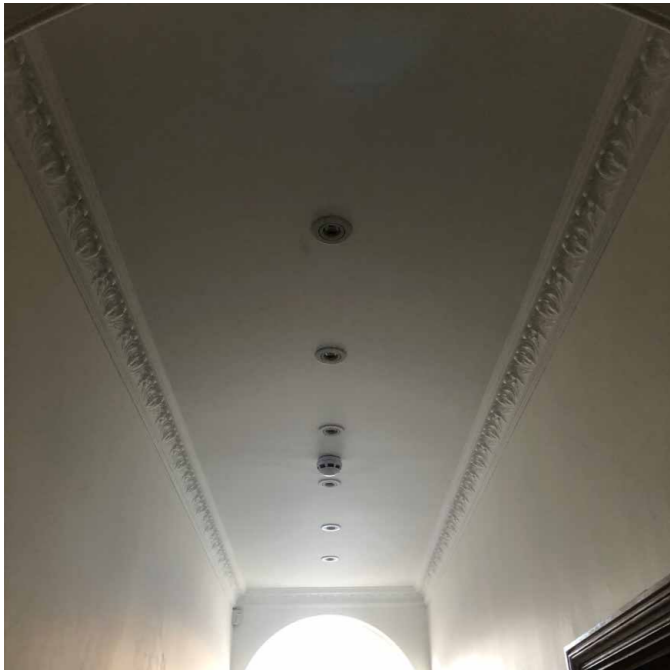
existing ceiling

Substrate:
timber joists

Condition:
good

Proposed specification:
plasterboard and skim

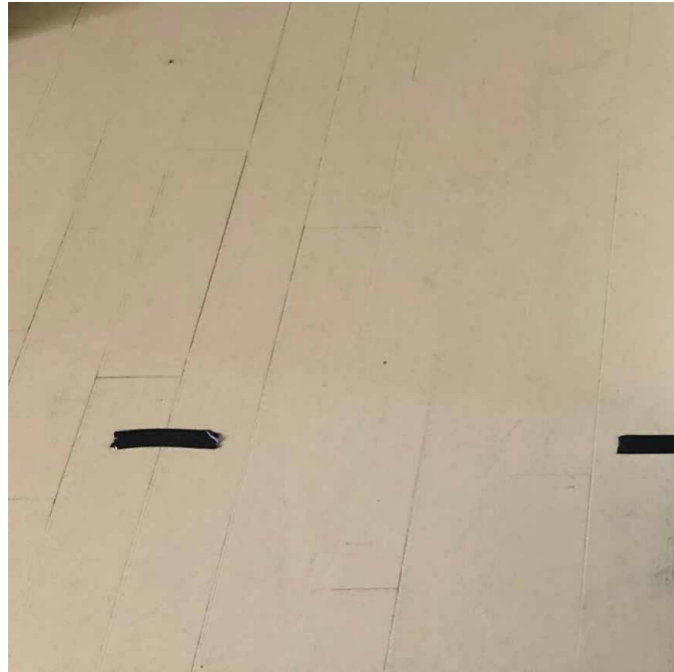
existing floor finish

Substrate:
Presumed original joists (c. h180mm) appear to have been strengthened/levelled with new timber joists. Modern plywood deck over, with some local ply pattressing between joists visible within the exploratory aperture.

Specification description:
painted timber T&G floorboards;
No signs of original floor finish was observed. Based on site evidence, we have concluded that the original flooring has been removed in the past, and current build-up most likely dates back to alterations permitted in 1996.

Condition:
fair; warping in places

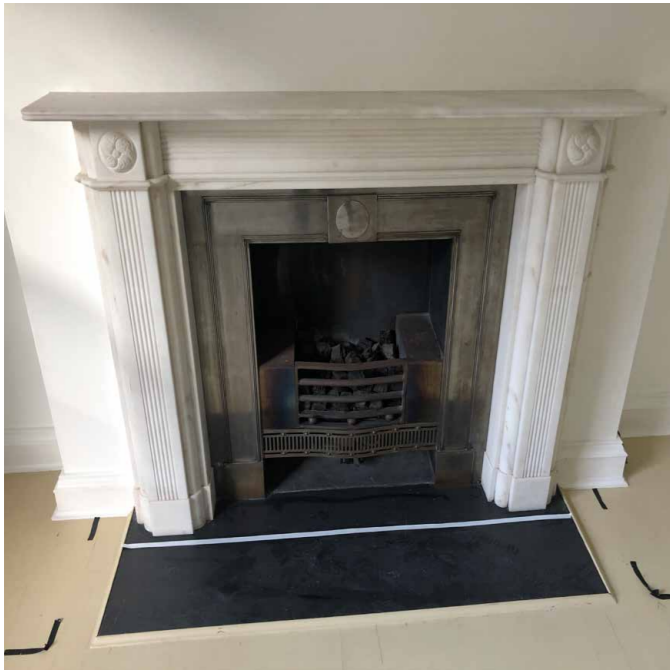
existing fireplace

Condition:
good

Proposed intervention:
remove surround, basket and gather; retain hearth

Proposed specification:
block up aperture with lightweight construction to facili-
tate functional family kitchen; vented

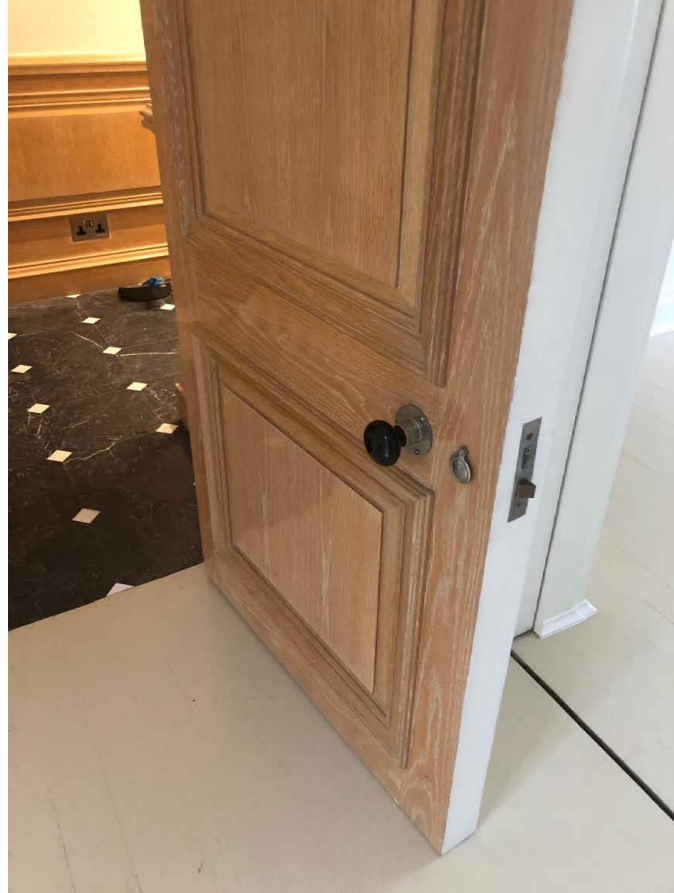
existing door (DG.02)

Specification description:
panelled timber, oversized thickness (c.50mm)

Condition:
good

Proposed intervention:
remove door leaf; relocate opening by c.100mm;
amend retained jamb; infill retained architrave holes,
brush filler

Proposed specification:
hinged, glazed timber frame, fire-rated, Georgian style
door leaf; new ironmongery and hardware
painted

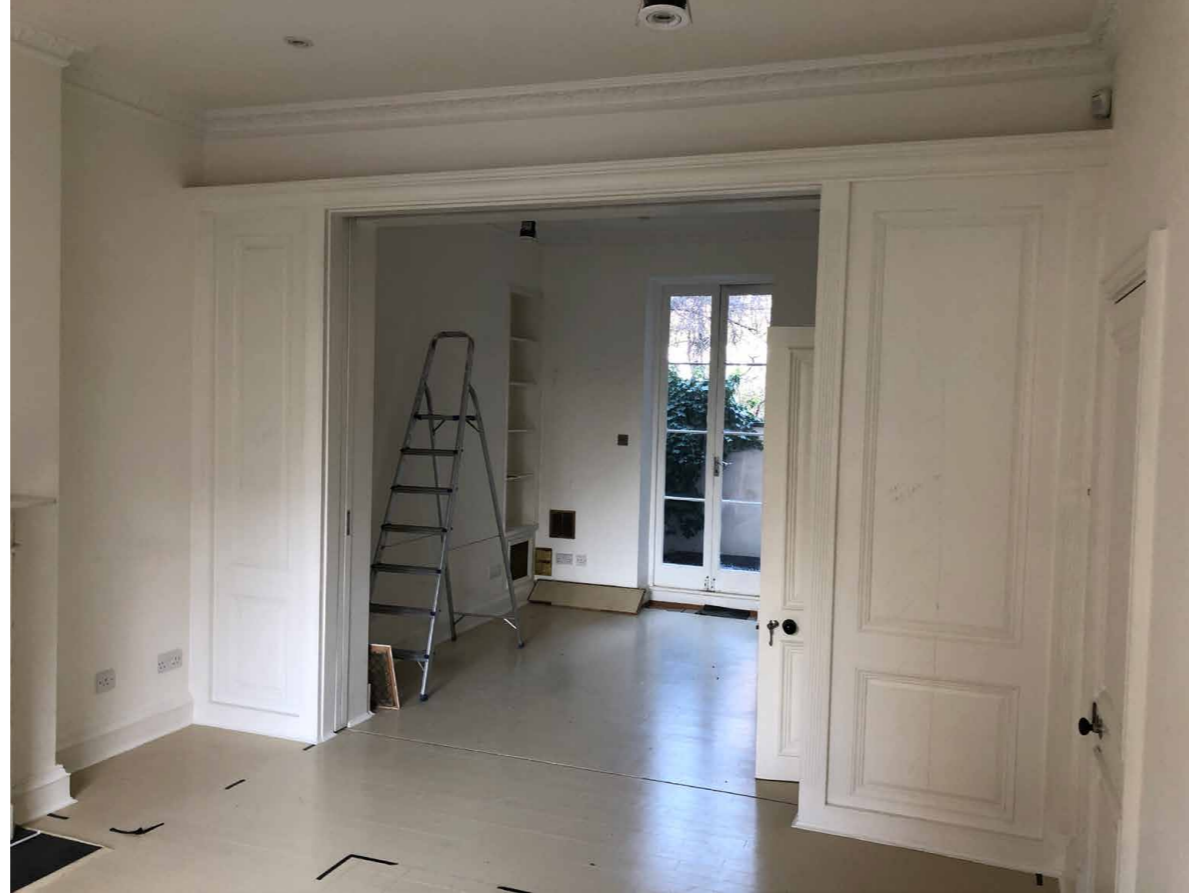
existing door (DG.02) and wall panelling

Specification description:
panelled timber, pocket

Condition:
fair

Proposed intervention:
remove door leaf & hardware; remove modern panel-
ling to 1no aspect and architrave to 1no aspect; make
good

Proposed specification:
redecorate frameless reveal lining and architraves

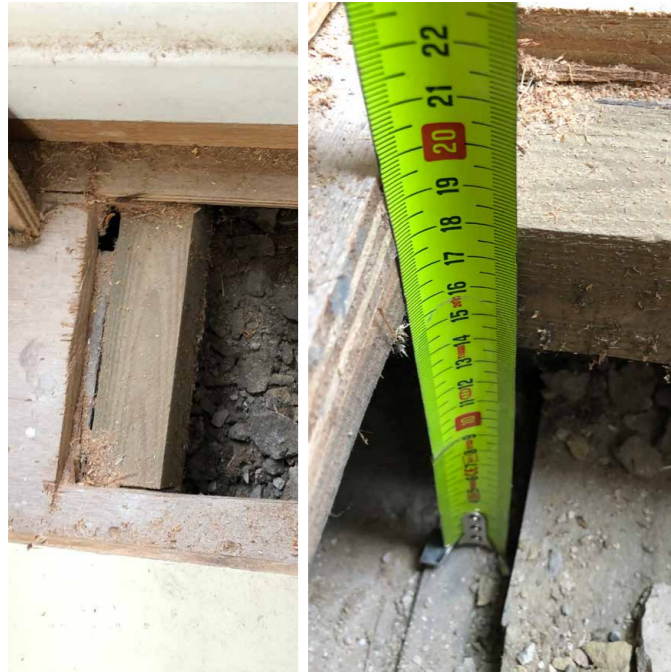
existing floor finish

Substrate:
Presumed original joists (c. h180mm) appear to have been strengthened/levelled with new timber joists. Modern plywood deck over, with some local ply patting between joists visible within the exploratory aperture.

Specification description:
painted timber T&G floorboards;
No signs of original floor finish was observed. Based on site evidence, we have concluded that the original flooring has been removed in the past, and current build-up most likely dates back to alterations permitted in 1996.

Condition:
fair; warping in places

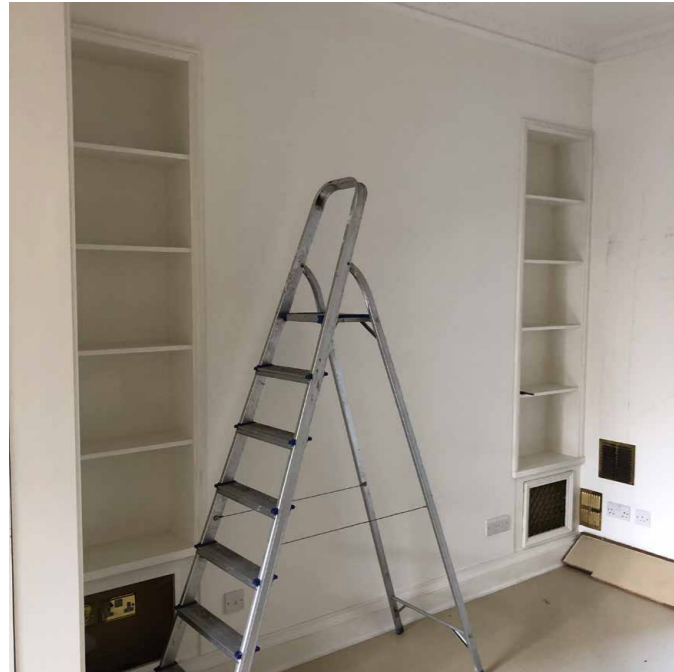
existing fireplace (FP.G2)

Specification description:
blocked up

Proposed intervention:
install wall lights

Proposed specification:
make good, decorate

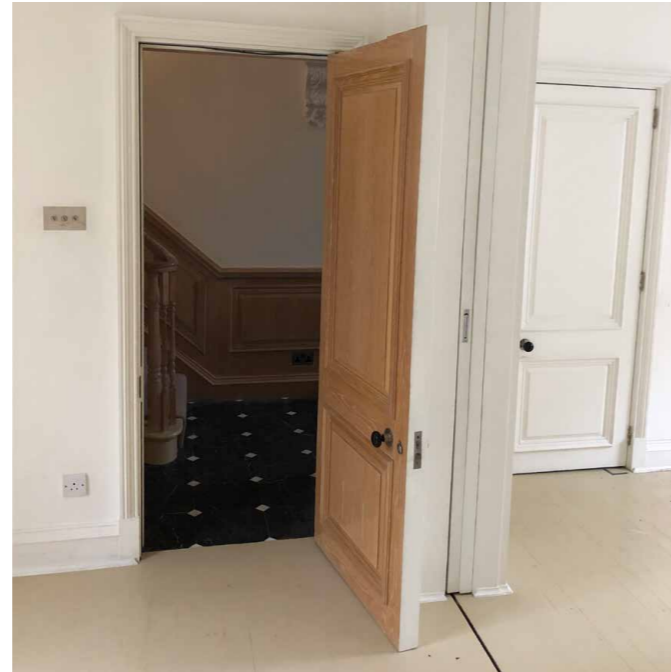
existing door (DG.04)

Specification description:
panelled timber, oversized thickness (c.50mm)

Condition:
good

Proposed intervention:
remove door leaf;
amend jamb; infill retained architrave holes, brush filler

Proposed specification:
hinged, glazed timber frame, fire-rated, Georgian style
door leaf; new ironmongery and hardware
painted

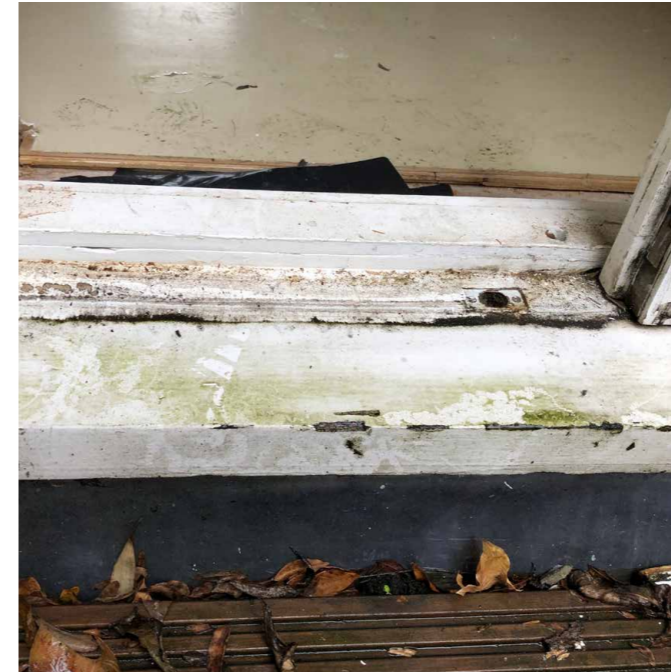
existing door (DG.05)

Specification description:
single glazed, timber frame French door

Condition:
fair; some warping and splitting due to water damage;
very difficult to open, shut and lock

Proposed specification:
new hardwood replacement parts to match existing;
redecorate entire doorset; new draft proofing
new ironmongery and hardware

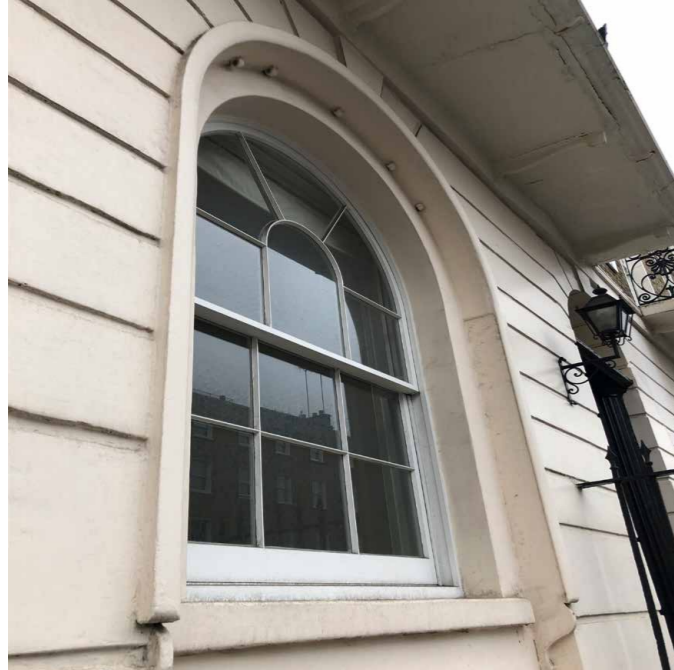
existing window (WG.02)

Specification description:
timber frame, single glazed, sashes;

Condition:
good

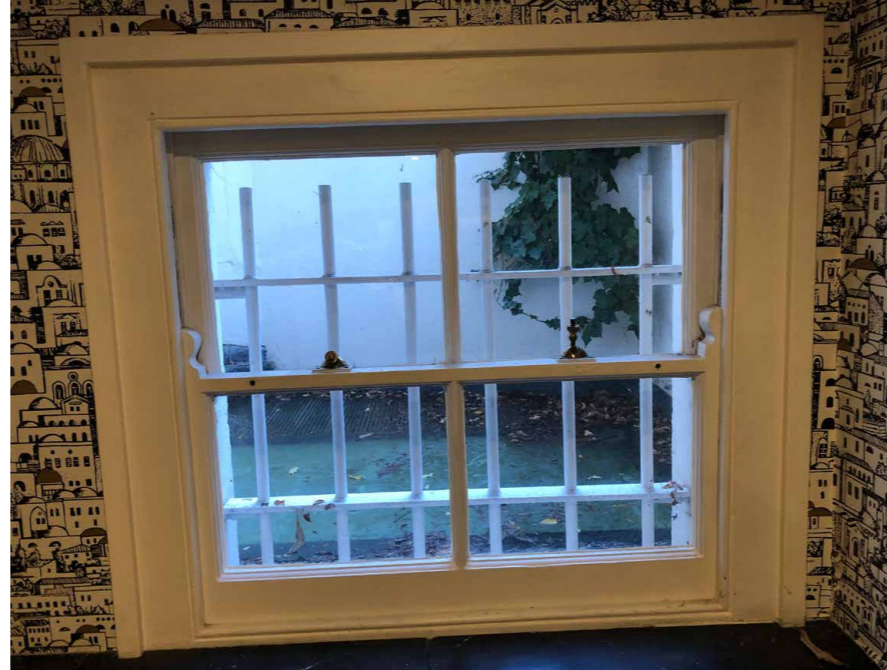
existing window (WG.03)

Specification description:
timber frame, single glazed, sashes;
metal security bars externally

Condition:
acceptable;

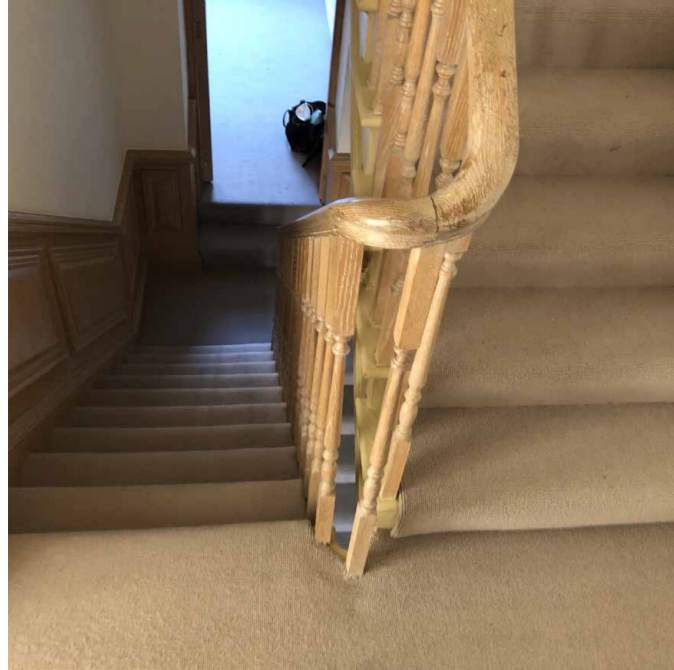
existing floor finish

Substrate:
Presumed original joists

Specification description:
carpet

Condition:
acceptable

Proposed intervention:
strip out floor finish

Proposed specification:
new ply deck (if required), acoustic underlay and Grade A engineered timber boards

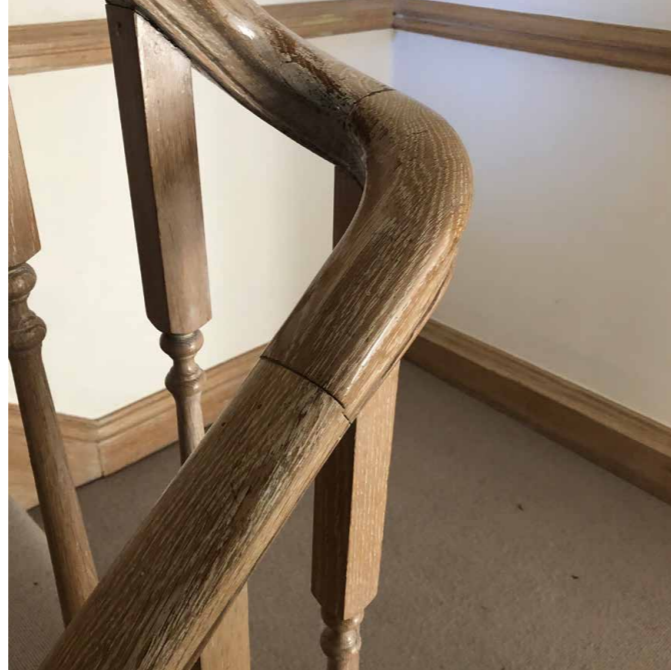
existing skirting board

Specification description:
timber ogee profile; varnished;

Condition:
good

Proposed intervention:
retain; paint

Proposed specification:
re-decorate
