Existing architectural fabric schedule

**26 Lower Belgrave Street
January 2021**

1.1 Overview

1.2 Purpose of the report

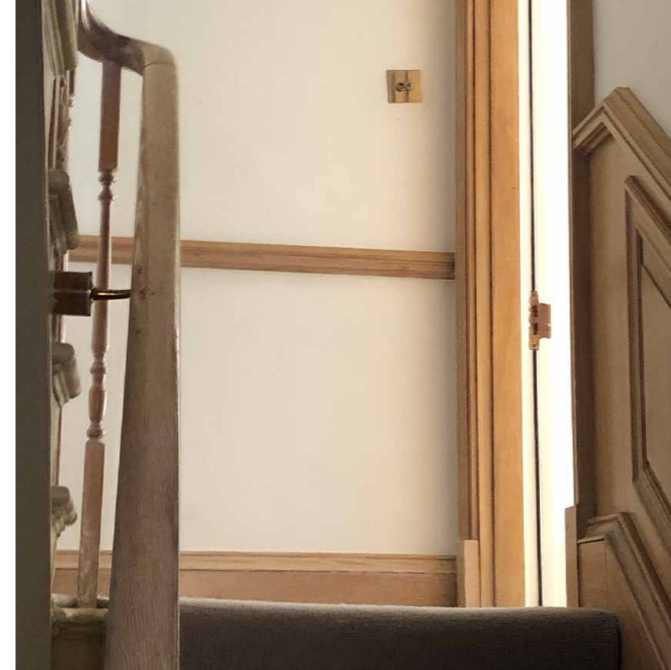
existing dado rail

Specification description:
timber ogee profile; varnished;

Condition:
good

Proposed intervention:
retain; paint

Proposed specification:
re-decorate

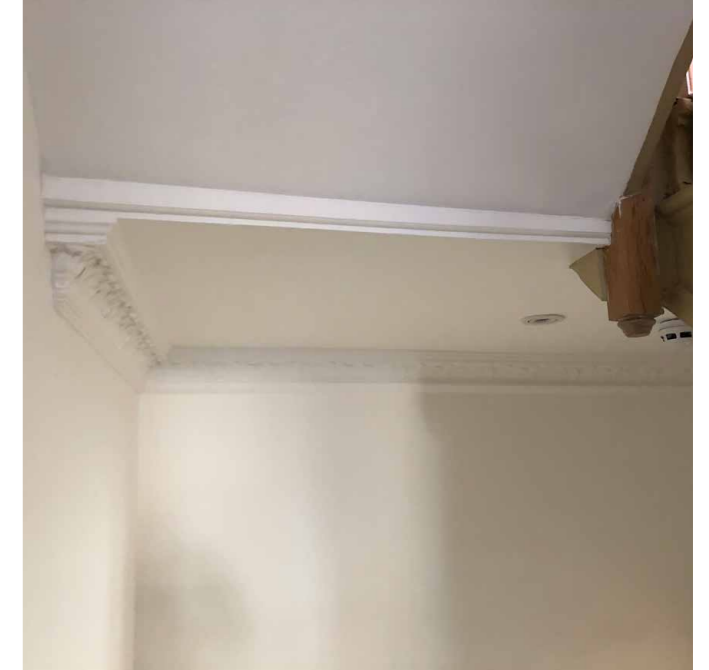
existing cornice

Specification description:
ornate, traditional

Condition:
good

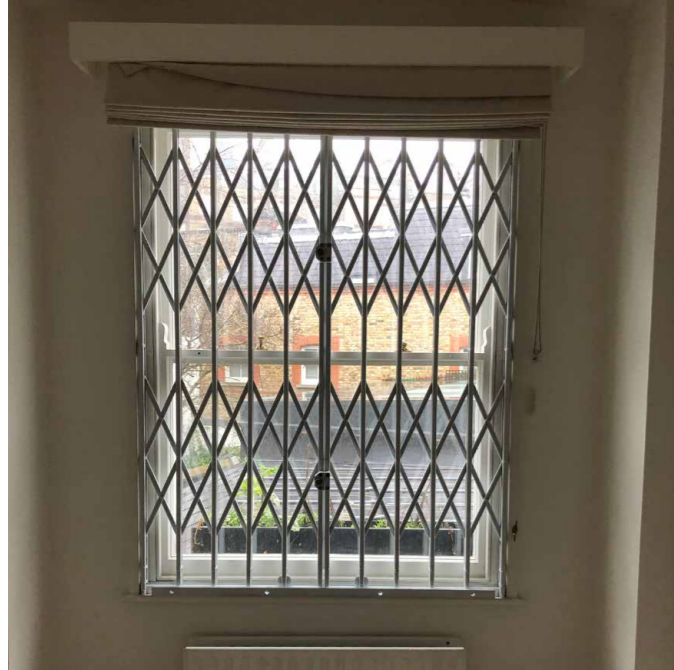
existing window (WG.03)

Specification description:
timber frame, single glazed, sashes;

Condition:
good;

Proposed intervention:
remove security shutter; retain window as is

Proposed specification:
new draft proofing- staff & parting beads; new pulley & cord;
new ironmongery
redecorate to match

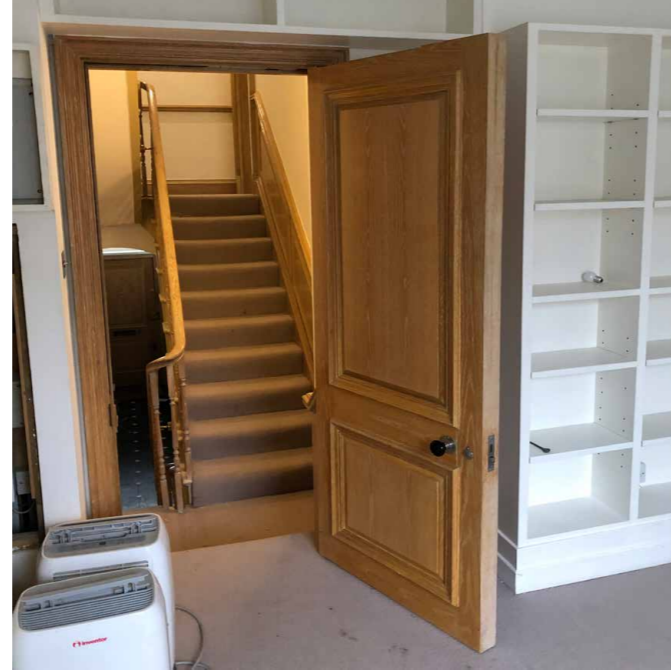
existing door (DF.01)

Specification description:
panelled timber, oversized thickness (c.50mm)

Condition:
good

Proposed specification:
hinged, glazed timber frame, fire-rated, Georgian style
door leaf; new ironmongery and hardware
painted

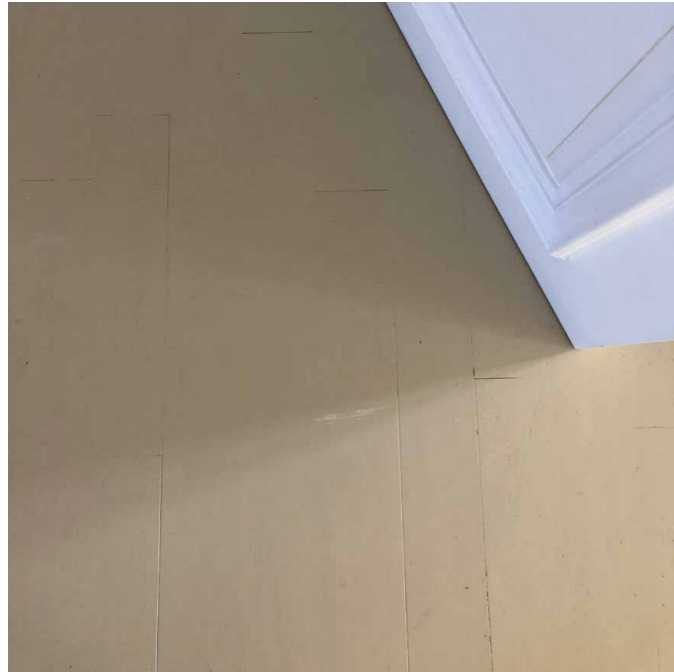
existing floor finish

Substrate:
Presumed original joists with modern mineral wool between, and herringbone struts. No signs of new timber joists or levelling observed. Modern plywood deck is installed over the aged joists structure, which is visibly unlevel- leaning towards front East corner.

Specification description:
painted timber T&G floorboards;
No signs of original floor finish was observed. Based on site evidence, we have concluded that the original flooring has been removed in the past, and current build-up most likely dates back to alterations permitted in 1996.

Condition:
unlevel

Proposed intervention:
strip out floorboards and deck

Proposed specification:
level as required; new ply deck, acoustic underlay and Grade A engineered timber boards

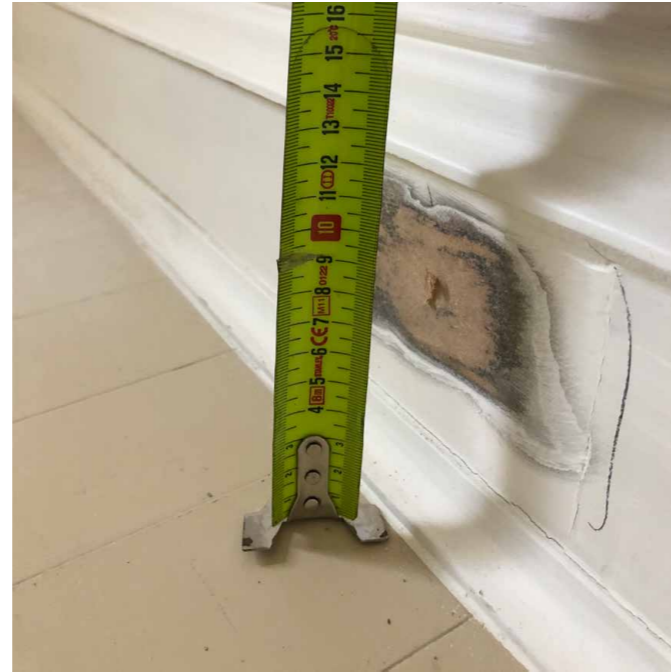
existing skirting board

Specification description:
timber ogee profile, painted.
Secondary 'bead' over skirting board appears to have been installed to conceal retrofit flooring junction along the perimeter.

Condition:
good

Proposed intervention:
retain; infill with sections to match where required

Proposed specification:
re-decorate

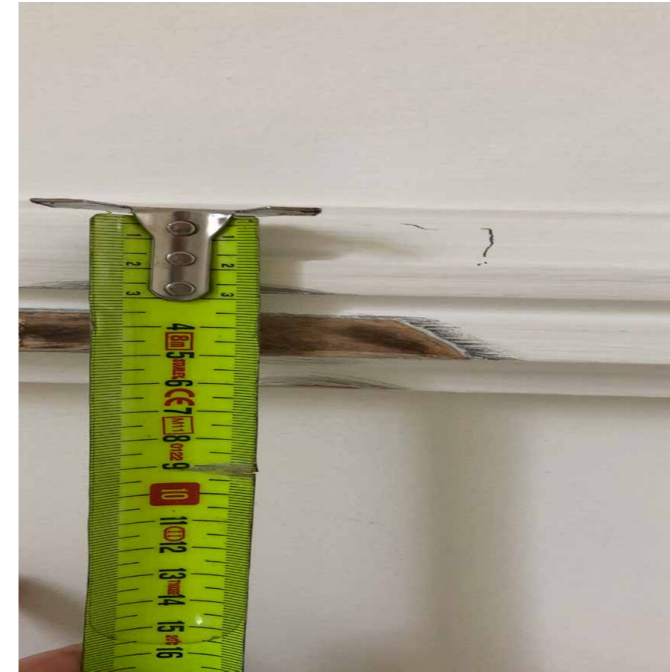
existing dado rail

Specification description:
timber ogee profile; varnished;

Condition:
good

Proposed intervention:
retain (except where new doorway opening is formed);

Proposed specification:
re-decorate

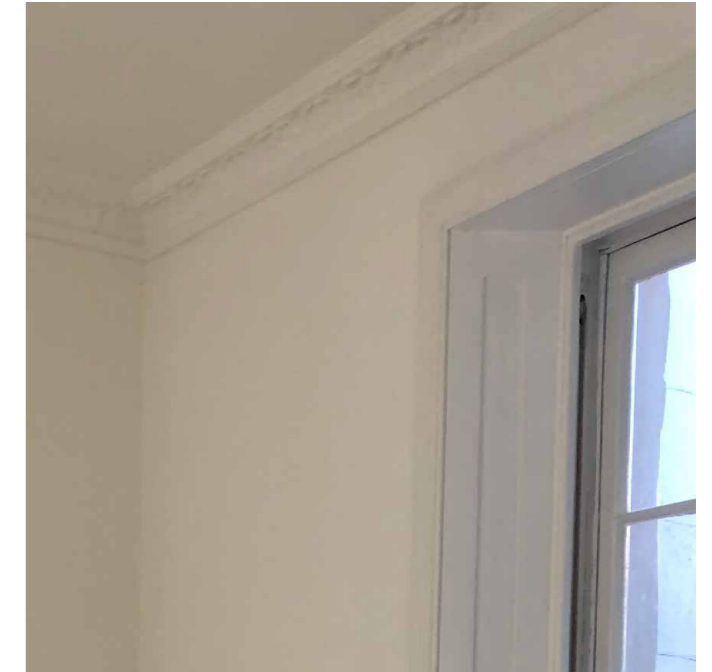
existing cornice

Specification description:
ornate, traditional

Condition:
good

Proposed intervention:
no works

Proposed specification:
re-decorate

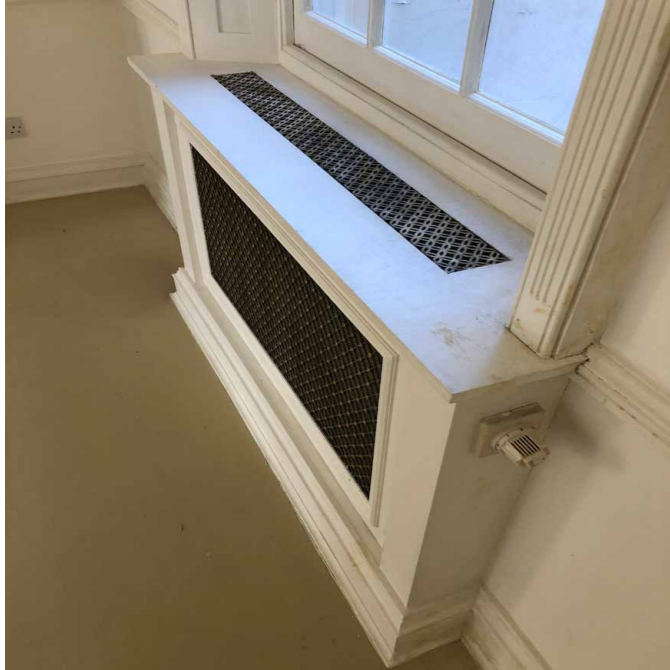
existing radiator and case (RF.02)

Specification description:
timber case with metal mesh to top and front panels;
ribbed steel panel radiator

Condition:
good

Proposed intervention:
retain amended

Proposed specification:
metal mesh replaced with timber slats and top pane;
paint over
new steel radiator

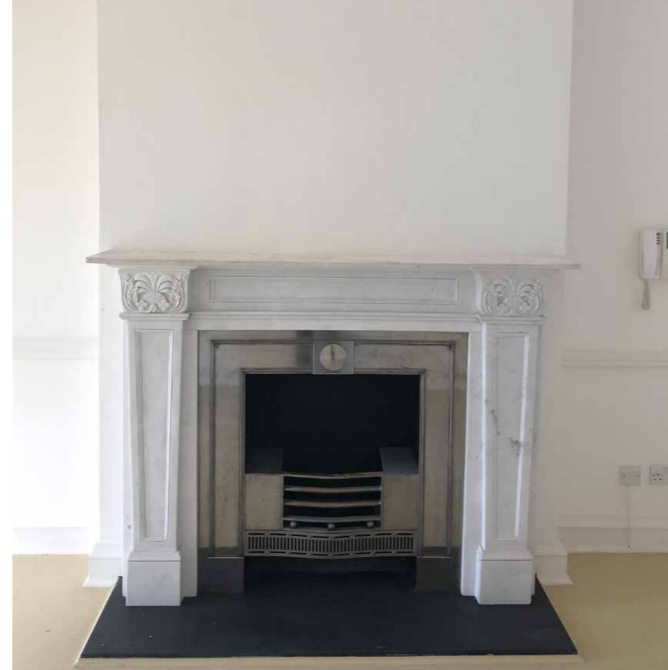
existing fireplace (FP.F1)

Specification description:
marble and metal surround; stone hearth

Condition:
good; flue sealed- the fireplace is decorative only

Proposed intervention:
remove surround, gather, hearth- make good

Proposed specification:
block up aperture with lightweight construction to facilitate functional family living area; vented

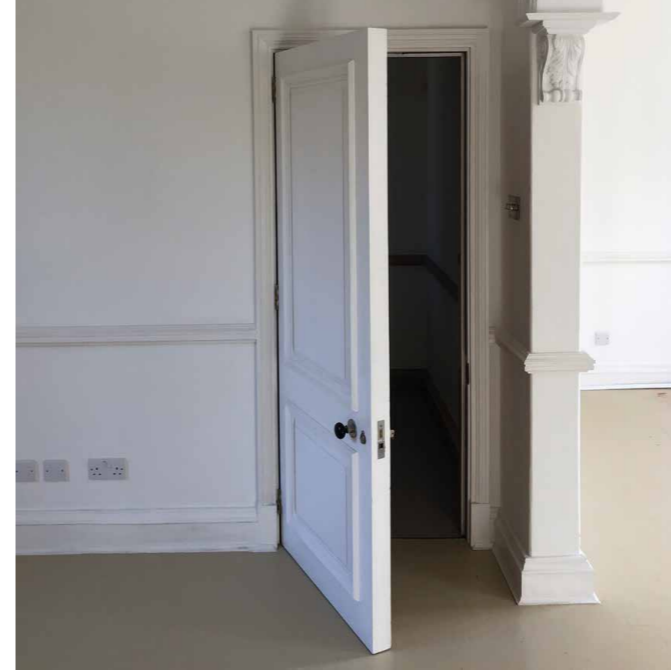
existing door (DF.02)

Specification description:
panelled timber, oversized thickness (c.50mm)

Condition:
good

Proposed intervention:
retain as is- lock shut (or replaced with new panel design- to match other new throughout the property)

Proposed specification:
new ironmongery and hardware
painted

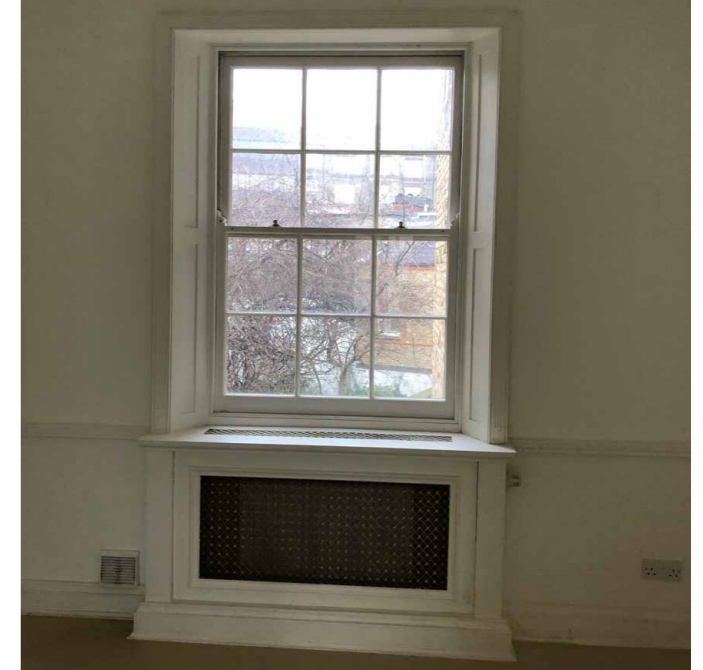
existing window (WF.02)

Specification description:
timber frame, single glazed, sashes;

Condition:
good

Proposed intervention:
new draft proofing- staff & parting beads; new pully & cord;
new ironmongery

Proposed specification:
redecorate to match

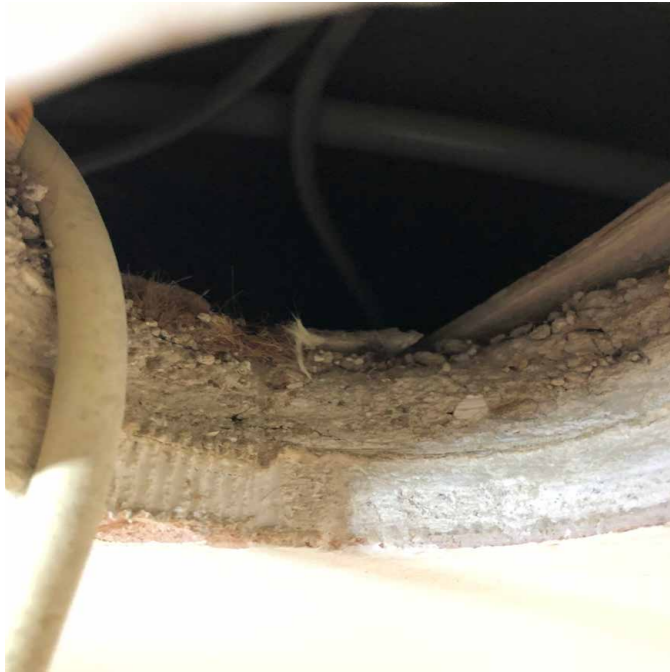
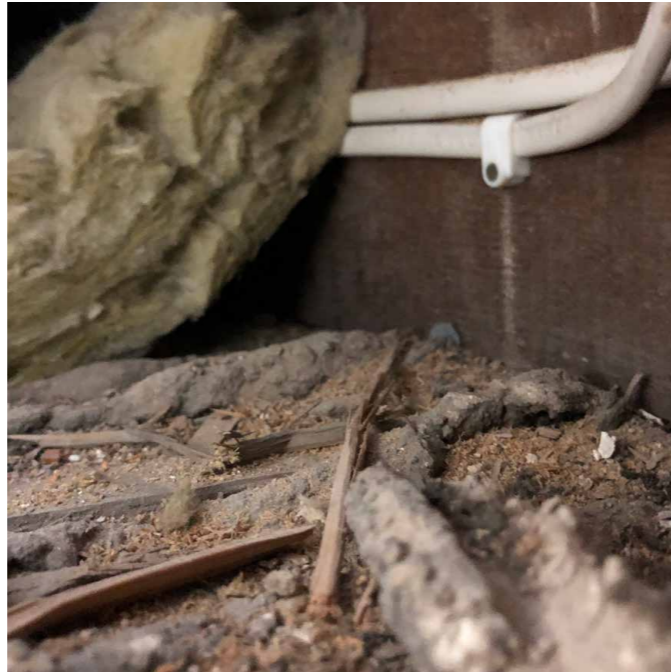
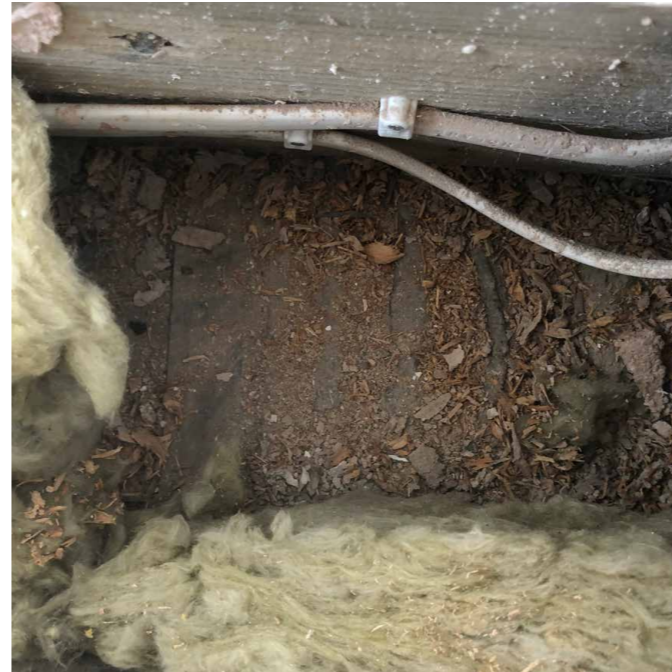
Substrate:
timber joists

Specification description:
lathe & plaster over boarded with modern plasterboard

Condition:
good

Proposed intervention:
retain as is; patch-in as required to suit new lighting layout

Proposed specification:
plasterboard and skim

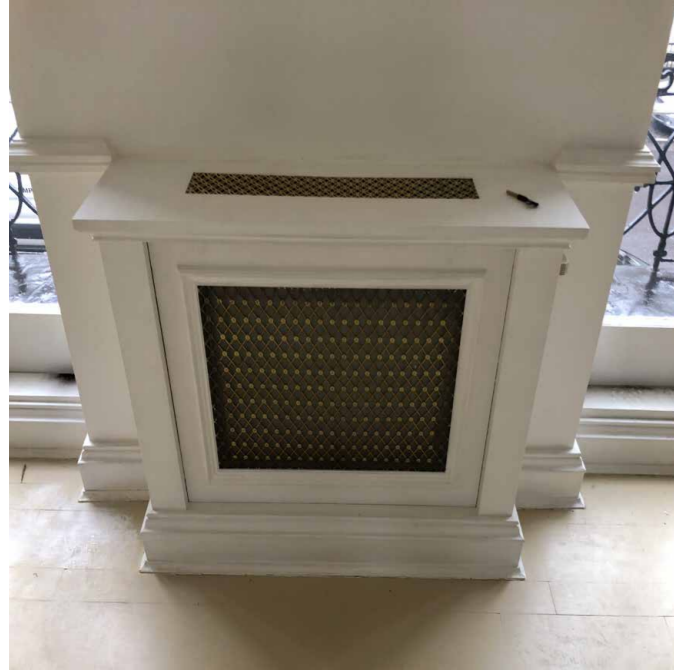
existing radiator and case (RF.03)

Specification description:
 timber case with metal mesh to top and front panels;
 ribbed steel panel radiator

Condition:
 good

Proposed intervention:
 retain amended

Proposed specification:
 increase height to line top pane through with dado rail;
 metal mesh replaced with timber slats and top panel;
 paint over
 new steel radiator

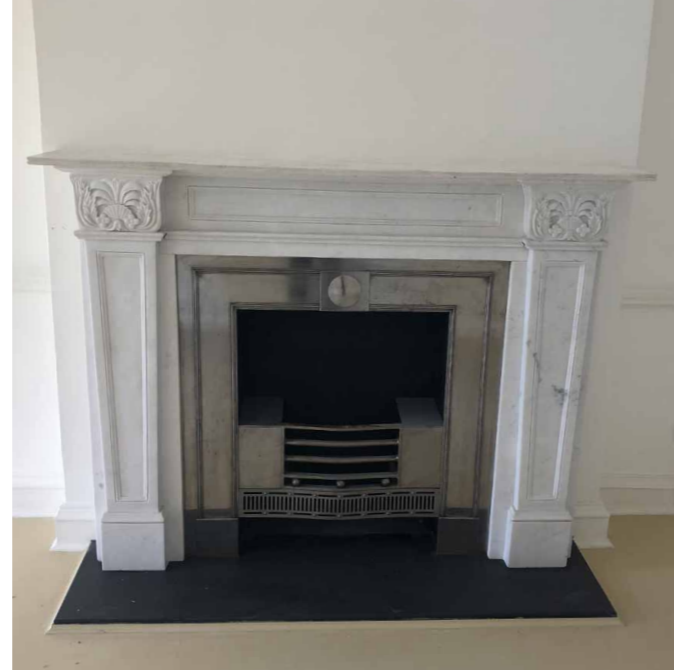
existing fireplace (FP.F2)

Specification description:
 marble and metal surround; stone hearth

Condition:
 good

Proposed intervention:
 retain all but the basket; renewed gas supply

Proposed specification:
 new basket

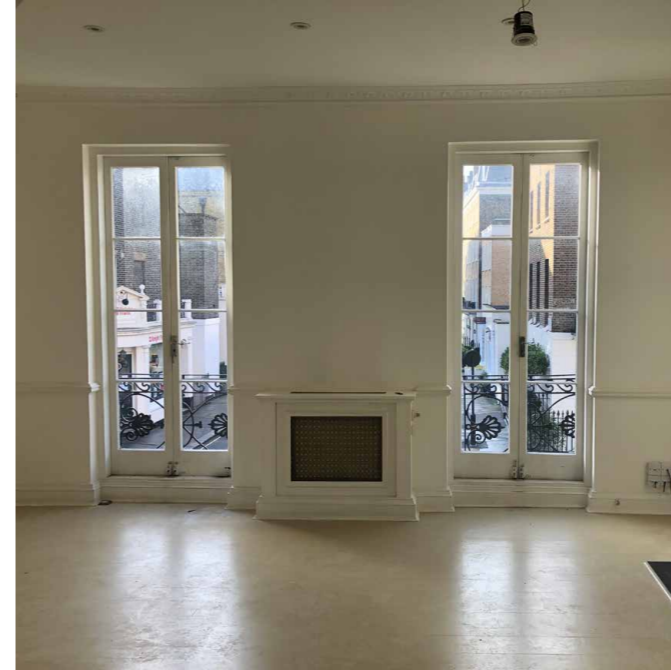
existing door (DF.03, DF.04)

Specification description:
 single glazed, timber frame French door

Condition:
 fair; some warping and rot due to water damage; very difficult to open, shut and lock

Proposed intervention:
 remove bottom rail to door leafs, sill and threshold

Proposed specification:
 new hardwood replacement parts to match existing;
 local repairs to mullions redecorate entire doorset;
 new draft proofing; new ironmongery and hardware;
 new privacy blind (fabric) to internal reveals to provide privacy from streetscape views and surrounding properties

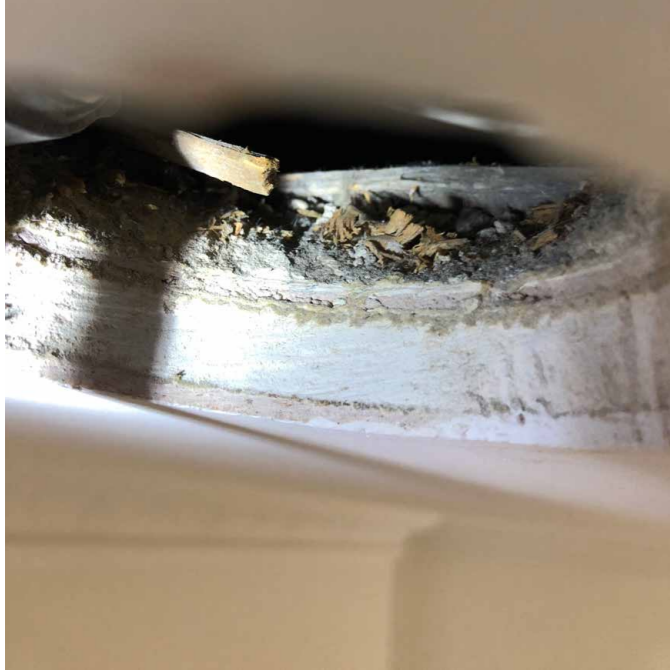
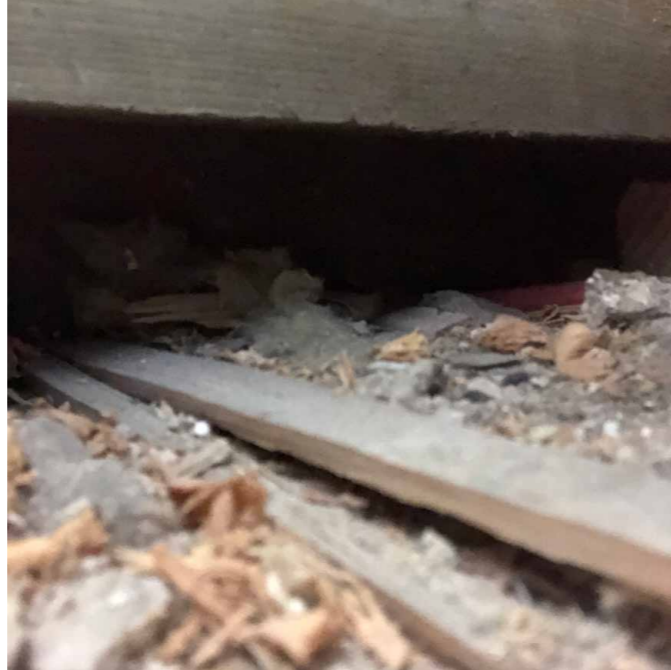
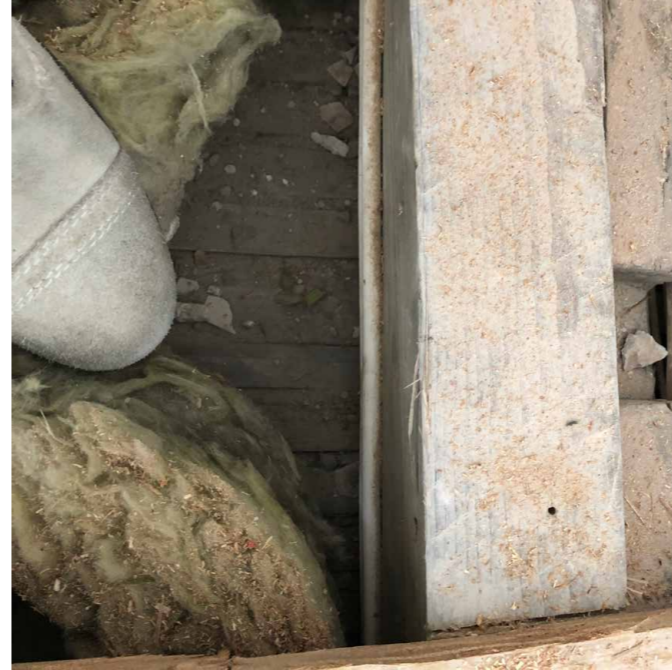
Substrate:
timber joists

Specification description:
lathe (some plaster) over boarded with modern
plasterboard

Condition:
good

Proposed intervention:
retain as is; patch-in as required to suit new lighting
layout

Proposed specification:
plasterboard and skim

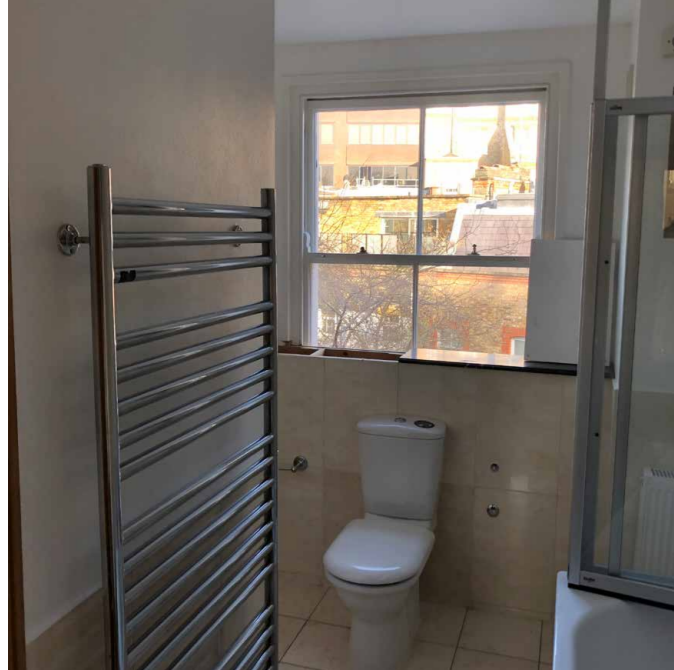
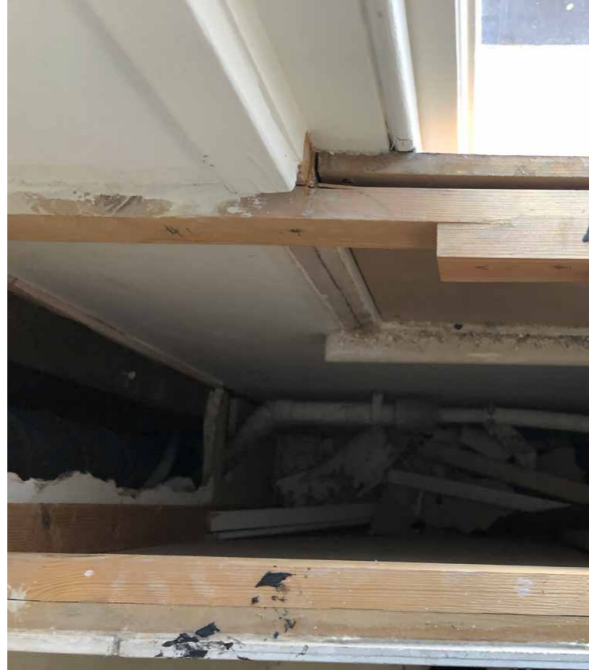
existing window (WS.04)

Specification description:
timber frame, single glazed, sashes;

Condition:
damage to architrave (internally)

Proposed intervention:
retain window

Proposed specification:
repair architrave to match;
new draft proofing- staff & parting beads; new pulley & cord;
new ironmongery
redecorate to match;
new roller black-out blind (fabric) to internal reveal.

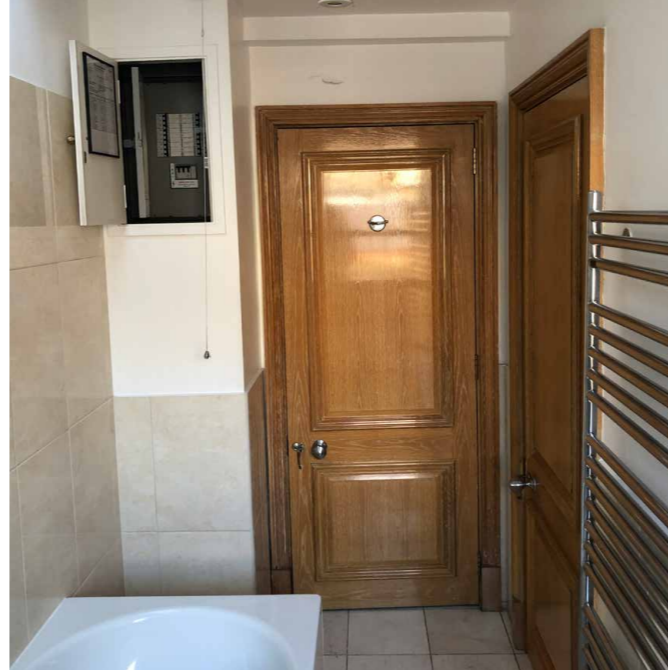
existing door (DS.01)

Specification description:
panelled timber, oversized thickness (c.50mm)

Condition:
good

Proposed intervention:
remove door leaf;
amend jamb; infill retained architrave holes, brush filler

Proposed specification:
hinged, panelled door leaf; new ironmongery and hardware
painted

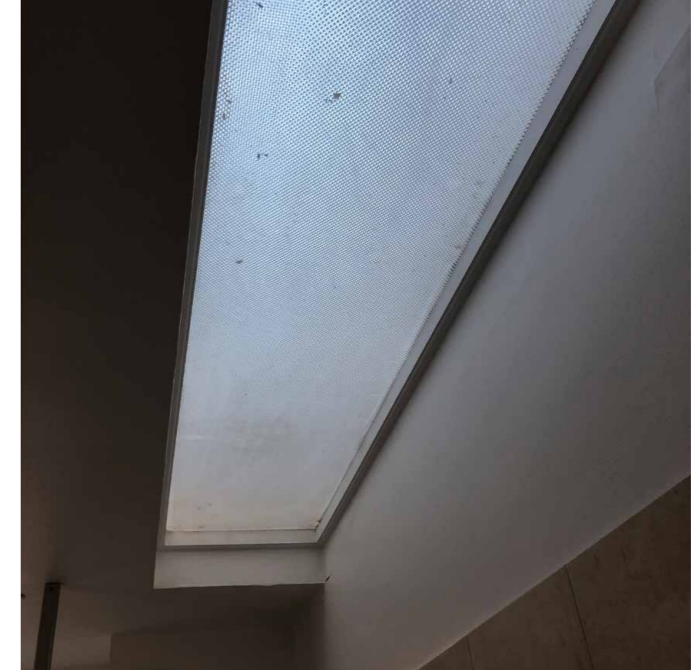
existing window (WS.05)

Specification description:
rooflight

Condition:
poor

Proposed intervention:
remove

Proposed specification:
infill roof

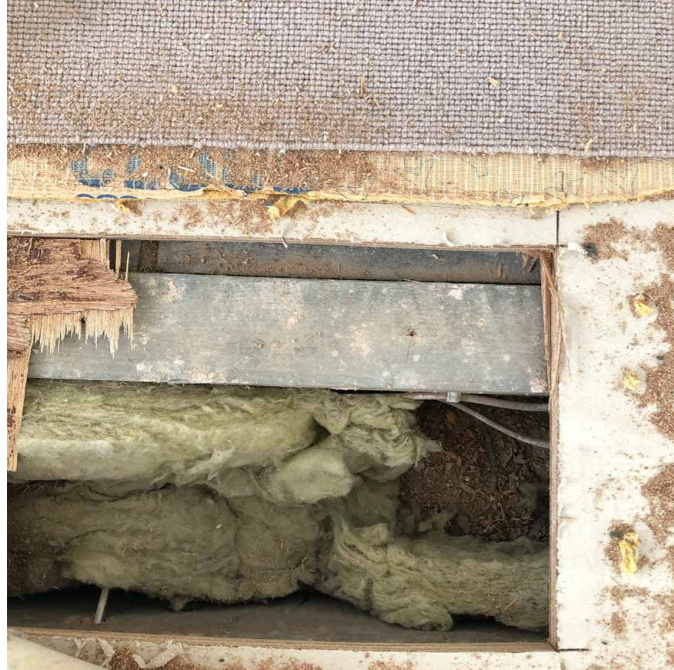
existing floor finish

Substrate:
Presumed original timber joists (c. h170mm) appear to have been strengthened/levelled with new timber joists (c.h145mm). Modern plywood deck is installed over the modernised joists structure. Mineral wool insulation within void. No signs of original floor finish was observed.

Condition:
good

Proposed intervention:
strip out floor finish

Proposed specification:
new ply deck (if required), acoustic underlay and new carpet

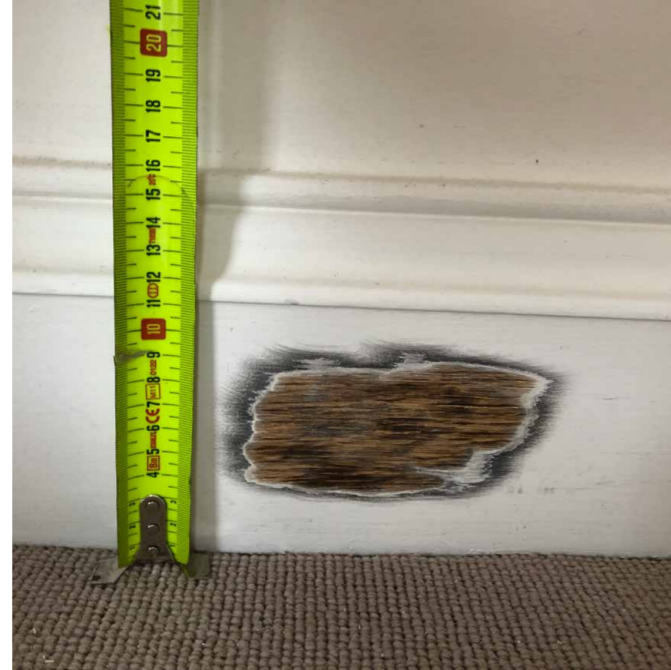
existing skirting board

Specification description:
timber ogee profile, painted.

Condition:
good

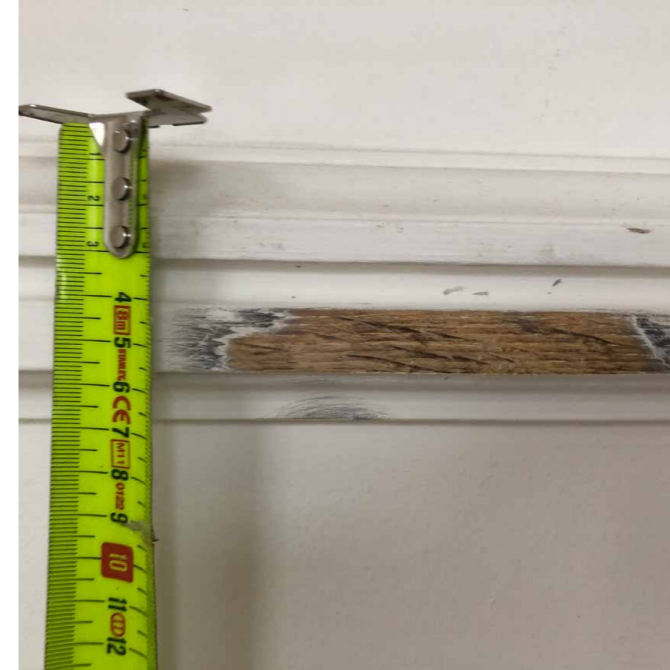
existing dado rail

Specification description:
timber ogee profile; painted;

Condition:
good

Proposed intervention:
retain, except along proposed new bathroom partition-
remove and set aside for re-use;

Proposed specification:
fit-back salvaged sections, infill with new to match
where required;
re-decorate

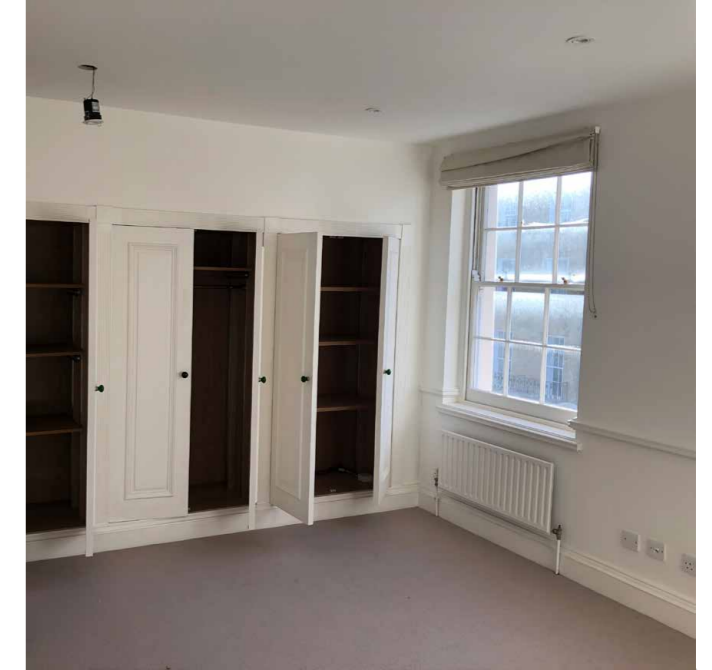
existing cornice

Specification description:
none present

Proposed intervention:
install new ornate cornice in keeping with the building's
heritage

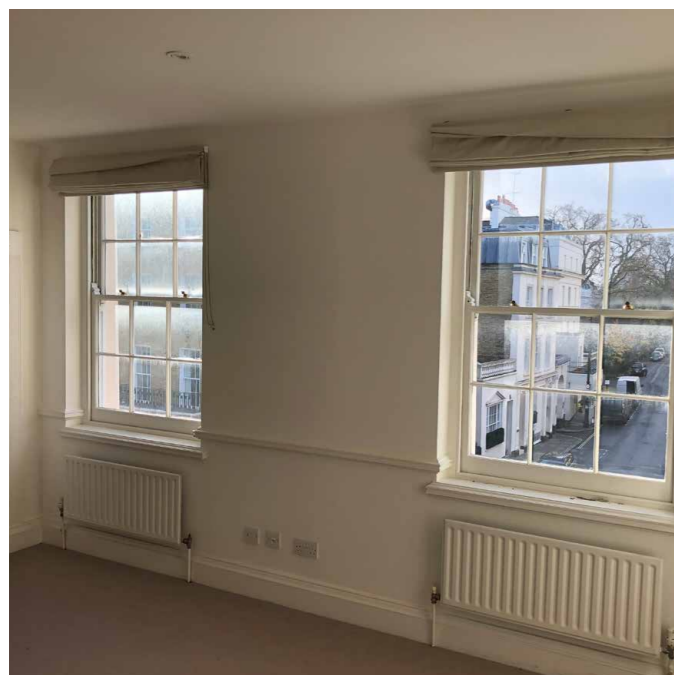
existing radiator (RS.02, RS.03)

Specification description:
ribbed steel panel radiator

Condition:
could not be tested

Proposed intervention:
strip out

Proposed specification:
new flat panel steel radiator enclosed within timber case, height to match retained window sills in adjusted location

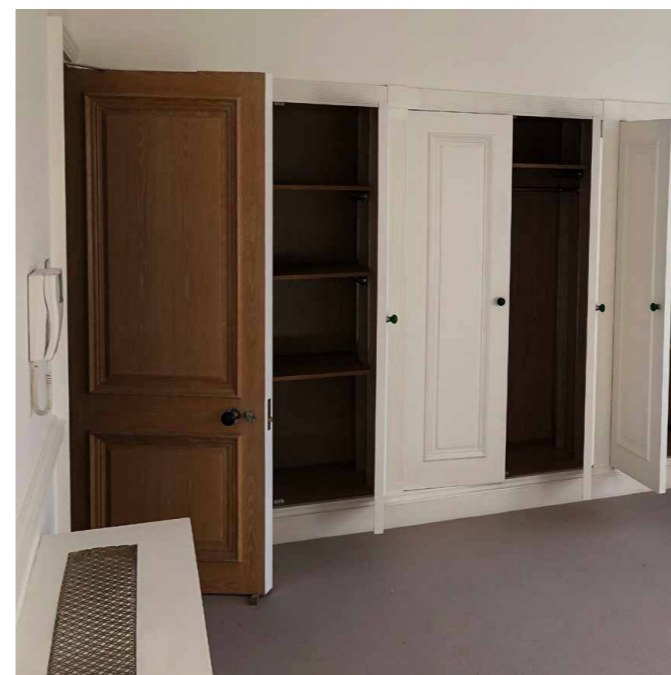
existing door (DS.04)

Specification description:
panelled timber, oversized thickness (c.50mm)

Condition:
good

Proposed intervention:
remove door leaf;
amend jamb; infill retained architrave holes, brush filler

Proposed specification:
hinged, panelled door leaf; new ironmongery and hardware painted

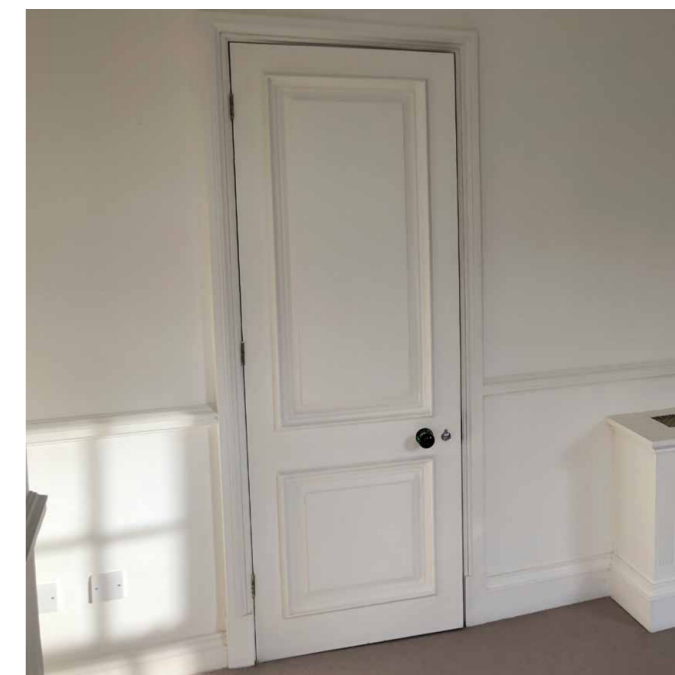
existing door (DS.05)

Specification description:
panelled timber, oversized thickness (c.50mm)

Condition:
good

Proposed intervention:
remove door leaf;
remove and set aside for re-use frame and architrave in new location; infill retained architrave holes, brush filler

Proposed specification:
hinged, panelled door leaf; new ironmongery and hardware painted
(re-use as door DS.05 to room FS.06)

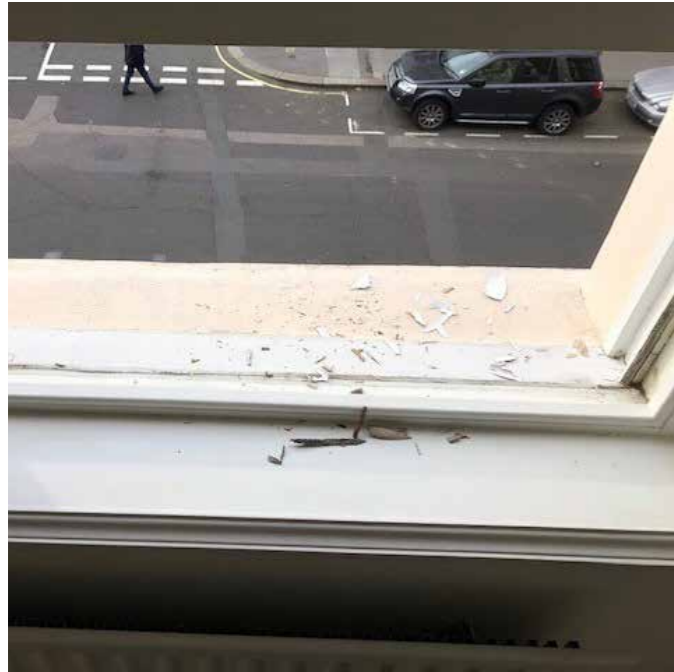
existing window (WS.01, WS.02)

Condition:
very poor- glass delaminated at corners/top rail

Proposed intervention:
retain frame and sash box

Proposed specification:
new sashes, single glazed- laminated 8.8mm acoustic;
new staff & parting beads; new draft proofing, pully & cord;
new ironmongery; repair & re-decorate external sill where damaged;
redecorate to match;
new roller black-out blind (fabric) to internal reveal.

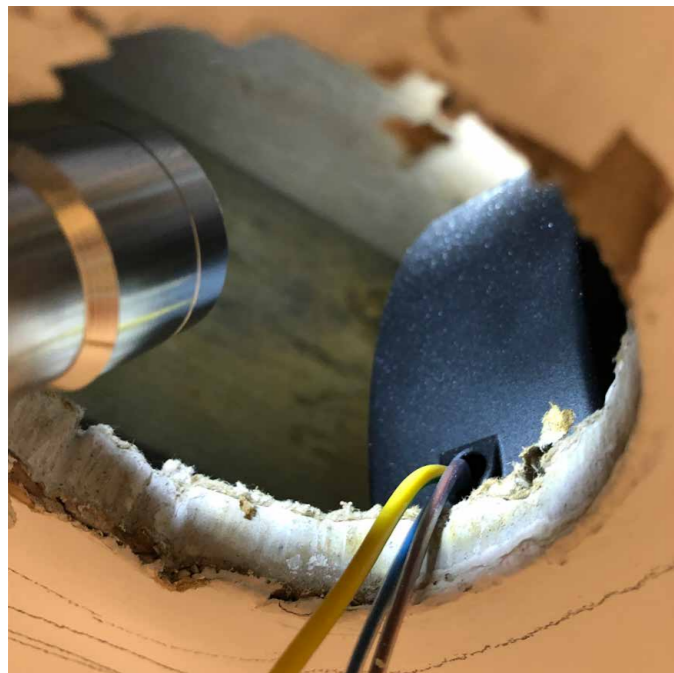
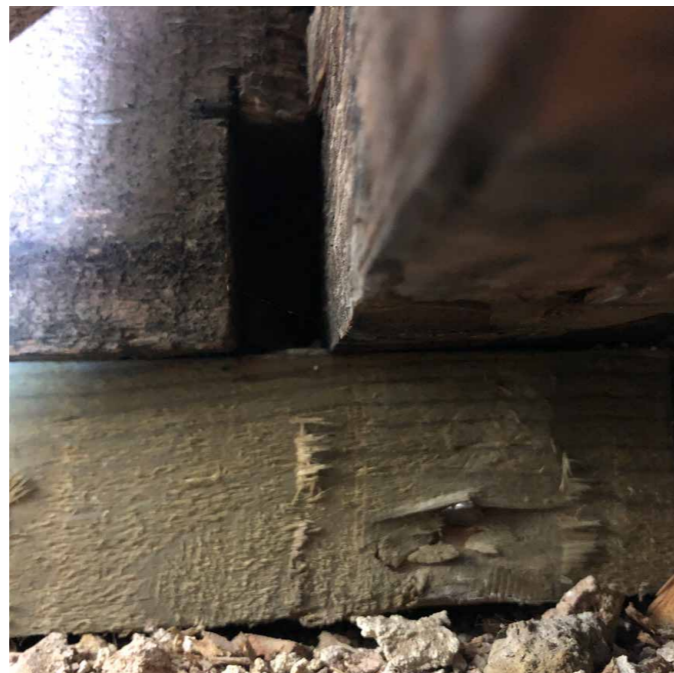
existing ceiling

Substrate:
timber joists with some insulation between

Specification description:
modern plasterboard

Condition:
good

Proposed intervention:
retain as is; patch-in as required to suit new lighting layout

Proposed specification:
plasterboard and skim

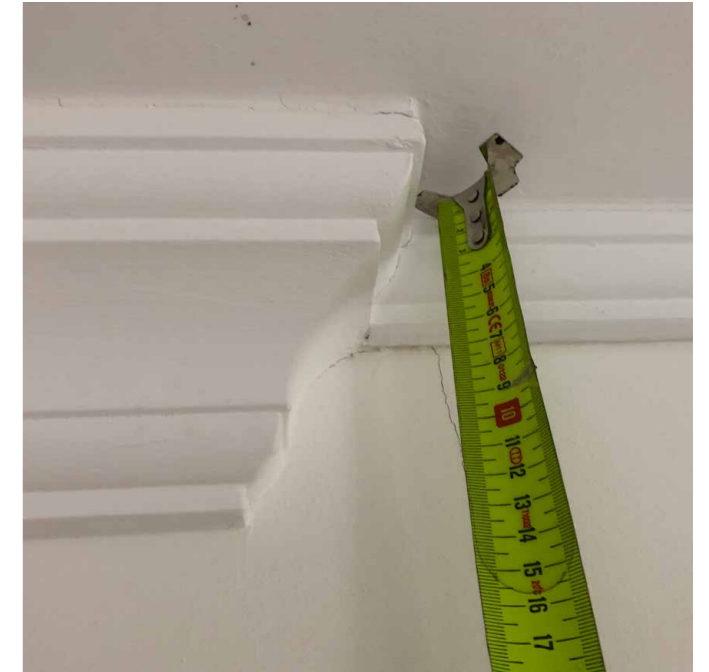
existing cornice

Condition:
good

Proposed intervention:
remove 2no short sections

Proposed specification:
install new ornate cornice, in keeping with building's
heritage- to entire room perimeter;
decorate

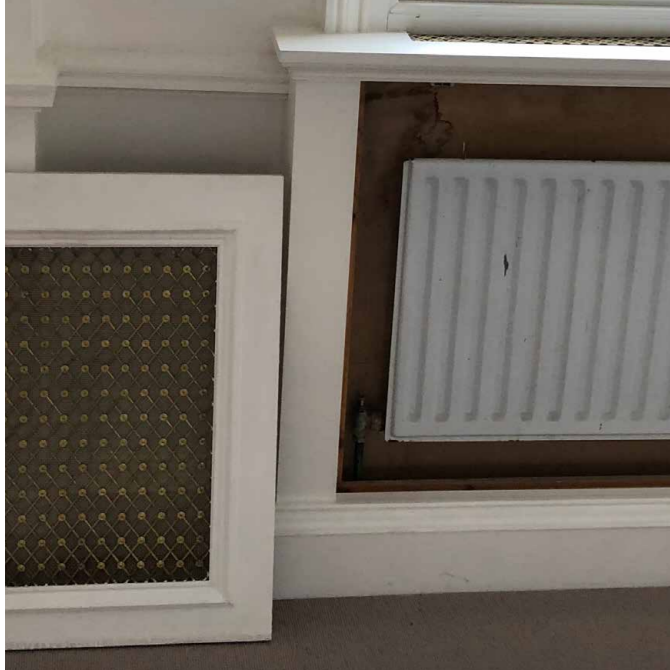
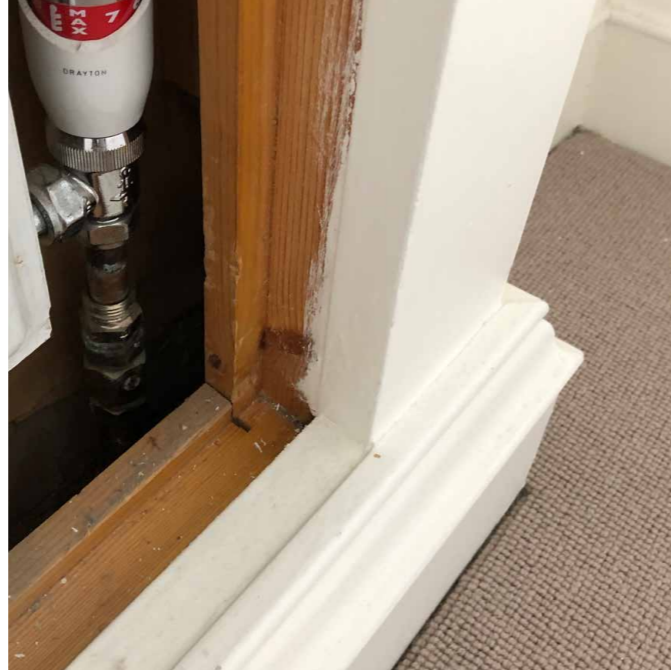
existing radiator and case (RT.01, RT.02)

Condition:
 fair

Proposed intervention:
 retain case; remove radiator

Proposed specification:
 metal mesh replaced with timber slats and top panel;
 paint over
 new steel radiator

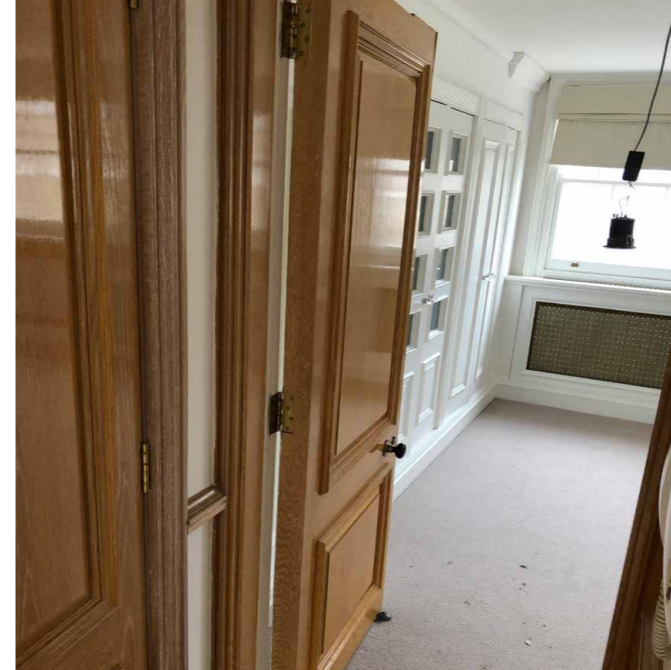
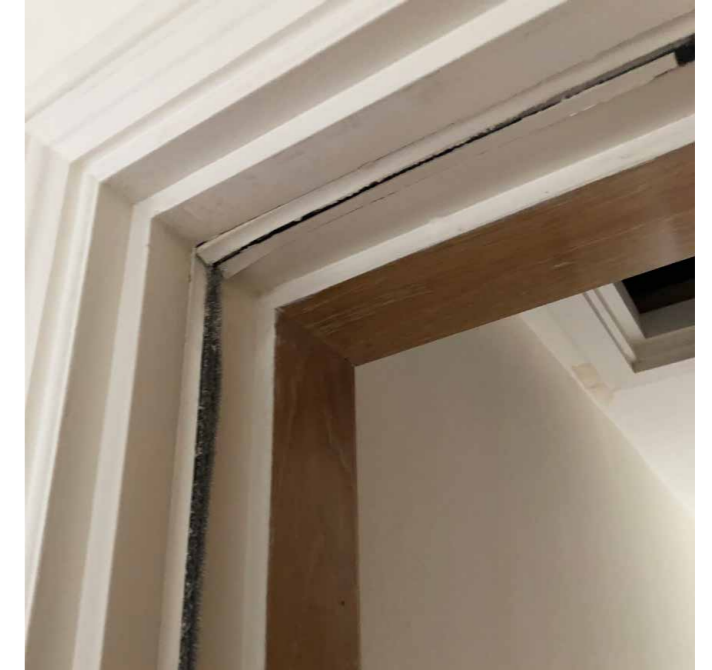
existing door (DT.03)

Specification description:
 panelled timber, oversized thickness (c.50mm)

Condition:
 good

Proposed intervention:
 remove door leaf;
 amend jamb; infill retained architrave holes, brush filler

Proposed specification:
 hinged, panelled door leaf; new ironmongery and
 hardware
 painted

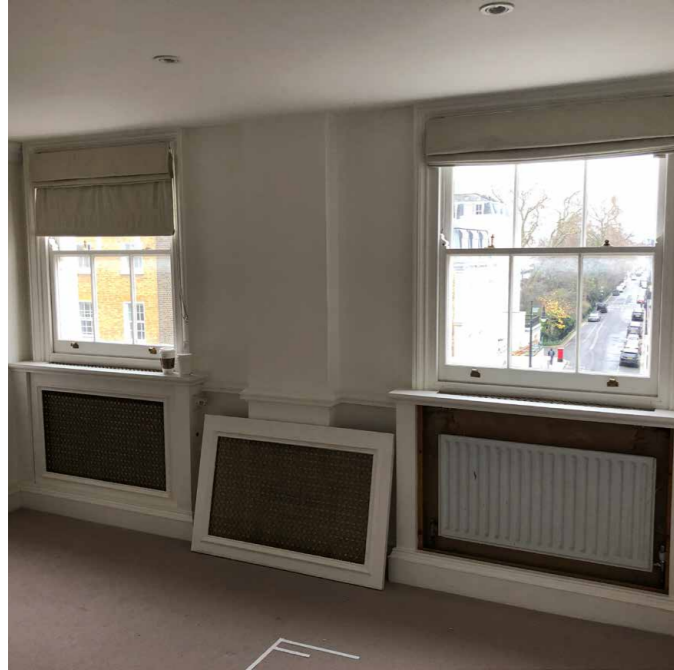
existing window (WT.01, WT.02)

Condition:
very poor- glass delaminated to corners/upper rail

Proposed intervention:
retain frame and sash box

Proposed specification:
repair sill; new sashes, single glazed- laminated acoustic
8.8mm glass; new staff & parting beads
new draft proofing, pulley & cord;
new ironmongery; repair & re-decorate external sill
where damaged;
redecorate to match;
new roller black-out blind (fabric) to internal reveal.

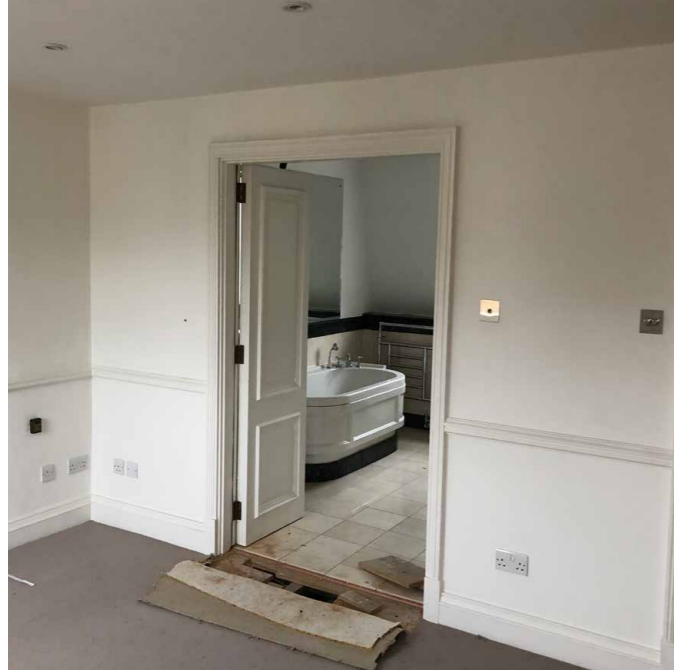
existing door (DT.03)

Specification description:
panelled timber

Condition:
good

Proposed intervention:
remove door leaf;
amend jamb; infill retained amended architraves as
required, brush filler

Proposed specification:
pocket, panelled door leaf; new ironmongery and
hardware
painted

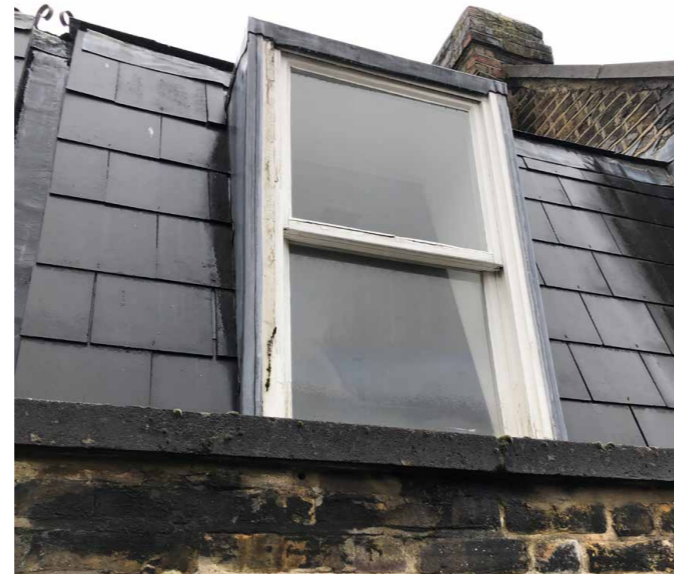
existing window (WT.03)

Specification description:
timber frame, single glazed, sashes- no mullions

Condition:
fair;
style not in keeping with the building's heritage and
other windows

Proposed intervention:
retain frame

Proposed specification:
repair frame and new spring balance; new sashes single
glazed (4mm)- to match mullion & transom design
elsewhere
new ironmongery;
redecorate to match
