Summary Heritage Asset Assessment of Brundish Manor, Brundish, Suffolk.

May 2018

Nicolaas Joubert MSc.
Historic Buildings Consultant Ltd.
M: 07717533498
E: historicbuildings.haa@gmail.com

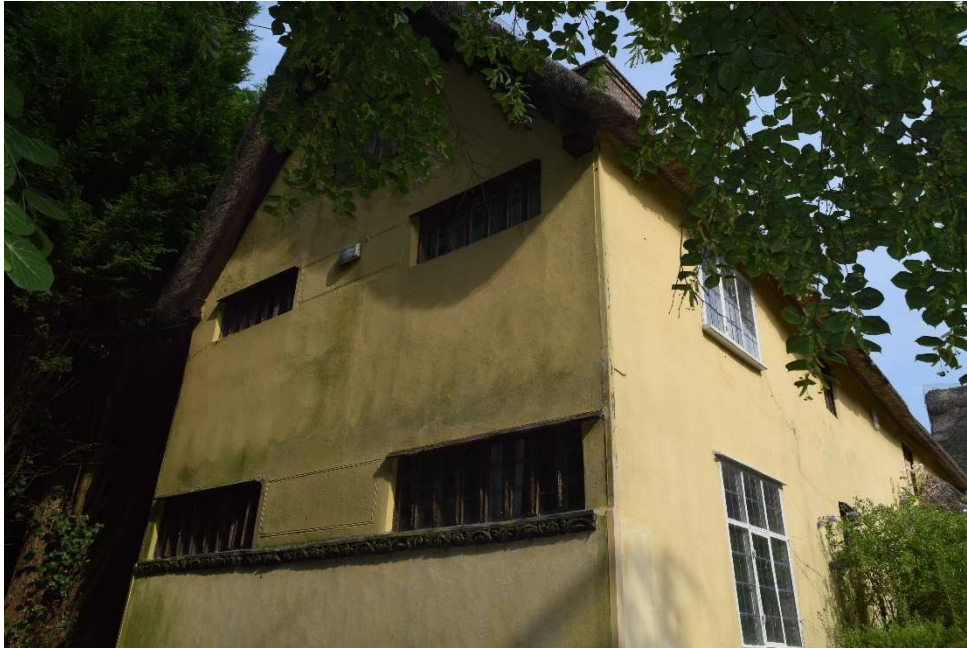
Figure 4: Main wing of Brundish Manor.

- 4.1.1 Brundish Manor consists of two wings which form an L-shaped footprint. The larger of the two wings which constitute the main range is gabled to the north-west arm of the moat and The Street. The second range which has a north-east to south-west orientation served as a service wing to the main range. The service wing is of an earlier date. The main wing of Brundish Manor dates to the latter half of the C16.

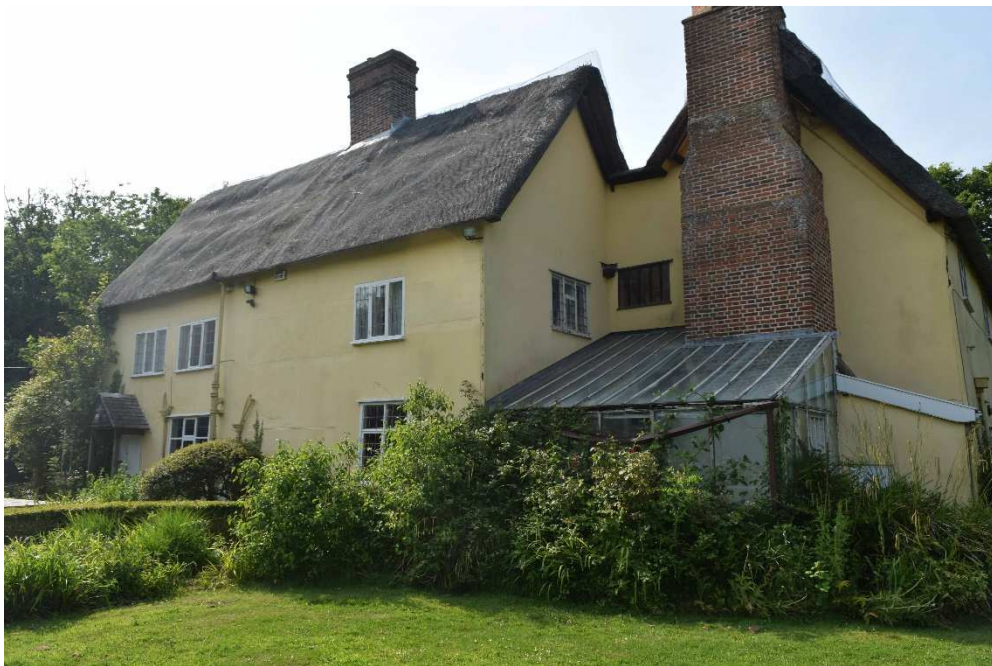
Figure 8: South-east elevation of the service wing and main wing.

4.2.1 The service wing of Brundish Manor appears to have been constructed in c.1500. There is evidence of severe historical fire damage to the original timber frame of the building which predates the C17 alterations to the building. This wing was a service wing from the outset which was clearly associated with a larger main dwelling which predates the current
