**FEBRUARY 2021**

**STRUCTURAL REPORT ON  
MORTIMER'S WAREHOUSE,  
RIVER HEAD, DRIFFIELD,  
YO25 6BA**

**PROJECT NO.  
MGC/SJH/HW/45057-Rp001**

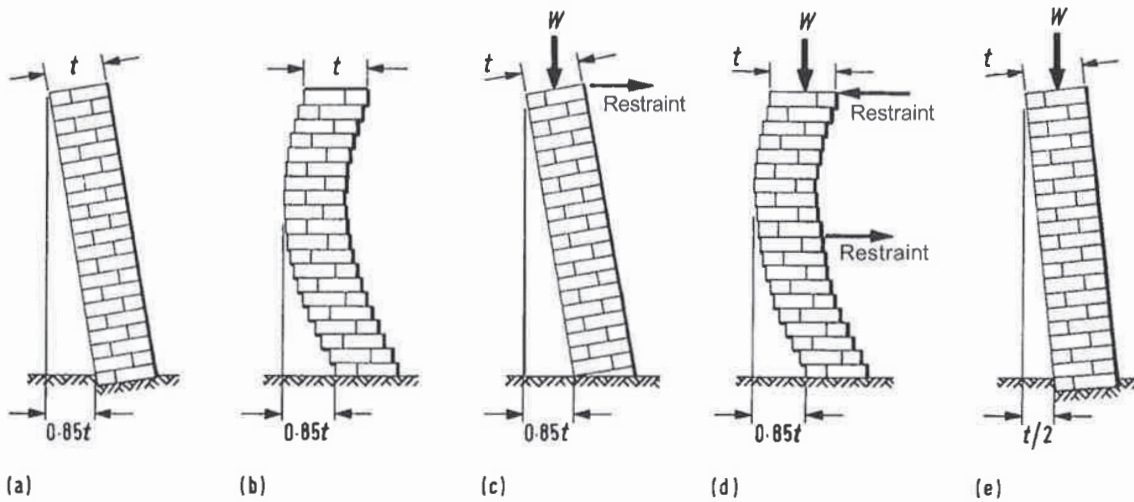
**Figure 12** Stability of free-standing and restrained walls

- 3.8 Given the apparent slight lean of the wall, we feel that it is stable. As CIRIA Report 111 – Figure 12 (a), a copy of which is in Appendix B, the lean of the wall should not exceed  $0.85 \times$  thickness of the wall, which is approximately 500mm thick at ground level, and 400mm thick at first floor and above. Therefore, the allowable lean before the wall becomes unstable is  $500\text{mm} \times 0.85 = 425\text{mm}$ , or  $400 \times 0.85 = 340$ . As previously measured, the wall is approximately 225mm out of plumb and does not exceed the allowable lean and can be considered to be stable at the time of inspection.

- 3.15 Given the apparent slight lean of the wall, we feel that it is stable. As CIRIA Report 111 – Figure 12 (a), a copy of which is in Appendix B, the lean of the wall should not exceed  $0.85 \times$  thickness of the wall, which is approximately 500mm thick. Therefore, the allowable lean before the wall becomes unstable is  $500\text{mm} \times 0.85 = 425\text{mm}$ . As previously measured, the wall is approximately 46mm out of plumb and does not exceed the allowable lean and can be considered to be stable at the time of inspection.

- 3.23 Given the apparent slight lean of the wall, we feel that it is stable. As CIRIA Report 111 – Figure 12 (a), a copy of which is in Appendix B, the lean of the wall should not exceed  $0.85 \times$  thickness of the wall, which is approximately 400mm thick. Therefore, the allowable lean before the wall becomes unstable is  $400\text{mm} \times 0.85 = 340\text{mm}$ . As previously measured, the wall is approximately 110mm out of plumb and does not exceed the allowable lean and can be considered to be stable at the time of inspection.
- 3.24 We noted that some of the original second floor joist have cracked, however, additional timbers have been bolted in place to provide support. See Photograph No. 25.

- 3.29 Given the apparent slight lean of the wall, we feel that it is stable. As CIRIA Report 111 – Figure 12 (a), a copy of which is in Appendix B, the lean of the wall should not exceed  $0.85 \times$  thickness of the wall, which is approximately 400mm thick. Therefore, the allowable lean before the wall becomes unstable is  $400\text{mm} \times 0.85 = 430\text{mm}$ . As previously measured, the wall is approximately 111mm out of plumb and does not exceed the allowable lean and can be considered to be stable at the time of inspection.

- 3.31 Given the apparent slight lean of the wall, we feel that it is stable. As CIRIA Report 111 – Figure 12 (a), a copy of which is in Appendix B, the lean of the wall should not exceed  $0.85 \times$  thickness of the wall, which is approximately 400mm thick. Therefore, the allowable lean before the wall becomes unstable is  $400\text{mm} \times 0.85 = 430\text{mm}$ . As previously measured, the wall is approximately 75mm out of plumb and does not exceed the allowable lean and can be considered to be stable at the time of inspection.
