3.7 Link Entrance—

4.1 External Repairs: Findings & Recommendations

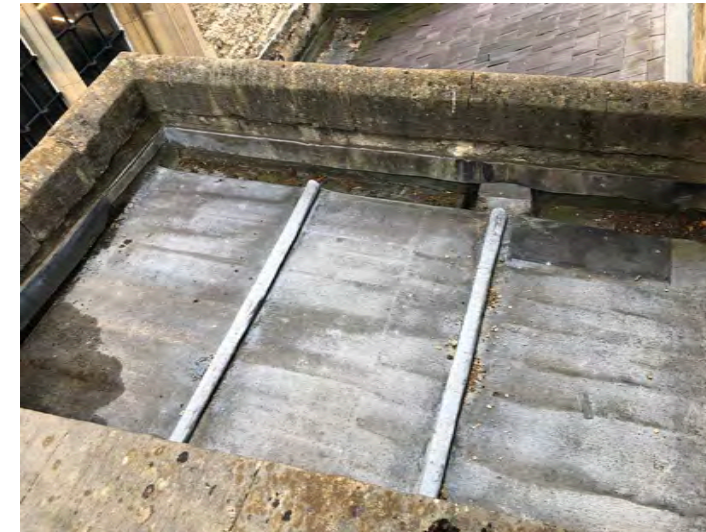
01. Flat lead roof to link block
02. Sloping slate roof above safe room and gardener's store

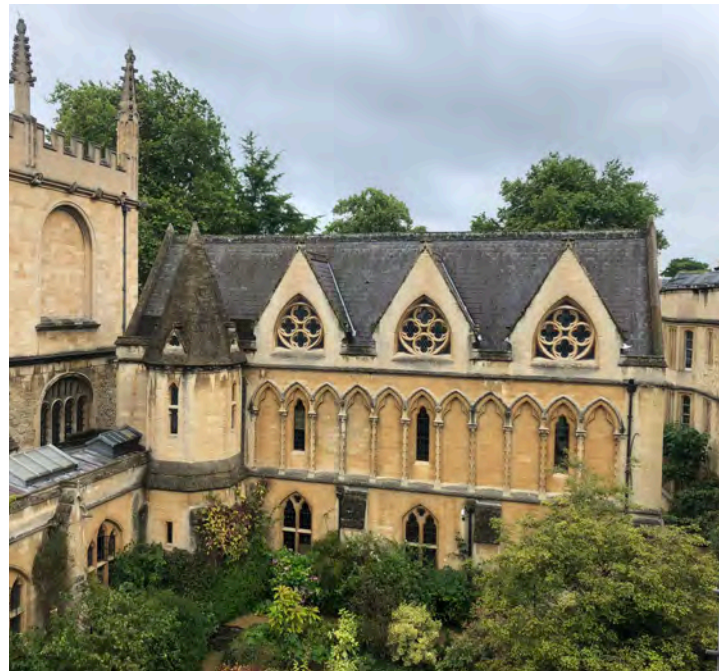
- 05. South elevation: main library and tower
- 06. West elevation: main library and tower
- 07. Top view of South elevation: main library
- 08. Top view of South elevation: tower, annexe and link building

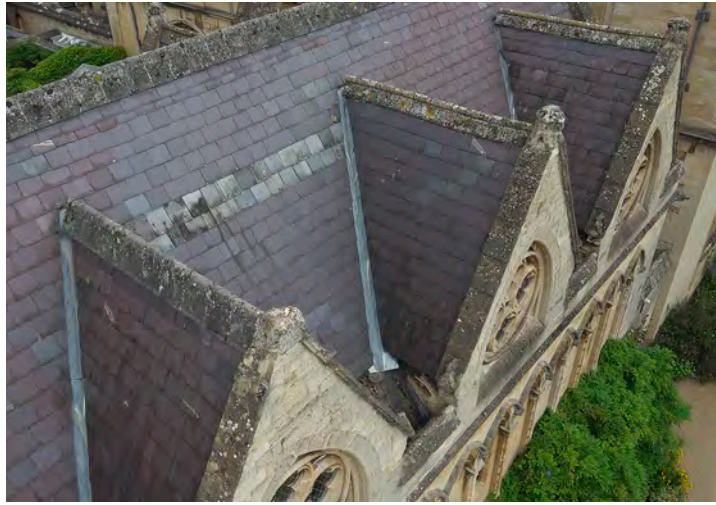
01. Bird's eye view of southern side of main library
 02. Annexe
 03. Junction at Main Library, Tower, Annexe and Link buildings
 04. Main Library
 07. Main Library - difference in slates

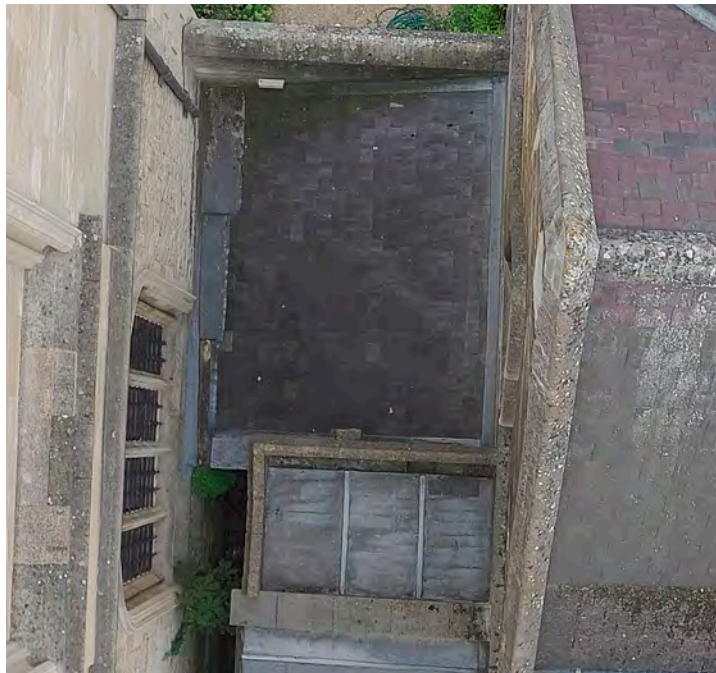
05. Link
 06. Annexe rooflights
 08. Main Library - Lead valleys

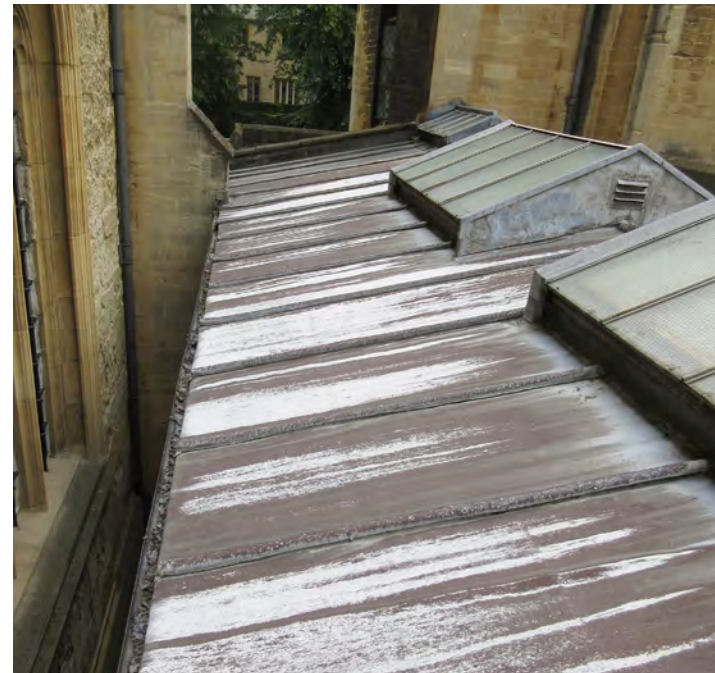
06.

The lead is suffering from severe surface oxidisation, due to atmospheric pollutants, while the method in which it was laid, with hollow intermediate rolls, has resulted in a number of stress fractures at the end drips.

In addition, the rooflights are not of the quality expected in such a prestigious building, utilising polycarbonate glazing and rudimentary frames, while the state of the under-boarding to the lead is questionable, due to the noticeable unevenness in places, while lifting one small area of lead revealed that the felt underlay had deteriorated completely.

Due to the need to re-lead the Annexe roof, this also provides us with the opportunity to replace the rooflights with a lantern of a quality appropriate to the building. Recovering the roof also allows us to incorporate a ventilated substrate allowing insulation to be incorporated within the roof structure, which currently has none. This will have the effect of pushing the existing ridge line upwards, due to both the incorporation of insulation and the new lantern design. As per Nex Architects drawings, the lead roof to the lantern will still lie below the existing north gable end of the Annexe, and due to the parapet to the west, the impact from the Rector's garden will be limited. Views have been included within the application drawings to illustrate this impact.

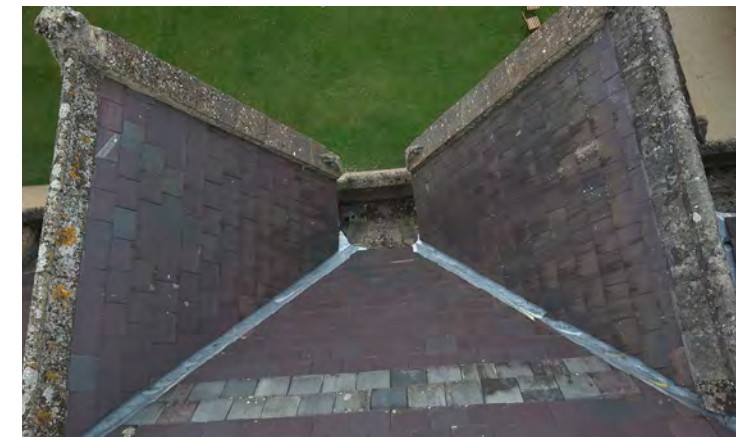
08.

While the condition of the slating appears to be reasonable, the condition of the valley and other flashings cannot be readily assessed without scaffolding or other means of access, while drone images suggest that cover flashings to the dormer cheeks have not been replaced.

At the same time, a multi-foil insulant will be incorporated to improve the thermal efficiency of the structure, while all leadwork is renewed. In conjunction with the ecological mitigation strategy, bat access slates will be incorporated where recommended in the north slope, located where possible to limit visibility from the ground.
