4.2 Repairs and Alterations to Windows: Findings & Recommendations

4.3 Internal Repairs: Findings & Recommendations

4.4 Repairs to Bookcases: Findings & Recommendations

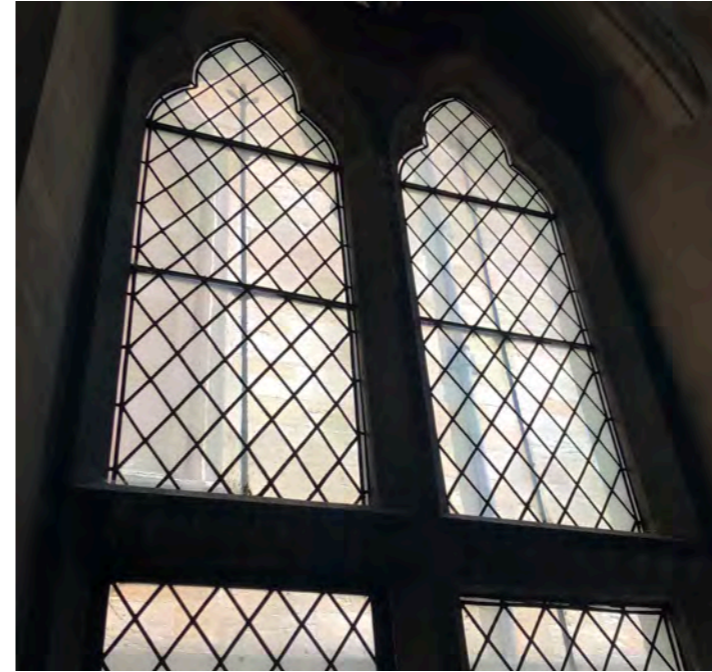
- 01. Sliding light to the ground floor of the main library
- 02. Close up of missing glazing to sliding unit
- 03. Surviving diamond quarries to west gable end
- 04. Burne Jones stained glass with casement below

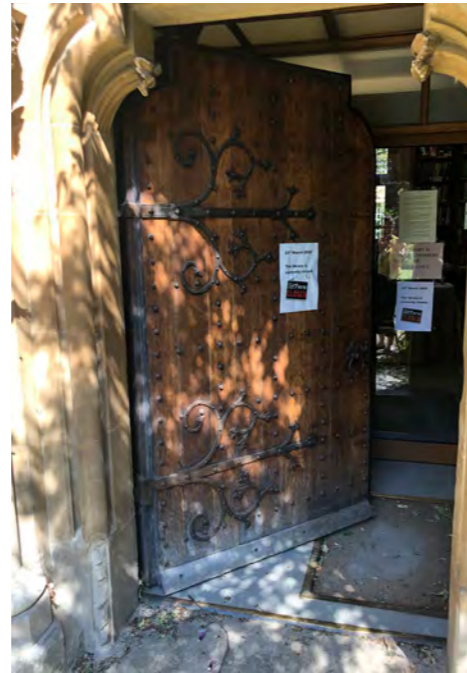
- 01. Door DG1 - Main entrance door
- 02. Door DG2 - To be removed
- 03. Door DG3 - To be upgraded
- 04. Door DG4 - No door
- 05. Door DG5 - To be removed
- 06. Door DG6 - Interior face
- 07. Door DG6 - Cut head to door
- 08. Door DG7 - To be upgraded

The existing entrance door requires minor repairs only and will be re-stained externally where it has been weathered. The remaining two doors to the gardener's store and basement book stack in the Annexe will be removed and set aside for use by the College.
