Detailed condition survey of

Rosewarne House, Holman Park, Camborne TR14 8FE

Lesley Anne Price RIBA

3rd January 2018

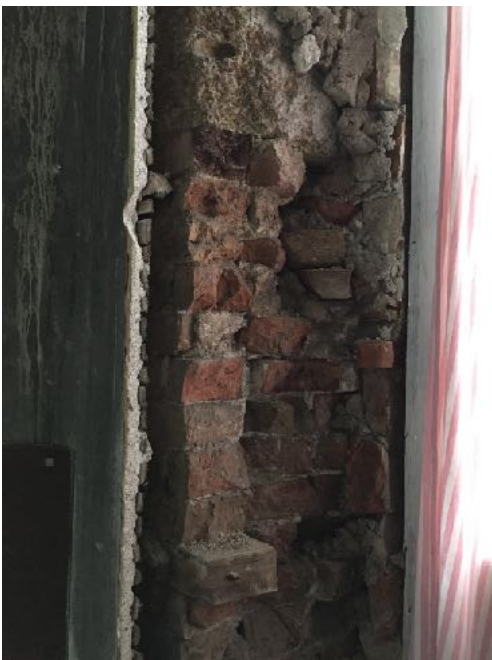
This is the area visibly most badly infested, and from where fruiting bodies were removed on a regular basis. You will see that this is probably the finest cornice in the building, albeit the most damaged.

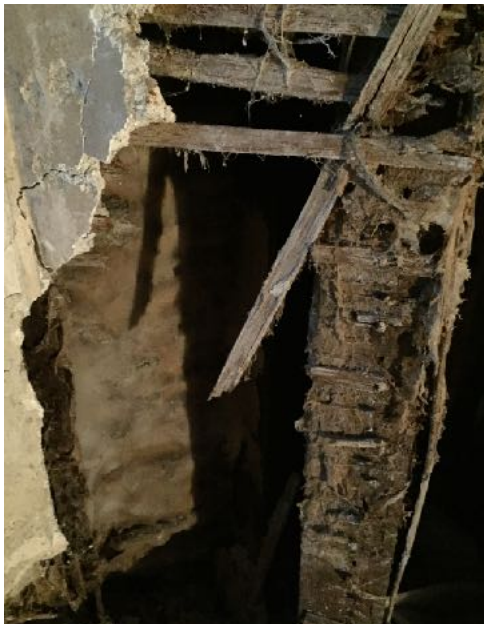
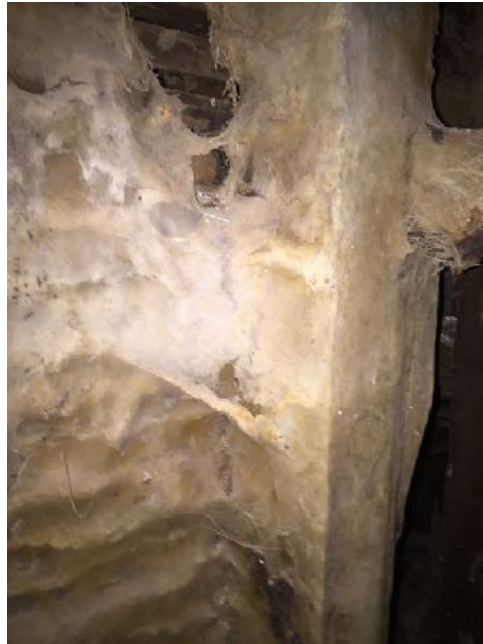
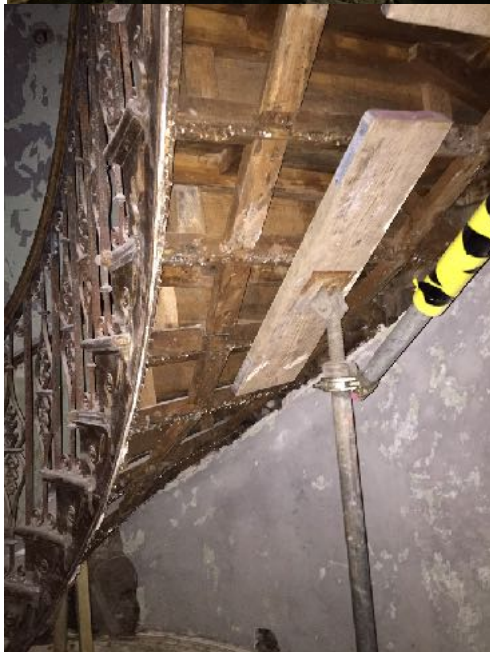
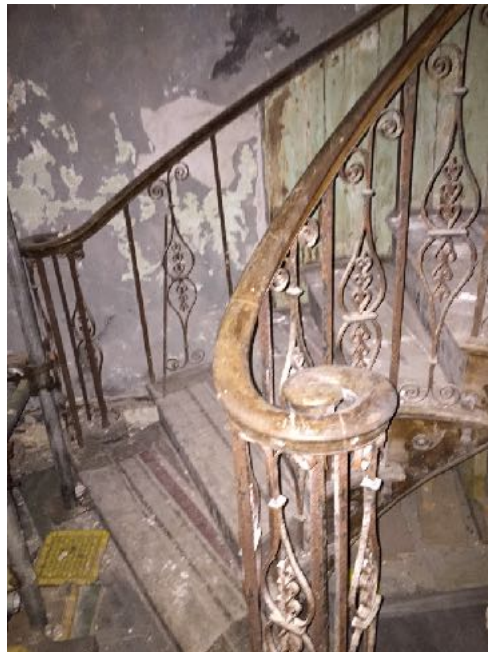
The structure of the semi-circular drum is (again) of undersized timber posts, all of which have been damaged by rot. The photographs show our investigations through from ground level in the rear corridor looking in to the drum, where the dry rot has done its damage. It is clear therefore that extra propping in steel between the existing posts will be required as the drum extends over 7 metres up to the ornate lantern light above.

There are a number of missing balusters which are already being made up in wrought iron by Tristan Kessel. We have had several samples made, including by 3D printing, but finally we have found an artist capable of making a direct copy. The treads are oak but thin and much damaged so we are devising a scheme whereby they are the top layer of a strengthened (and invisible) tread supported by the interspersed steel posts behind.

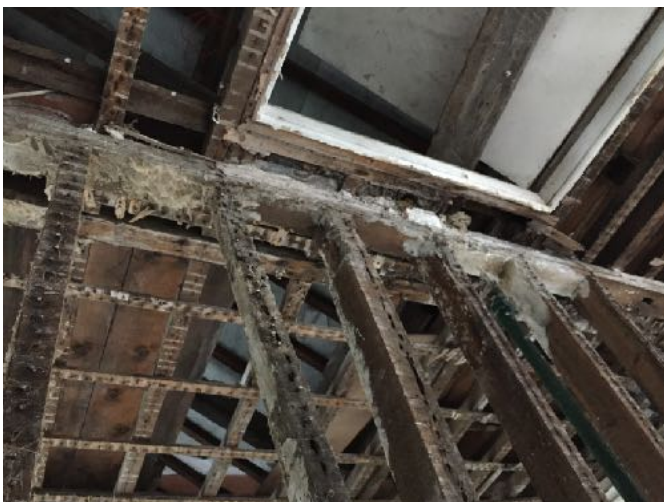
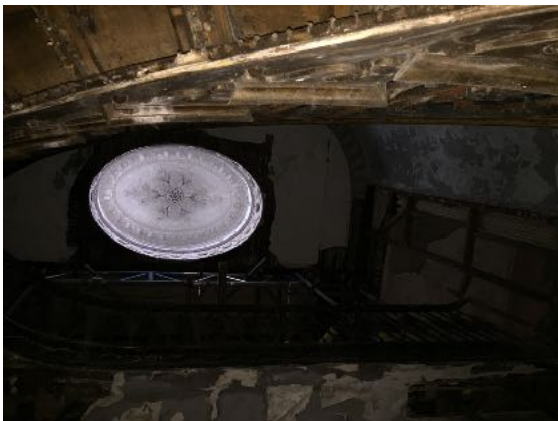
**Above in the upstairs corridor and landing**

All much damaged by water ingress and vandalism

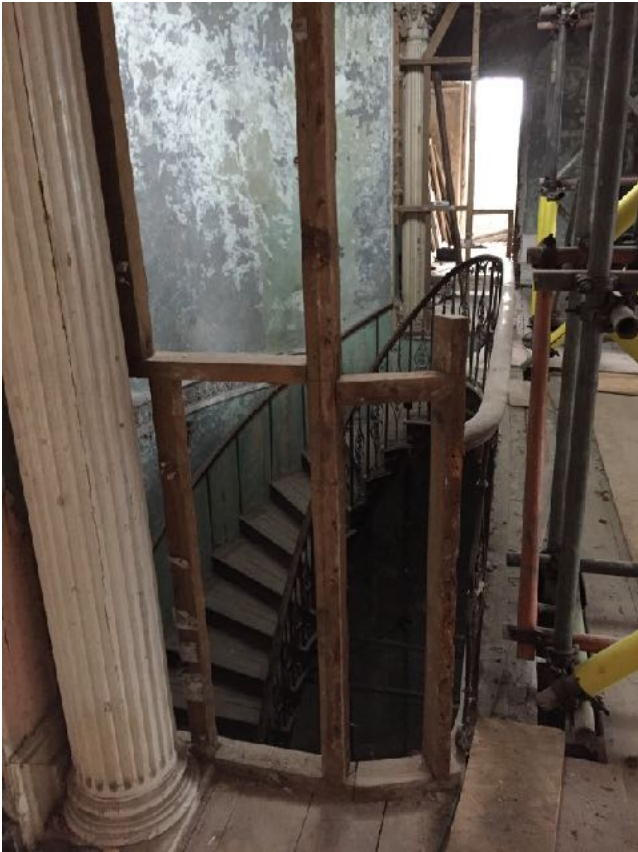
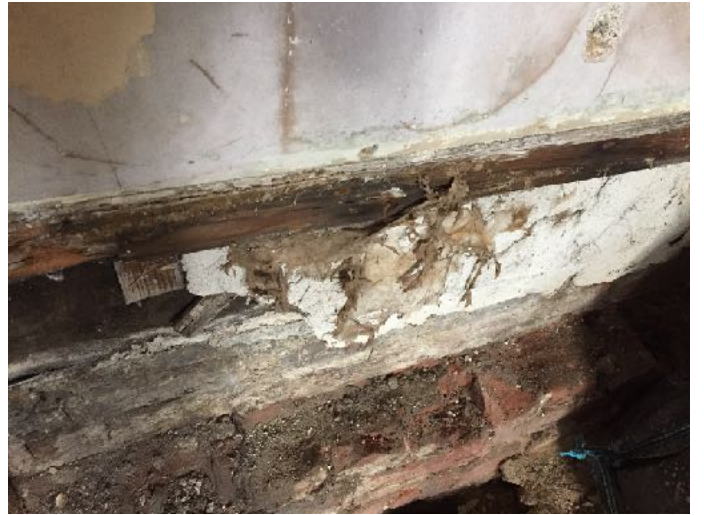
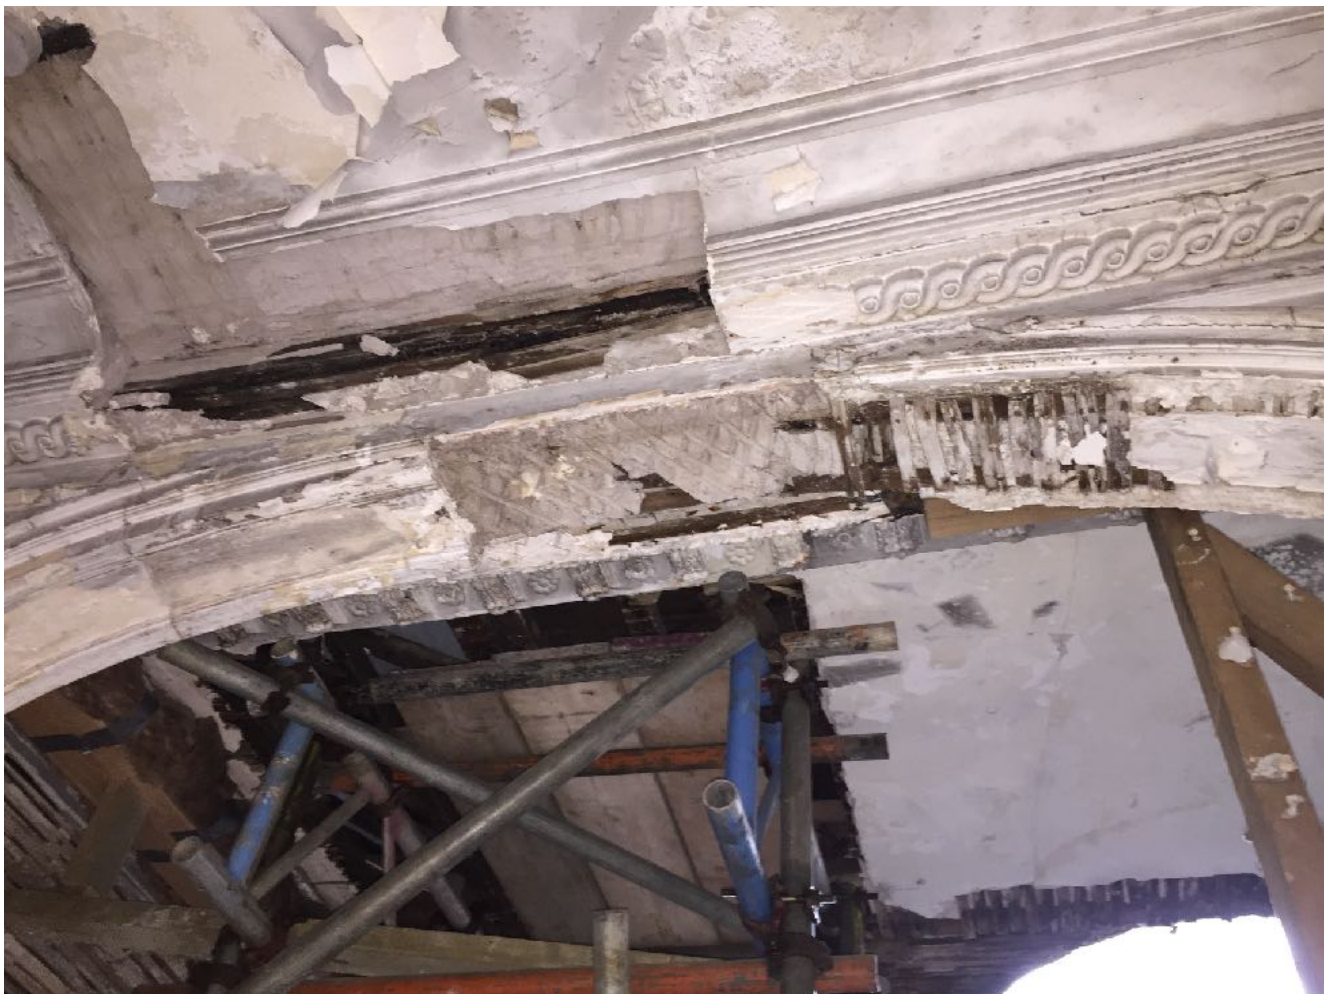
The drum around the staircase is in need of extra support, and the moving of the landing partition 120mm towards the front of the building (west) means that it is no longer supporting the weight of the roof. This area requires steel framing within the depth of the existing partitions and floors to avoid changes to room proportions.

A proposal has been drawn up and will be forwarded to you separately.

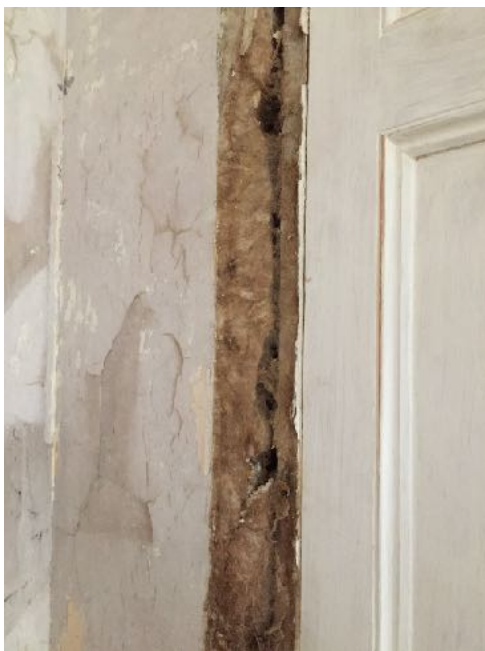
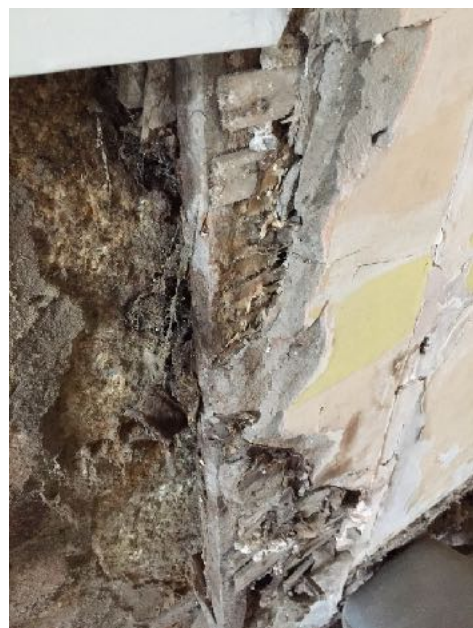
Structurally there is a big problem as the thin timber partitions are having to support upper walls.

The spans are so great that the upper floor timbers cannot successfully support the corridor walls and bedroom partitions, particularly now that they have been damaged by rot. We are proposing the introduction of 4" steel posts in between the 2" x 3" timber posts to assist them. This means that we do not need to thicken the walls and the fancy cornices and room proportions can be maintained.

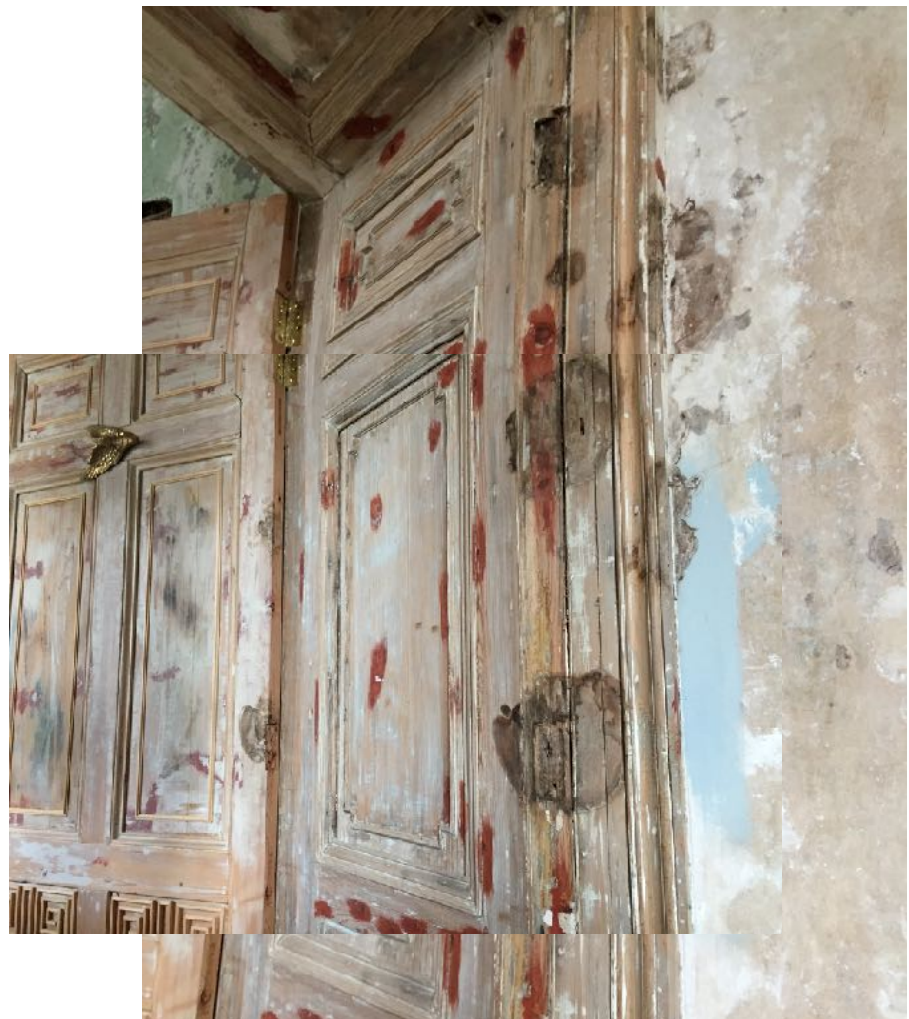
At first glance this appears to be the room in the best condition, however, the area around the doorway in to the Entrance Hall is riddled with dry rot. We have been dismayed to see that there is still a live body to the left of the door.

You can see evidence of the earlier infestation, when we removed large yellow-orange fruiting bodies from the door case. We shall have to remove this to check that there is no damage to structural elements.

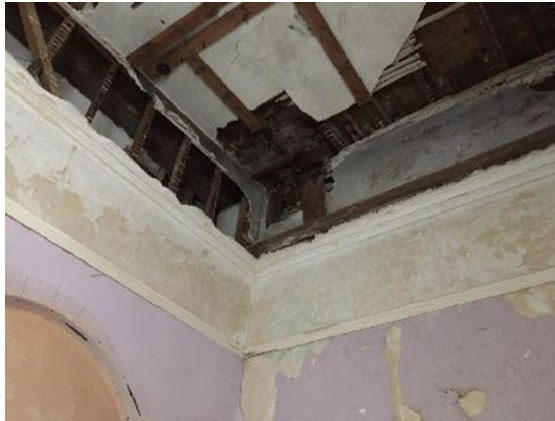
As in every other room, this north facing room has suffered from water ingress from above. The floor surface in the bathroom above is of marble on a lead tray so the water has been cascading down the walls, the weight leading to the failure of the ceiling structure, which has collapsed.

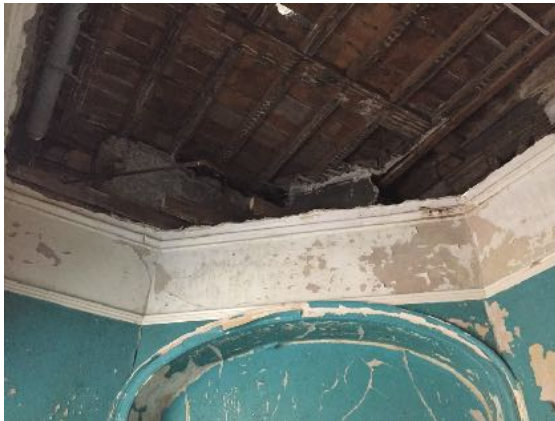
In these photographs you can see the evidence of dry rot mycelia and an earlier higher ceiling height. These traces of earlier walls still have their paint surfaces.

We shall be reinstating the lower ceiling (probably early C20th) as the room will be retained as a bathroom.

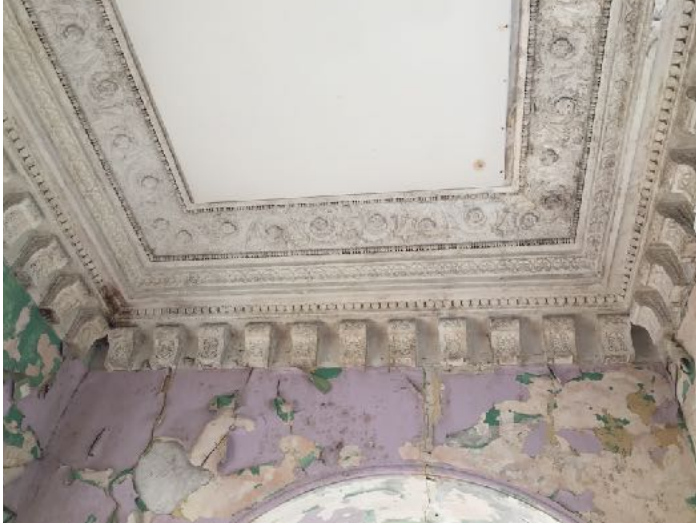
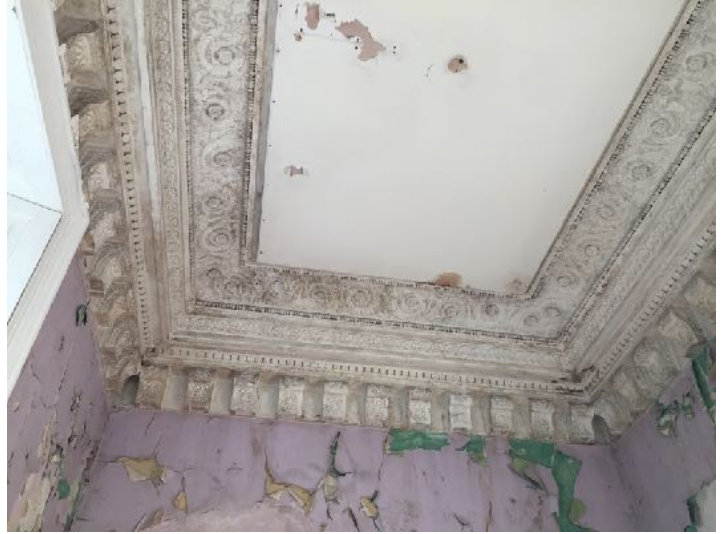
The ceiling central section of plasterboard will need to be removed once the cornice has been propped with the intention of saving most if not all from falling. The floor structure above has been badly damaged by water and dry rot but we are looking at mechanically fixing the cornice back to the walls - all of which are stone or brick.

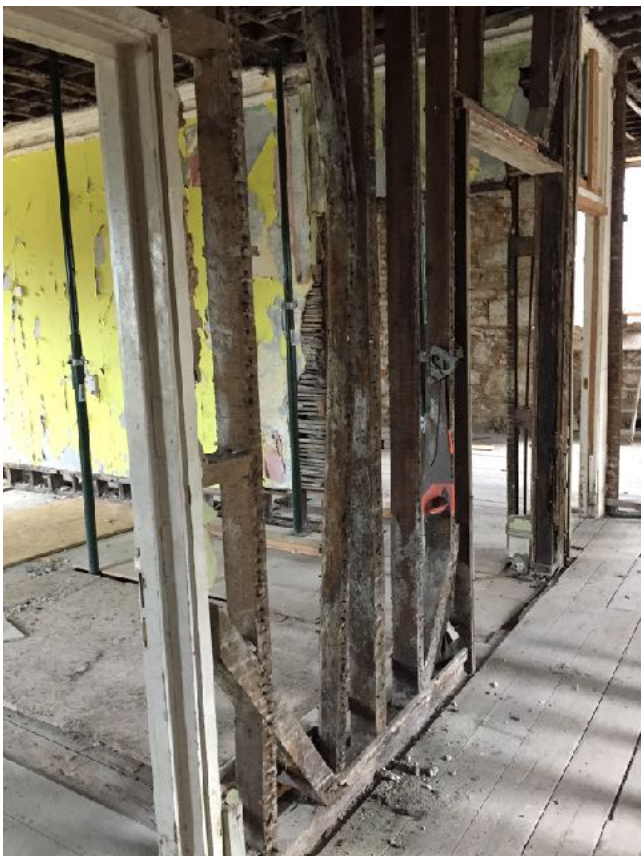
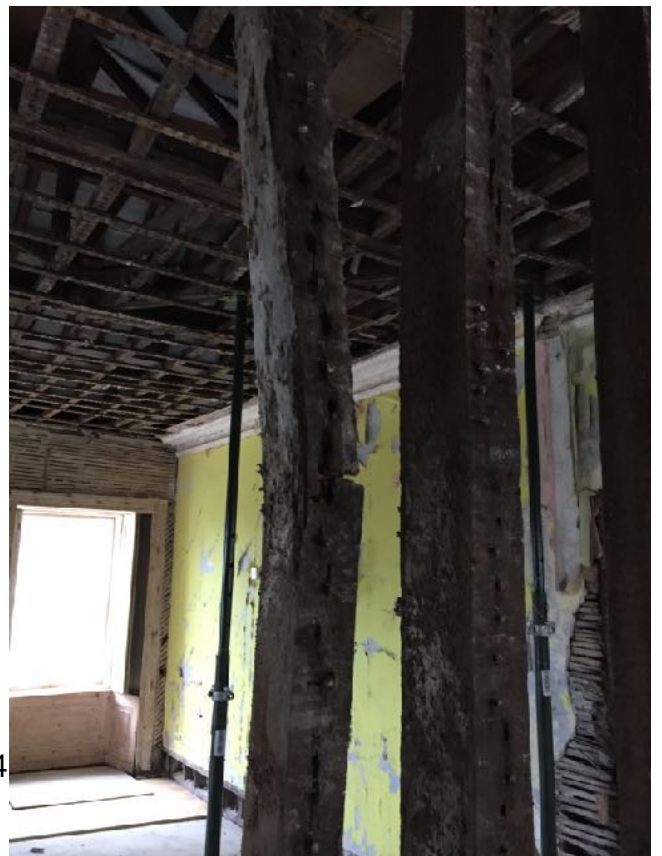
This has reached to the ceiling battens in places, but we intend to retain most of the roof structure. However, the timber partitions, which had already been much damaged by later cut-outs for new doorways, have failed completely. They were of small dimension and had been moved across the room to a position where they have been unable to support the roof above. We shall need to reinstate structural support without altering the dimensions of the rooms.

The walls themselves have deep horizontal timber fillets (to which to attach the plaster framework), all of which have rotted, and which we shall replace with brick and slate as a permanent repair.

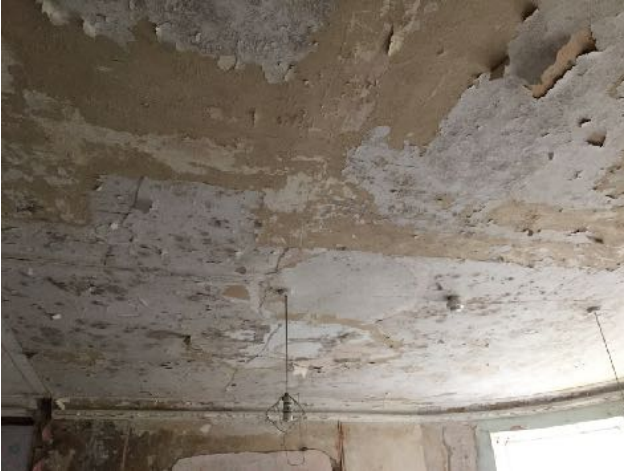
Bedroom 1 is a vast room above the Ballroom. Its ceiling is still in place but the floor has suffered catastrophic collapse through to the room below.

We believe that the original fireplace area (which was later used as an internal bathroom) is the original source of the historic dry rot outbreak - probably a small undetected leak over a number of years.

You can see the three large I beams which have saved the floor from further collapse.

There are also two very large original timbers at a slight angle; all are to be retained. The floor is very much deflected, however, by as much as 120mm in the hall, so we shall need carefully considered intervention to create a level floor.

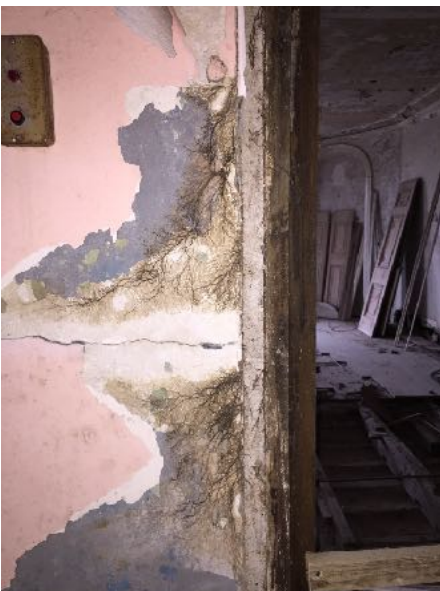
The linking corridor of these two rooms has also suffered. Fortunately none of the ceilings is ornate and the running mould cornices will be easy to repair and replicate.

To left, you can see the pattern of fungus behind the architrave.

Below you can see the deflection from left to right.

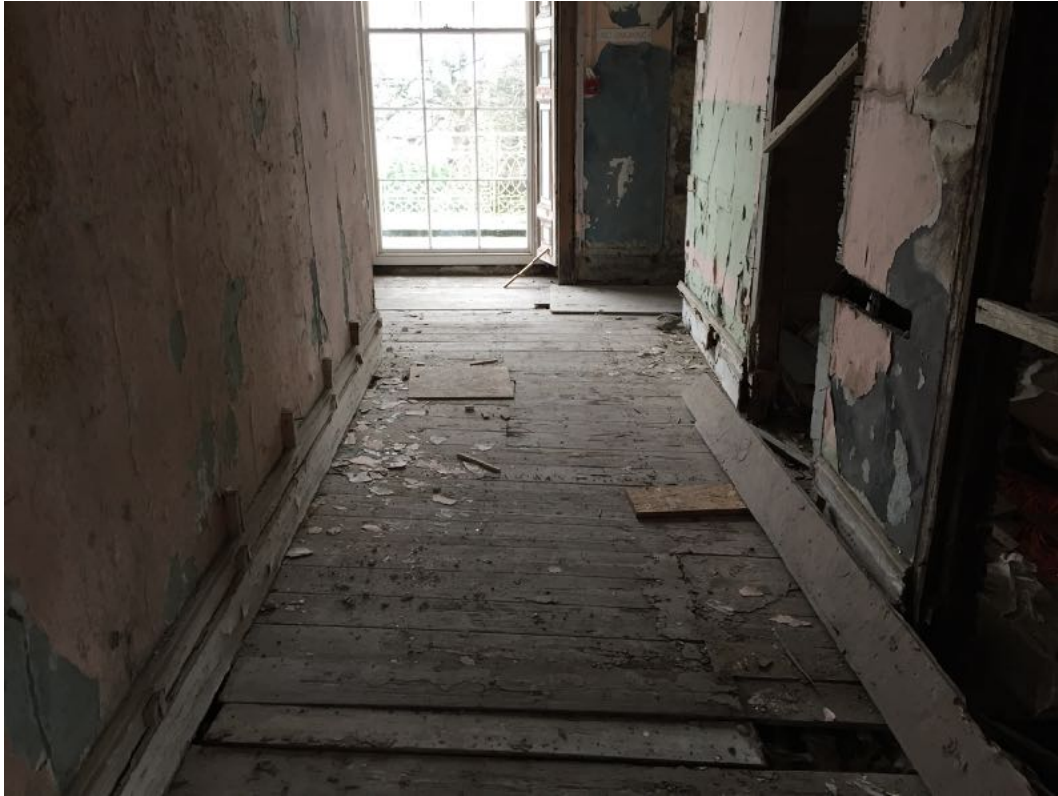
Bedroom 2 is west facing. Unfortunately its ceiling has collapsed, together with its laths, and the floor is deflected by 175mm, so major structural work is required to bring the room back in to use.

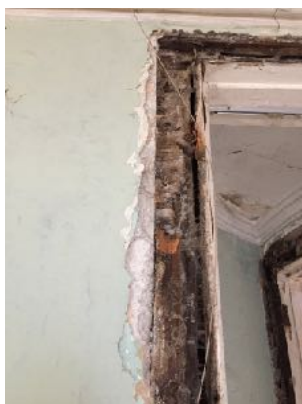
Unfortunately dry rot has been active in the whole of this area.

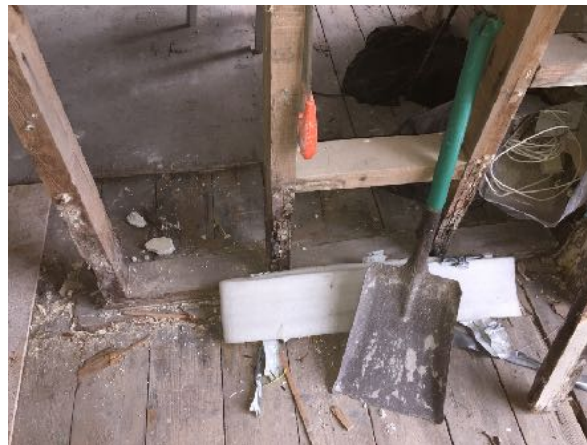
Even relatively new timbers dating from Scope's ownership have suffered rot at their bases. I don't think we should underestimate the amount of water which flowed through this building for at least 5 years...

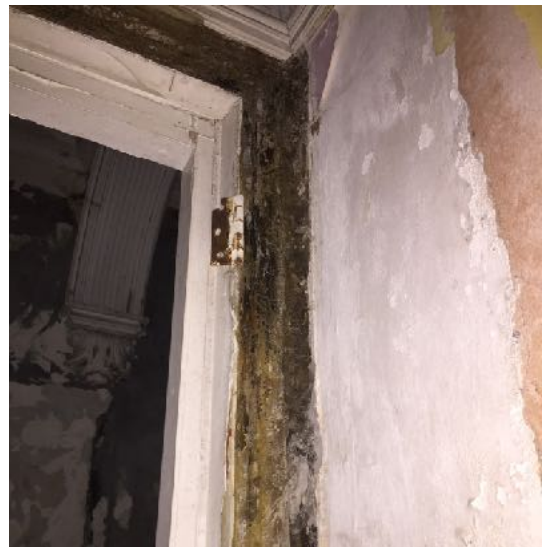
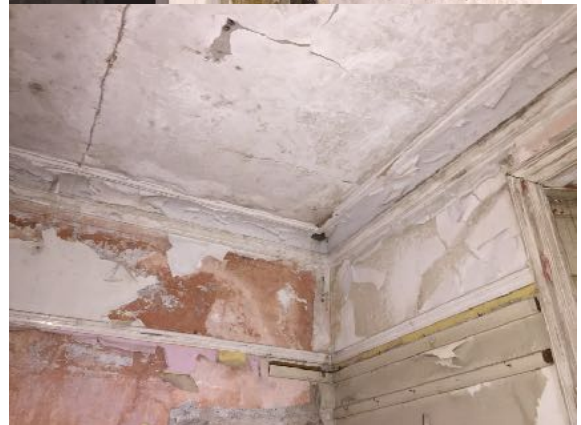
Obviously it has all been soaking wet as the parapet gutters above had been stripped of their lead over the years prior to our arrival. This has led to cracking of the ceiling plaster, damage to floor boards and the growth of mould.

We opened up the fireplaces soon after our arrival to aid ventilation through the window grilles and up the chimneys so hopefully some further damage has been avoided.

While the doors and windows and shutters have been repaired successfully, the architraves and skirtings are for the most part beyond repair and can be replaced.

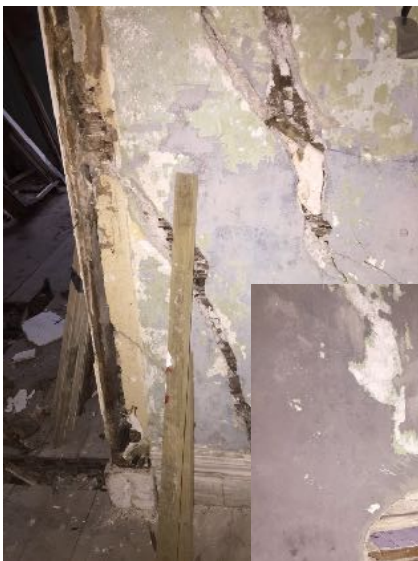
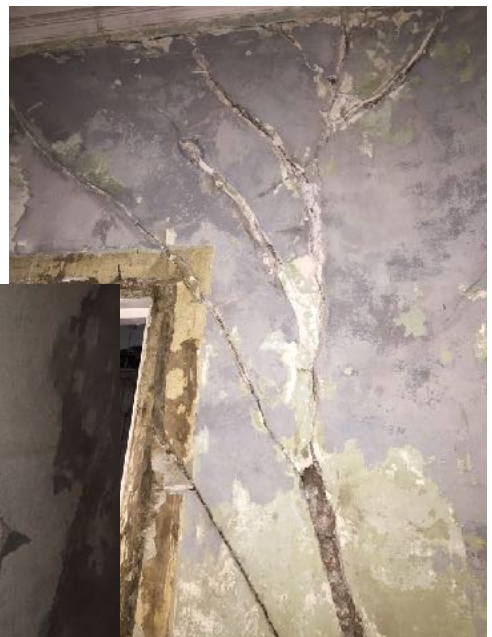
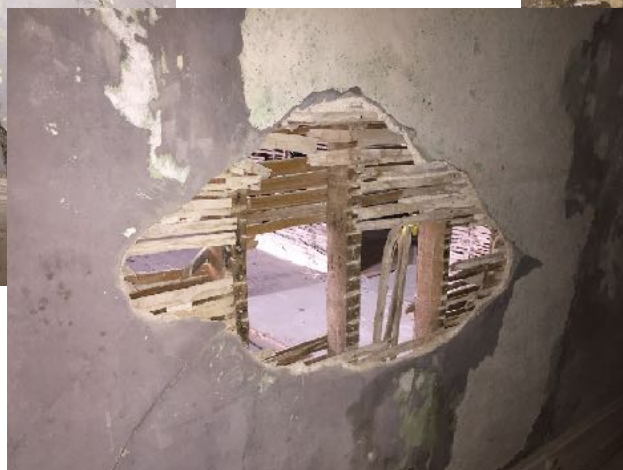
The corridor: Looking through to the corridor beyond, the cracks in the plaster are remarkable.

And just as remarkable, is the dry rot in the door frames. However, we have removed the architraves for repair and treatment. They have been labelled and are being stored in the house.

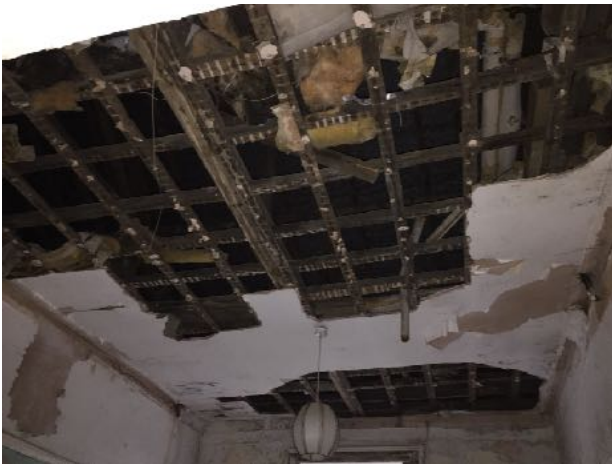
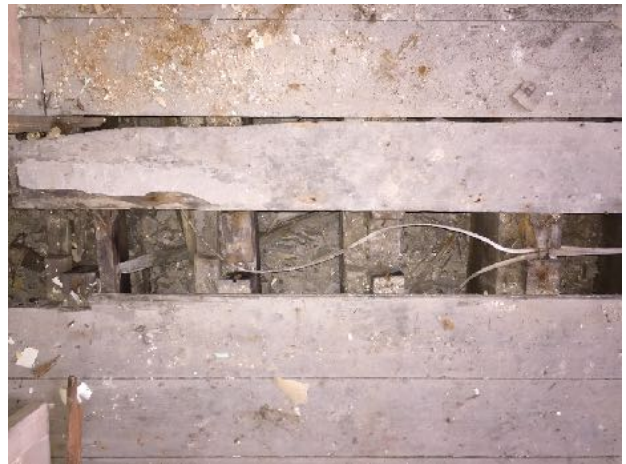
The ceiling has fallen but fortunately there is no ceiling rose or cornice to save.

The door frame will need attention.

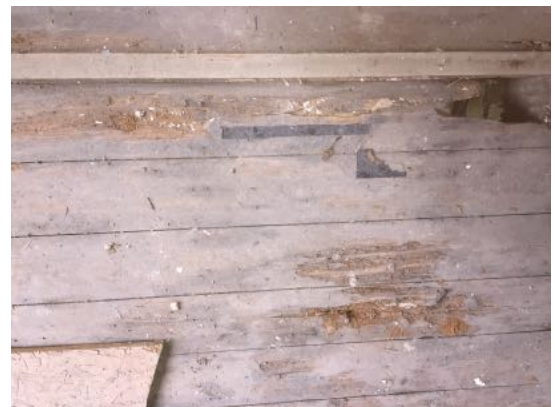
Some of the floors are abraded; we do not know the cause of this although it may possibly be damage from the use of wheelchairs..

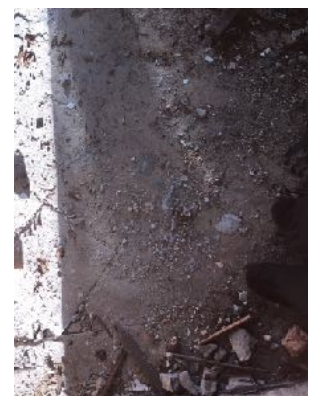
Going back in to the corridor area (previously a bathroom), it has a green and white marble tiled floor sitting in a lead tray. It is much deflected and broken, but we hope to save it to reuse in this area, perhaps by turning it over. We have also managed to retrieve matching marble slabs from this area which were used vertically.. from the courtyard behind where they had been removed and smashed in an attempt to steal them. Some will be reusable and whatever we can use we shall.

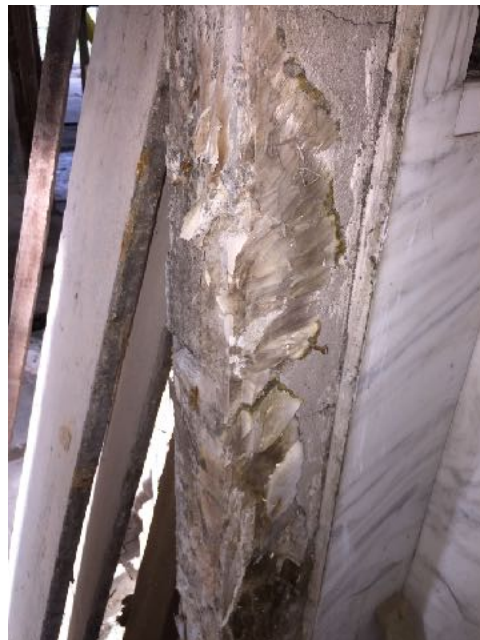
There are various areas of plaster fall, and due to removal of supporting walls, there is a major structural issue in this area which we shall resolve by use of cantilevering steels (invisible when in situ).

Dry rot in the door frame (much altered) and dry rot fringes beside some of the marble cladding.
