Tree Hazard Assessment Report

17 February 2021

Devenish Warren
Belle Vue Road
Weymouth
DT4 8SN

TS/64921/AC

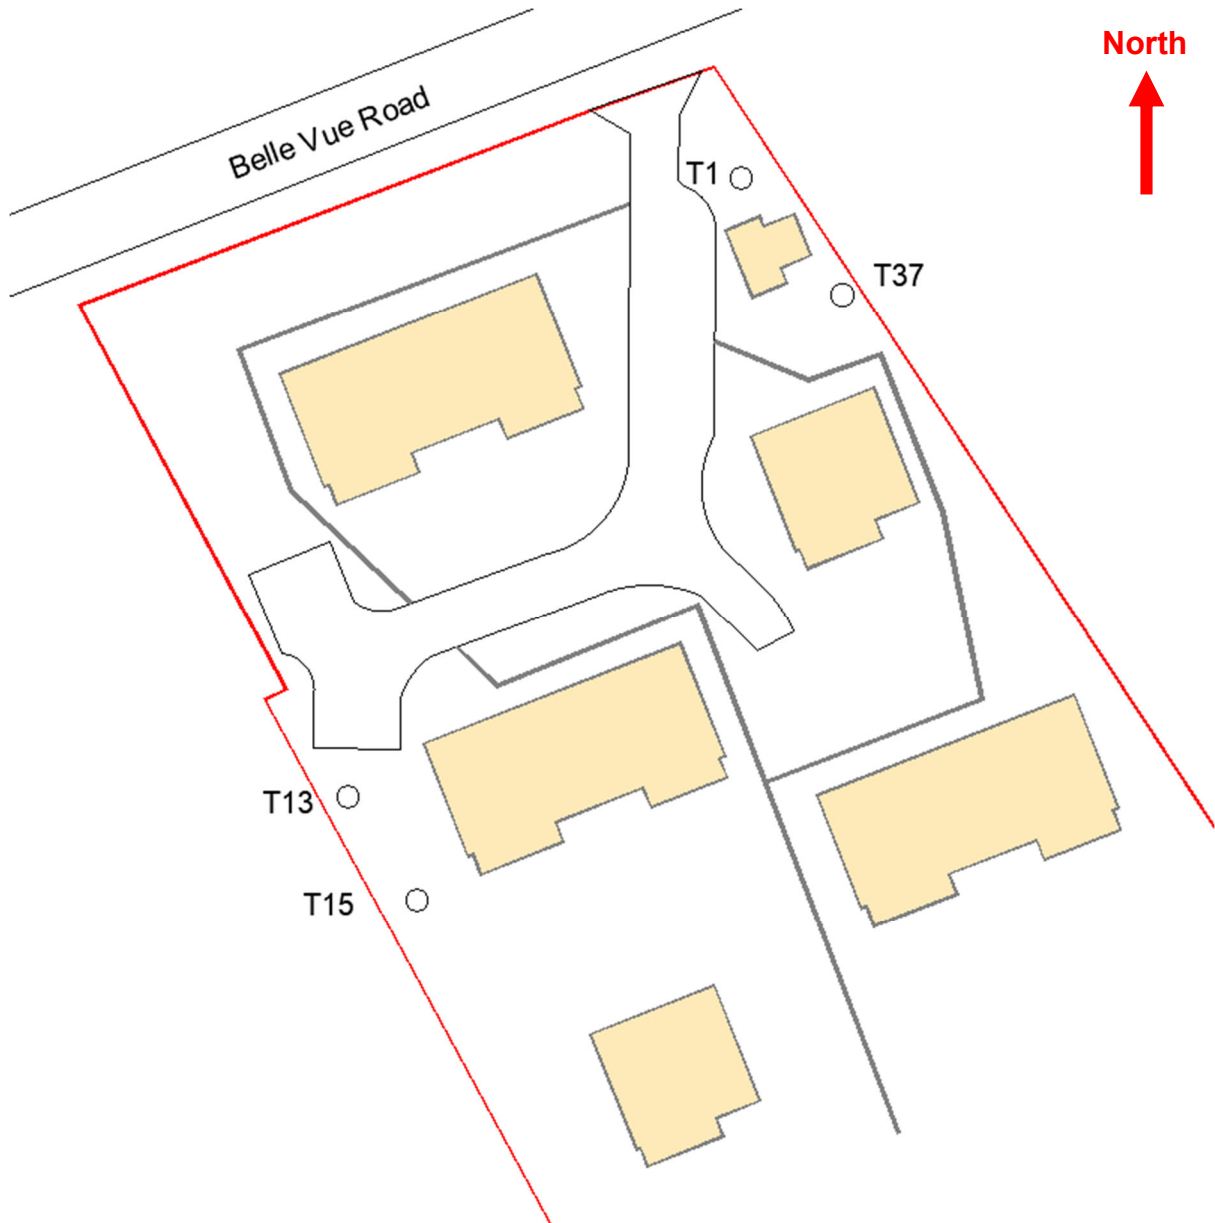
Appendix B: Plan TC1

- The circles show the approximate positions of the trees referred to in this report.
- The red line shows the approximate site boundary.
- This plan is not to scale.

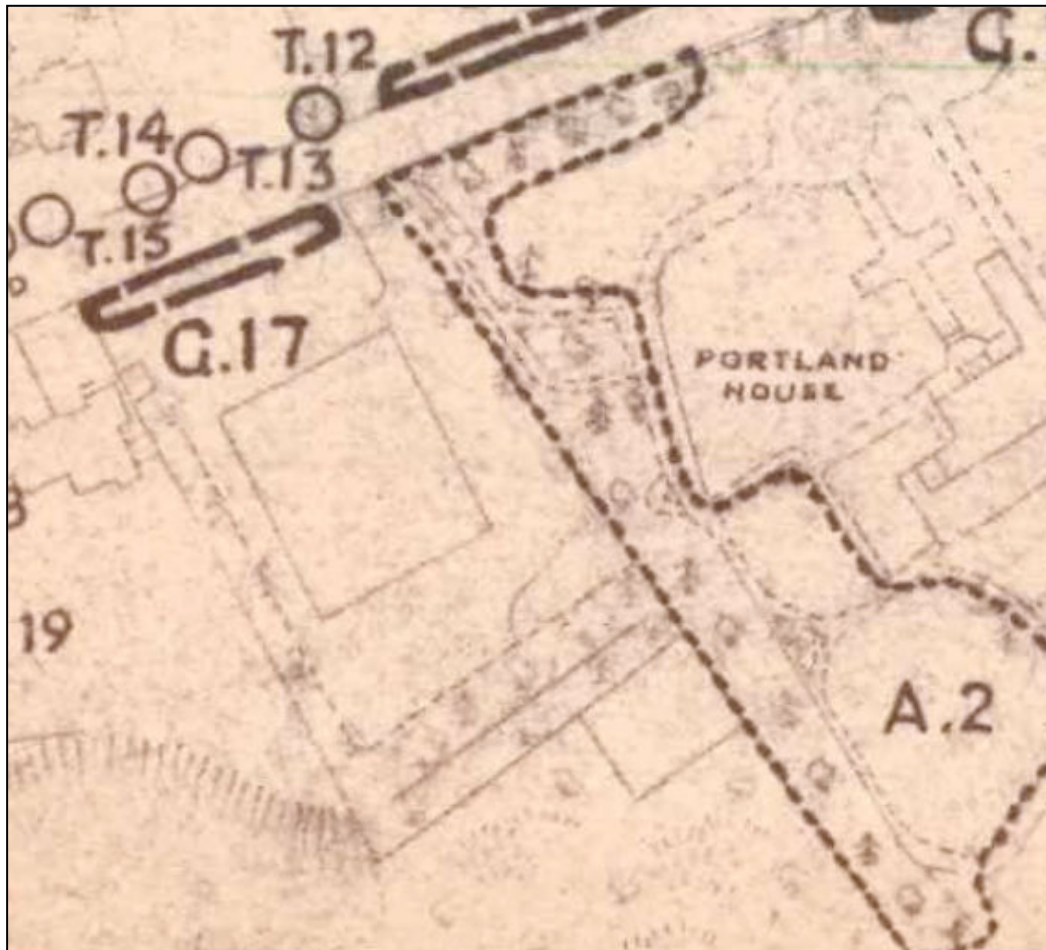
Appendix E: Tree Preservation Order Details

- G.17. 6 Elm, 2 Pine, 2 Hawthorn and 1 Plain Leaf Holly.

- A.2. Area consisting of Cupressus, Evergreen Oak, Pine, Elm and Poplar.
