Project Name: Jonathan Ungar 15.4.14	Project number:	Date: 29/04/2014	Contact:	
---	-----------------	---------------------	----------	--

Project name :
Jonathan Ungar 15.4.14

Contractor **DrainTechnology (UK) Ltd**
Contact Name: **Paul Ferrito**
Department: **Surveying**
Road: **67 Lashford Lane**
Town: **Dry Sandford**
County: **Oxfordshire, OX13 6DZ**
Telephone:
Fax:
Mobile:
E-mail:

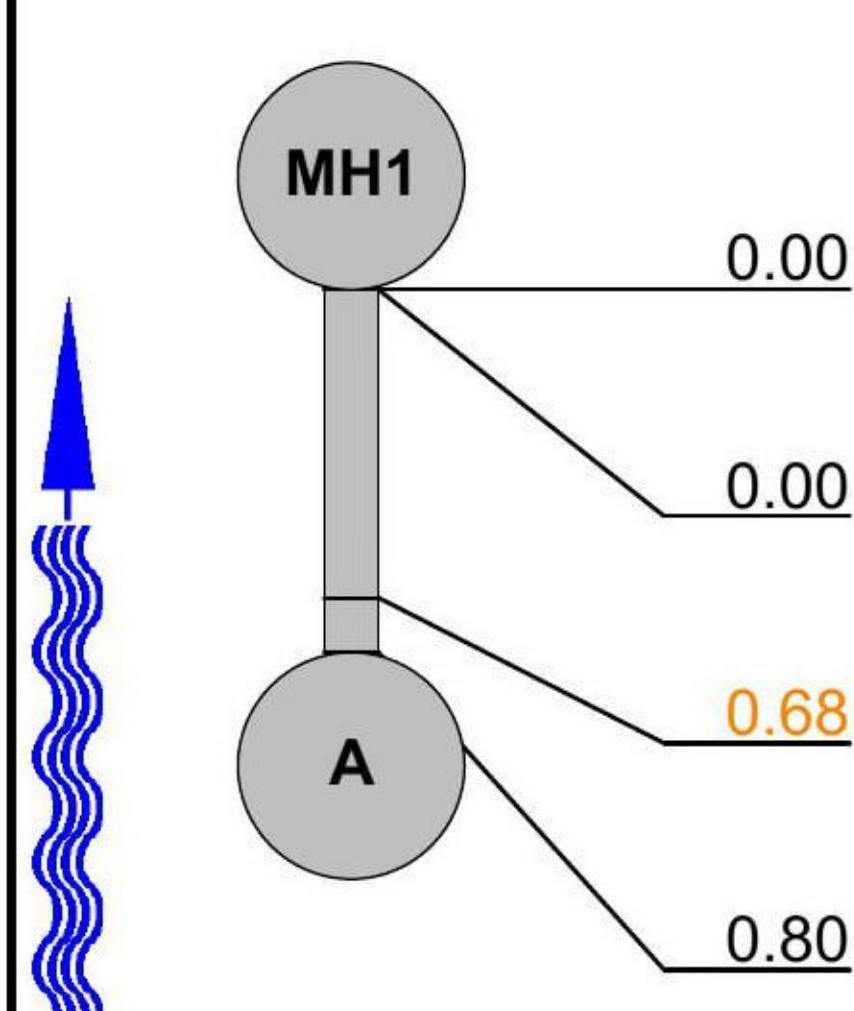
<p>Start node type, manhole reference number: MH1</p> <p>Water level 0 % of the vertical dimension</p> <p style="color: orange;">Settled deposits, coarse 5 % cross-sectional area loss</p> <p>Finish node type, other special chamber reference number: A END / POP UP Remarks: END / POP UP</p>

STR no def	STR peak	STR mean	STR total	STR grade	SER no def	SER peak	SER mean	SER total	SER grade
0	0	0	0	1	1	2	2.5	2	4

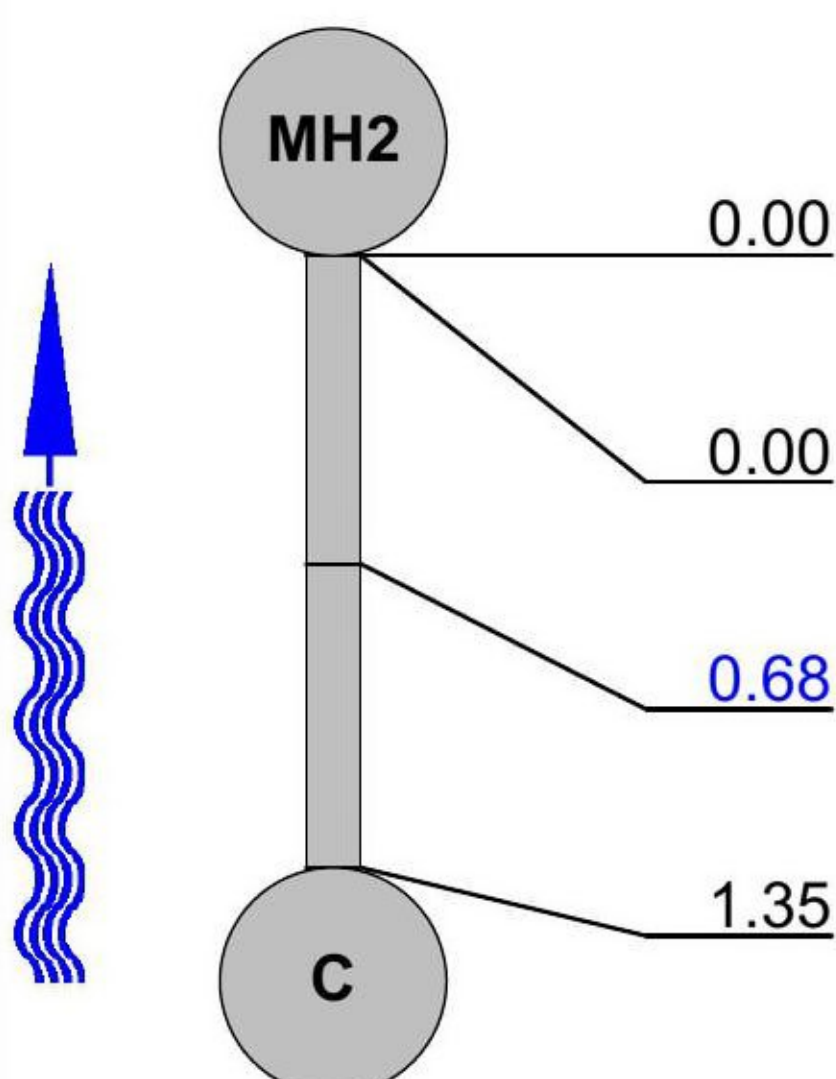
<p>Start node type, manhole reference number: MH2</p> <p>Water level 0 % of the vertical dimension</p> <p style="color: blue;">Roots, fine</p> <p>Finish node type, other special chamber reference number: C END / POP UP Remarks: END / POP UP</p>

STR no def	STR peak	STR mean	STR total	STR grade	SER no def	SER peak	SER mean	SER total	SER grade
0	0	0	0	1	1	1	0.74	1	2

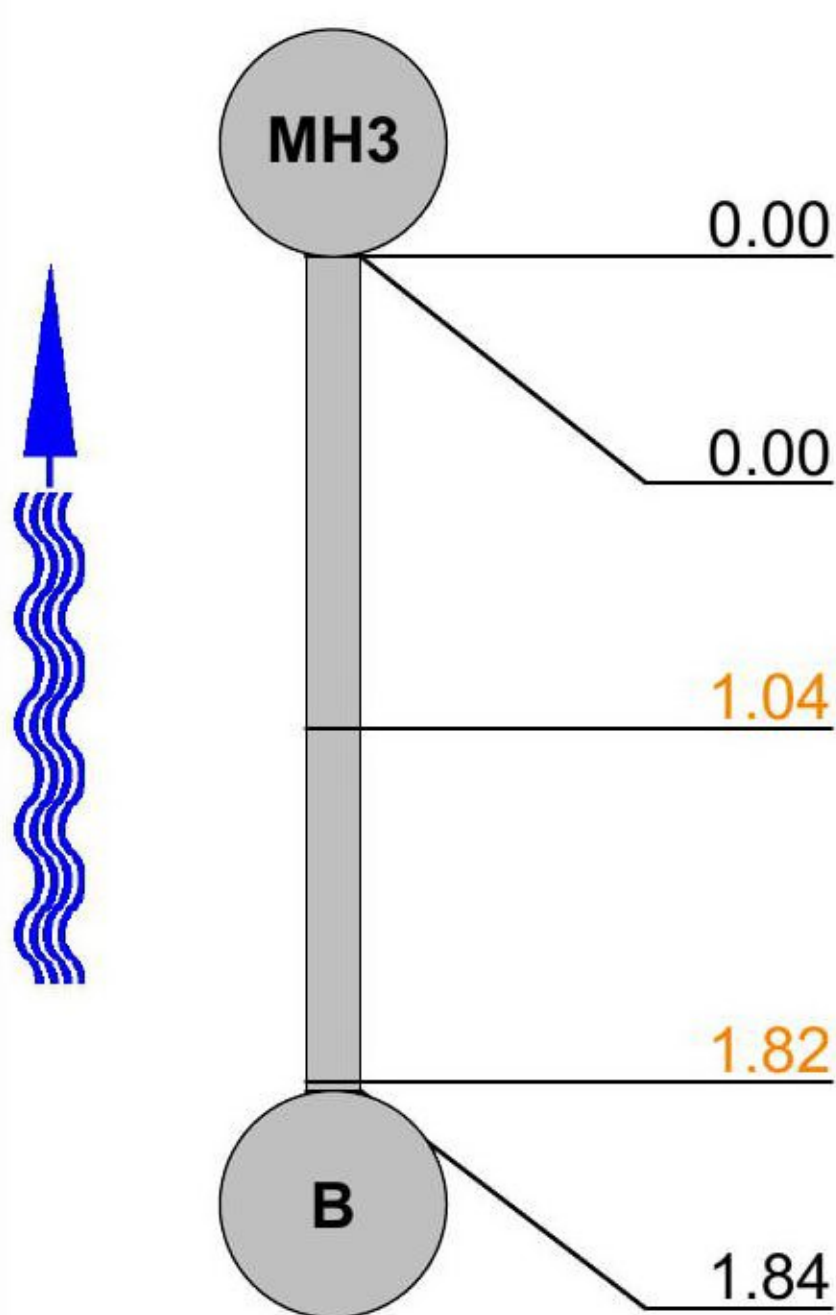
<p>Start node type, manhole reference number: MH3</p> <p>Water level 0 % of the vertical dimension</p> <p>Attached deposits, encrustation from 4 O'Clock to 7 O'Clock 10 % cross-sectional area loss</p> <p>Attached deposits, encrustation at 6 O'Clock 5 % cross-sectional area loss</p> <p>Finish node type, gully reference number: B END Remarks: END</p>

STR no def	STR peak	STR mean	STR total	STR grade	SER no def	SER peak	SER mean	SER total	SER grade
0	0	0	0	1	2	2	2.17	4	3

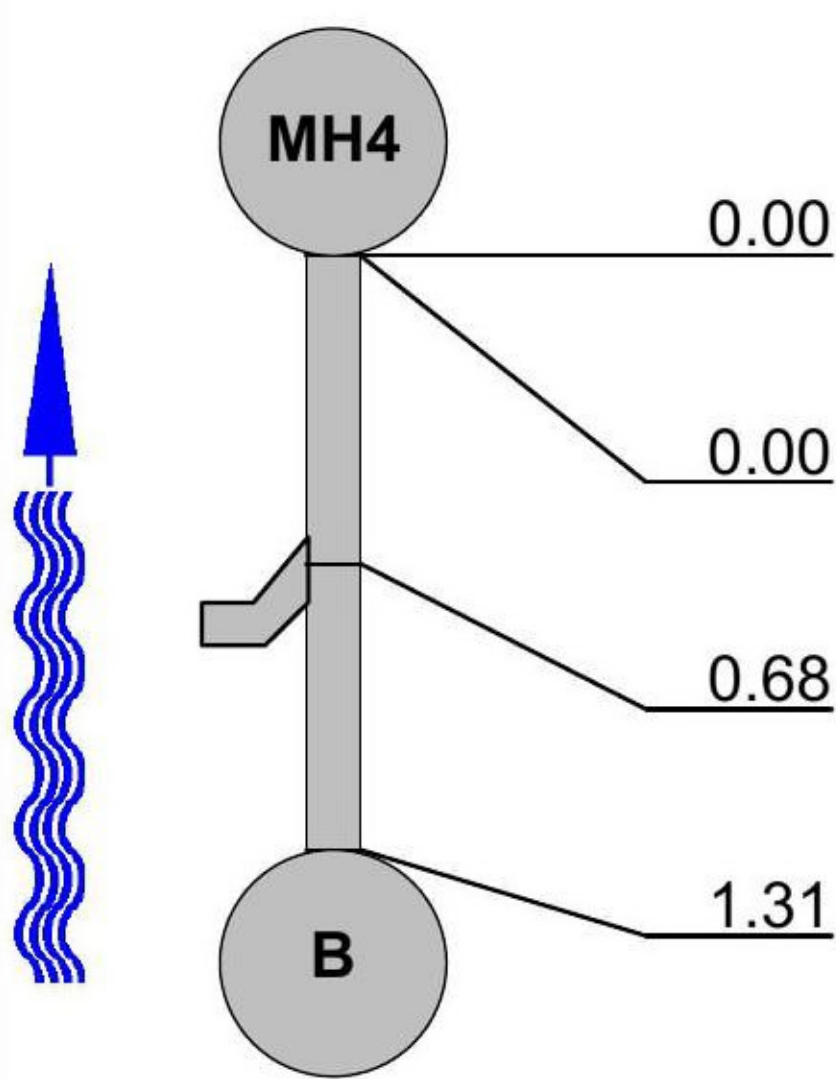
<p>Start node type, manhole reference number: MH4</p> <p>Water level 0 % of the vertical dimension</p> <p>Junction from 1 O'Clock diameter: 100 mm</p> <p>Finish node type, other special chamber reference number: B END SVP Remarks: END SVP</p>

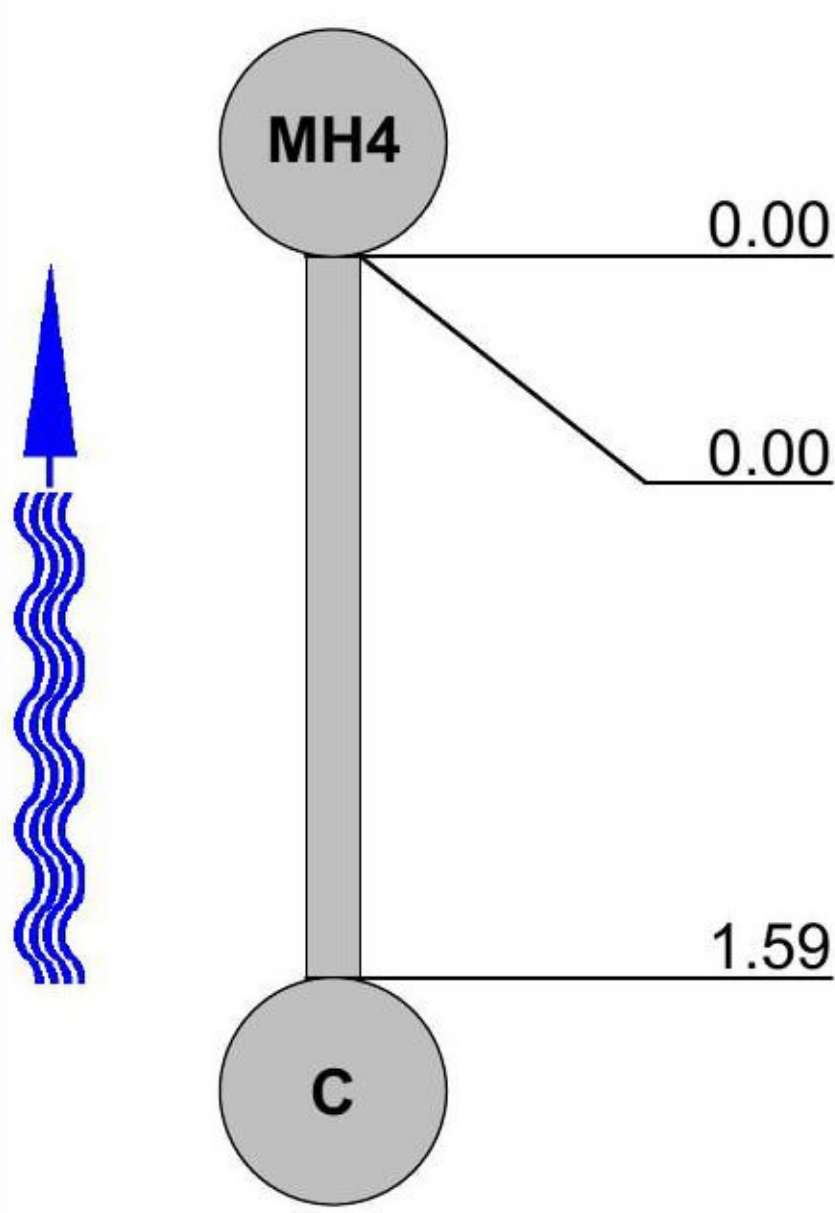
<p>Start node type, manhole reference number: MH4</p> <p>Water level 0 % of the vertical dimension</p> <p>Finish node type, other special chamber reference number: C END SVP Remarks: END SVP</p>
