REPORT NO. 21-033R_001

**Proposed Conversion of Agricultural Building at Pear
Tree Farm, Hinderclay**

Mr D Thorrold

February 2021

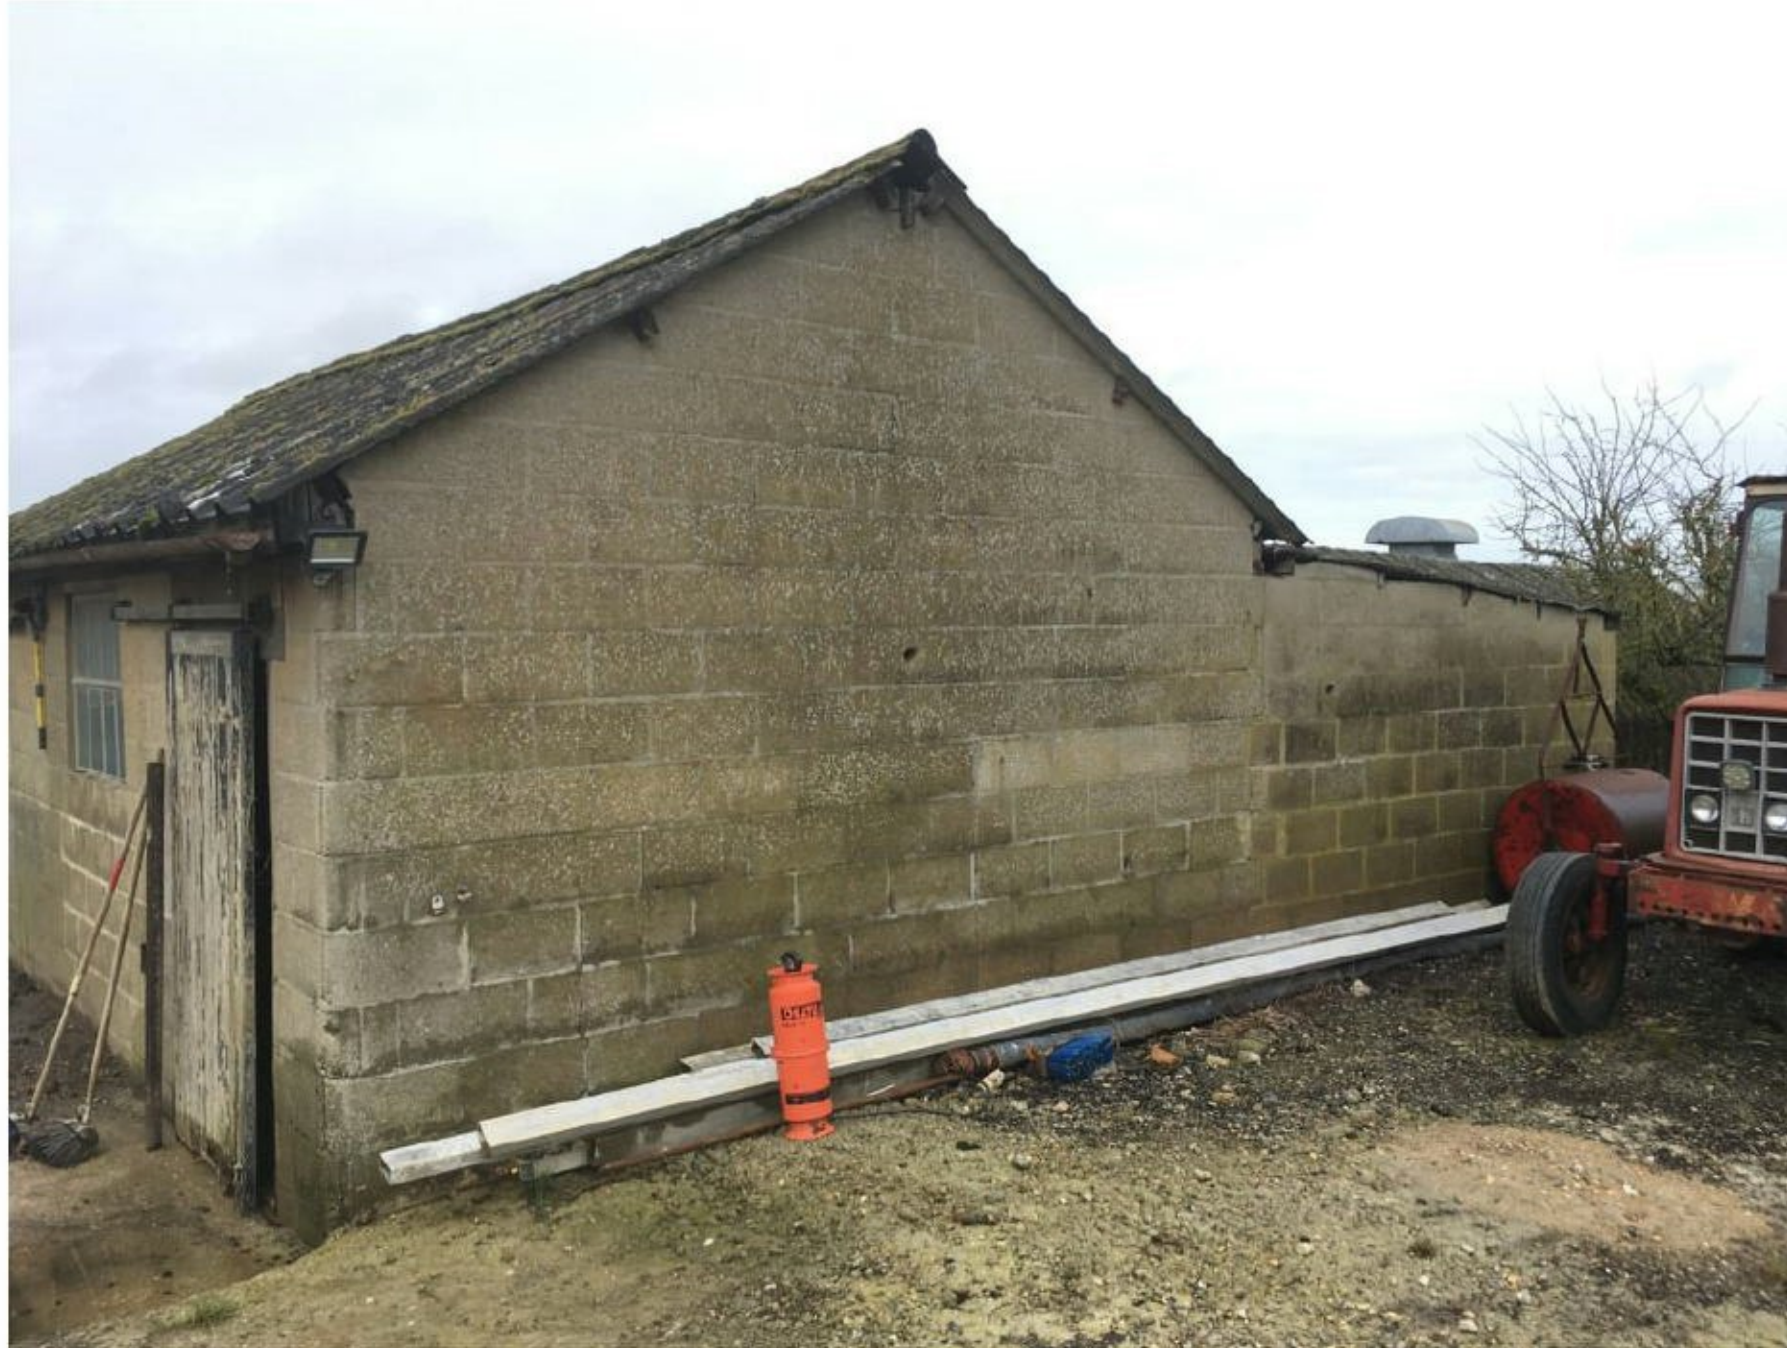
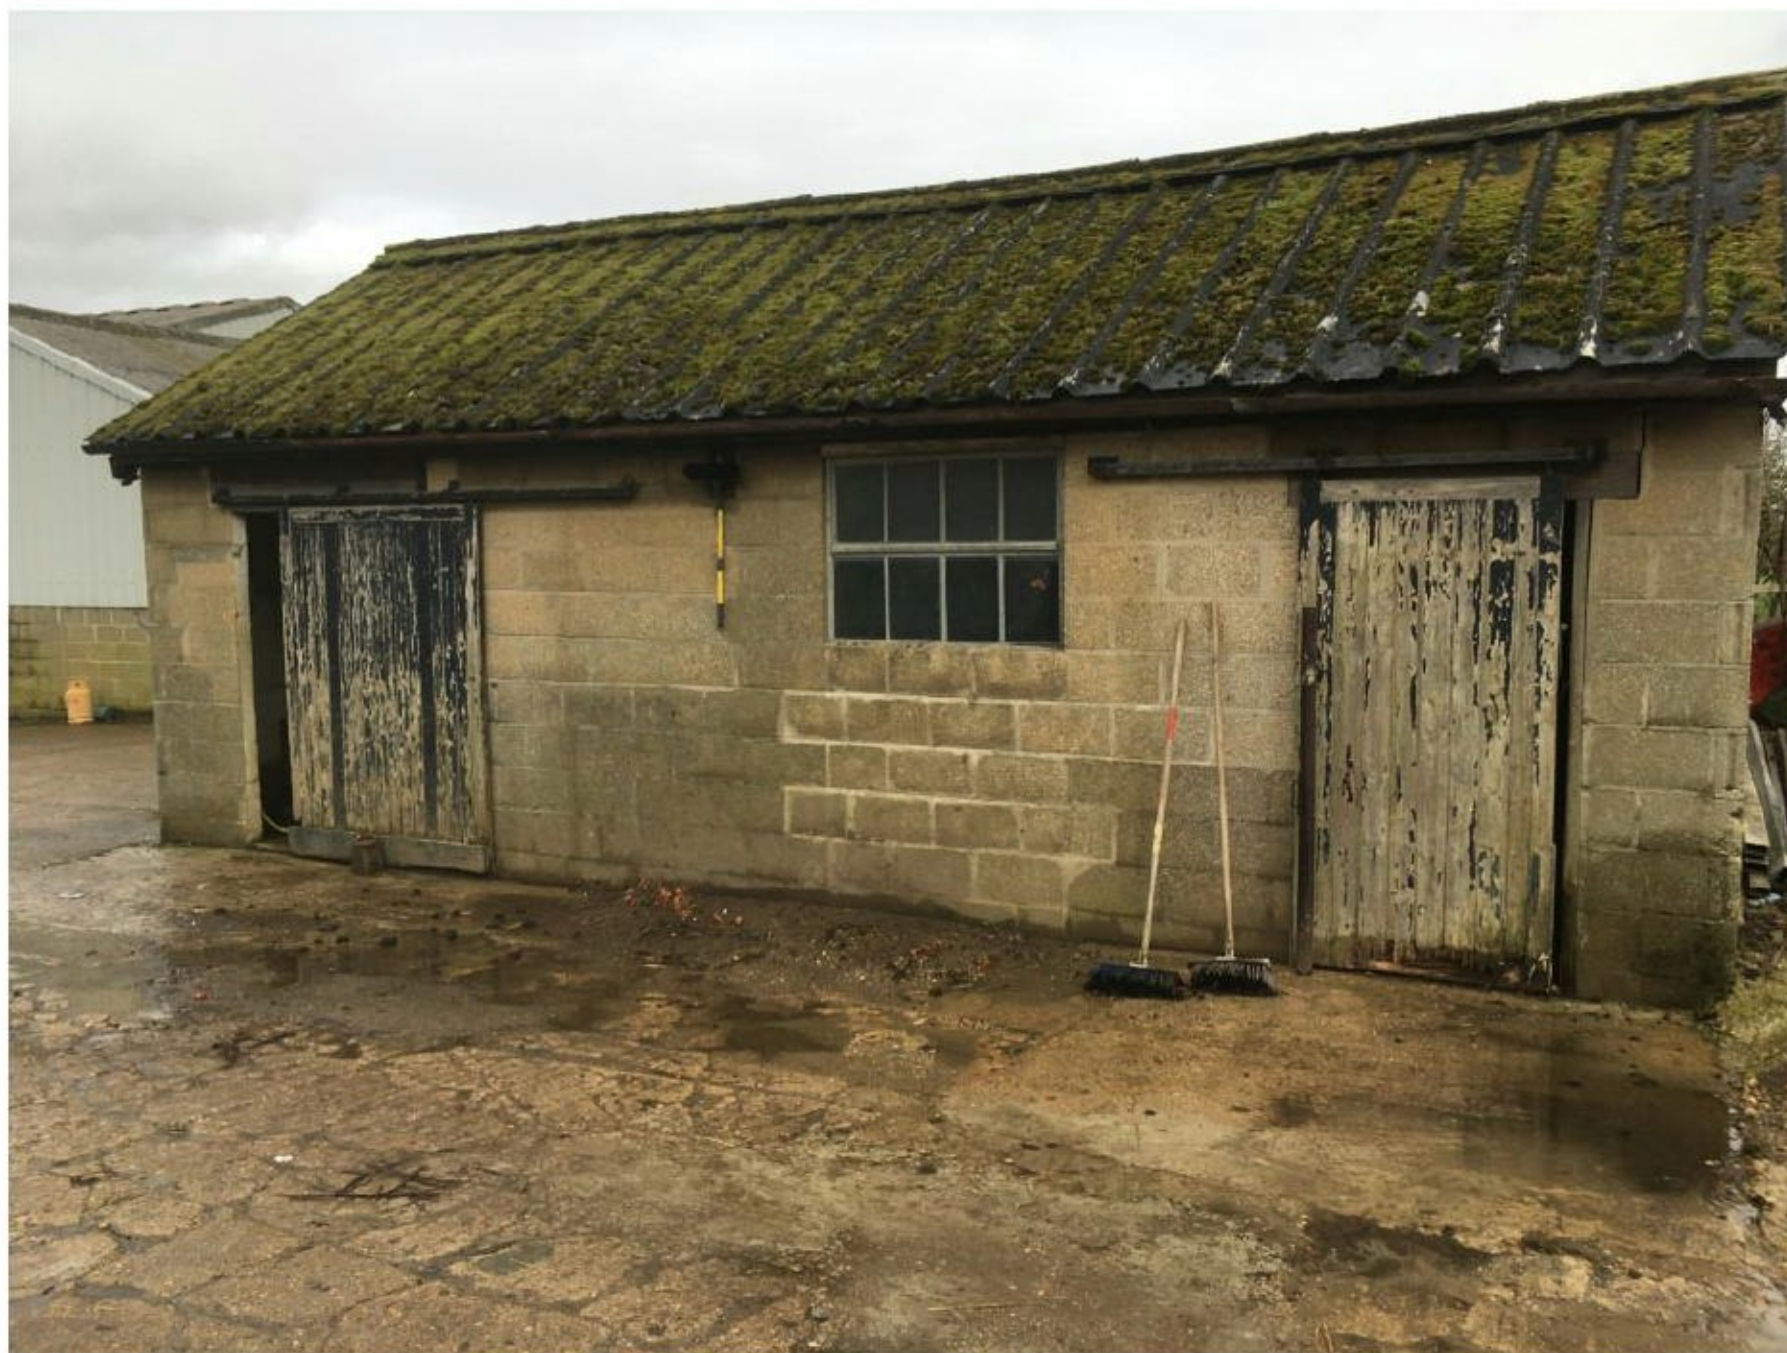
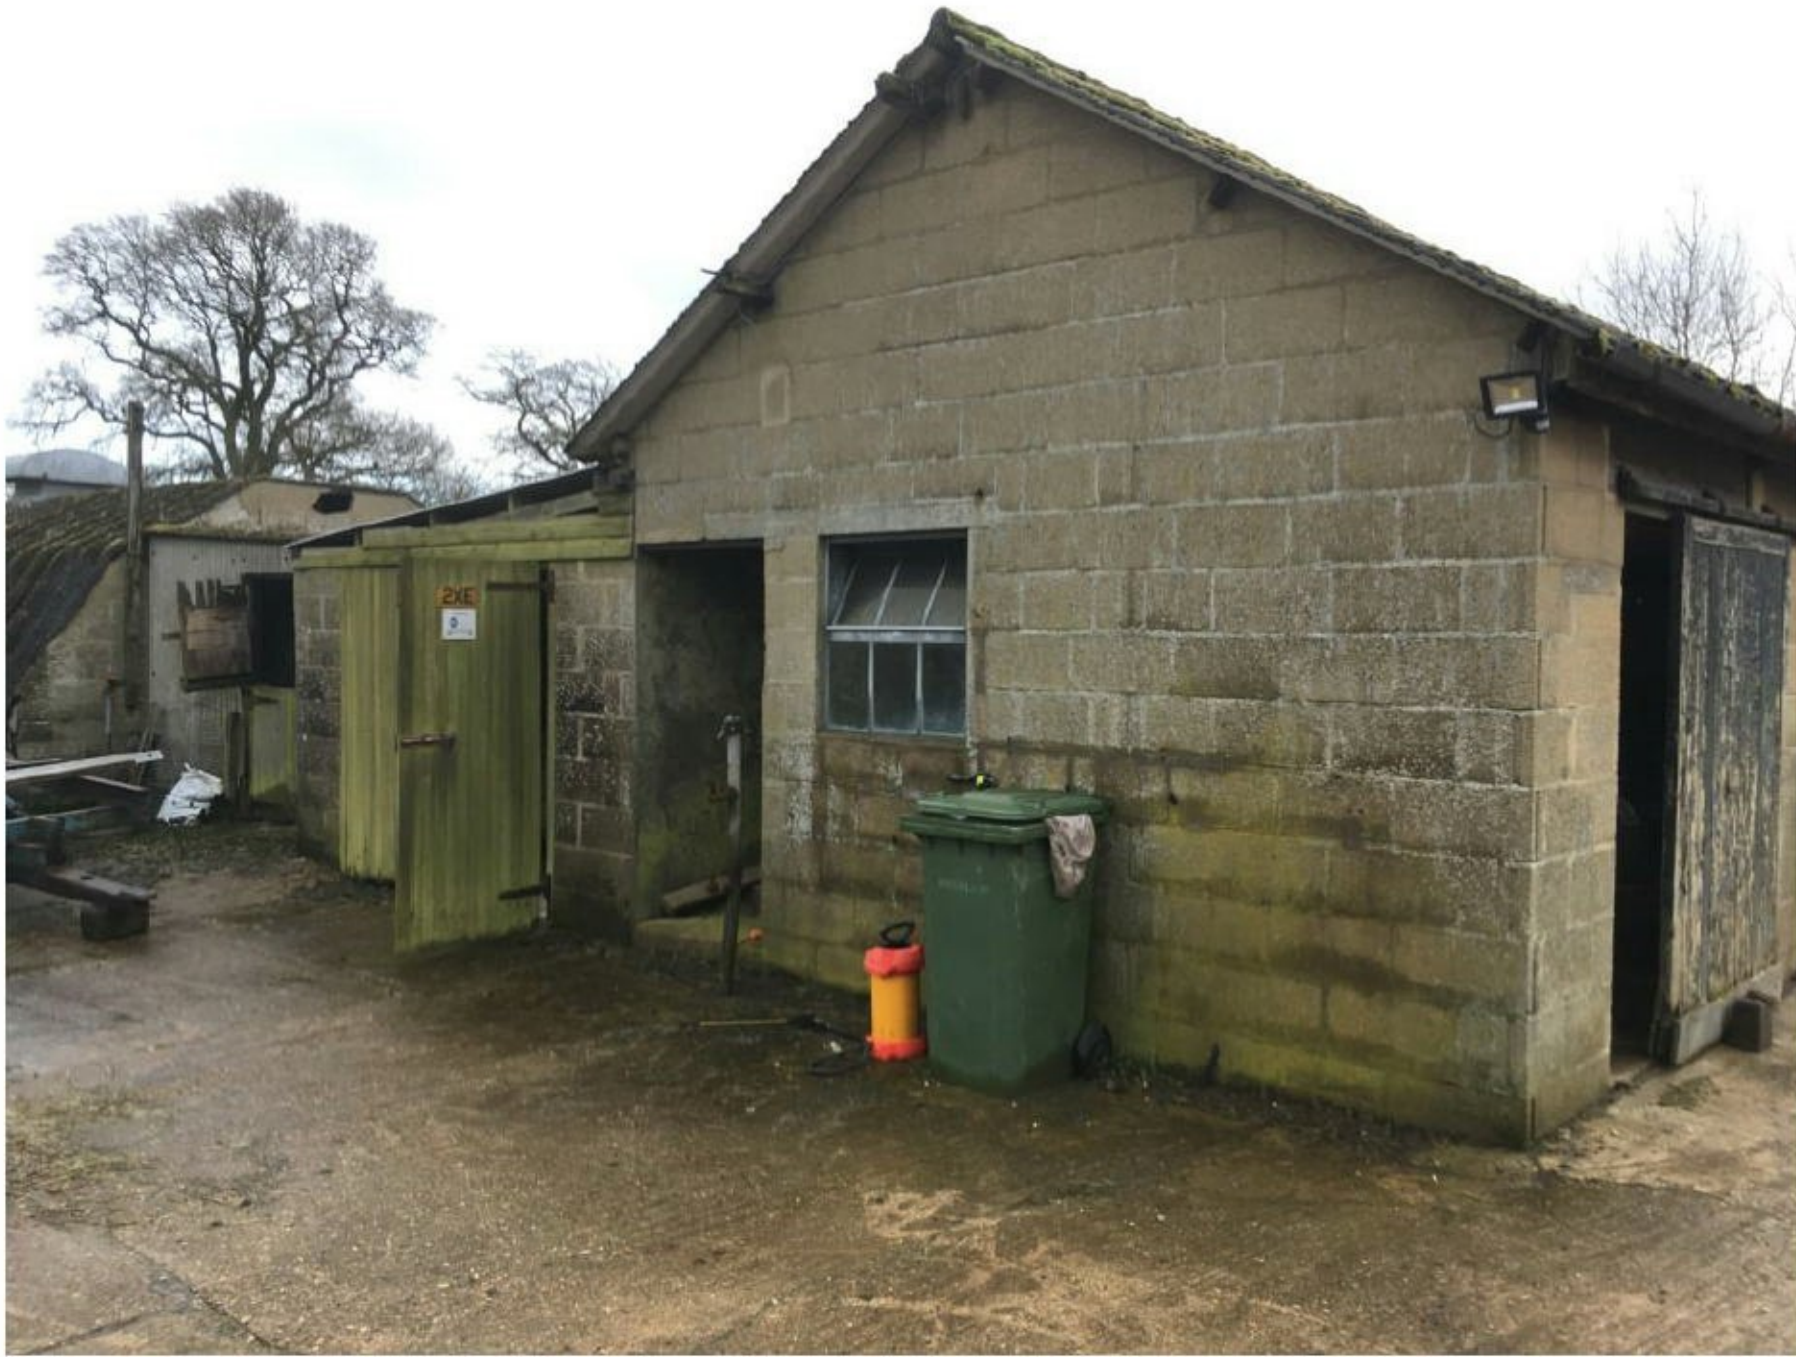
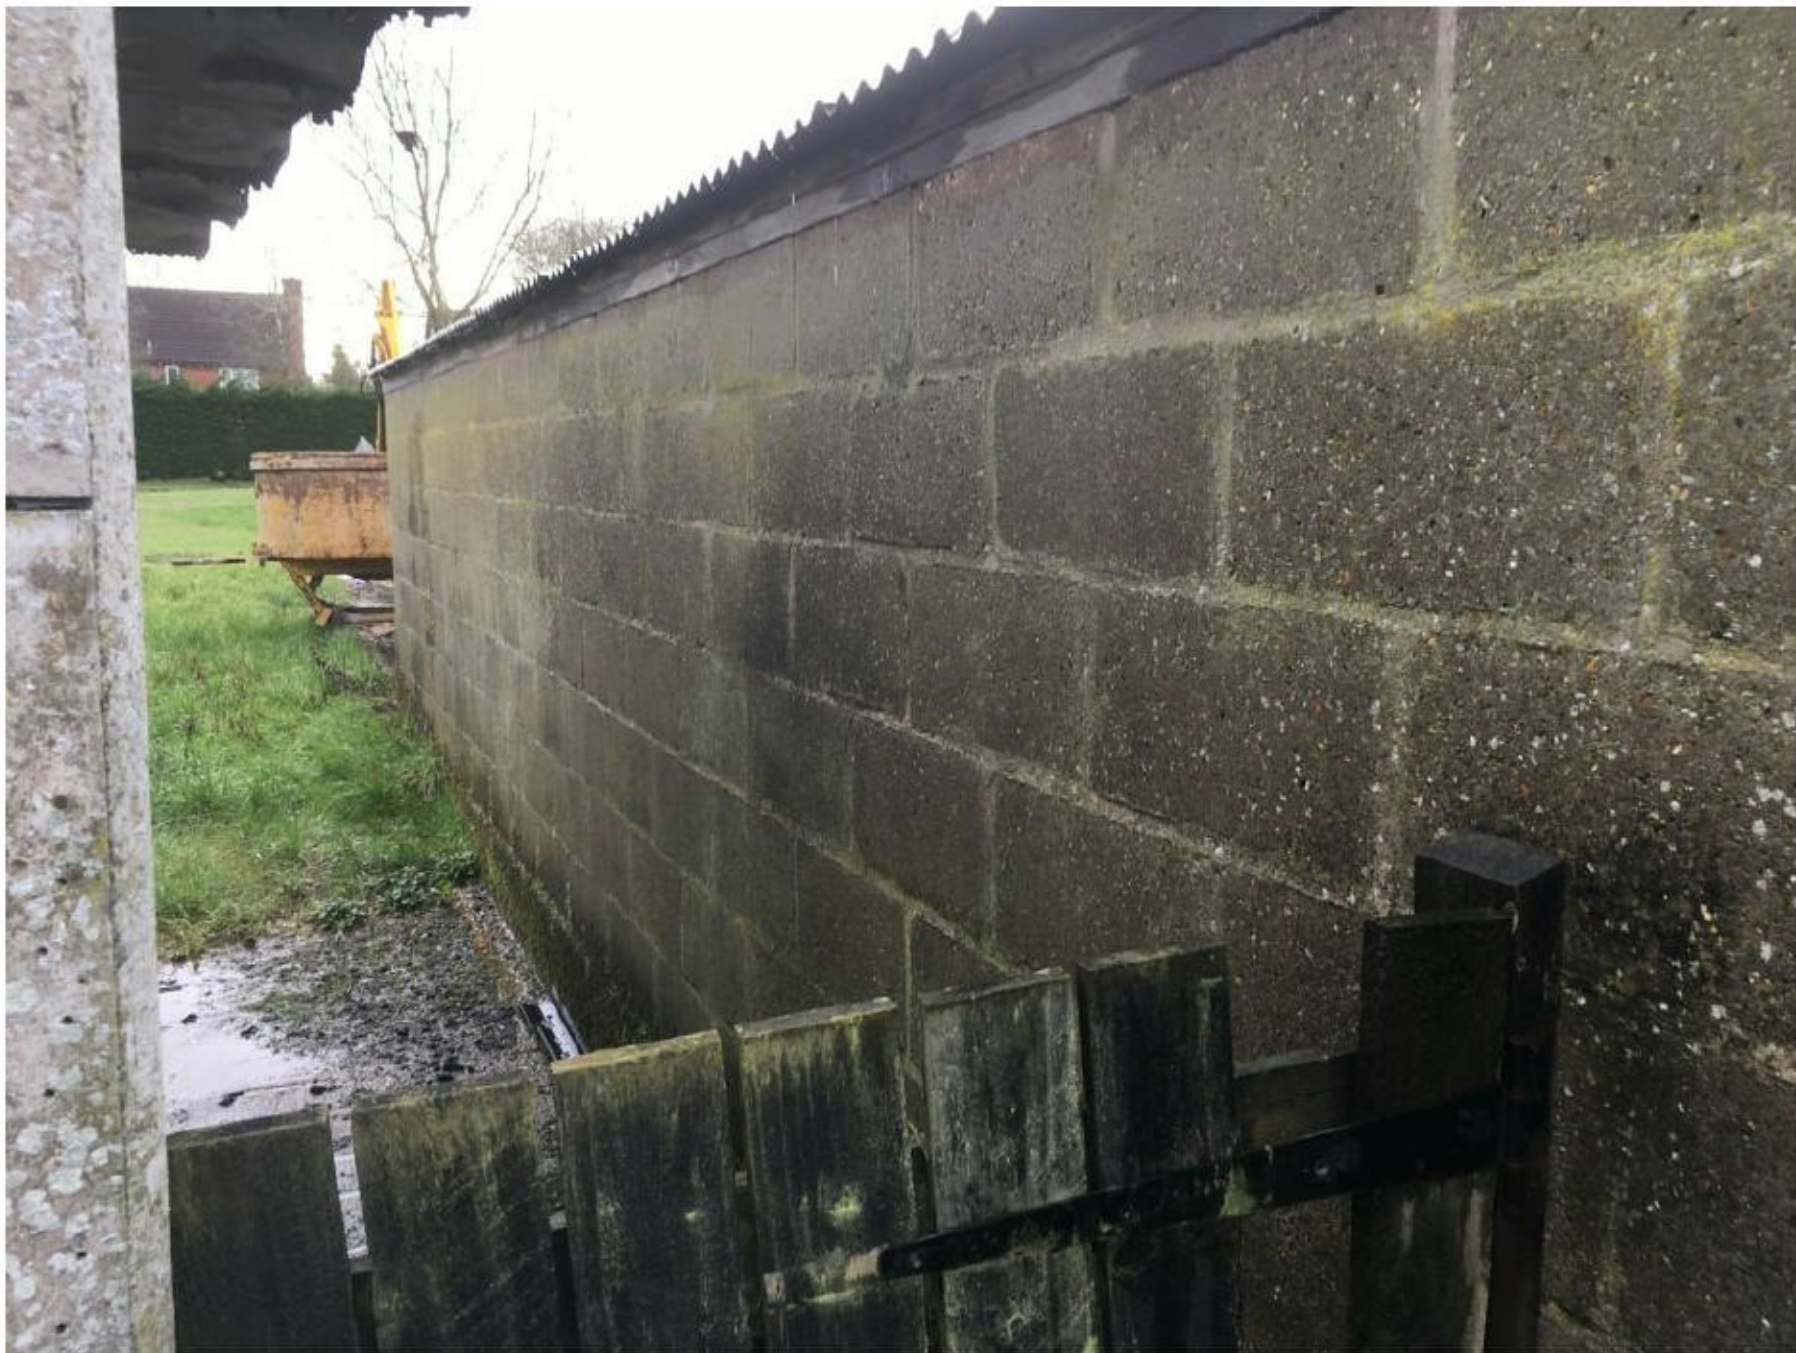
Property Elevations

Externally the masonry has a vertical crack on the southern elevation at the duo pitch front section of the barn and the rear mono pitch section. There is a minor vertical crack to the southern elevation a mid point of the duo pitch section wall, propagating from low level.

To the western elevation there is some minor damage that has displaced the masonry around the door openings at lintel level, along with a minor vertical crack central to the masonry elevation.

The northern elevation has a small displaced crack within the masonry adjacent to a door opening. There are no other defects to the remainder of the masonry to the building.

As with any building of this age, there may be a degree of repair required when converted and of note some stitching of the historic cracking noted to the southern and western elevations should be attended to, however it is considered the structure is adequate to support a conversion of this type.
