# **Barn at Ashfield Lodge, Ashfield cum Thorpe, Suffolk**

## **Heritage Asset Assessment**

# **Barn at Ashfield Lodge, Clowe's Corner, Ashfield cum Thorpe, Suffolk**

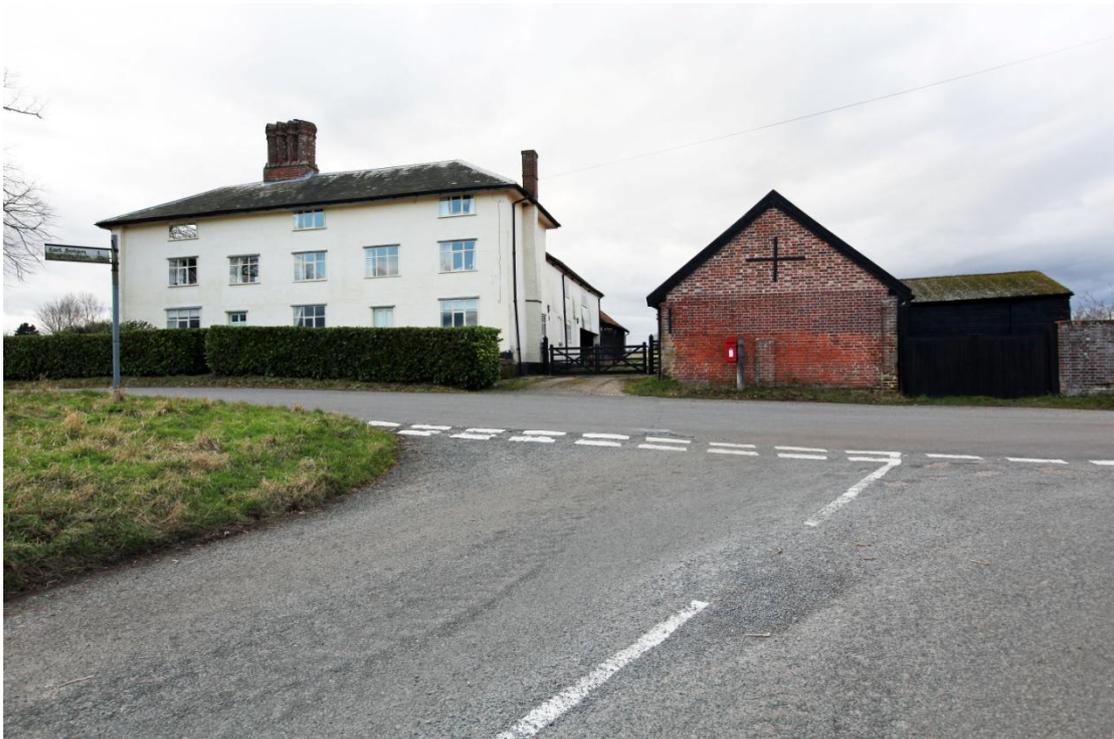
**Illus. 1. Ashfield Lodge from Low Road to the north-east showing the extent to which the property dominates the junction. The walls of the original 16<sup>th</sup> century farmhouse rose only to the lintels of the first-floor windows but were raised in the 19<sup>th</sup> century. The rear barn is visible between the house and the mid-19<sup>th</sup> century shelter-shed on the right.**

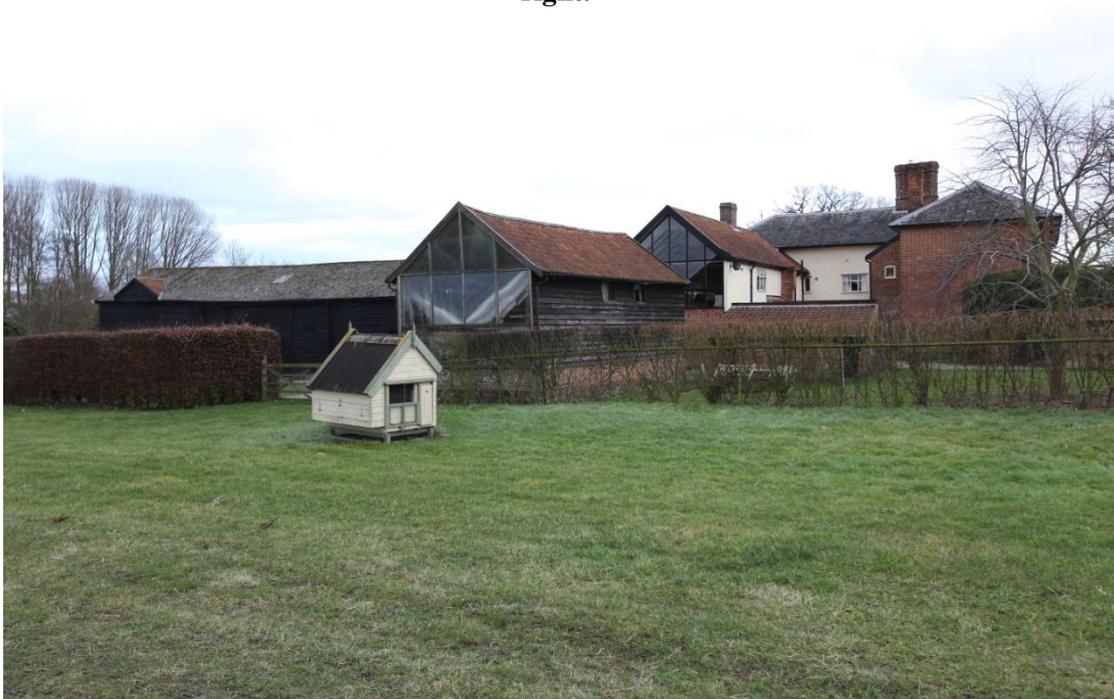
**Illus. 2. The site from the north-west showing the rear barn in the centre with the U-shaped 16<sup>th</sup> century house on the right and the much altered weatherboarded threshing barn of approximately the same date on the left.**
