ST CATHERINE'S COLLEGE, OXFORD
REPAIRS TO THE GARDEN WALLS
HERITAGE STATEMENT
DESIGN & ACCESS STATEMENT
DECEMBER 2020

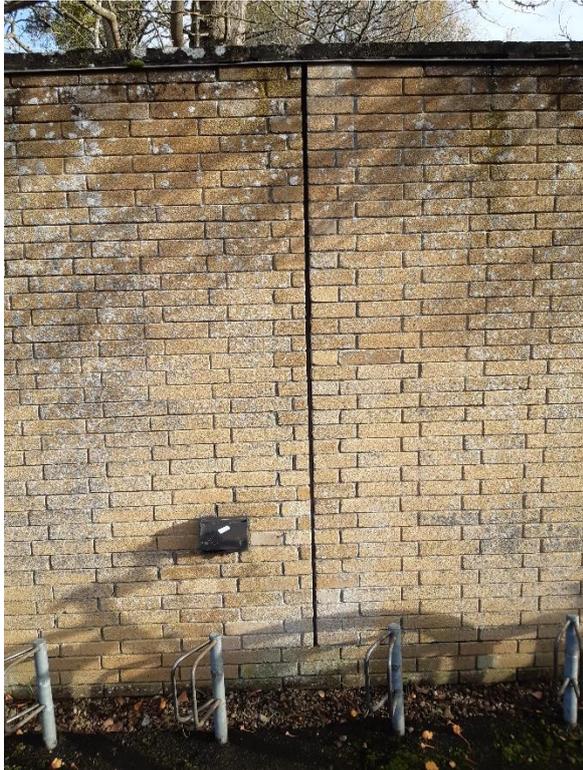
It is also interesting to note the condition of the freestanding walls elsewhere in the original College buildings. The circular cycle store walls were also built without any movement joints, as two semicircles with gaps in the walls for the gates. The two semi-circular walls have both moved outwards towards the top and there are some vertical cracks. Nearby, the Master's Lodgings garden walls were built towards the end of the original construction period. Those walls do incorporate some original vertical movement joints, at approximately 6 metre intervals and there has been no cracking of the brickwork.

Original movement joint in west garden wall to Master's Lodgings
