DESIGN AND ACCESS STATEMENT and HERITAGE STATEMENT

Poplars Farm, Lower Road, Hardwick, Aylesbury, Bucks HP22 4DZ

March 2021

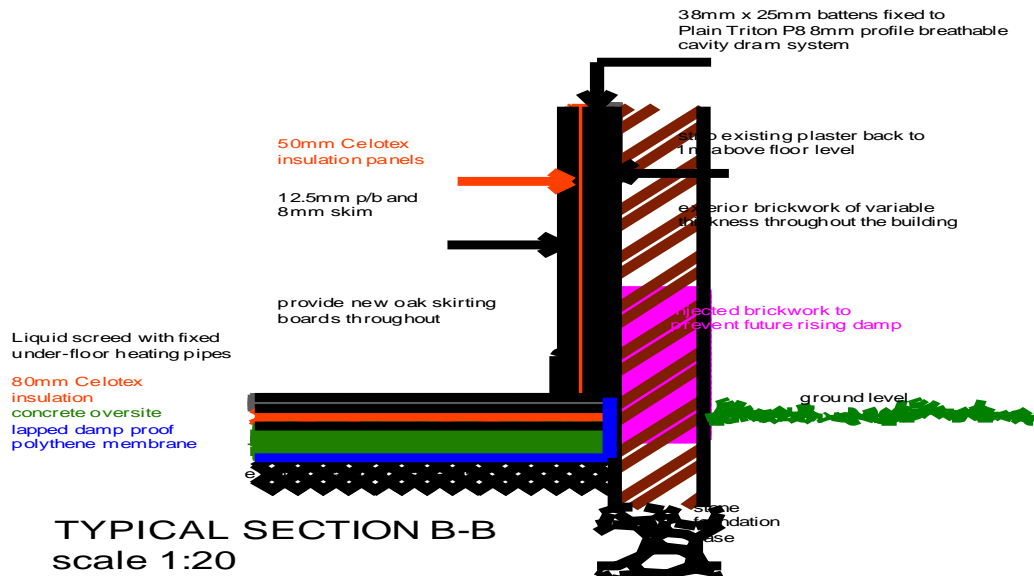
The main defect of the building related to rising damp, both through the floors and the internal and external walls. Ill-advised attempts had been made by previous owners to rectify the problem by lining the walls with stud framework, plasterboard and skim attached directly to the walls and the floors laid with concrete and old plastic fertiliser bags used as a damp proof membrane. Not surprisingly, these futile attempts to resolve the situation only resulted in the problem continuing to cause further deterioration and damage to other parts of the building.

Take up existing concrete floors down to the existing hardcore base, level and apply sand blinding to avoid any sharp corners puncturing the polythene damp proof membrane. Replace and lay concrete oversite over newly laid damp proof membrane. Lay 80mm Celotex GA400 insulation boards and fix 16mm underfloor heating pipes encased in 50mm self-levelling liquid screed.

Remove modern stud framework and plasterboard, strip back plaster to 1m above floor level and inject a chemical damp proof course into the brickwork. Scrape off all loose plaster and line the walls with plain Triton P8 cavity dram system wall tanking fixed with 38mm x 25mm battens. Line throughout with 50mm Celotex insulation and 12.5mm plasterboard and skim. Please note the Triton P8 system is specifically designed to allow the brick wall and remaining plaster to breath freely, thus avoiding any potential lack of ventilation problems.

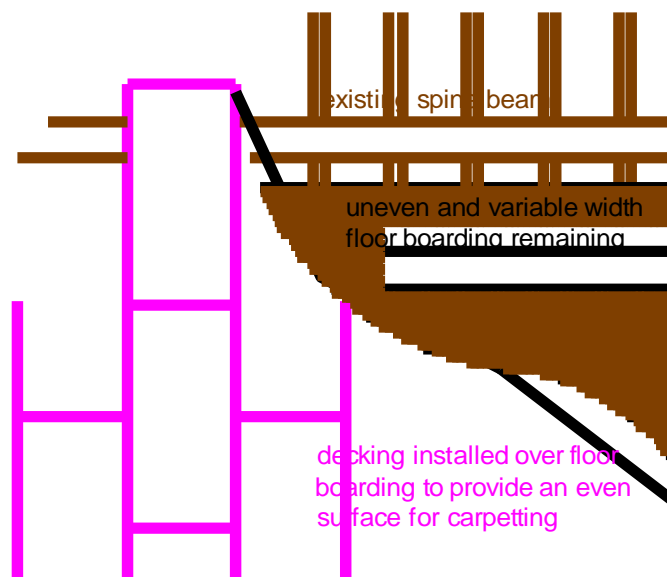
The original floor joists span between the front and rear walls are supported by spine beams that run the entire width of both The Range and The Farmhouse. In some areas the joists are exposed and in others covered by plasterboard and skim. Typically, the joists have dropped slightly at the outer edges and fall away from the level of the spine beams. The original floorboards vary in width and length and twisted with the floor joists. Many of the floorboards are damaged due to lifting for access in the past and no longer suitable for carpets or bathroom tiling. Accordingly, the original boards have been repaired and remain intact, but covered with flexible 12mm x 2.4m x 1.2m ply boards to provide a smoother surface in readiness for carpets and tiling.

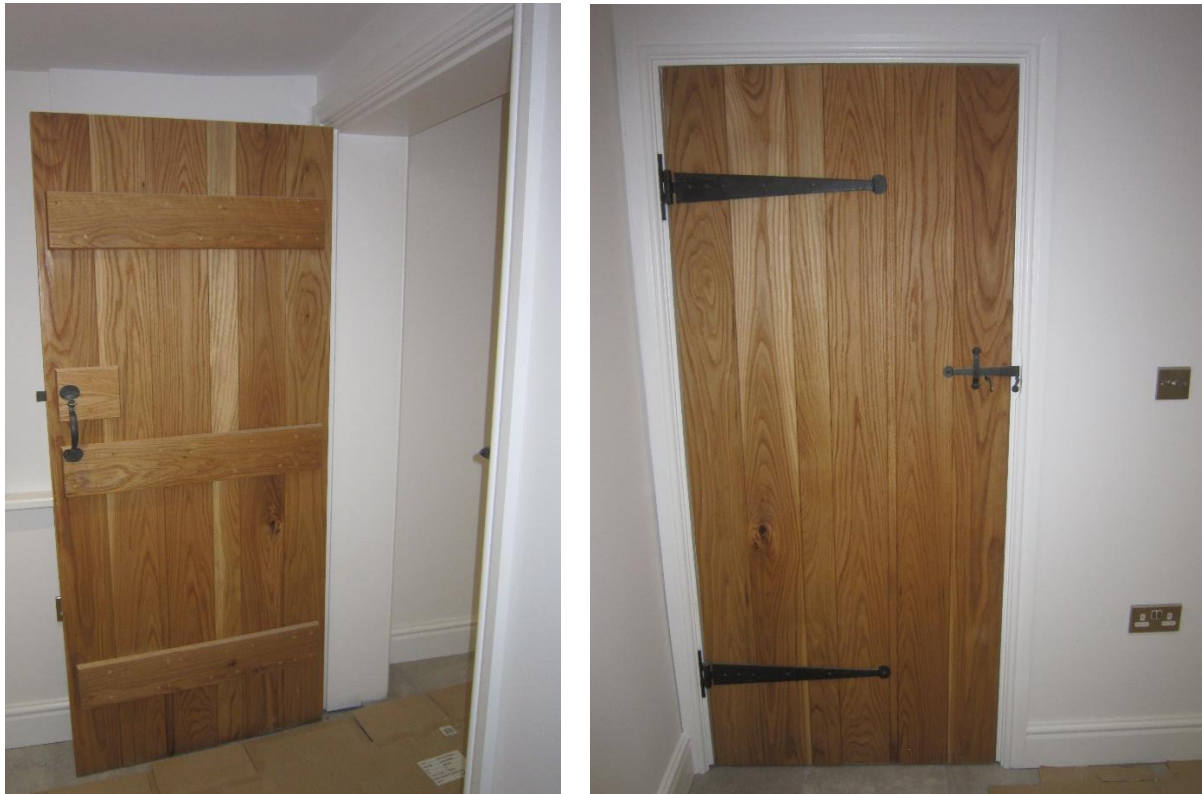
Typical replacement doors showing both sides of the same door

All other modern post 1948 doors and architraves have been removed and replaced with oak ledged doors with traditional latch and strap hinges.
