K WING OUTER BOUNDARY WALL

PROJECT
K WING BOUNDARY WALL
OXFORD UNIVERSITY PRESS
GREAT CLARENDON STREET
OXFORD
OX2 6DP

DRAWING TITLE
PROPOSED REMEDIAL WORKS TO K WING BOUNDARY WALL
GREAT CLARENDON STREET

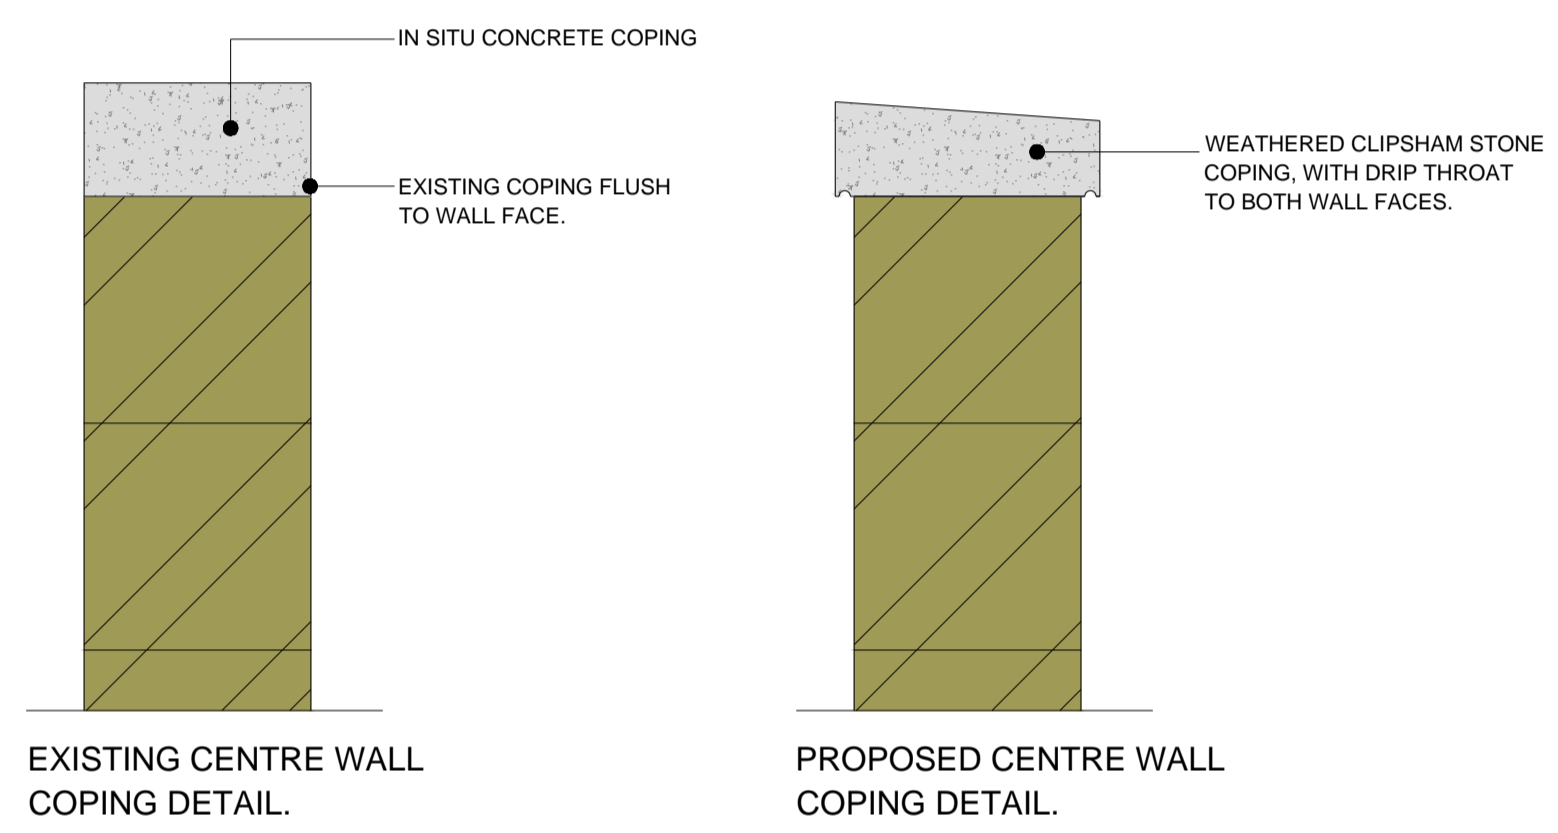
DETAILS APPROX 1:10@A1

Copings
The central horizontal wall section copings have been replaced with in situ cast concrete, which is cracked and worn, with vegetation growth to it and the initial stone wall course below.
Carefully remove concrete copings and take off upper course of masonry.
Clean surfaces, remove vegetation and treat with suitable weedkiller.
Reinstate upper course of masonry.
Supply and install new once weathered Clipsham (or similar) stone copings, with drip throat to both wall faces, to match adjacent existing stone copings.

Repair methodology to be:
General
Tool back loose and friable stone surfaces due to Sulphates and rainwater action.
Tool back old cement/sand render patch repairs.
Indents
Generally caused by corrosion of fixings within the bed joints, resultant expansion of the metal and fracturing of the surrounding stone faces.
Broken stone to be removed; any corroded fixings to be removed and replaced with stainless steel.
Indent with new section of stone to match existing.
Replacement stone
Individual stone blocks beyond repair (estimated less than 5No to complete wall) to be carefully cut out and replaced with stone block to match existing.
It is envisaged that a suitable stone for indent/replacement work would be Clipsham; Conservation Officer to agree sample repair/indent.
Repointing
Remove any loose/cracked materials; rake out by hand and repoint in suitable lime mortar, to match existing colour and texture.
