PRELIMINARY BAT ROOST ASSESSMENT

FORT HALSTEAD, KENT
PRELIMINARY BAT ROOST
ASSESSMENT

A Report to: CBRE Ltd

Report No: RT-MME-127947-02 Rev B

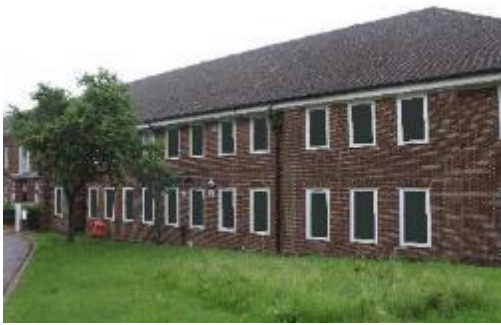
Plate 4.1: Brick building with hipped, tiled roof

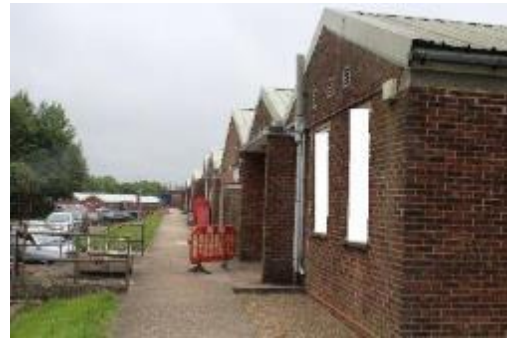
Plate 4.2: Brick building with pitched, corrugated metal roof

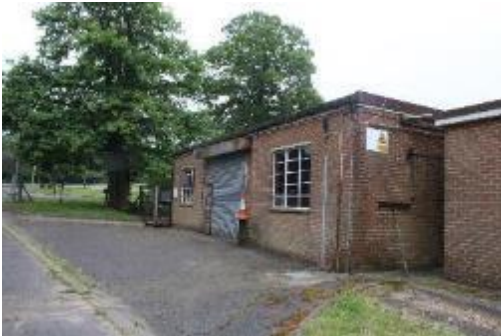
Plate 4.3: Brick building with flat, felt roof

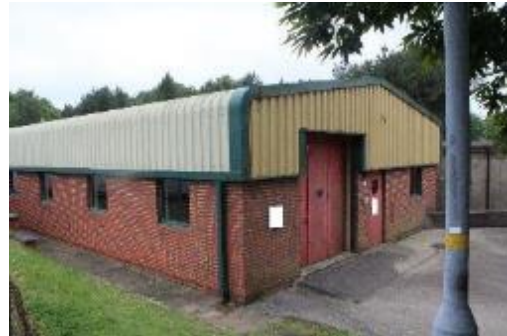
Plate 4.4: Brick building with pitched, corrugated metal roof and corrugated metal cladding

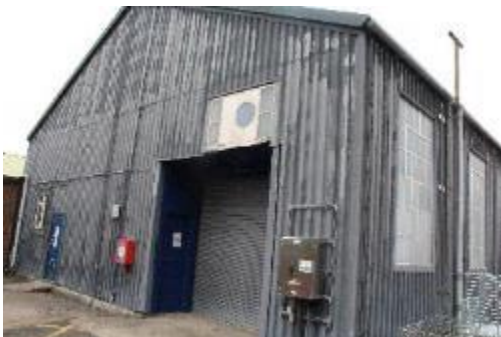
Plate 4.5: Corrugated metal building with pitched roof

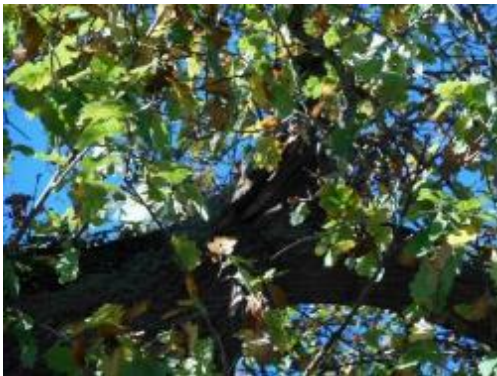
Plate 4.18: Tree 247

| Tree No. | Species | Description | BCT Suitability Class |
|---|---|--|---|
| 247 (Tag 1136) | Oak | Tree measures approximately 12 m in height and 0.6 m in stem diameter at chest height. There was a split in the end of an upper limb that was partially dead (Plate 4.18). However, this did not lead into any cavities. | Negligible |

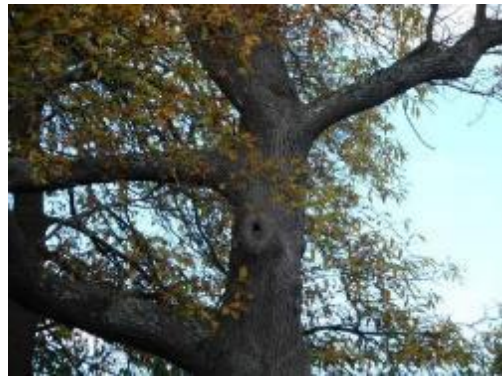
Plate 4.19: Tree 1402

| Tree No. | Species | Description | BCT Suitability Class |
|---|---|--|---|
| 1402 (Tag 309) | Oak | Tree measures approximately 14 m in height and 0.7 m in stem diameter at chest height. There was a hole at the end of a limb on the northern aspect at approximately 10 m above ground level. Holes were also present on the southern aspect of the main stem at 6 m and 7 m above ground level (Plate 4.19). These holes were checked and they did not ingress beyond 10 cm, offering only limited roosting opportunities for bats. A scar was present on the upper side of a lateral limb located above a covered walkway. Due to its position, this scar could not be inspected. | High |

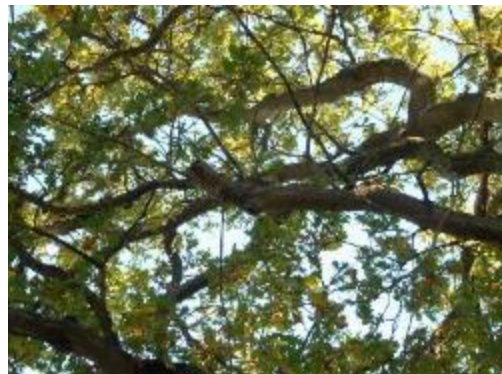
Plate 4.21: Tree 1531

| Tree No. | Species | Description | BCT Suitability Class |
|---|---|--|---|
| 1531 (Tag 655) | Oak | Tree measures approximately 14 m in height and 0.8 m in stem diameter at chest height. There was a dead hollow branch on the southern aspect at approximately 7 m above ground level (Plate 4.21). The hollow extended 30 cm and was quite dry inside despite it being slightly open. No evidence of bats was recorded. | High |

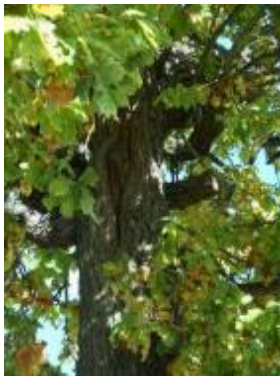
Plate 4.26: Tree 1571

| Tree No. | Species | Description | BCT Suitability Class |
|---|---|---|---|
| 1571 (Tag 849) | Oak | Tree measures approximately 9 m in height and 0.5 m in stem diameter at chest height. There was a split in the south-eastern aspect of the main stem at 5 m above ground level (Plate 4.26). This did not ingress to any significant depth, offering only limited roosting opportunities for bats. It contained leaf litter and cobwebs, indicating no recent use by fauna. It was also quite wet inside, so likely to only be used by opportunistic bats. | Low |

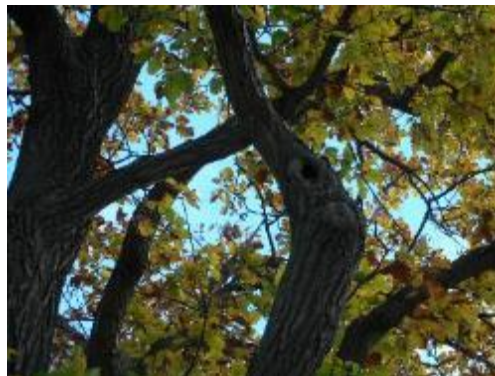
Plate 4.28: Tree 1573

| Tree No. | Species | Description | BCT Suitability Class |
|---|---|---|---|
| 1573 (Tag 847) | Oak | Tree measures approximately 16 m in height and 0.8 m in stem diameter at chest height. There was a hole on the northern aspect at 7 m above ground level, and a scar with a hole on the south-eastern aspect at 7 m above ground level (Plate 4.28). These features connect but do not extend further into the tree. The cavity created by the two features extends 20 cm upwards and 20 cm downwards. It was predominantly clear of cobwebs, possibly indicating recent use by fauna. No evidence of bats was recorded. | High |
