# SLOPE STABILITY REPORT

Fort Halstead, Kent

February 2015

**Client Name:** Armstrong (Kent) LLP  
**Document Reference:** EED12715-102-R-8.1.8-RD  
**Project Number:** EED12715

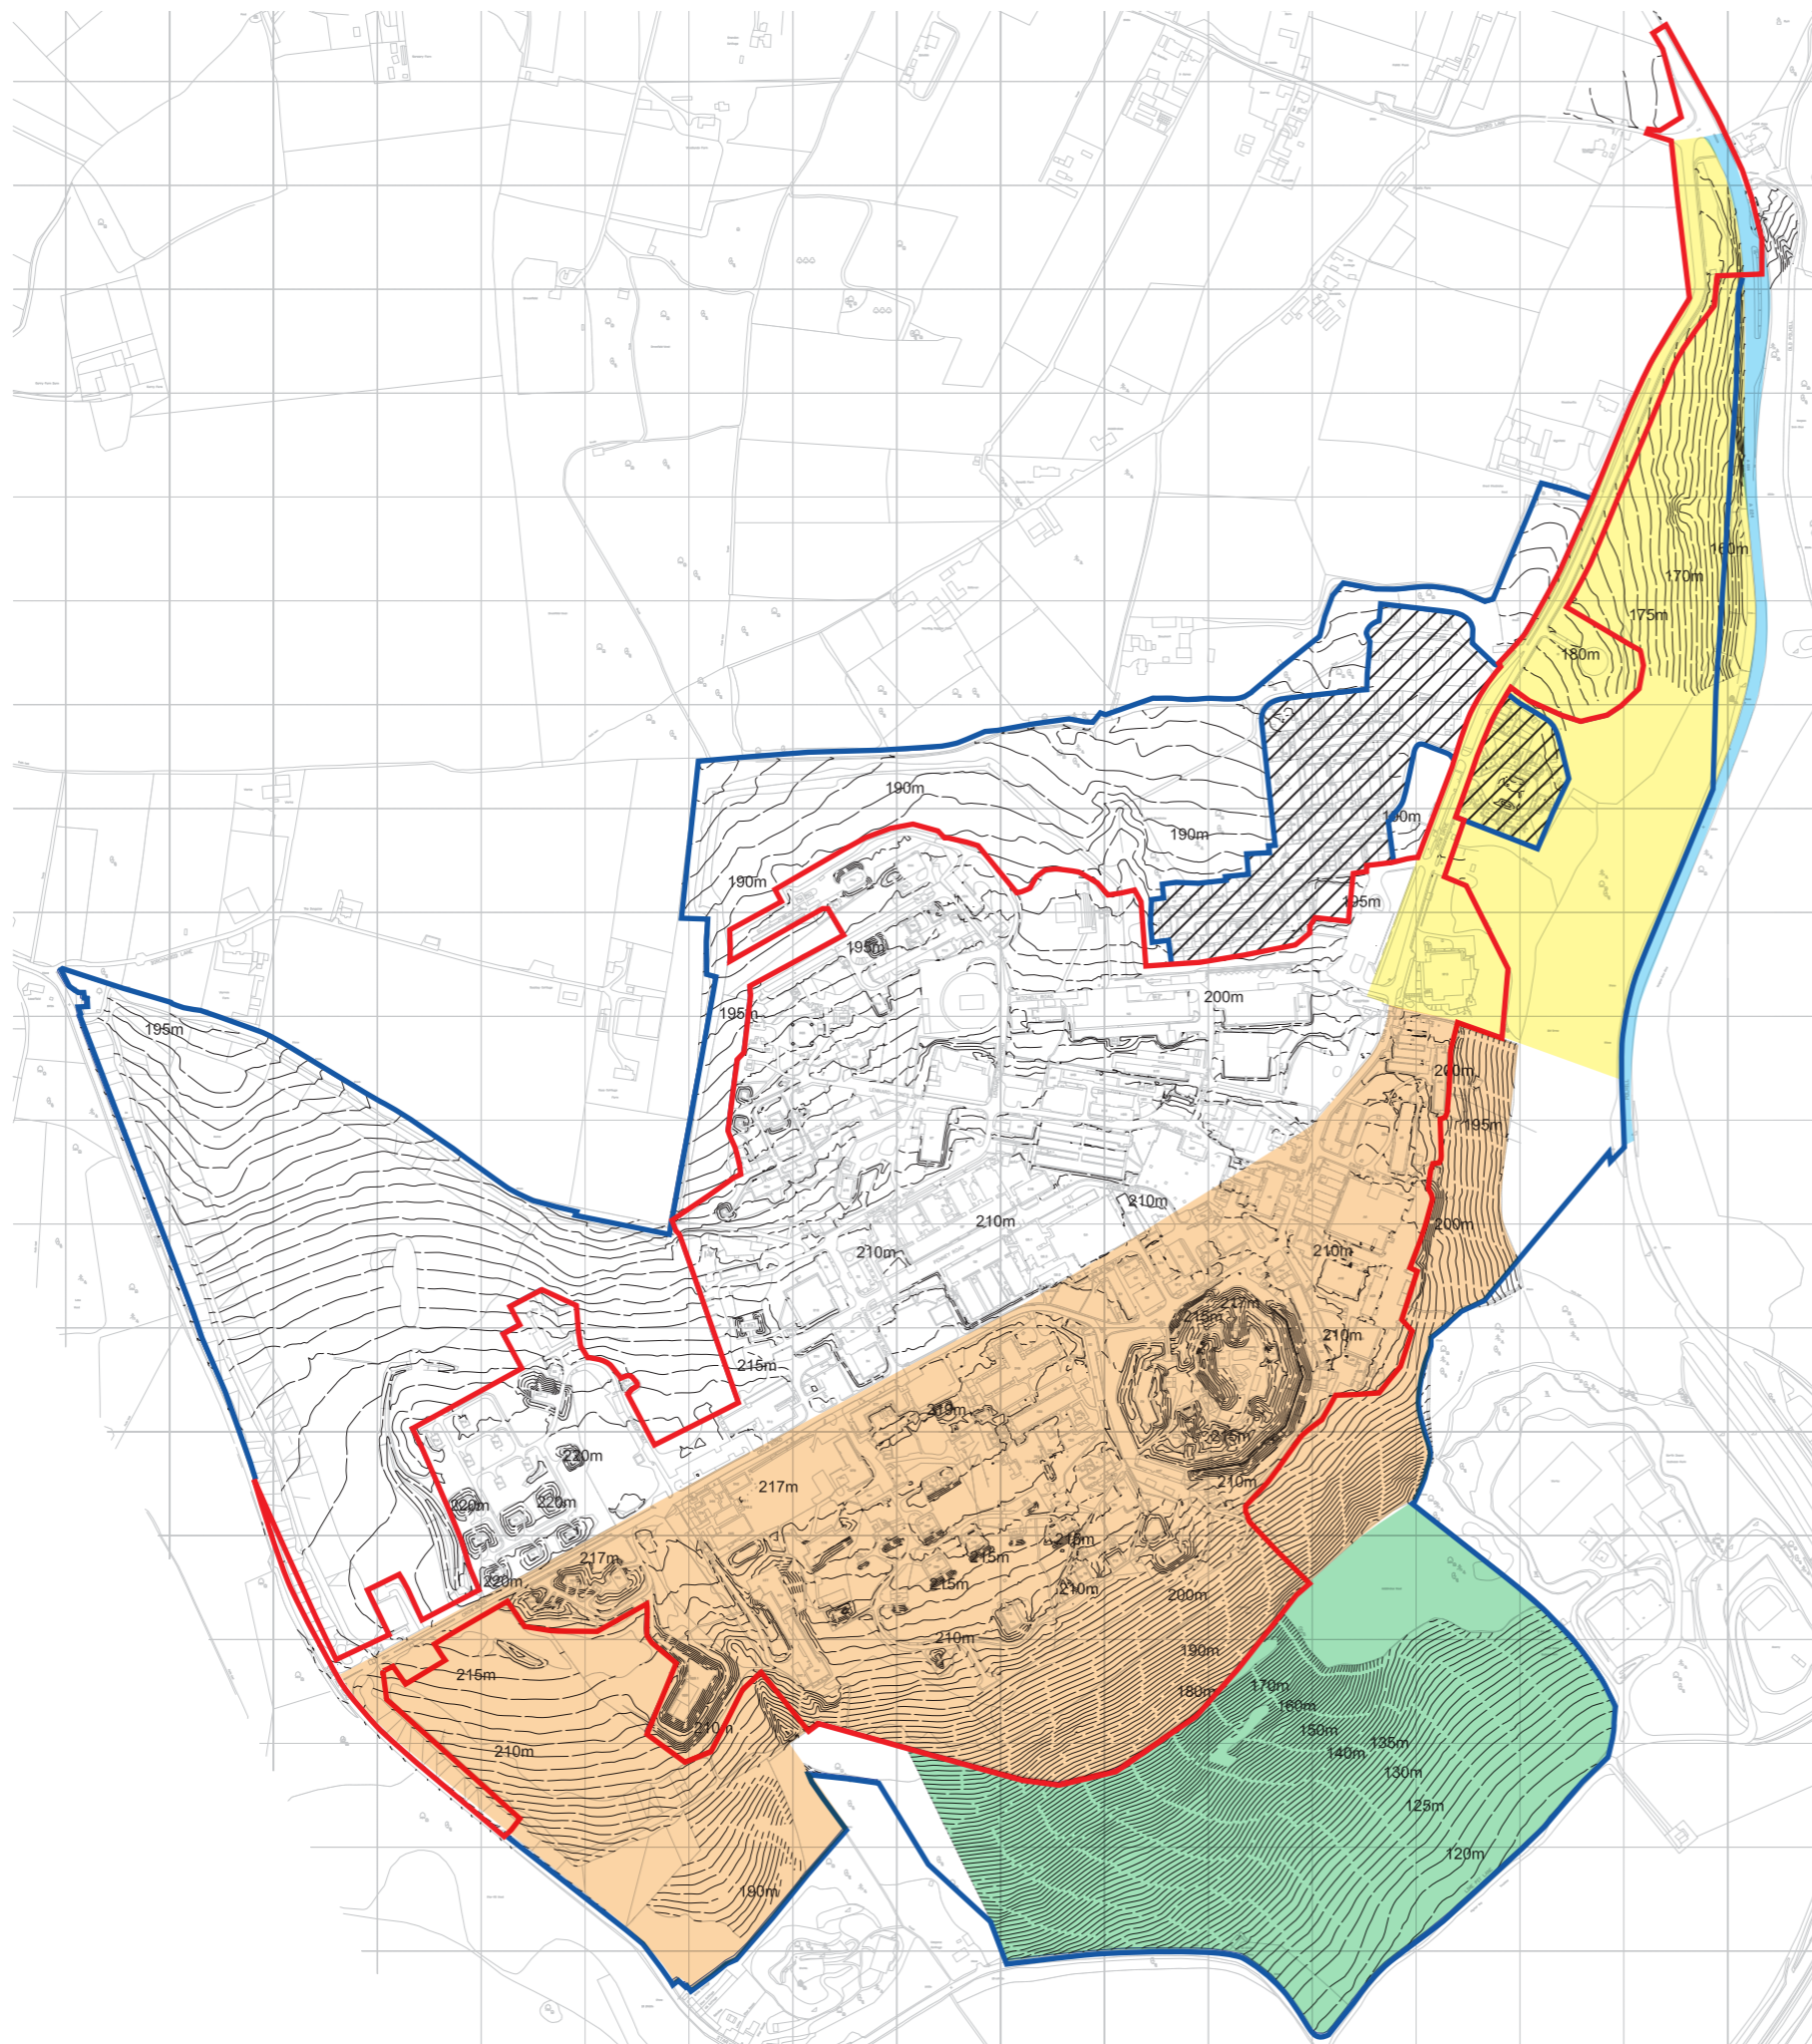
Project Details	EED12715-102: Fort Halstead
Figure Title	Figure A3: Plan Showing the Locations of Slopes Inspected
Figure Ref	EED12715-102_GR_ES_A3A
Date	January 2015
File Location	\\nt-incs\weed\projects\eed12715\102\graphics\eia\issued figures

- 6.4 No evidence of slope instability such as cracking of structures, soil creep, hummocky ground, slip scars, leaning of trees etc, was observed on Site during the walkover.

- Ground levels should not be increased close to the top of the existing chalk escarpment or other existing slopes. Additionally, new foundations should not be placed so that they increase the loads at the top of existing slopes.
