Condition report/conservation proposal

Location: Bubwith Almshouses, Wells- Medieval glass to the Chapel

North east window- small rectangular light 310 x 1230mm

Date of survey: 7th March 2019

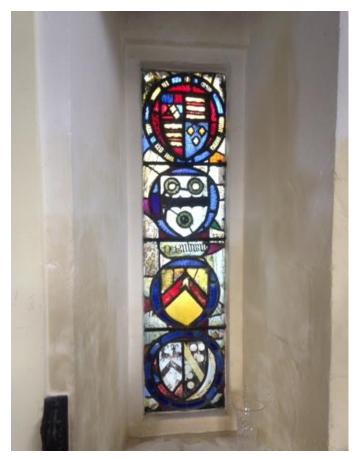
The surviving medieval stained glass is gathered in this window, although it had originally been elsewhere in the building.

There are some insertions of unpainted purple, blue and green glass which date from the 19th century. The arms of Stafford has a large insertion of yellow stained glass, probably 19th century.

There is an external galvanised steel wire guard, which is necessary on the street side, but is very dirty, with a considerable build-up of debris at the base, which will hold moisture against the ancient glass, which is undesirable. (See appendix 3- Degradation of Glass).

The glass has corrosion pits on both faces, and some loss of painted detail, as well as surface abrasion. There is soma algal growth to the upper and lower edges on the internal face corresponding with debris trapped in the wire guard on the external face.

The glass is dirty on the internal face. There are a number of single cracks to the window, but the pieces of glass remain stable. The arms of Bubwith has a ground of holly leaves, there are several ugly historic repair leads, and fragments of glass are parted. This area needs some work to remove the repair leads and stabilise the fragments for aesthetic and structural improvement. However glass is not in danger of becoming dislodged at present.

There are also several other unsightly repair leads in the arms of Stafford

There is significant corrosion with pitting to the internal and external faces of the glass .This is fairly common in 15th century glass.

The condition of the painted detail is varied, but there is general slight paint loss. This general loss is almost certainly to do with cycles of condensation over the centuries. There are also areas which have been roughly handled with obvious abrasion- notable are the rams in the lower shield, and the Fleur de Lys in the Royal Arms.

The lead is a rather heavy 3/8 inch flat section, not sympathetic to the delicacy of the work, but of historic significance itself as part of a 19th century restoration. It remains in reasonable condition, there is no justification for re-leading at present.

There are a few glints of daylight where stained glass cement has fallen away, or glass is ill-fitting, but this is easily remedied with the application of small areas of linseed oil putty stained with Lamb Black pigment.

Projected works: Condition/ Priority Code – C3

It would be sensible to clean, conserve and protect the glass to ensure its long term survival for the enjoyment of future generations. We suggest that the glass is cleaned, and minor repairs carried out insitu.
