Conservation Report: Gas Lamps at St Paul's Church, Covent Garden

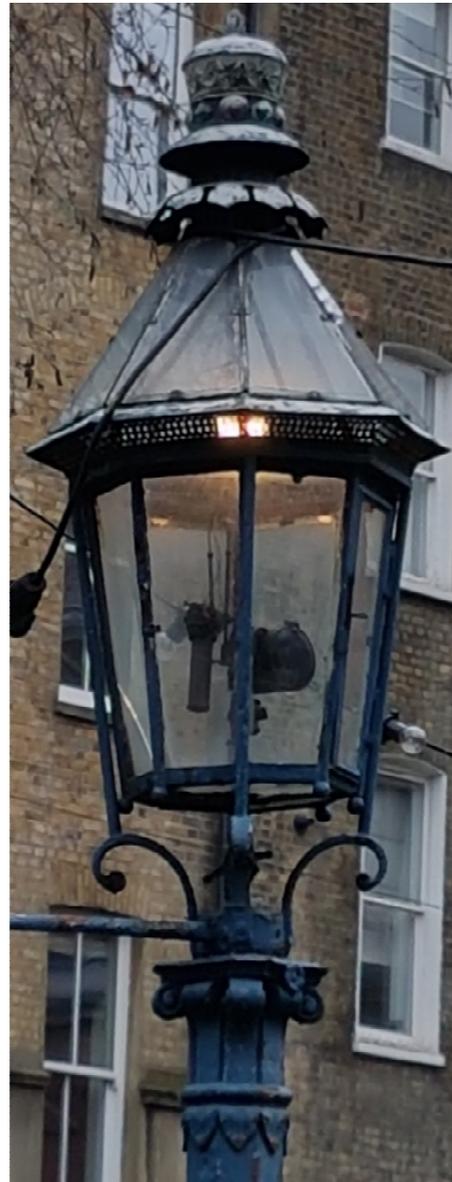
Notably one gas-lamp was damaged in an explosion in the winter of 2019/20. This was caused when a vehicle snagged on a cable around a standard facing the west front. Approximately half of the lantern still exists and all of the standard although it too is cracked and probably slightly deformed. Interestingly the ventilation trims look as if they are twentieth century replacements as they are rows of drilled holes rather than the slots of the other lanterns.

Damaged standard

The damaged standard will be carefully restored. It is in reasonable alignment but fixed on features such as the wrought iron scrolls carrying the lantern and the lantern cage will be taken off and straightened or replaced. The internal gas pipe will be investigated for damage and repaired as required. A new lantern will be fabricated using existing lanterns as a model for each of the components.
