GROUND STABILITY APPRAISAL

8 PRINCES ESPLANADE
GURNARD
COWES
ISLE OF WIGHT
PO31 8LE

CLIENT : MCLEAN CONSTRUCTION

REF : 21C036

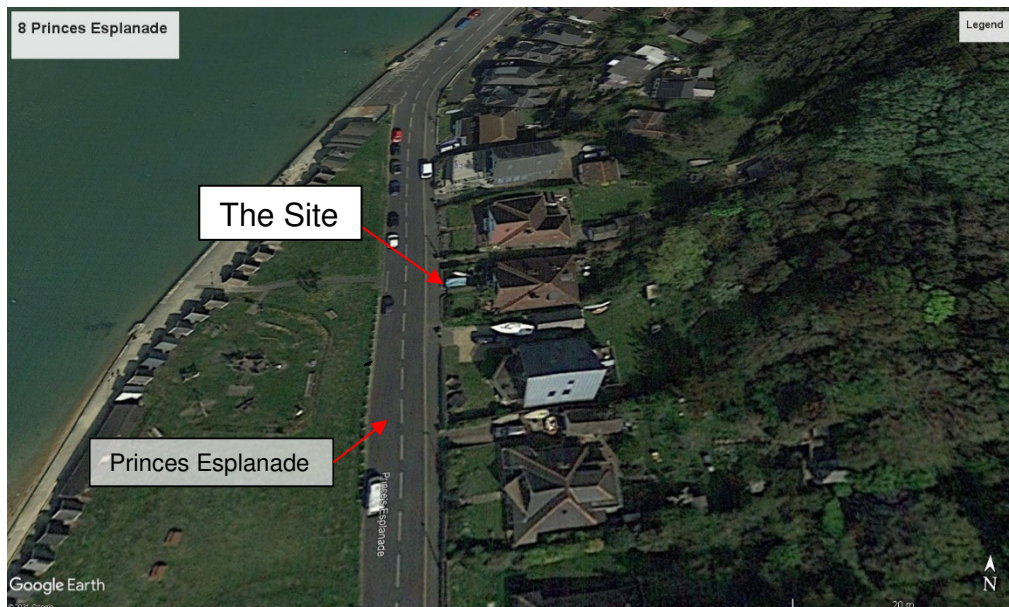
Figure 2 : Aerial Image (© Google 2021)

8 Princes Esplanade is a detached early-20th Century chalet bungalow that sits to the east of Princes Esplanade, Gurnard near Cowes (Figures 1 & 2).

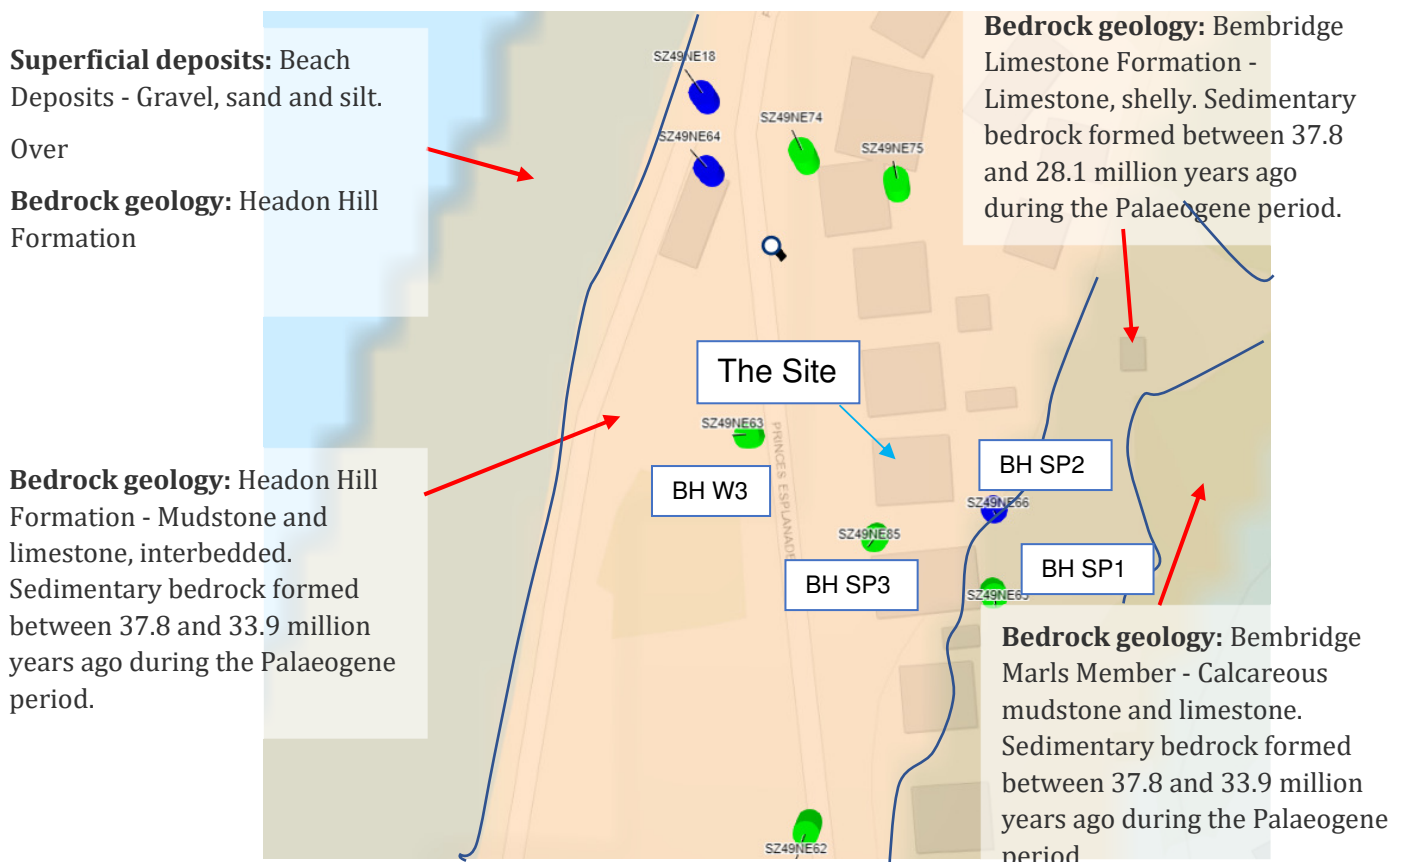
Figure 3 : Geology Strata (<http://mapapps.bgs.ac.uk/geologyofbritain3d/>)

Bedrock geology: Headon Hill Formation - Mudstone and limestone, interbedded. Sedimentary bedrock formed between 37.8 and 33.9 million years ago during the Palaeogene period.

Outcrops of the *Bembridge Limestone Formation* and *The Bembridge Marls Member* are shown just upslope (east) of the site within the garden area.

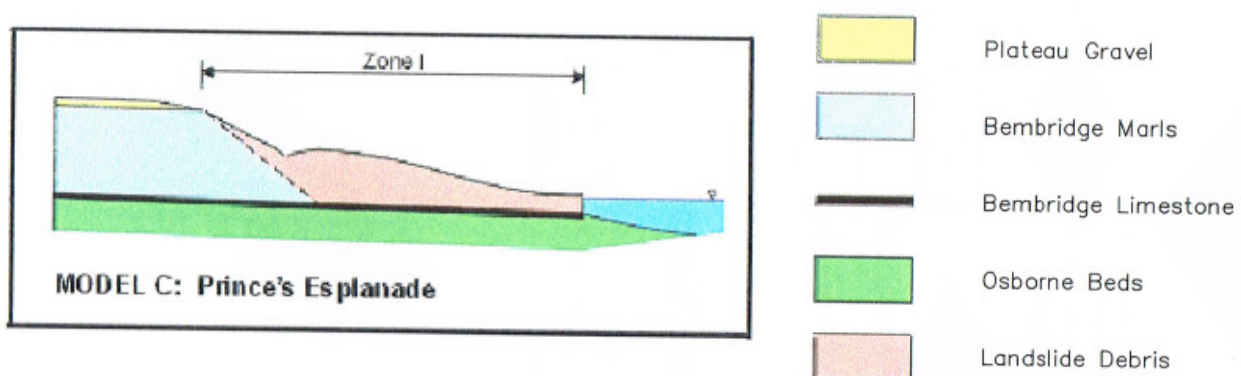
Figure 4 : Indicative Model Type C from Halcrow Report

The site is shown within an area described as Cliff Behaviour Model C which is defined as *deep-seated landslide (uncertain mechanism) protected by sea walls*. The Halcrow Report notes that Model C is characterised by a bench of landslide debris at the base of the Bembridge Marls Cliffs. The debris bench and the Bembridge Marls sit over the in situ Osborne Beds as shown by Figure 4).

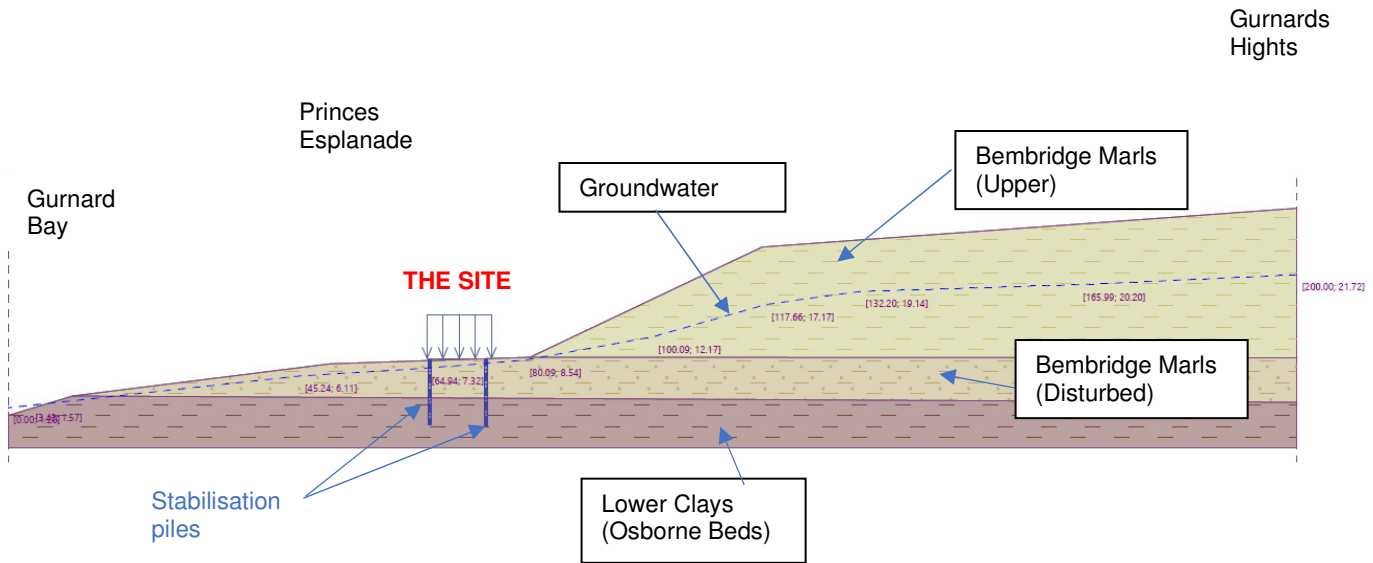
Figure 5: Simplified ground model used for preliminary analyses

No intrusive ground investigation has yet been carried out at the site. The assessments have therefore been based on a ground model extrapolated from boreholes carried out as part of other developments in the area and supplemented by local knowledge. Further computer analysis based on borehole data from the site itself shall be required prior to final foundations design.

Figure 5 shows the interpolated ground profile. No significant change in ground profile is proposed as part of the development although final levels have not been set. Some small excavation may be required for the garage building to the rear of the site.
