Project Name: 2020-09-14309 Campbell Reith Whitworth High School Hall Fold Whitworth

Project Date: 04/11/2020

Inspection Standard: MSCC4 Sewers & Drainage GB (SRM4 Scoring)

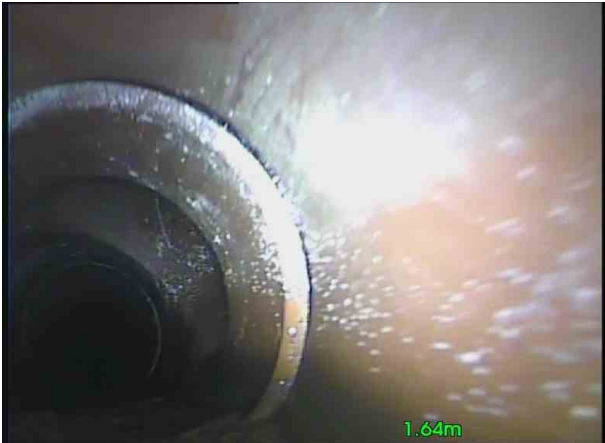
USX_e4652b06-f726-4408-8d5c-c6ae3c572580_20201105_1
02722_947.jpg, 00:00:21, 1.65 m
Open joint, medium

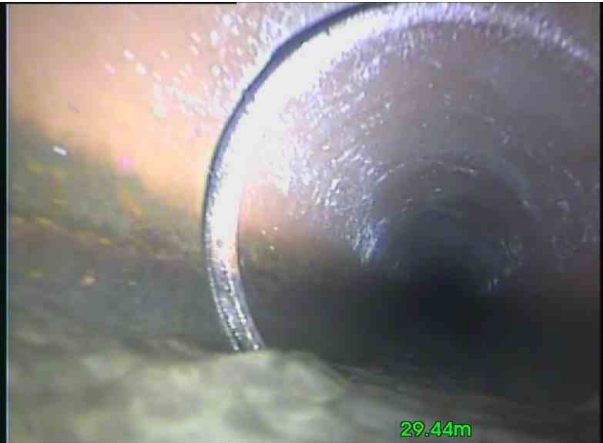
S32X_13c4fc26-014e-4cdd-93fd-172d1cec2aa2_20201105_1
24231_289.jpg, 00:01:58, 29.44 m
Open joint, medium

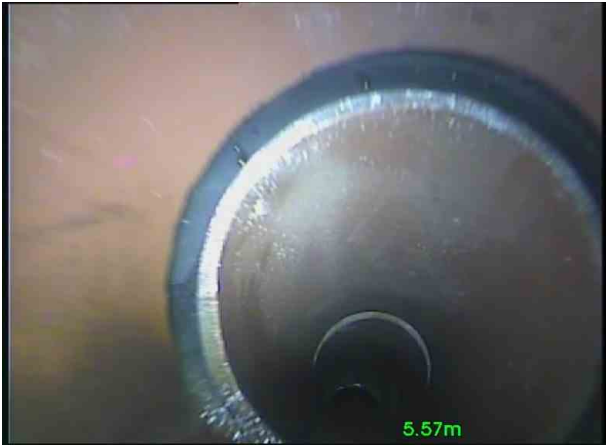
S31X_05363f99-1af7-4496-aafe-47c1ad740398_20201105_1
52546_886.jpg, 00:00:35, 5.57 m
Open joint, medium

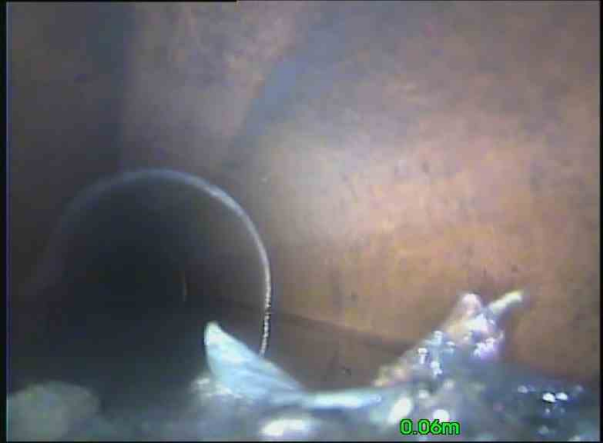
USX_eddd4ecc-7660-4389-938d-367d4dfd7d1e_20201105_1
55626_975.jpg, 00:00:08, 0.01 m
Settled deposits, coarse, 15% cross-sectional area loss

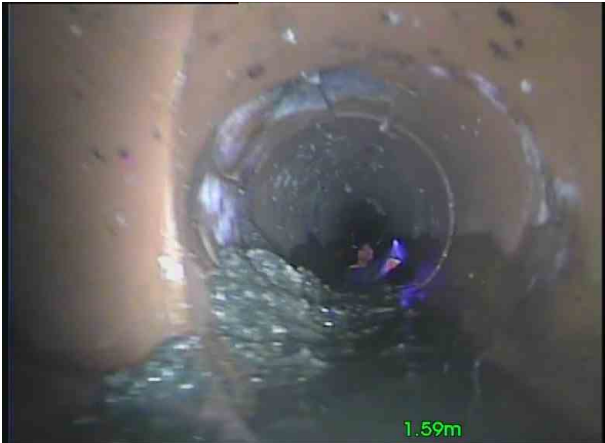
End O
 LineX_396f7d95-15bd-42e3-a1d6-70655c974d52_20201105_162252_673.jpg, 00:00:13, 1.60 m
 Settled deposits, fine, 10% cross-sectional area loss

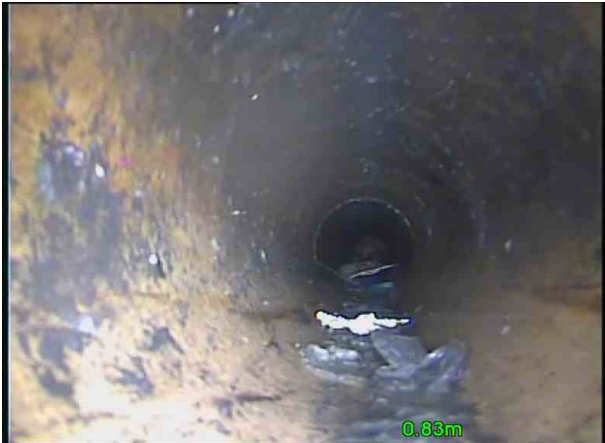
Branch
 2X_a6bca09d-0fae-4926-938a-ae7fc9b9cde3_20201105_163
 446_274.jpg, 00:00:15, 0.80 m
 Settled deposits, coarse, 5% cross-sectional area loss

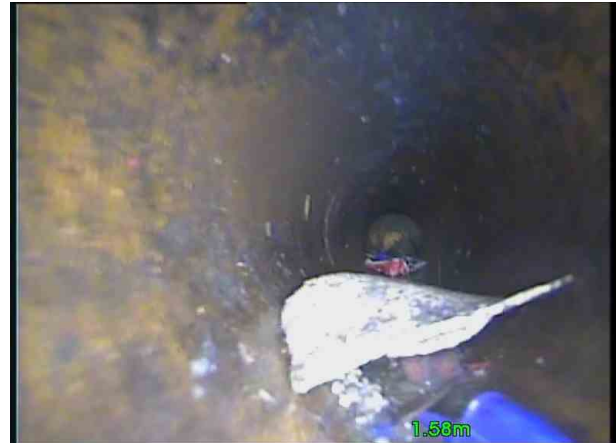
Branch
 2X_36cd05c7-09a3-4c61-8e7a-1168bfbe9d40_20201105_163
 513_104.jpg, 00:00:19, 1.58 m
 Settled deposits, other, 10% cross-sectional area loss, Debris

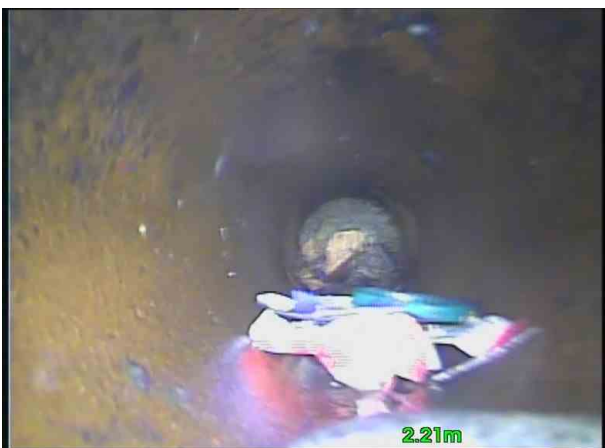
Branch
 2X_9a73fe33-edb5-41b6-b069-6c5d146a0752_20201105_163
 533_503.jpg, 00:00:21, 2.20 m
 Settled deposits, other, 10% cross-sectional area loss, plastic

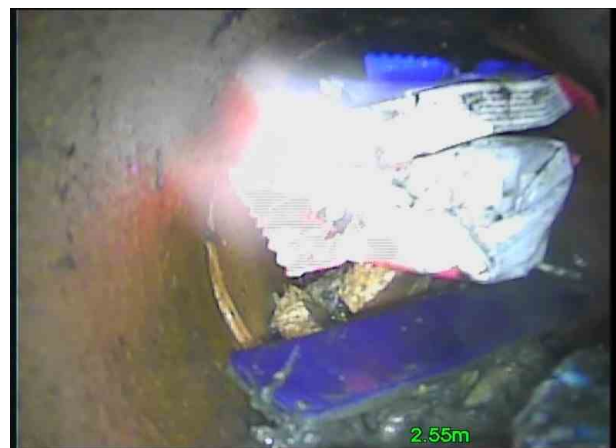
Branch
 2X_88eebec7-9bc3-4ced-9545-07b14c0d7634_20201105_16
 3556_805.jpg, 00:00:27, 2.55 m
 Settled deposits, other, 70% cross-sectional area loss, debris

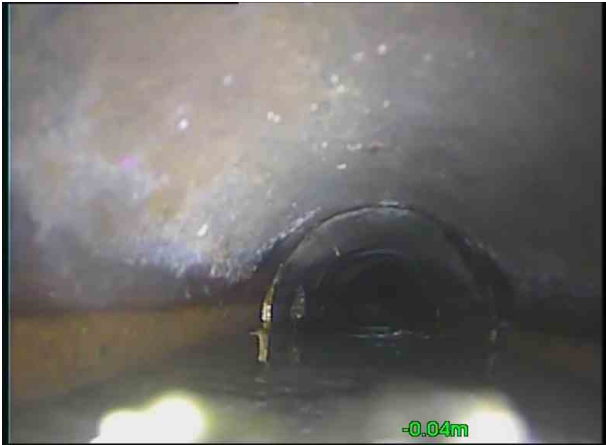
S42X_27c6418a-1244-4c36-829a-6bba5c22d076_20201105_163758_758.jpg, 00:00:08, 0.05 m
 Settled deposits, fine, 15% cross-sectional area loss

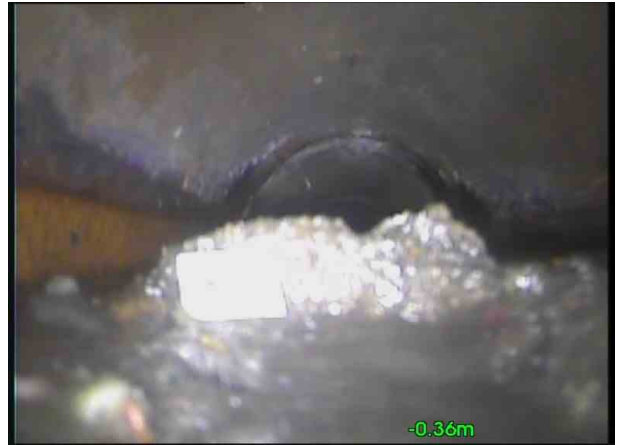
S42X_880e25ce-ba96-456c-ba13-4a50570136b5_20201105_163947_665.jpg, 00:00:08, 0.05 m
 Settled deposits, fine, 15% cross-sectional area loss

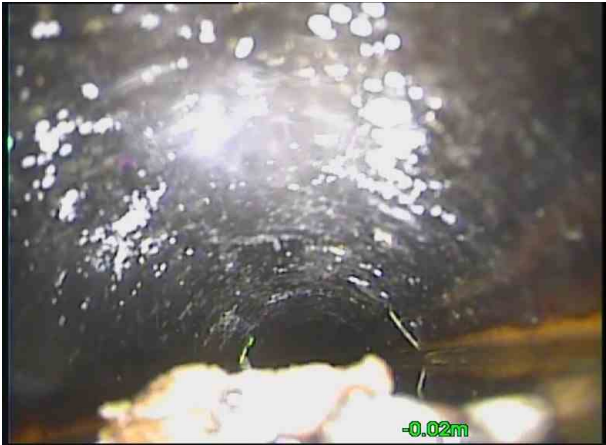
USX_6685c647-a3d7-4118-89c1-d5b9e974c8bc_20201105_1
64424_906.jpg, 00:00:08, 0.01 m
Settled deposits, coarse, 15% cross-sectional area loss

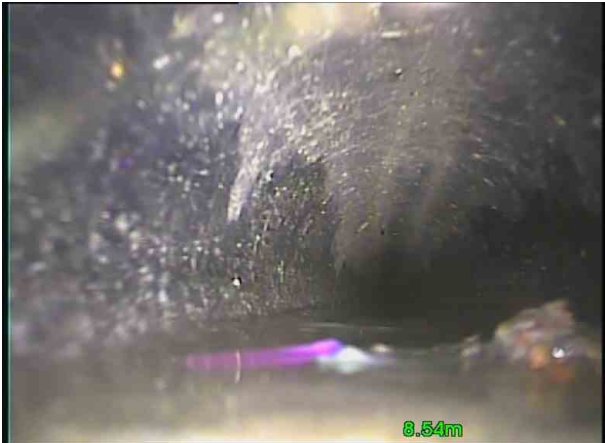
USX_967d721b-1628-40e5-a7c0-2b55291a5f7f_20201106_114922_555.jpg, 00:00:50, 8.54 m
 Settled deposits, other, 10% cross-sectional area loss,
 Unknown

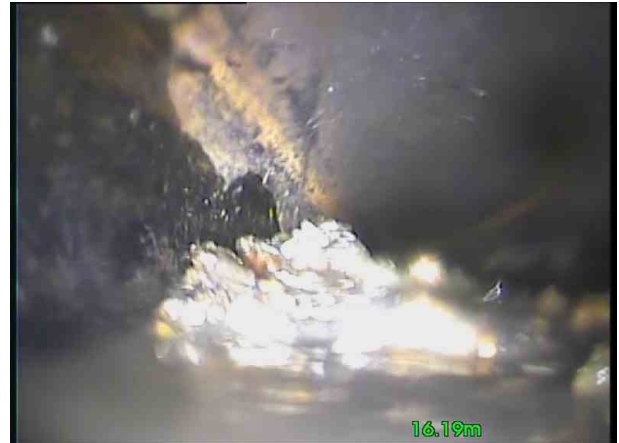
USX_5f3638b9-4dc3-41dc-b97a-df562f0a5bc9_20201106_120715_594.jpg, 00:01:50, 16.19 m
 Settled deposits, coarse, 30% cross-sectional area loss

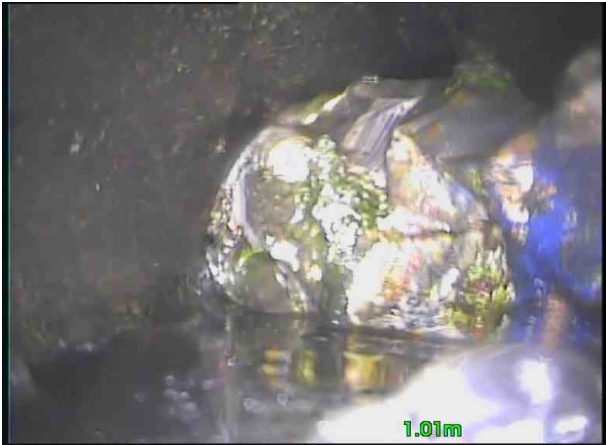
S36X_e1b14cac-e86d-4bc9-b260-0c5c9f46dc73_20201106_1
22359_538.jpg, 00:00:15, 1.00 m
Settled deposits, other, 85% cross-sectional area loss, Debris

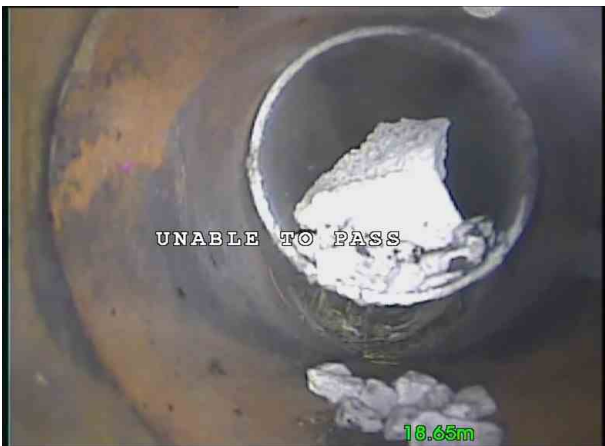
Branch
2X_7eabd447-ee63-4cae-99c3-d46371f48a00_20201106_124
208_870.jpg, 00:02:39, 18.65 m
Obstacles, external pipe or cable from 12 o'clock to 12 o'clock,
50% cross-sectional area loss, Smaller pipe in drain, Debris at
the entrance

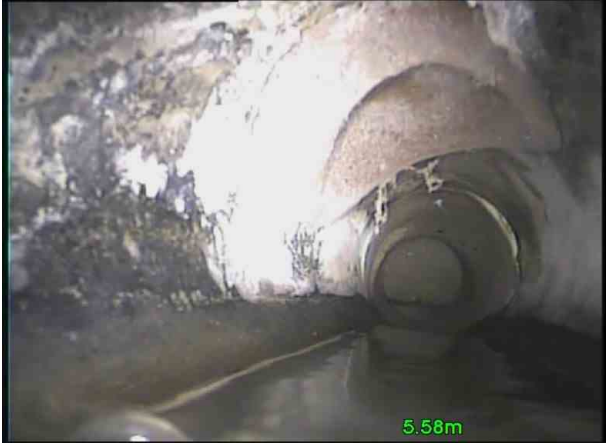
S17X_30903c72-e751-4bb4-97b8-41e7abac8dc8_20201106_125030_183.jpg, 00:00:38, 5.58 m
Connection other than junction at 11 o'clock, diameter: 100mm

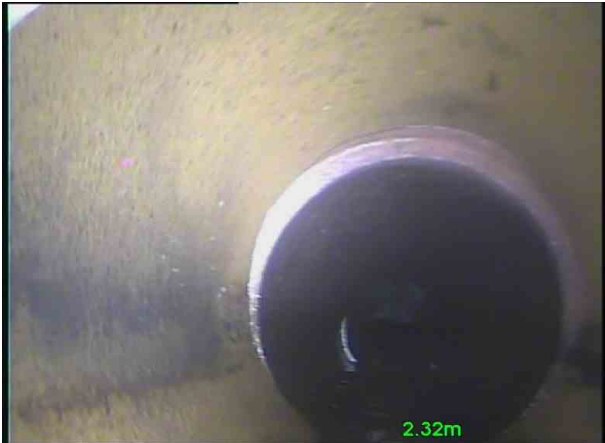
C18X_2b4e6725-5ec7-4fe6-b17b-e7f27026f290_20201106_130629_316.jpg, 00:00:18, 2.30 m
 Joint displaced, medium

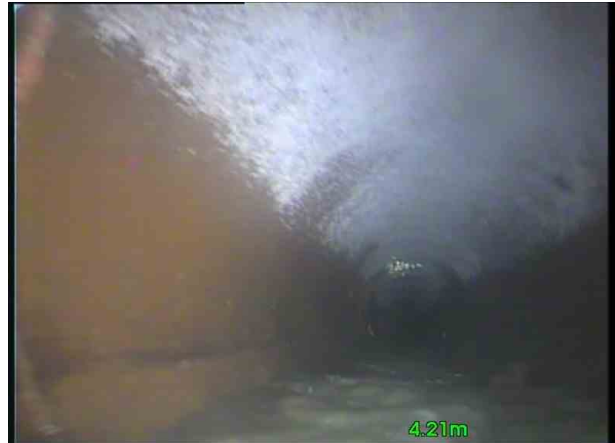
C16X_b5c9fa4-a52f-4b42-afac-de1a3b28e62c_20201106_130819_774.jpg, 00:00:33, 4.43 m
 Attached deposits, grease from 10 o'clock to 2 o'clock, 5% cross-sectional area loss, start

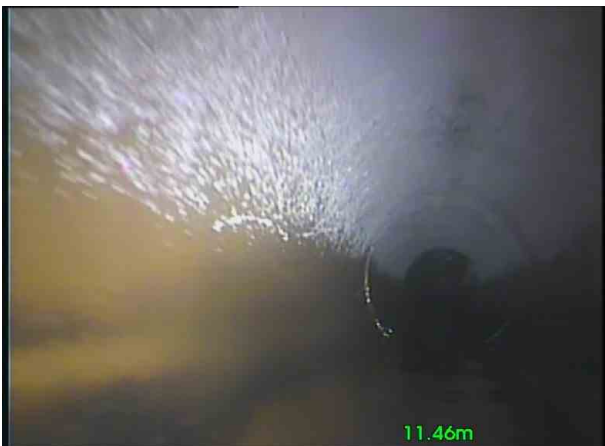
C16X_770be9cc-2366-4201-a38f-93e0c4affe35_20201106_131026_871.jpg, 00:00:58, 11.46 m
 Attached deposits, grease from 10 o'clock to 2 o'clock, 5% cross-sectional area loss

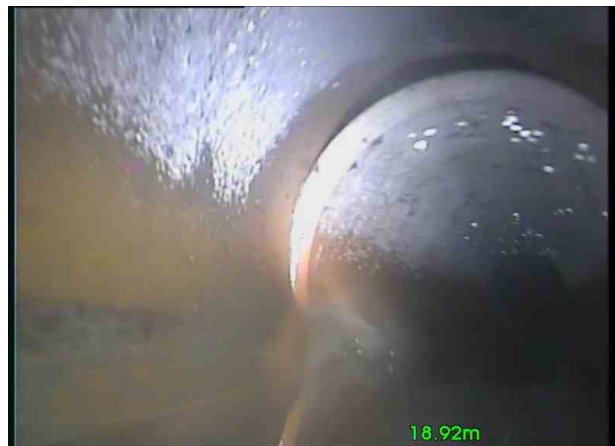
C16X_a0bf3a70-5b99-4b94-89e4-4b00dc26ef9f_20201106_142553_779.jpg, 00:01:22, 18.90 m
 Joint displaced, medium

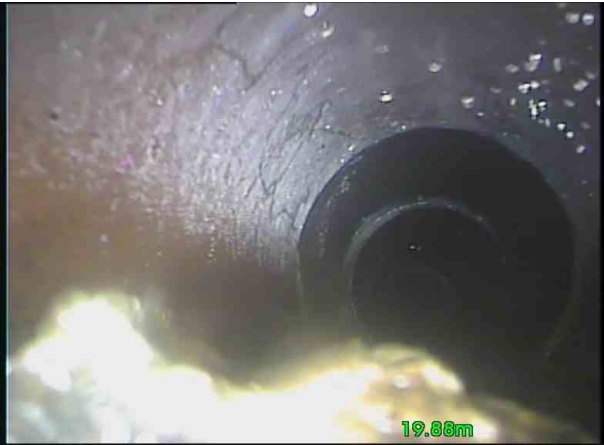
C16X_09b27c50-9367-4d7f-a19f-a535eadf9aae_20201106_142741_812.jpg, 00:01:27, 19.88 m
 Settled deposits, other, 15% cross-sectional area loss, Debris

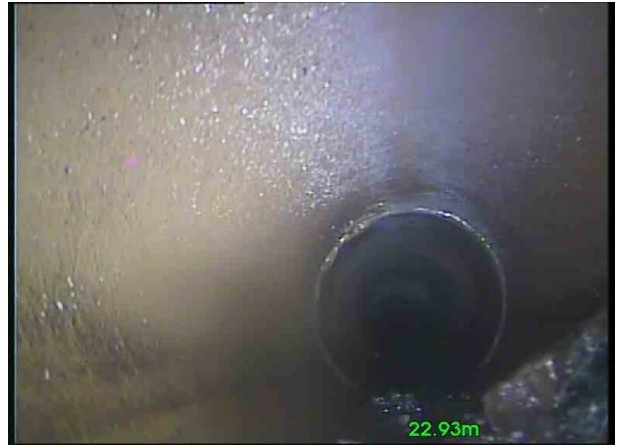
C16X_4a0ca8ad-960e-49ee-9f73-2d3afb1d0411_20201106_143019_940.jpg, 00:01:45, 22.98 m
 Settled deposits, coarse, 15% cross-sectional area loss

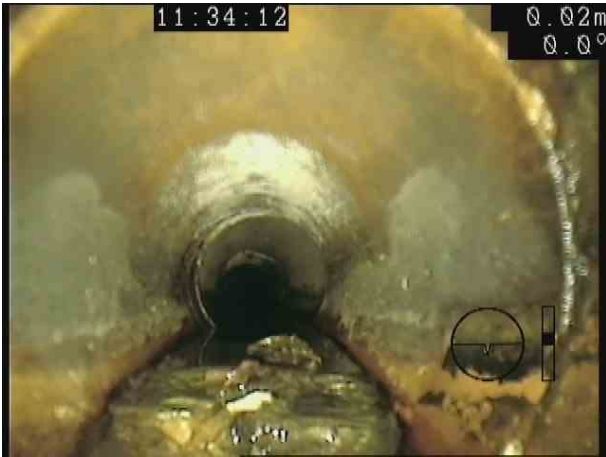
USX_d8e434eb-1a70-44c0-8233-0b88441ca576_20201106_152412_326.jpg, 00:00:18, 0.05 m
 Settled deposits, hard or compacted, 15% cross-sectional area loss

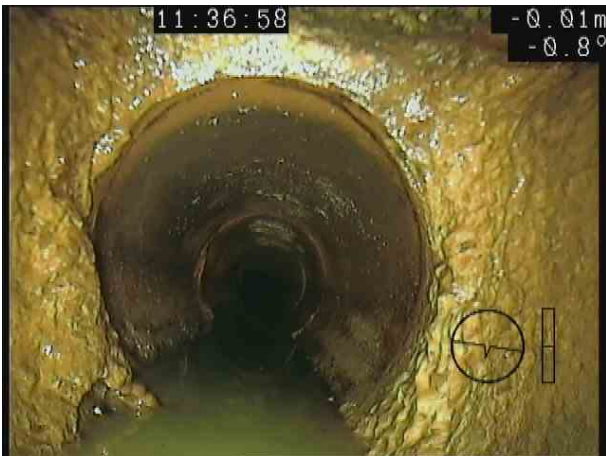
S18X_4f4e42f7-d649-41b4-afad-11ae3afd3798_20201106_153415_880.jpg, 00:00:12, 0.01 m
Attached deposits, encrustation from 7 o'clock to 5 o'clock, 15% cross-sectional area loss

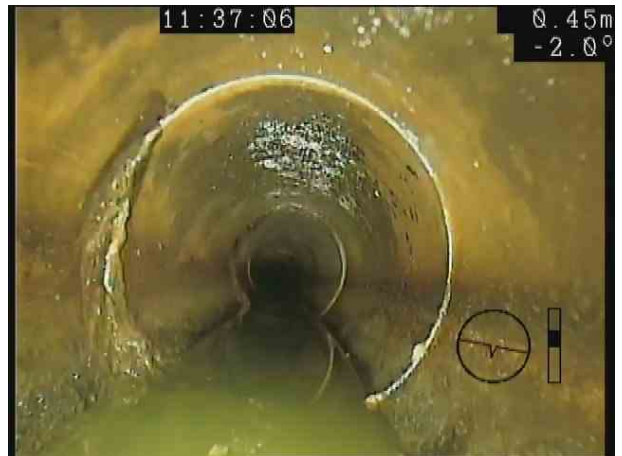
S18X_7cb84242-ac10-4d80-a729-1f478ad9e85a_20201106_153445_446.jpg, 00:00:20, 0.50 m
Attached deposits, encrustation at joint from 7 o'clock to 11 o'clock, 5% cross-sectional area loss

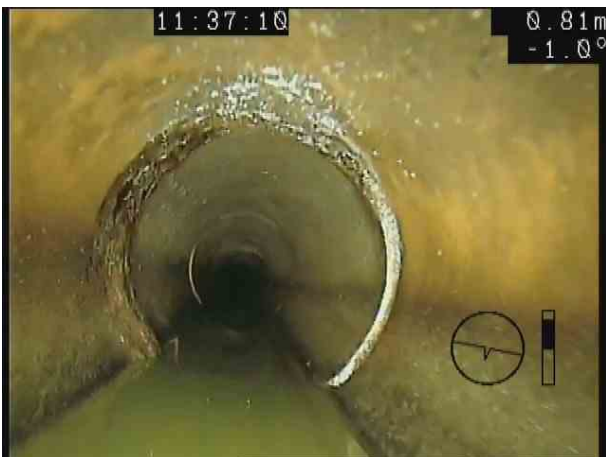
S18X_de190b00-621f-47ca-956d-04f5f0933d43_20201106_153522_380.jpg, 00:00:23, 0.88 m
Attached deposits, encrustation at joint from 7 o'clock to 11 o'clock, 5% cross-sectional area loss

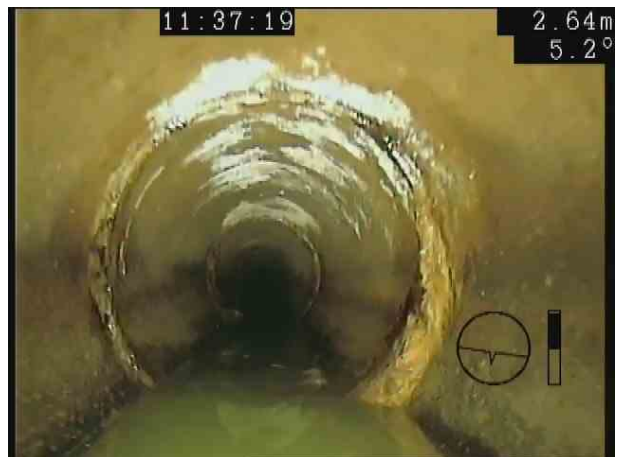
S18X_ef0b9b6f-b33f-4e0c-8aac-f53774f2120b_20201106_153552_219.jpg, 00:00:32, 2.72 m
Attached deposits, encrustation at joint from 1 o'clock to 5 o'clock, 10% cross-sectional area loss

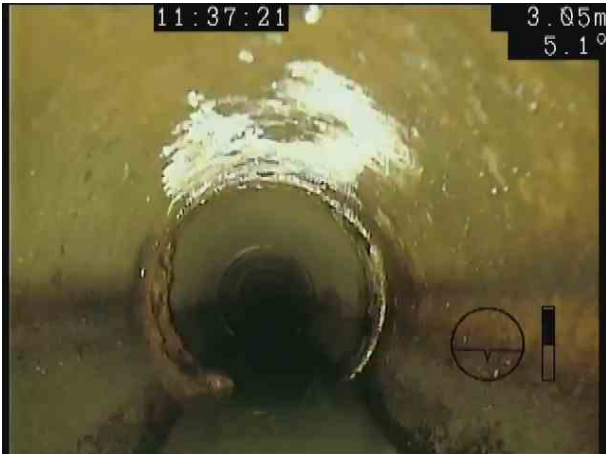
S18X_a922fc15-c22a-4cfa-a59b-7f10750e23f9_20201106_153613_417.jpg, 00:00:35, 3.20 m
 Attached deposits, encrustation at joint from 7 o'clock to 10 o'clock, 10% cross-sectional area loss

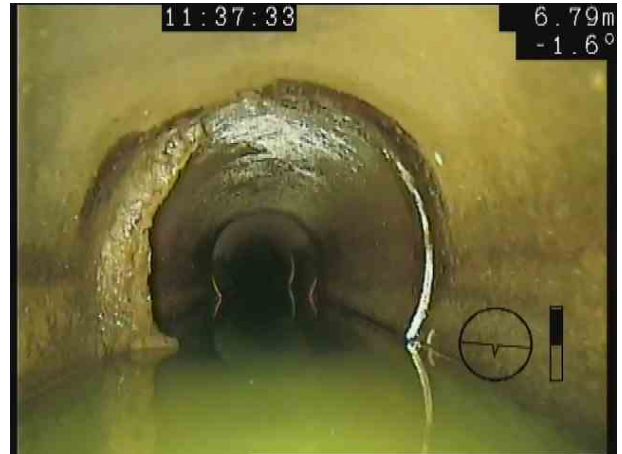
S18X_054f7b2c-a29f-4628-88b7-492c1cc25d0d_20201106_153702_095.jpg, 00:00:46, 6.80 m
 Attached deposits, encrustation at joint from 8 o'clock to 11 o'clock, 15% cross-sectional area loss

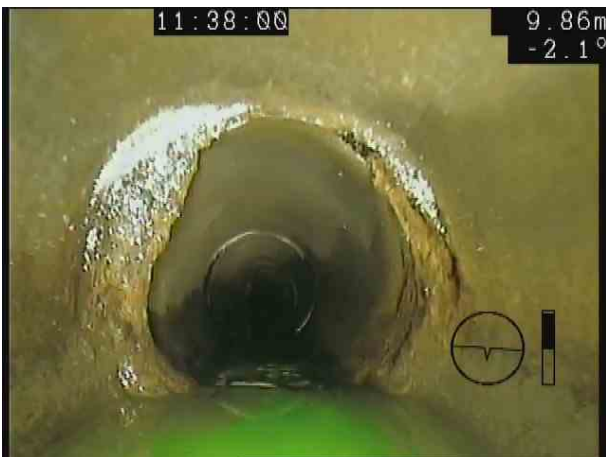
6.80	WL	Water level, 20% of the vertical dimension	00:00:46		
		8.82	JXD	Defective junction, damaged at 2 o'clock, diameter: 100mm	00:00:54		
		9.86	DEEJ	Attached deposits, encrustation at joint from 7 o'clock to 4 o'clock, 20% cross-sectional area loss	00:01:05	S18X_7d9cedae-6969-4f7c-9fb	3

S18X_7d9cedae-6969-4f7c-9fb5-eeb3deca9ce9_20201106_153857_968.jpg, 00:01:05, 9.86 m
 Attached deposits, encrustation at joint from 7 o'clock to 4 o'clock, 20% cross-sectional area loss

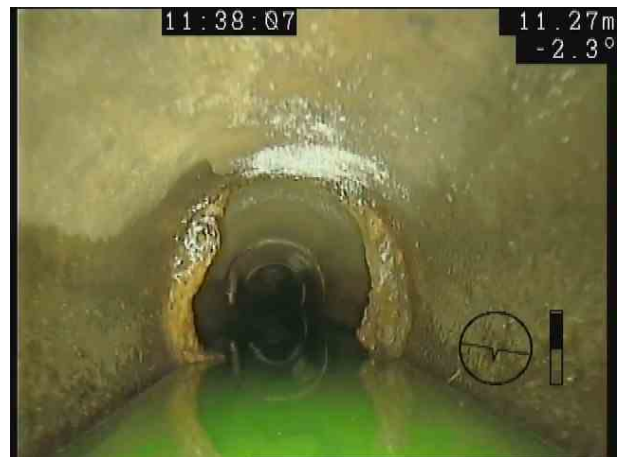
S18X_f6316c98-aa94-48ba-afd9-23bb97cd5314_20201106_153940_750.jpg, 00:01:12, 11.36 m
 Attached deposits, encrustation at joint from 8 o'clock to 4 o'clock, 20% cross-sectional area loss

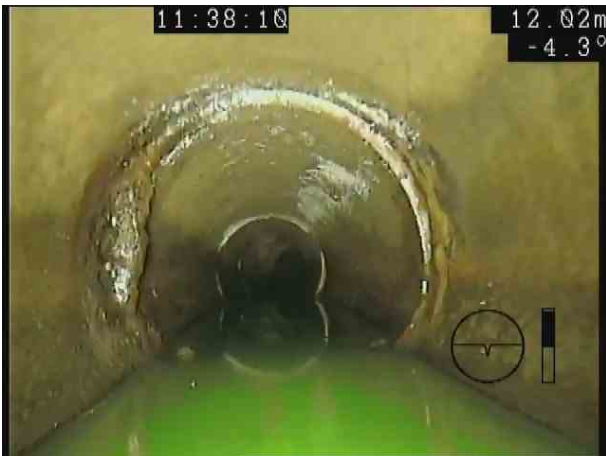
S18X_cd62f348-0ced-41b3-8e51-f44f8b37d90b_20201106_154120_416.jpg, 00:01:15, 12.02 m
 Attached deposits, encrustation at joint from 8 o'clock to 11 o'clock, 10% cross-sectional area loss

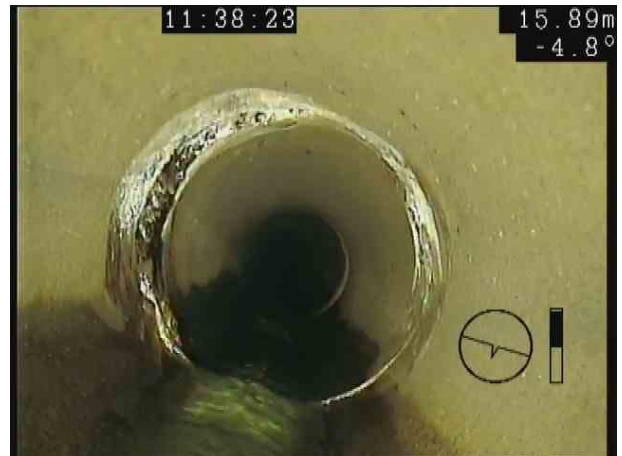
S18X_7603648c-90b4-4d52-afa6-e9f0c6276b99_20201106_154455_860.jpg, 00:01:29, 16.00 m
 Attached deposits, encrustation at joint from 7 o'clock to 12 o'clock, 10% cross-sectional area loss

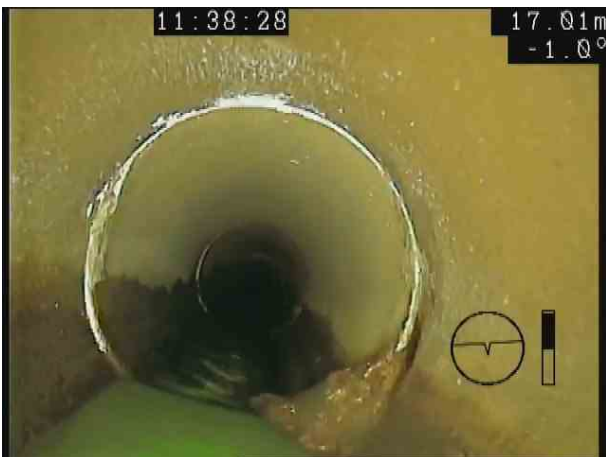
S18X_7d525312-1222-4814-8bbc-cbb9a8beed21_20201106_154519_346.jpg, 00:01:34, 17.00 m
 Attached deposits, encrustation at joint from 4 o'clock to 6 o'clock, 10% cross-sectional area loss

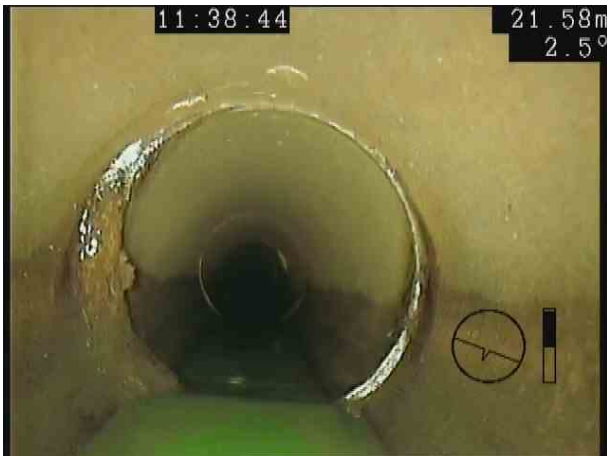
S18X_b4cb2a48-c6e3-4e24-b5f5-6e3029eb44ee_20201106_154627_087.jpg, 00:01:50, 21.67 m
 Attached deposits, encrustation at joint from 7 o'clock to 10 o'clock, 10% cross-sectional area loss

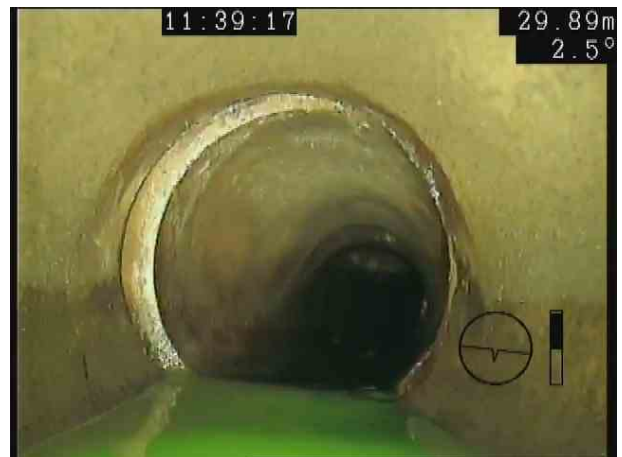
29.97	JDM	Joint displaced, medium	00:02:22	S18X_818 ec3eb-e12 a-4c5d-a0	1
		30.05	LR	Line deviates right	00:02:23		
		30.84	MHF	Finish node type, manhole, reference number: S19	00:02:27

S18X_818ec3eb-e12a-4c5d-a018-6fb7a24fb8a0_20201106_154759_826.jpg, 00:02:22, 29.97 m
 Joint displaced, medium

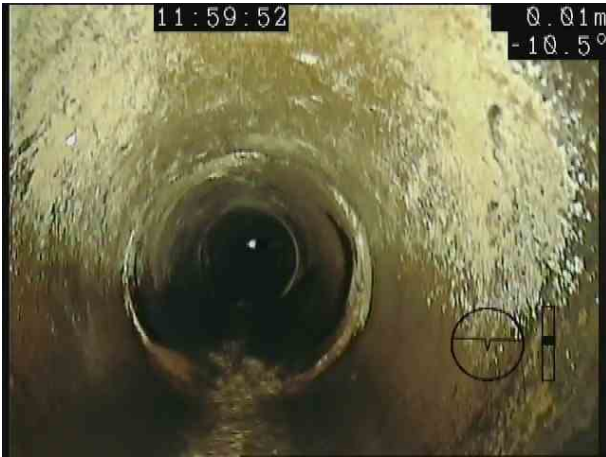
S19X_a7df55b7-a0bf-4cd2-98cc-bbabe69b83d3_20201110_11208_279.jpg, 00:00:14, 0.30 m
Attached deposits, encrustation at joint from 3 o'clock to 7 o'clock, 5% cross-sectional area loss

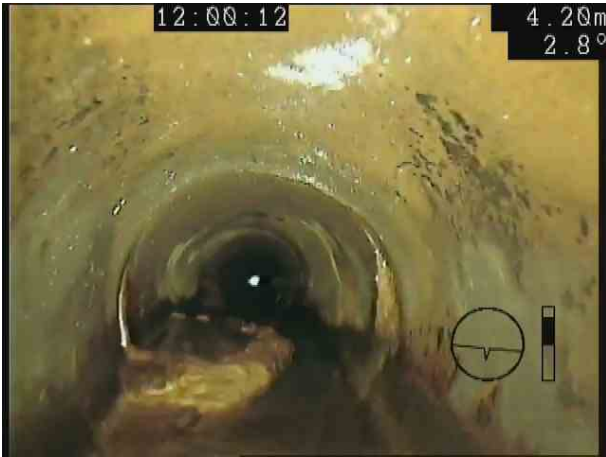
S19X_4a93d849-7f6e-4131-852a-cdd98a75d6d2_20201110_111358_217.jpg, 00:00:35, 4.33 m
 Settled deposits, hard or compacted, 25% cross-sectional area loss

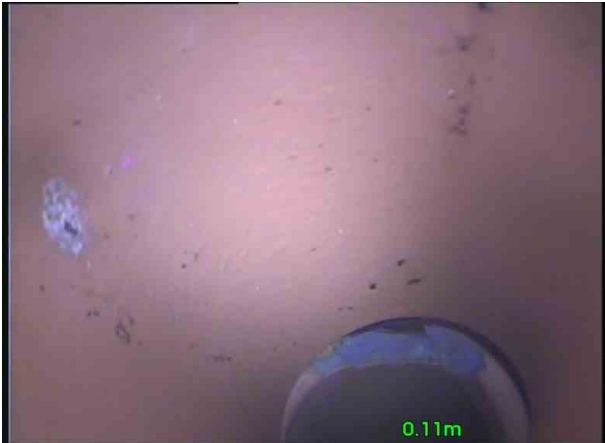
End O
LineX_3ebf0905-8f12-4606-8371-2f1d9c809901_20201106_160101_166.jpg, 00:00:09, 0.15 m
Hole in drain or sewer at a joint from 10 o'clock to 1 o'clock

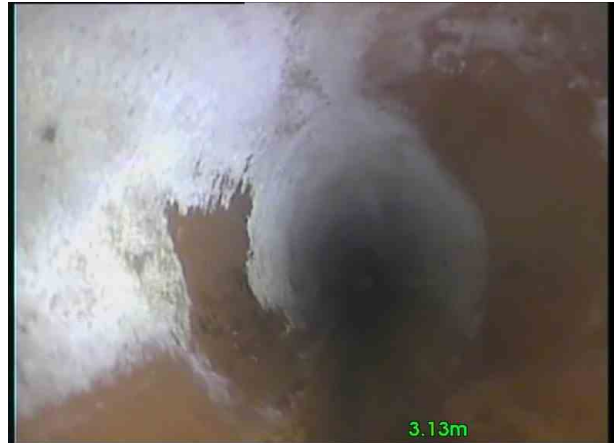
End O
LineX_128482e2-076d-411b-9ac6-ab903f453058_20201106_160149_706.jpg, 00:00:30, 3.13 m
Attached deposits, grease from 8 o'clock to 4 o'clock, 5% cross-sectional area loss

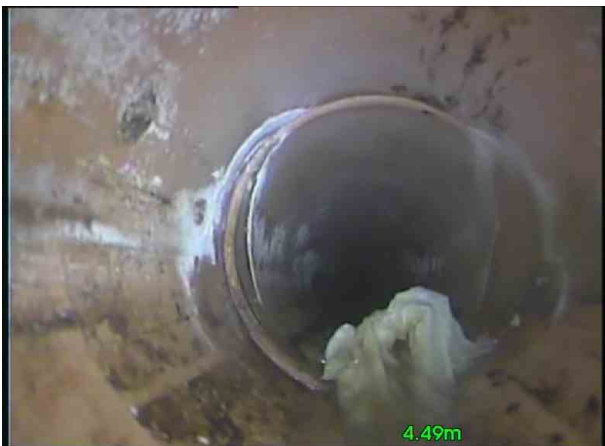
End O
LineX_cbb0c64e-17da-49d4-bf4e-dc356e92833c_20201106_160214_546.jpg, 00:00:35, 4.50 m
Settled deposits, other, 10% cross-sectional area loss, Wipes

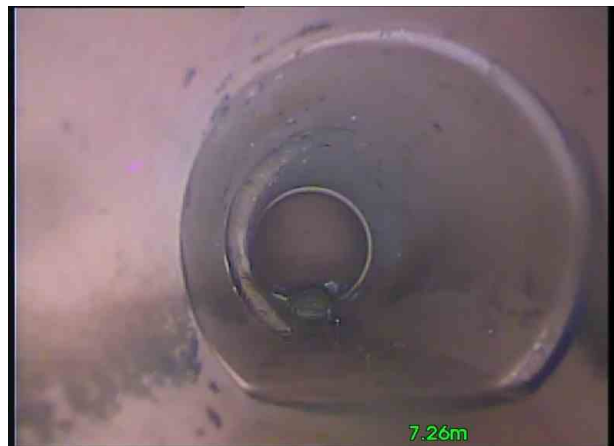
End O
LineX_7f7e4528-b4be-4f11-8280-db7c87e05b26_20201106_160351_269.jpg, 00:00:53, 7.30 m
Open joint, medium

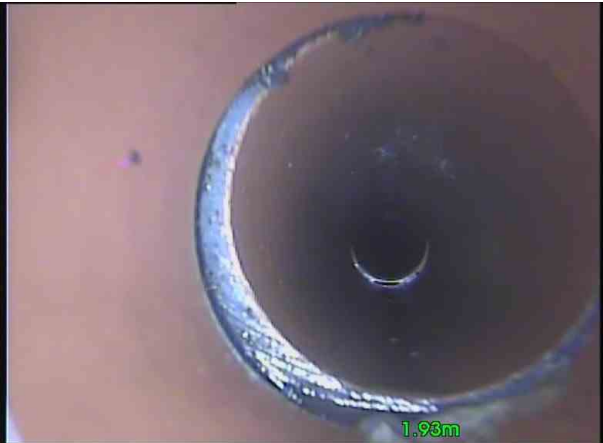
F28X_a46558c5-b511-4540-a0c1-7286a003c394_20201106_161117_787.jpg, 00:00:23, 1.93 m
 Joint displaced, medium

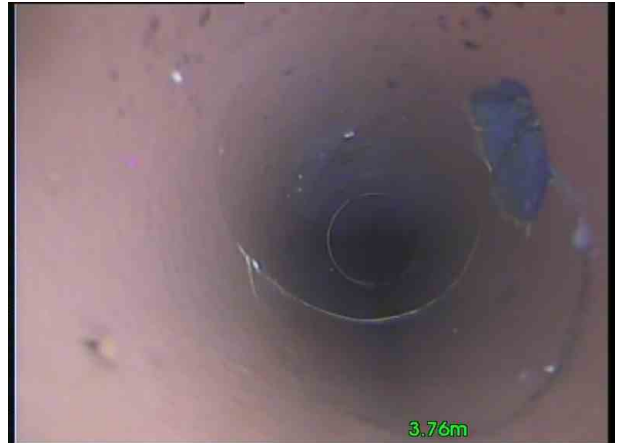
F28X_6381d4ca-e373-4aa9-98b2-bce59e1edac9_20201106_161212_176.jpg, 00:00:33, 3.76 m
 Hole in drain or sewer from 1 o'clock to 3 o'clock

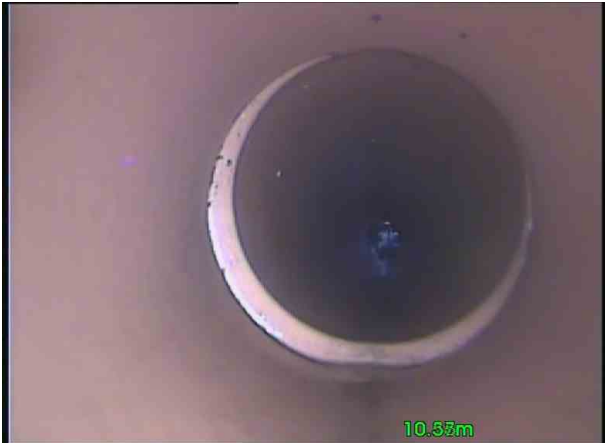
F28X_fb5ef1a3-a45c-44d0-8bd2-b5880a3a00ba_20201106_1
61347_387.jpg, 00:01:00, 10.55 m
Joint displaced, medium

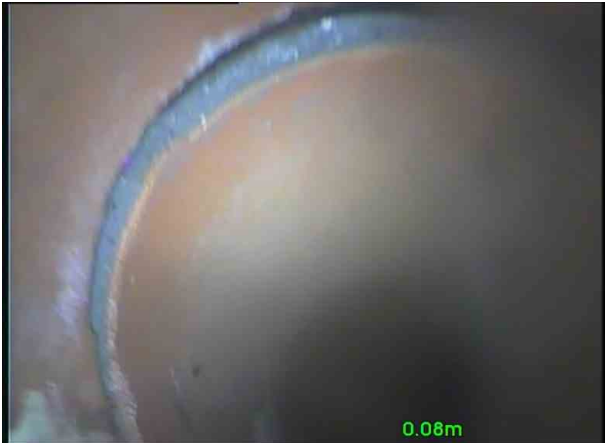
Branch
 1X_3a75bf34-27d8-4ee7-93c5-f93aee379d16_20201106_162
 422_024.jpg, 00:00:11, 0.10 m
 Open joint, medium

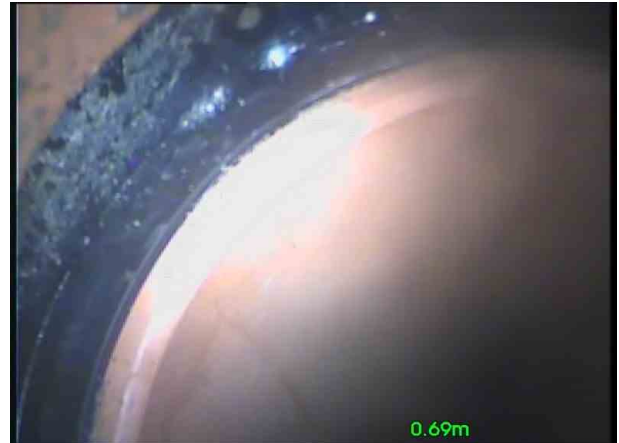
Branch
 1X_dd23a22d-c947-42e0-945c-c064d316966b_20201106_16
 2516_940.jpg, 00:00:13, 0.70 m
 Open joint, medium

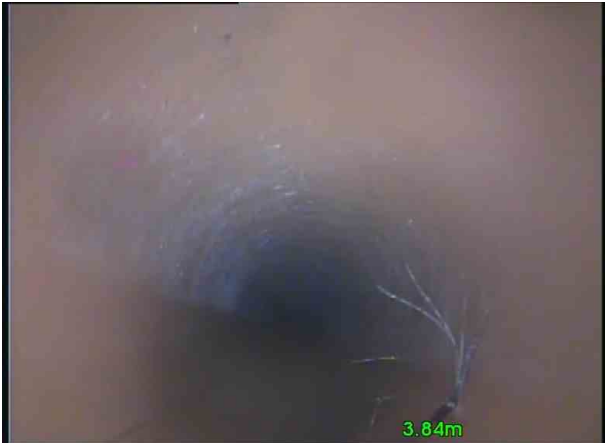
Branch
1X_777a0828-0268-4eb1-b3a1-b9d566abd343_20201109_09
3047_318.jpg, 00:00:29, 3.84 m
Roots, fine

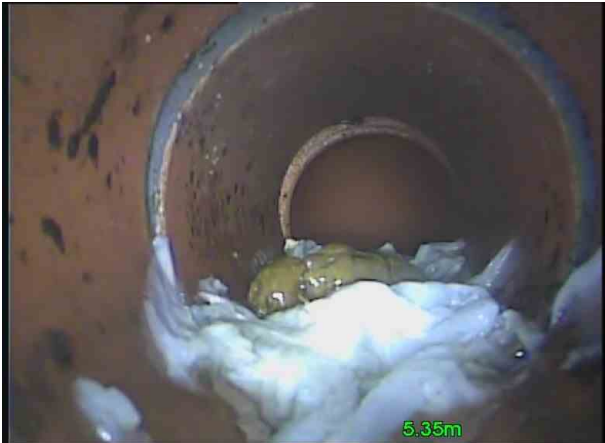
LineX_cc27e7c5-fb7c-4fef-bf07-64c30c27bfb5_20201109_094
 343_111.jpg, 00:00:35, 5.35 m

Settled deposits, other, 15% cross-sectional area loss, Wipes
 & foul waste

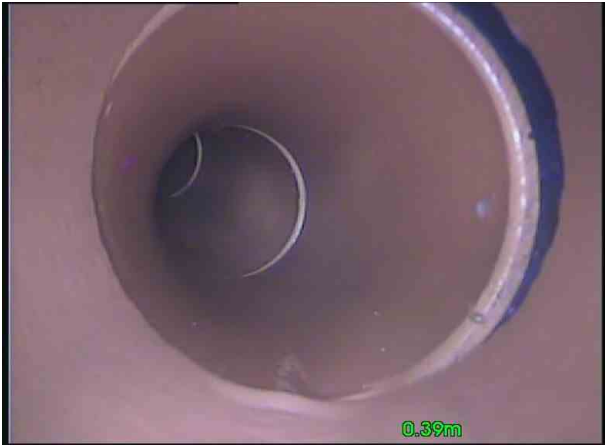
1X_848e8163-0862-4f8a-aa67-ac770125ea9f_20201109_100
 036_112.jpg, 00:00:13, 0.39 m
 Joint displaced, medium

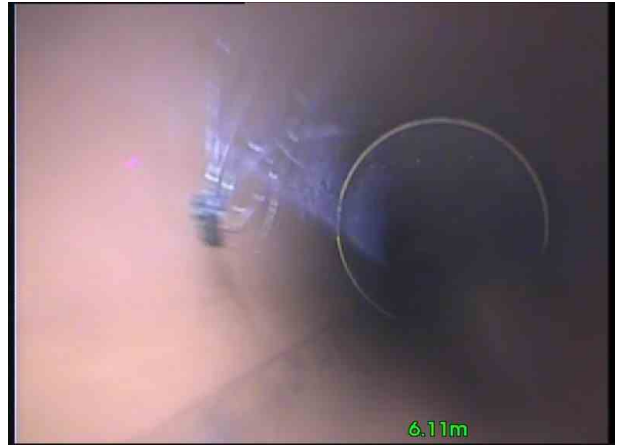
1X_a54a3905-e5f8-4af7-8158-9a2c2354d86a_20201109_100
 252_369.jpg, 00:00:33, 6.77 m
 Roots, fine

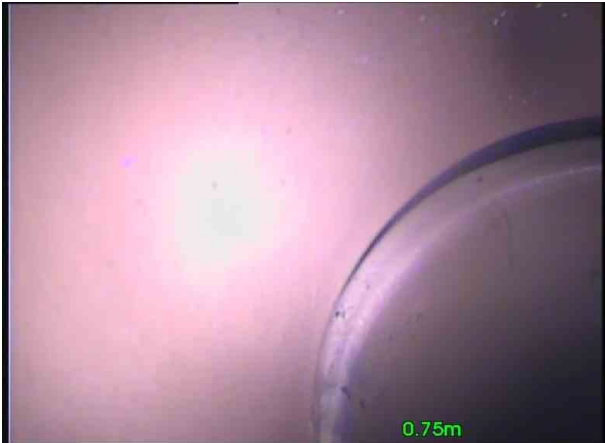
2X_e280bd65-7c4f-4d8b-a048-7ee9601a9f15_20201109_102
427_241.jpg, 00:00:14, 0.75 m
Open joint, medium

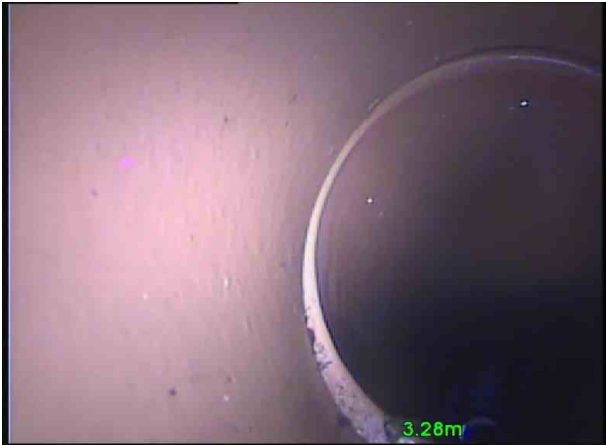
F26X_8a316306-a8c9-4c09-a751-6550f28f0739_20201109_1
03701_751.jpg, 00:00:40, 3.28 m
Joint displaced, medium

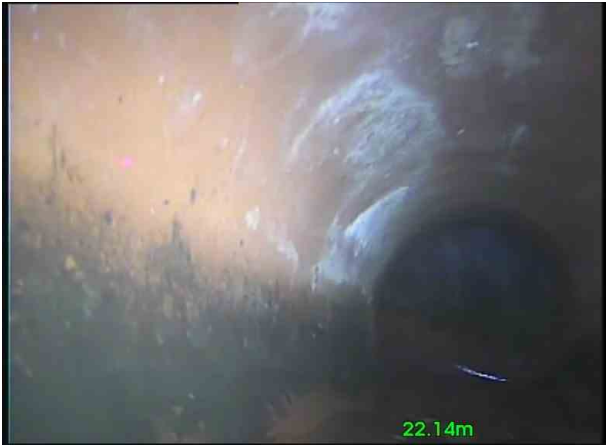
F20X_93474d2a-d8f9-4b89-9b81-7183b8db47b1_20201109_111728_977.jpg, 00:01:14, 22.15 m
Settled deposits, hard or compacted, 10% cross-sectional area loss

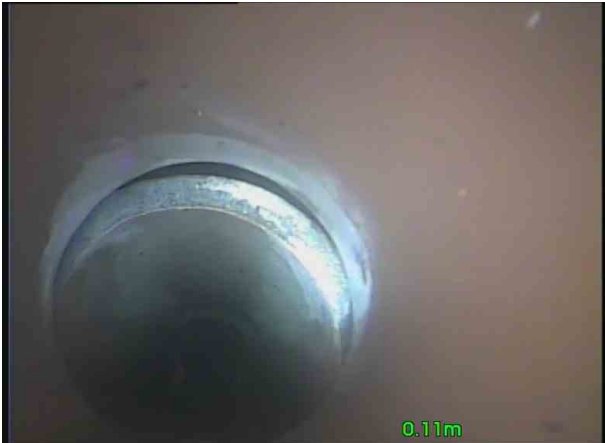
C22X_e022b4d2-b8ae-4c06-b650-ffd1859f2783_20201109_1
 12516_904.jpg, 00:00:10, 0.10 m
 Joint displaced, large

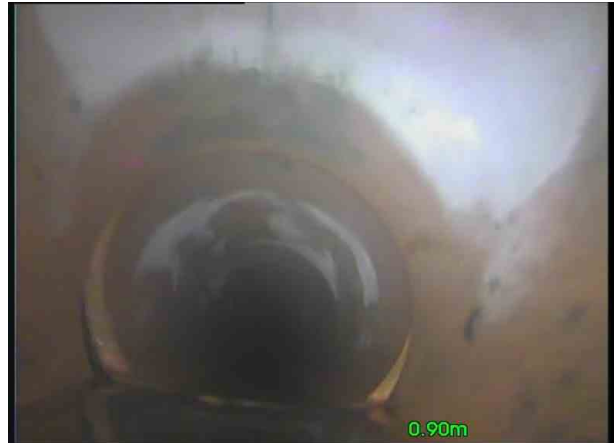
C22X_2cfd079-b21c-420a-b1b0-7a9959477650_20201109_1
 12618_757.jpg, 00:00:13, 0.90 m
 Joint displaced, medium

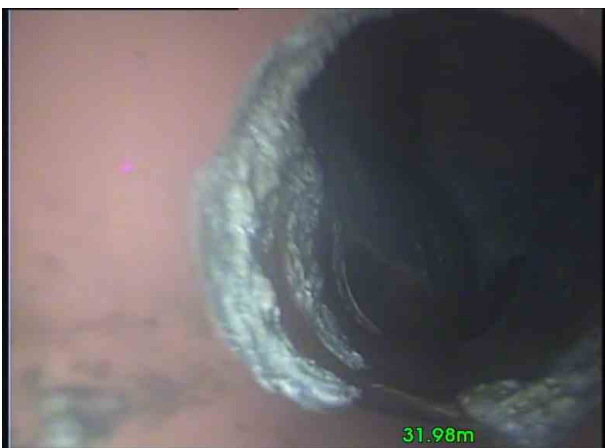
C22X_f3fcc9f7-461d-4e92-92ea-bebe98ced525_20201109_1
 12953_401.jpg, 00:01:56, 31.98 m
 Attached deposits, grease at joint from 7 o'clock to 5 o'clock,
 10% cross-sectional area loss

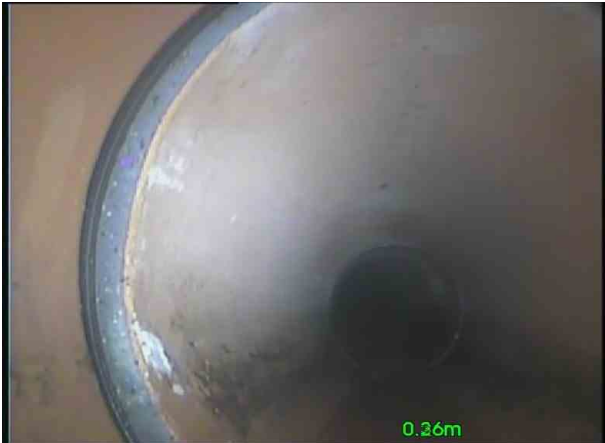
C24X_63162552-599b-4347-9877-9fc4f1c0b111_20201109_1
 51053_716.jpg, 00:00:11, 0.36 m
 Open joint, medium

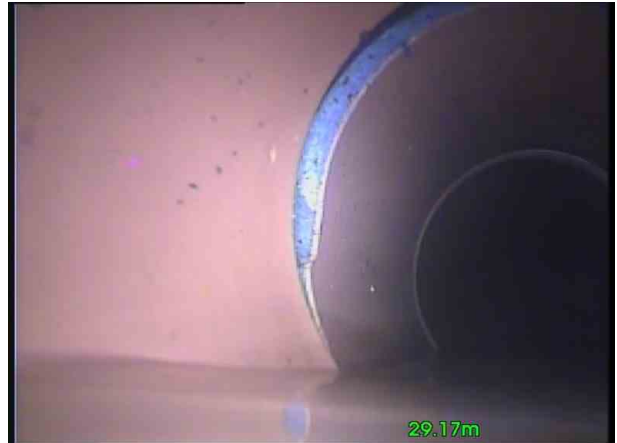
C24X_5fde7871-3cd0-44f8-ba4d-524881231a5b_20201109_1
 51425_981.jpg, 00:01:31, 29.17 m
 Joint displaced, medium

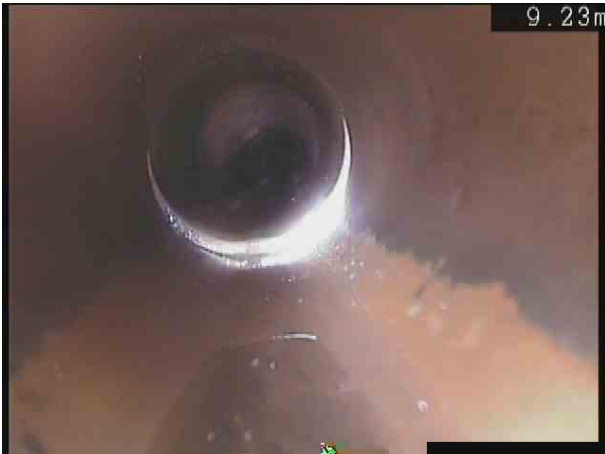
USX_548e278a-9421-410b-8288-2751742eba9c_20201109_152809_858.jpg, 00:01:00, 9.34 m
 Joint displaced, medium

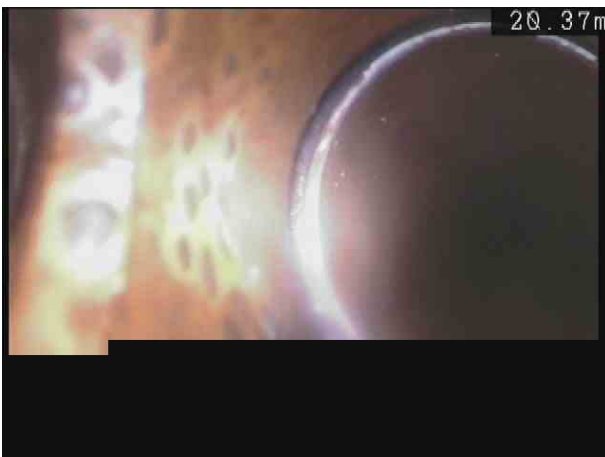
USX_c1a7a67d-7f3b-4912-aec4-3ebd35dbefb3_20201109_153226_774.jpg, 00:02:21, 20.37 m
 Open joint, medium

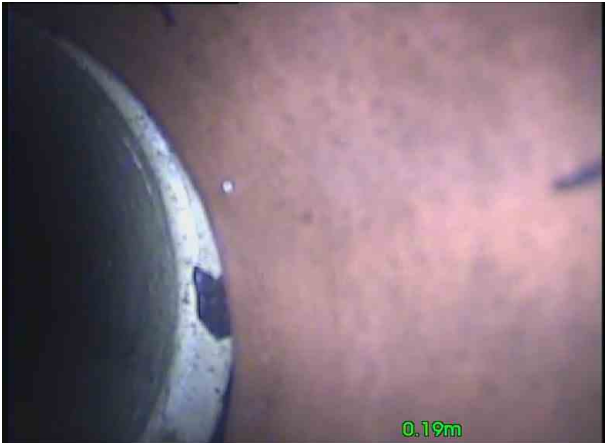
Branch
 X_e285e34a-465d-4f25-9dfa-2063601f360a_20201109_1536
 30_017.jpg, 00:00:12, 0.20 m
 Joint displaced, medium

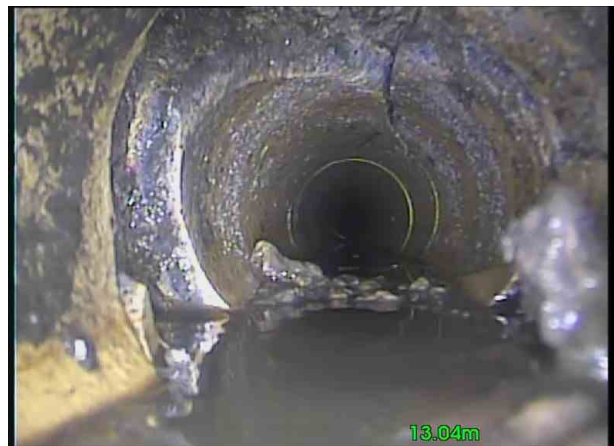
Branch
 X_6f930d41-94af-4faa-8532-c03527b4e997_20201109_16223
 9_091.jpg, 00:01:37, 13.05 m
 Hole in drain or sewer from 7 o'clock to 12 o'clock

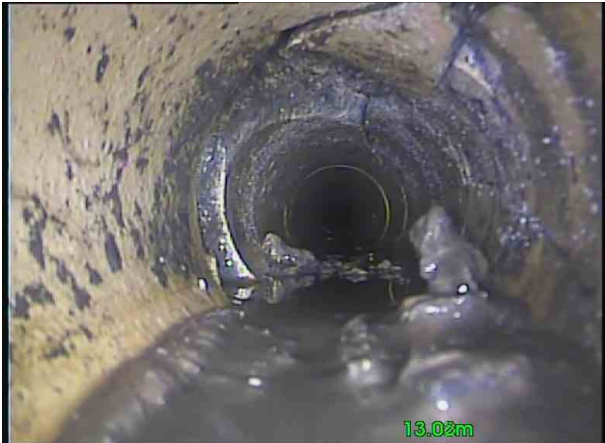
Branch
 X_2e8ff3b5-9aed-4fae-8d18-226792160f50_20201109_16221
 5_021.jpg, 00:01:32, 13.06 m
 Deformed drain or sewer, 5%

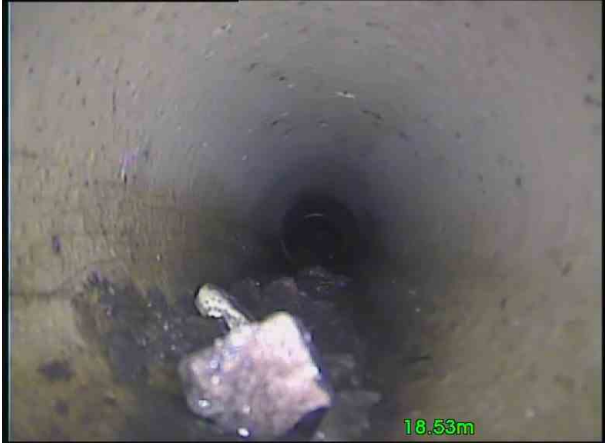
Settled deposits, coarse, 10% cross-sectional area loss

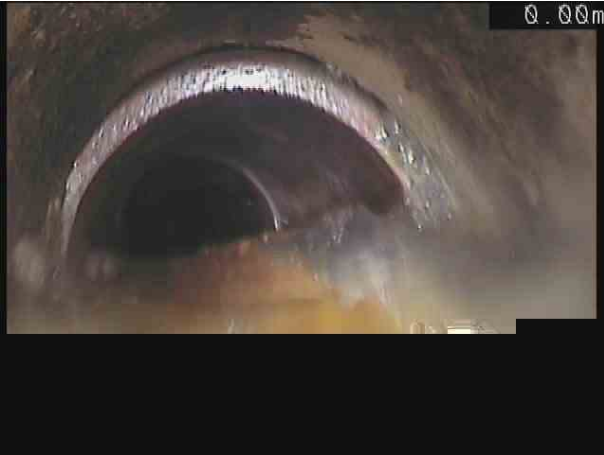
F6X_36db4c7e-f239-4a9e-ba2a-911e01c3538a_20201109_16
2818_233.jpg, 00:00:18, 0.05 m
Joint displaced, medium

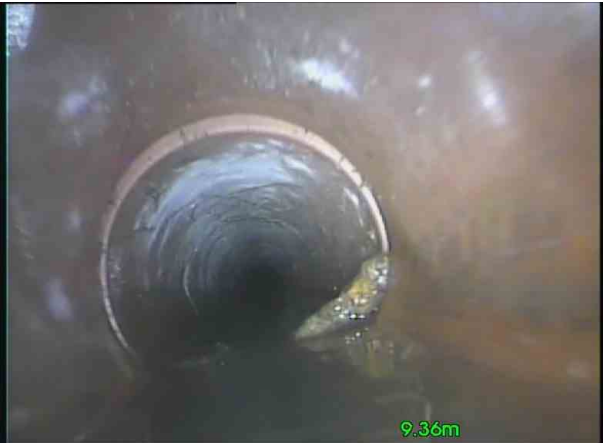
F40X_88b48801-c946-4518-9ade-fa31307cdf2a_20201110_092028_462.jpg, 00:00:44, 9.36 m
 Attached deposits, encrustation at joint from 3 o'clock to 7 o'clock, 20% cross-sectional area loss

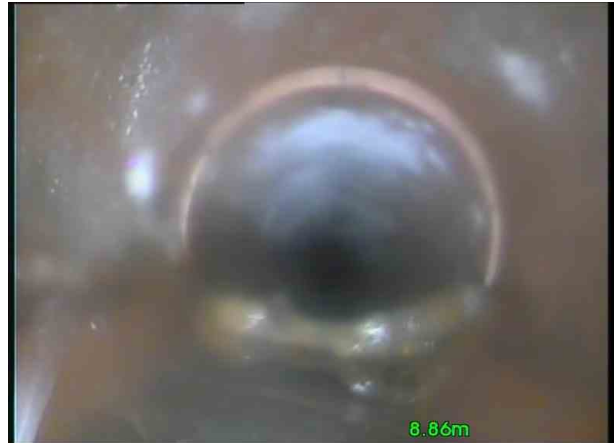
F40X_3bd4db38-9d64-4bea-a178-5b7277d45a9d_20201110_092204_494.jpg, 00:00:44, 9.36 m
 Attached deposits, encrustation at joint from 3 o'clock to 7 o'clock, 20% cross-sectional area loss

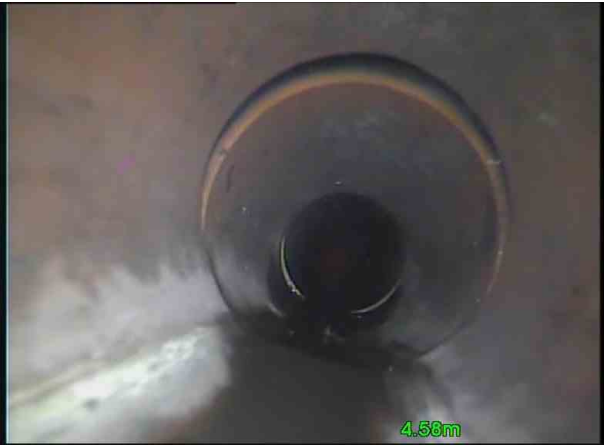
F39X_fca828d8-2945-469c-b869-a62eabfb5a2e_20201110_092727_827.jpg, 00:00:24, 4.60 m
Joint displaced, medium

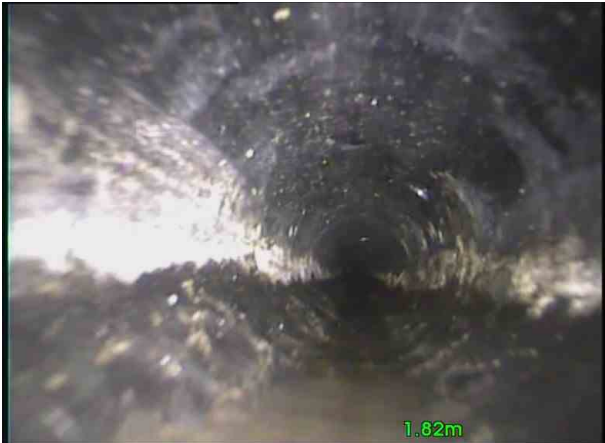
F41X_38ed019c-606b-45ac-8ff2-08375c96b1cd_20201110_093505_136.jpg, 00:00:14, 1.82 m
 Attached deposits, grease from 3 o'clock to 4 o'clock, 5% cross-sectional area loss, start

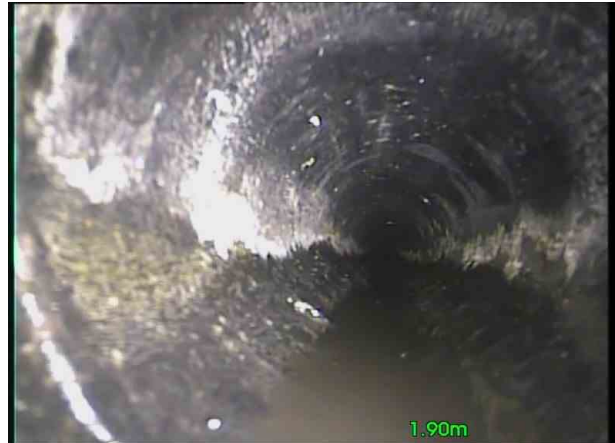
F41X_7d235afc-c23d-4967-929f-0e520c81505b_20201110_093437_363.jpg, 00:00:14, 1.90 m
 Attached deposits, grease from 9 o'clock to 10 o'clock, 5% cross-sectional area loss, start

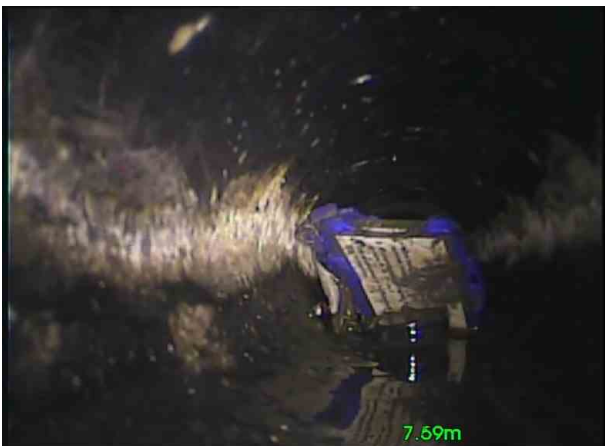
F41X_369843dd-2f5f-40e1-a73b-766876051f5b_20201110_093622_204.jpg, 00:00:37, 7.70 m
 Other obstacles from 12 o'clock to 12 o'clock, 65% cross-sectional area loss, Plastic/ lanyard
