Project Name: 2020-09-14309 Campbell Reith Whitworth High School Hall Fold Whitworth

Project Date: 04/11/2020

Inspection Standard: MSCC4 Sewers & Drainage GB (SRM4 Scoring)

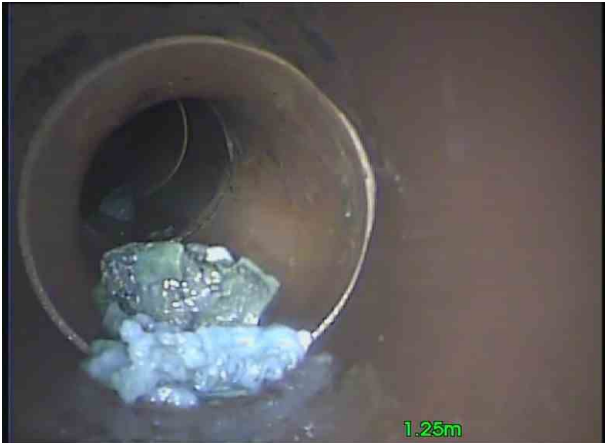
USX_348c6604-30e1-48ee-bb8d-109f76e78d33_20201110_095931_892.jpg, 00:00:53, 1.25 m
Settled deposits, other, 25% cross-sectional area loss, Rock

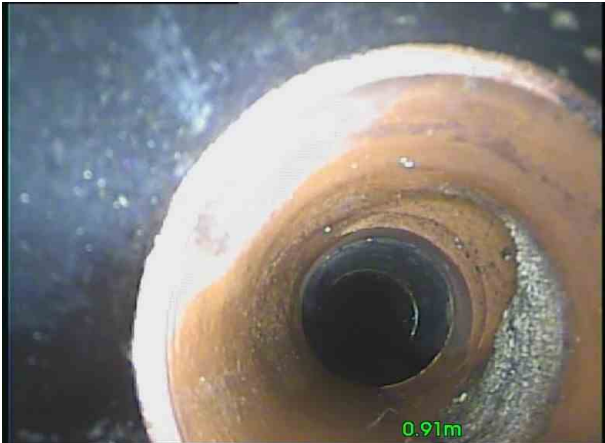
0.91m

C14X_bc6e54ad-f258-4e90-a4d6-1941b1339a90_20201110_100739_457.jpg, 00:00:19, 0.91 m
 Attached deposits, encrustation from 2 o'clock to 5 o'clock,
 15% cross-sectional area loss

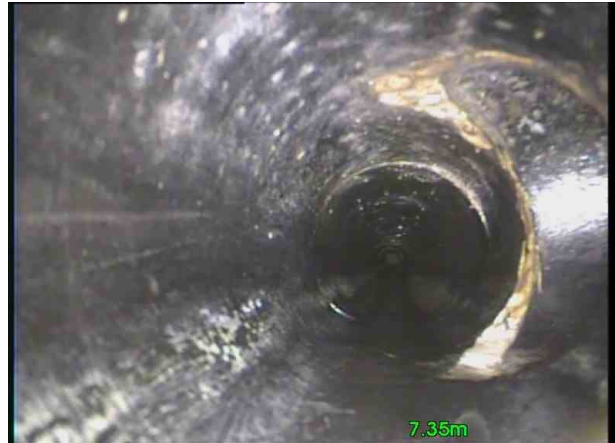
7.35m

7.27	JN	Junction at 3 o'clock, diameter: 100mm	00:00:43		
		7.35	SS	Surface damage, spalling from 1 o'clock to 5 o'clock	00:00:52	C14X_246 a5af2-a51 1-4cae-92	2

C14X_246a5af2-a511-4cae-9286-fc1cb87eaa7e_20201110_100909_011.jpg, 00:00:52, 7.35 m
 Surface damage, spalling from 1 o'clock to 5 o'clock

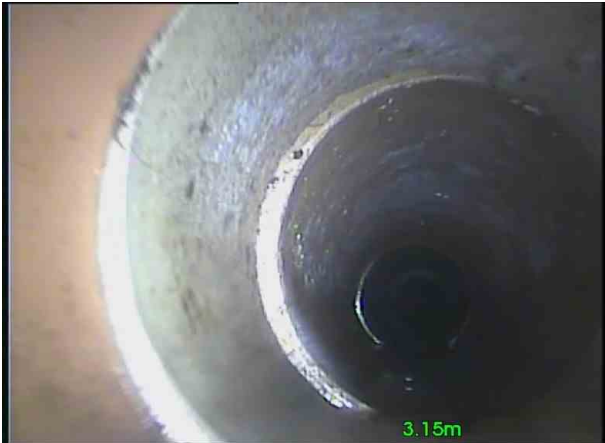
C9X_202de8bf-c946-4cd9-8a53-768cba2822e4_20201110_104335_375.jpg, 00:00:37, 3.15 m
 Joint displaced, medium

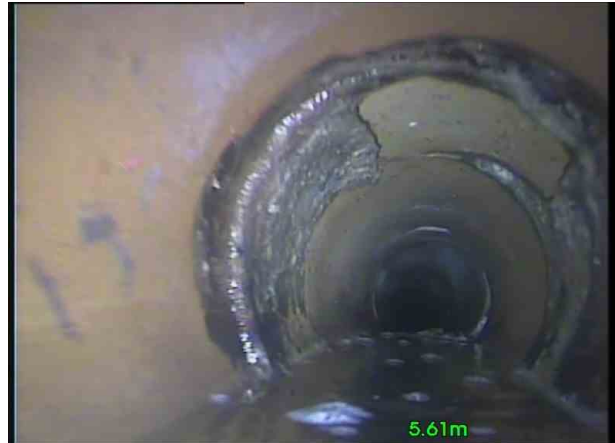
C9X_95031c20-1ff7-4ff3-930a-f197296a0122_20201110_104457_410.jpg, 00:00:56, 5.61 m
 Attached deposits, other at joint from 7 o'clock to 5 o'clock, 10% cross-sectional area loss, Unknown

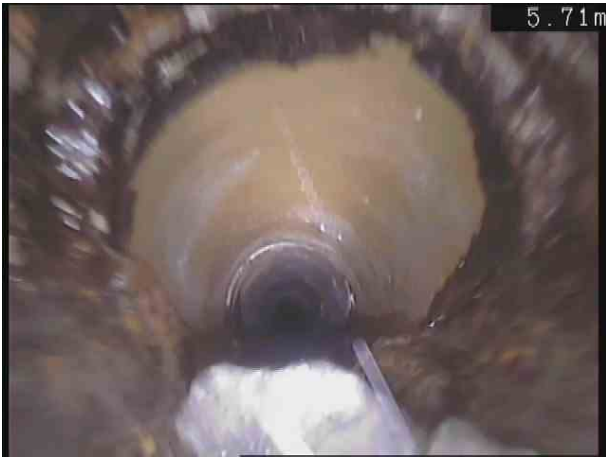
F1X_3e609a3d-5da2-461c-b477-8145ea55b999_20201110_105709_081.jpg, 00:00:37, 5.70 m
 Attached deposits, encrustation at joint from 12 o'clock to 12 o'clock, 25% cross-sectional area loss

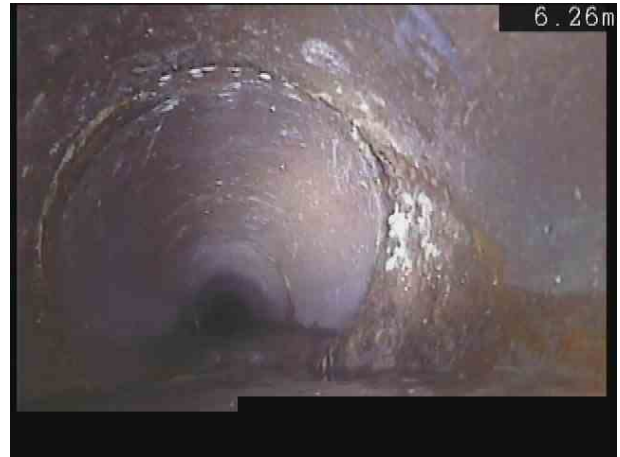
F1X_6a6c9ba3-5217-4132-a09d-0052345f46ce_20201110_105858_308.jpg, 00:00:45, 6.26 m
 Attached deposits, encrustation at joint from 2 o'clock to 6 o'clock, 15% cross-sectional area loss

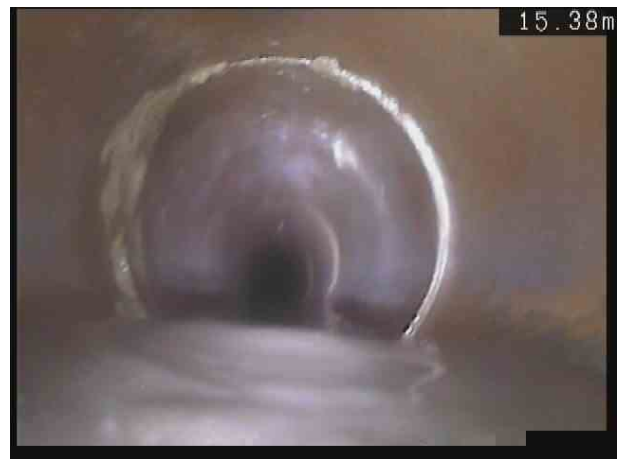
F1X_806fd6a6-3e72-43f3-bf46-e7725bc9fd1a_20201110_110438_127.jpg, 00:01:47, 15.40 m
 Attached deposits, encrustation at joint from 7 o'clock to 11 o'clock, 5% cross-sectional area loss

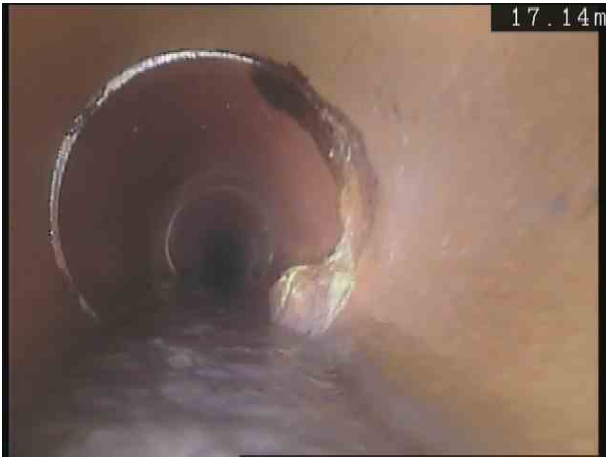
F1X_05b06084-92c3-4860-9708-6e39ca92a0bd_20201110_1
10503_382.jpg, 00:01:54, 17.25 m
Attached deposits, encrustation at joint from 1 o'clock to 5
o'clock, 10% cross-sectional area loss
