PROJECT  
Whitworth High School  
Whitworth  
Rochdale

DRAWING TITLE  
PAS 128 Utility Survey

Project: **WHITWORTH COMMUNITY HIGH SCHOOL**

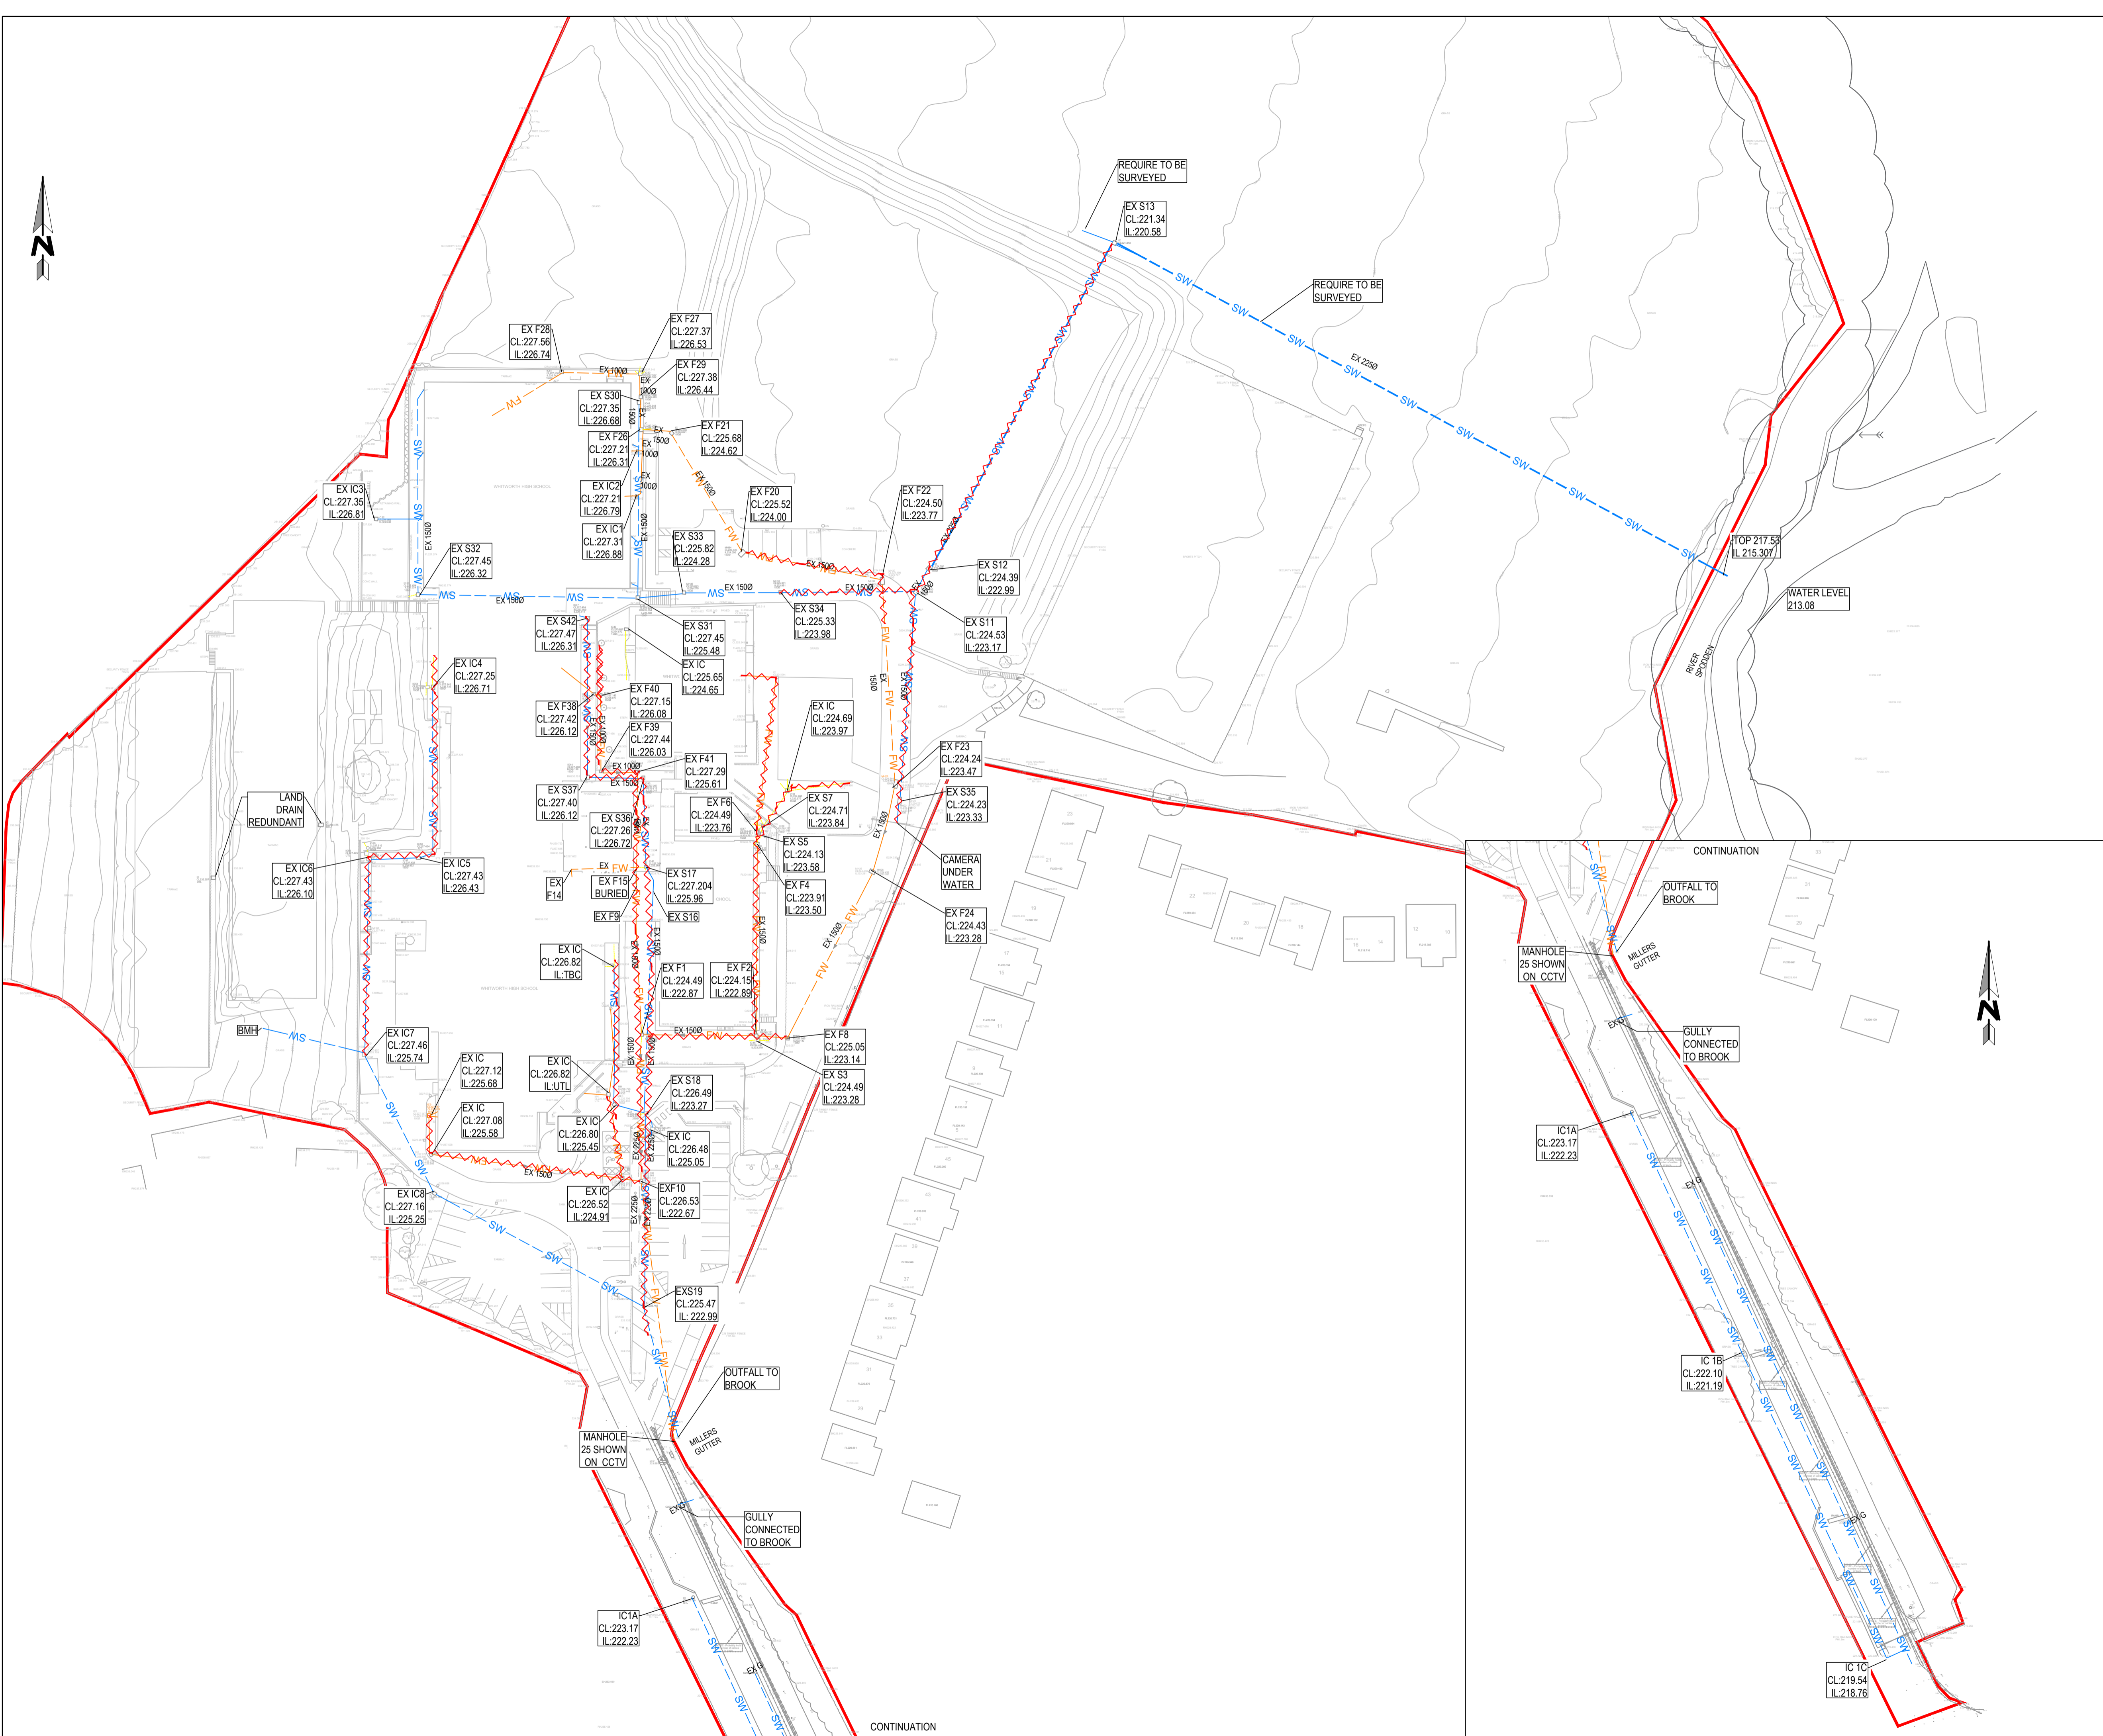
ADDITIONAL SURVEY IS REQUIRED  
PIPE WHICH HAS NOT BEEN INDICATED TO BE ABANDONED REQUIRES TO BE CLEANED / REPAIRED REFER TO CCTV SURVEY REPORT
