Revised
Arboricultural Appraisal Report

Subsidence Damage Investigation at:

59 Pearson Park
 Hull
 HU5 2TQ

CLIENT:	Crawford & Company
CLIENT REF:	SU1903936
MWA REF:	SUB200127-6652Rev01
MWA CONSULTANT:	John Graham B.Sc. Hons PhD
REPORT DATE:	20/02/2020
REVISED REPORT DATE:	08/07/2020

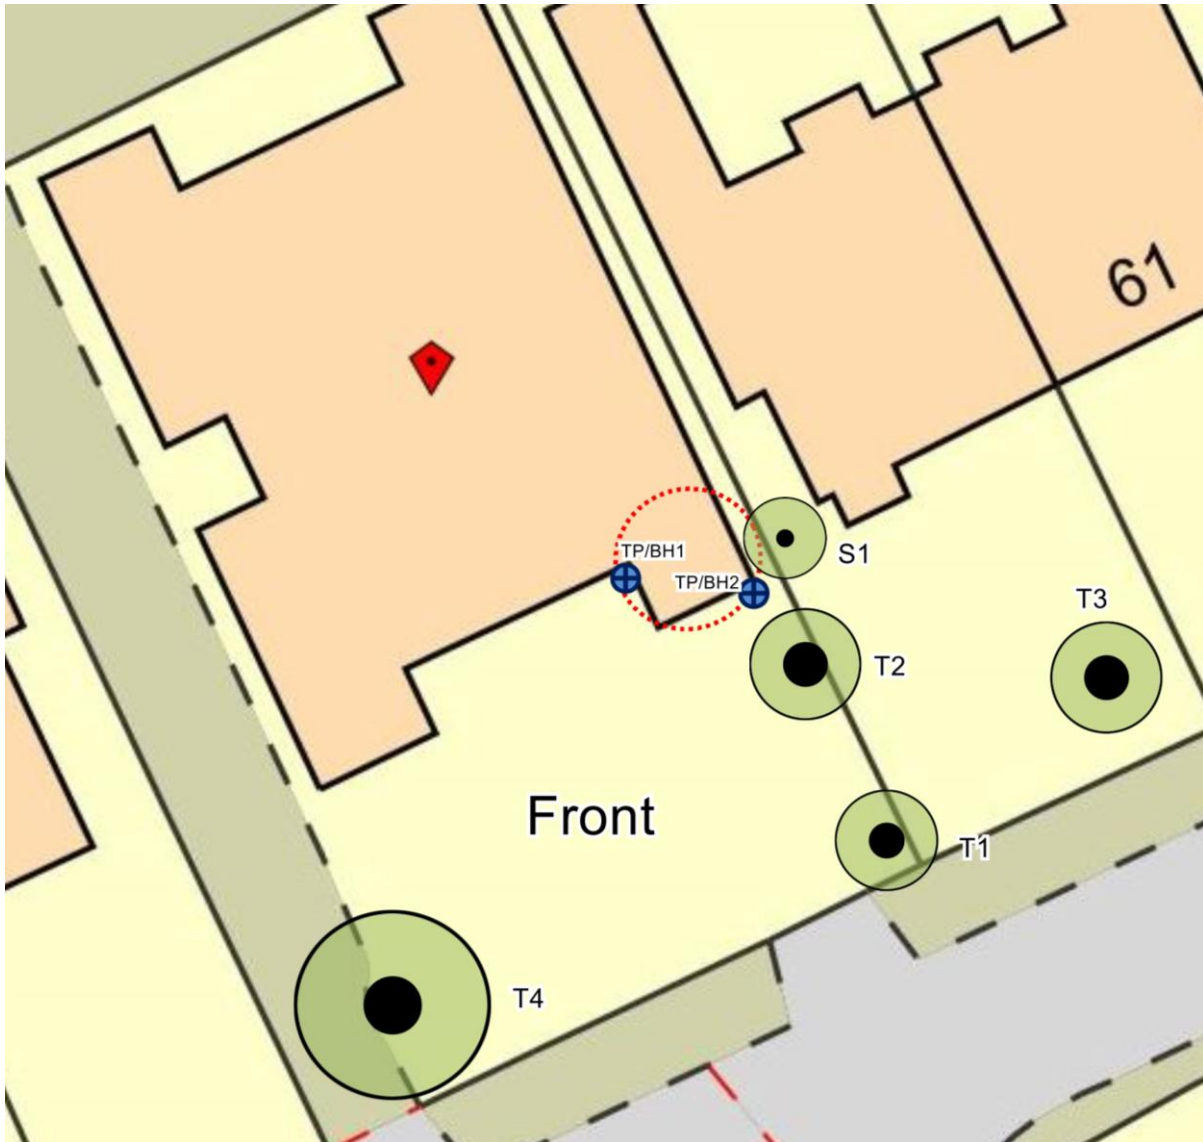
Site Plan

If an arboricultural solution is to be implemented to mitigate the influence of the implicated trees/vegetation we recommend that T2, T3, T4 and S1 are removed. Other vegetation recorded presents a potential future risk to building stability and management is therefore recommended.
