# Ampney Park

## Preliminary Bat Roost Assessment and Survey

April 2021

Client: Simon Morray-Jones  
Architects Ltd  
Report Ref: SEB2429\_01  
Author:  
Kate Hayward MCIEEM  
[www.seasonsecology.co.uk](http://www.seasonsecology.co.uk)

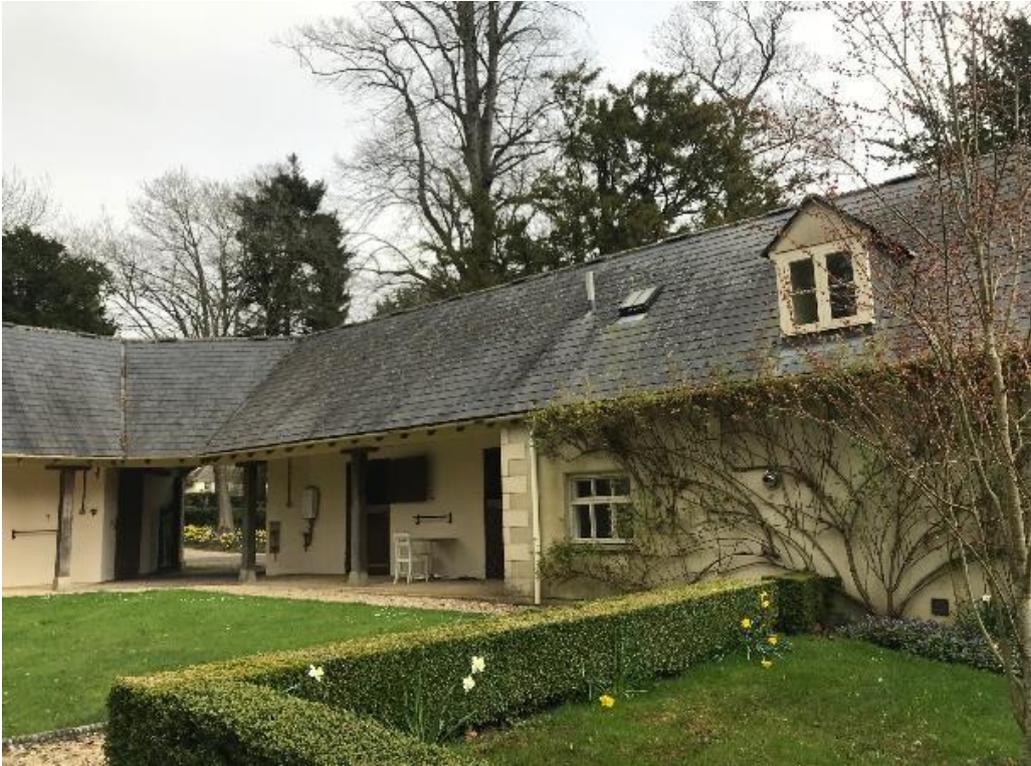
- 4.2.16 The Stables and Grooms Flat is an L-shaped building, with rendered external stone walls and a pitched slate-tiled roof. The Grooms Flat is at the southern end and has a dormer window and a roof light on the west aspect of the roof and two dormer windows on the east aspect of the roof. A car port is located beneath the first floor of the Grooms Flat on the east aspect (refer to Photographs 8 and 9, Annex 4).
- 4.2.17 The rendering of the walls is in good condition with no gaps or cracks presents and the slate tiles are flush and in good condition with no gaps evident. Gaps are present underneath the ridge tiles at equal spacings along the ridge.

Photograph 9. The east aspect of the Stables and Grooms Flat showing the car port below the flat.

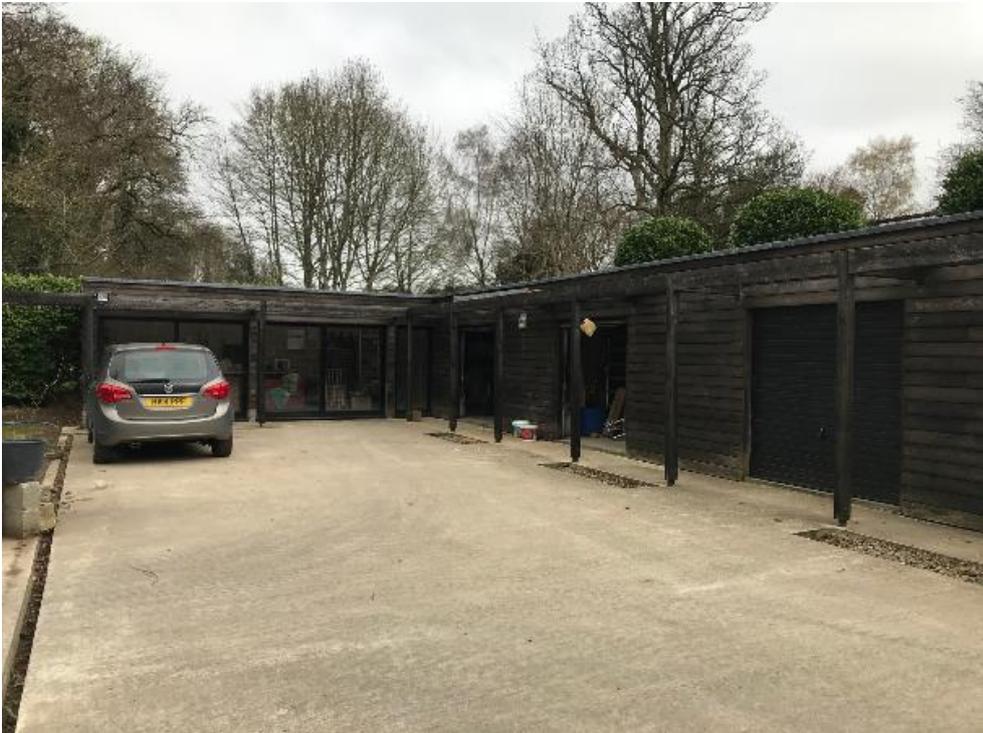
Photograph 14. The Grounds Building.

- 4.2.27 The Grounds Building is a modern, single-storey, L-shape building, located within the wider grounds of the estate away from the Main House and other ancillary buildings. It constructed of blockwork walls with wooden cladding and a flat, lead-lined, gravel roof (refer to Photograph 14, Annex 4). Two large windows are present on the east aspect and three large metal garage doors are located on the south aspect. The external wood cladding and lead-lining of the roof are tight and well-sealed.
- 4.2.28 The internal area was not accessed, but there is no enclosed roof space, all areas being living accommodation/storage.

- 5.2.6 Grounds Building – This building will be converted/modified or replaced to create a ceremony space. This building is assessed as *Negligible* suitability to roosting bats. No further surveys are recommended.
